ASBESTOS SURVEY REPORT FOR DOXFORD PRINT WORKS, PALLION QUAY, SUNDERLAND, SR4 6TQ

Asbestos Register for Doxford Printworks, Pallion Quay

Doxford Printworks Last updated 14/03/2024 V.2.0

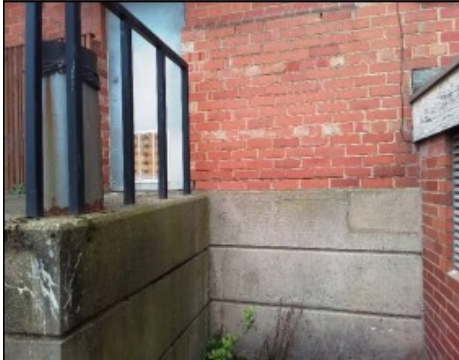
Item 1 Ref: OQ000197

The damp proof course to WH Forster (Older Red Bricks) External to Factory/Warehouse does not contain asbestos.

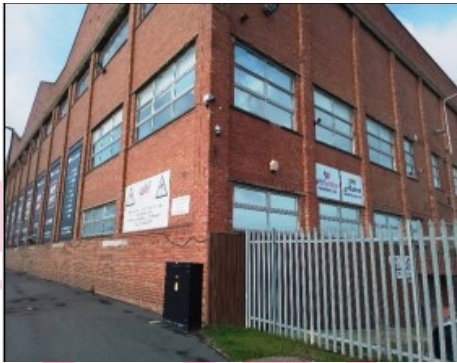
Item 2 Ref: OQ000198

The damp proof course beneath concrete window sills to WH Forster, External to Factory/Warehouse does not contain asbestos.

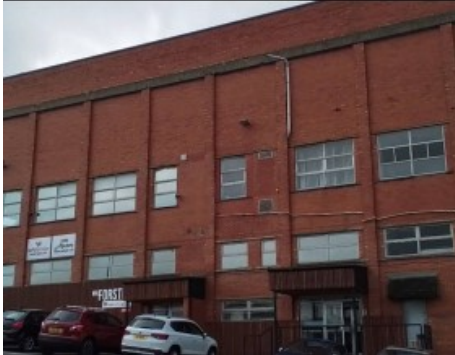
Item 4 Ref: OQ000200

The window putty/seal to aluminium window frames, External to Factory/Warehouse does not contain asbestos.

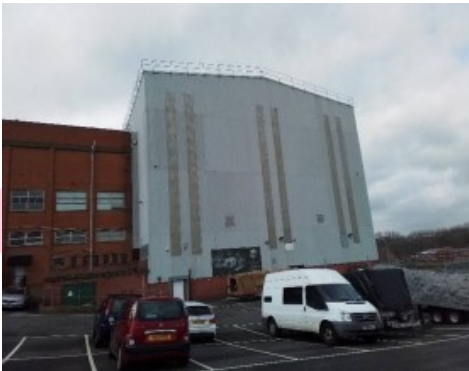
Item 5 Ref: OQ000201

The wall – sheet/cladding, External to Factory/Warehouse does not contain asbestos.

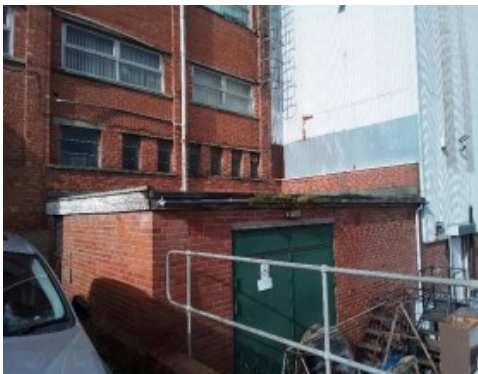
Item 6 Ref: OQ000202

The roof – felt to canopies and flat roof, External to Factory/Warehouse does not contain asbestos.

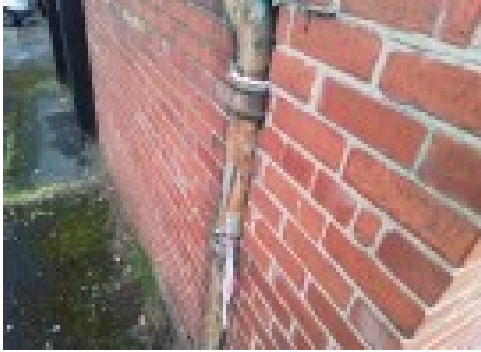
Item 7 Ref: OQ000203

The pipe joints –
caulking/packing, External to
Factory/Warehouse does
contain asbestos.

Any change in its appearance
should be recorded and
passed to Property Services.
