ASBESTOS SURVEY REPORT FOR BURNSIDE ACADEMY, BURNSIDE ESTATE,
HOUGHTON LE SPRING

Asbestos Register for

**BURNSIDE ACADEMY, BURNSIDE ESTATE, HOUGHTON LE
SPRING**

Burnside Academy - Last updated 13/02/2025 – Version 2

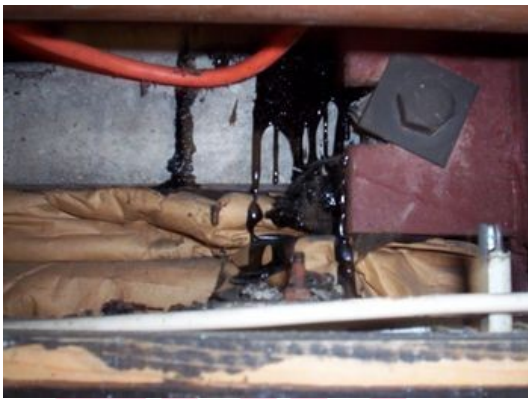
Item 2 - Ref: BS/02

The bitumen overspray to the void above the staff room does not contain asbestos.

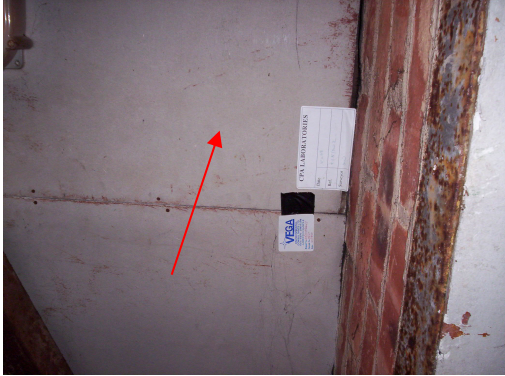
Item 18 – Ref: BS/07

The ceiling panel to the gas house contains asbestos.

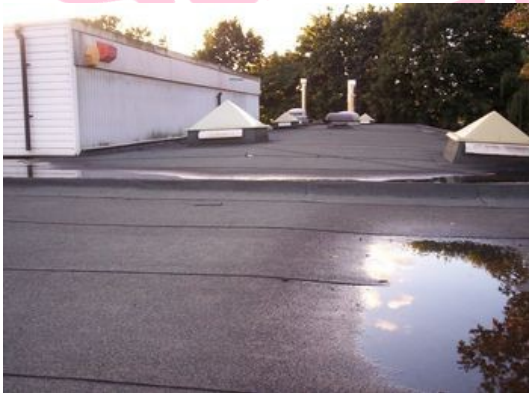
Item 23 – Ref: BS/02

The roof felt to the exterior does not contain asbestos.

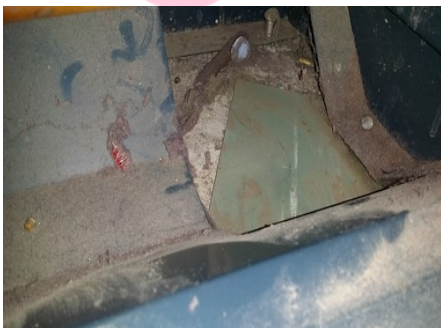
Item 29 – As 78145-1

The remnant floor covering trapped below the heater cabinet in the classroom contains asbestos.

Any change in its appearance should be recorded and passed to Property Services.

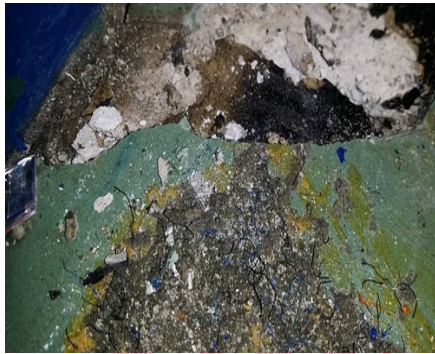
Item 34 – As 78145-2

The remnant floor adhesive to the corridor contains asbestos.

Removed March 2018.

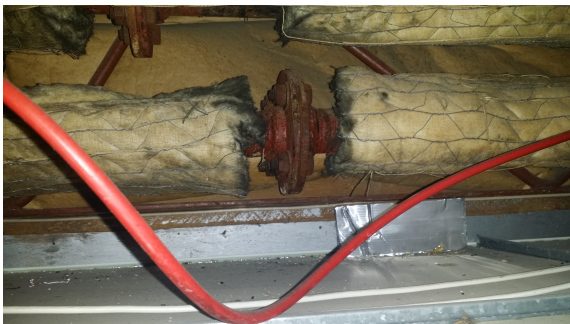
Item 41 – Ref Presumed

The gasket to the pipework in the void above the kitchen is presumed to contain asbestos.

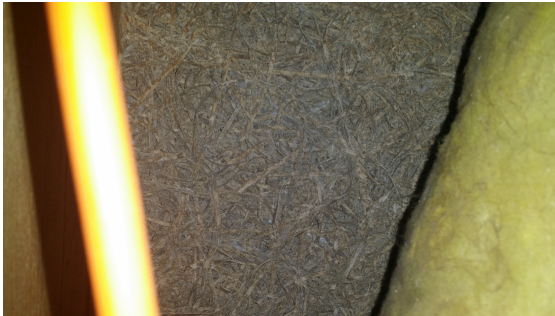
Item 42 – Ref: 139157-2

The insulation board to the void above the corridor does not contain asbestos.

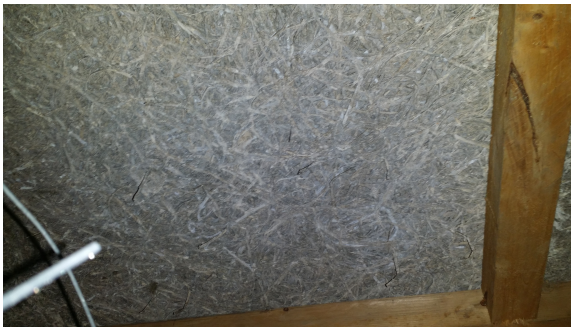
Item 43 – Ref As 139157-2

The insulation board to the void above the staff room does not contain asbestos.

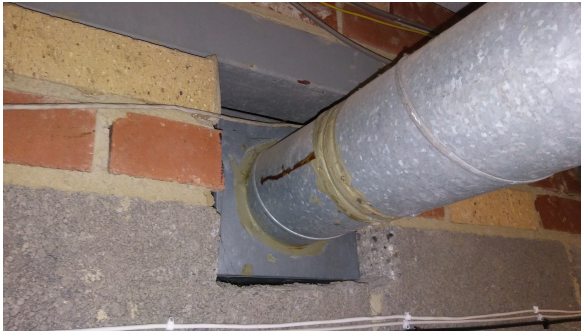
Item 46 – Ref: 303561-1

The sealant to the ductwork in the KS2 Boiler Room (Room 028) does not contain asbestos.

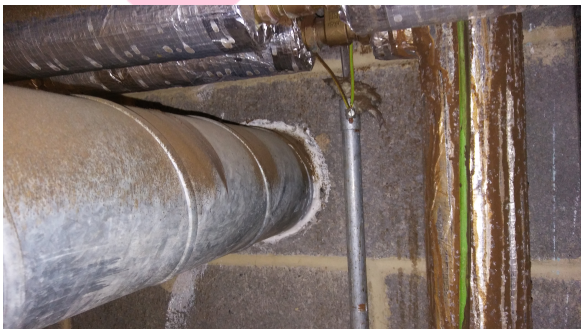
Item 47 – Ref: 303561-2

The packing to the ductwork penetration to the wall in the KS2 Boiler Room (Room 028) does not contain asbestos.

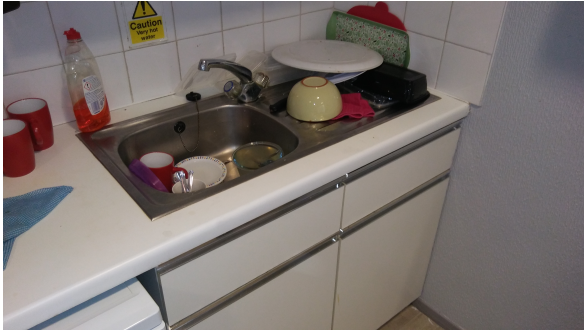
Item 48 – Ref: 345636-3

The acoustic sink pad in the staff room (Room 008) does not contain asbestos.

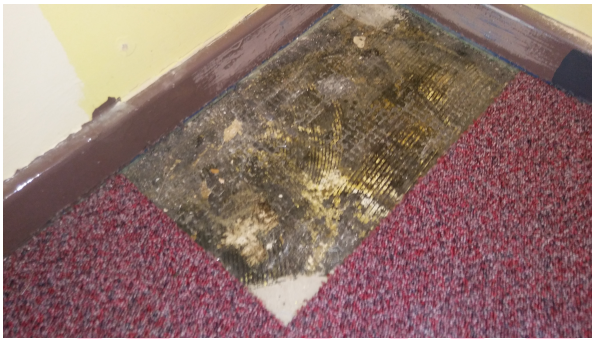
Item 49 – Ref: 345636-1

The remnant adhesive to the floor in classroom (room 020) does contain asbestos.

Any change in appearance should be reported to Property Services.

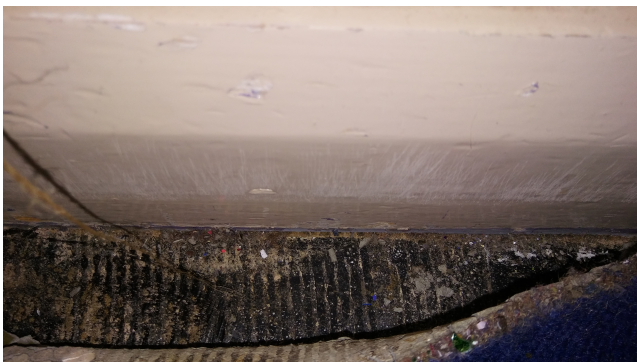
Item 53 – Ref: 345636-2

The remnant adhesive to the floor in classroom (room 029) does contain asbestos.

Any change in appearance should be reported to Property Services.

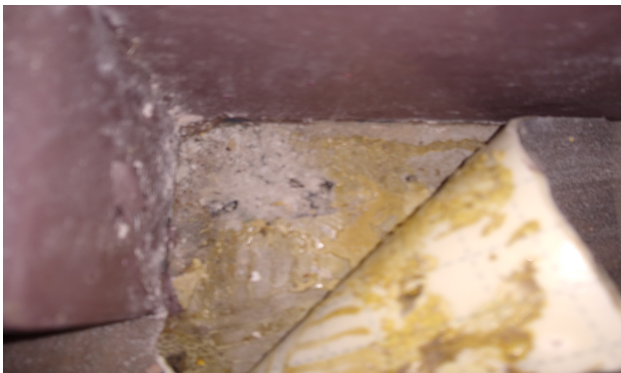
Item 56 – Ref: 366050-1

The remnant adhesive to the floor in corridor (room 021) does contain asbestos.

(Screeded over Oct 22 – But residual still in place)

Any change in appearance should be reported to Property Services.

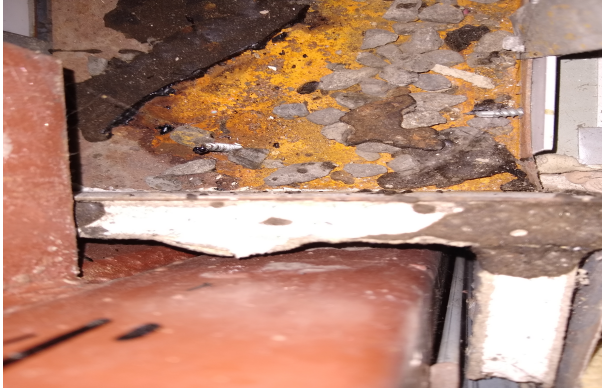
Item 57 – Ref: 345636-2

The remnant adhesive to the floor in classroom (room 028) does contain asbestos.

(Screeded over Oct 22 – But residual still in place)

Any change in appearance should be reported to Property Services.

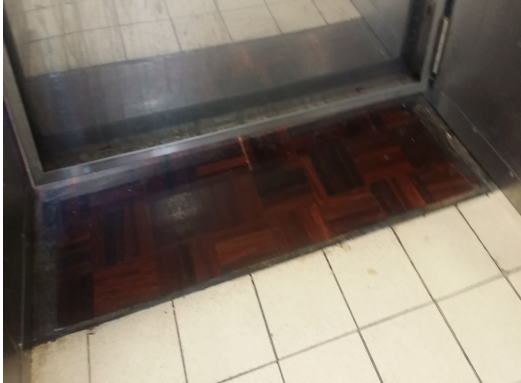
Item 60 – Ref: 209851-2

The bitumen underside of wooden parquet and concrete floor in adj hall in Kitchen (Room 001) does not contain asbestos.

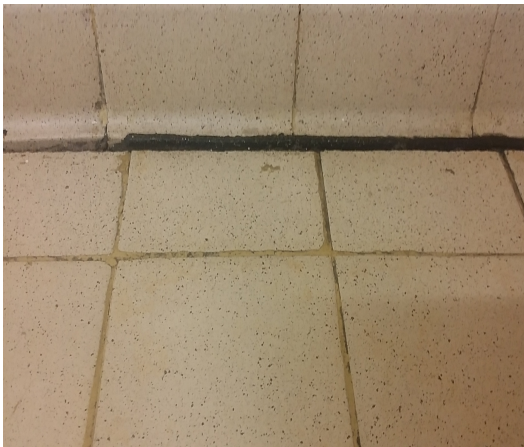
Item 61 – Ref: 209851-1

The filer to floor covering edges in the kitchen (Room 001) does not contain asbestos.

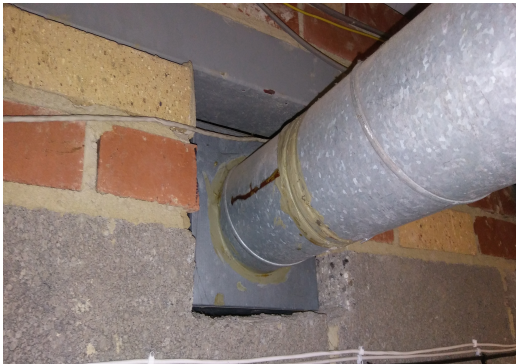
Item 62 – Ref: 303561-1

The sealant to ductwork in the KS2 boiler room (Room 028) does not contain asbestos.

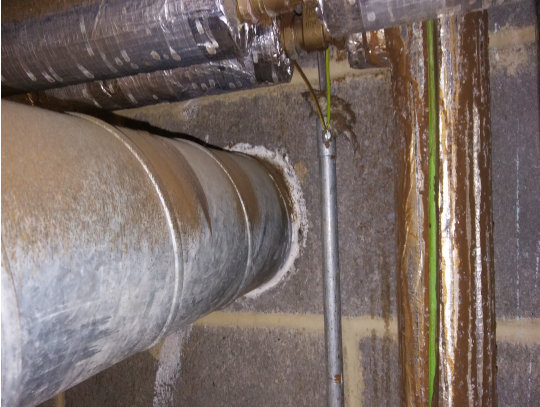
Item 63 – Ref: 303561-2

The packing to ductwork penetration to wall in the KS2 boiler house (Room 028) does not contain asbestos.

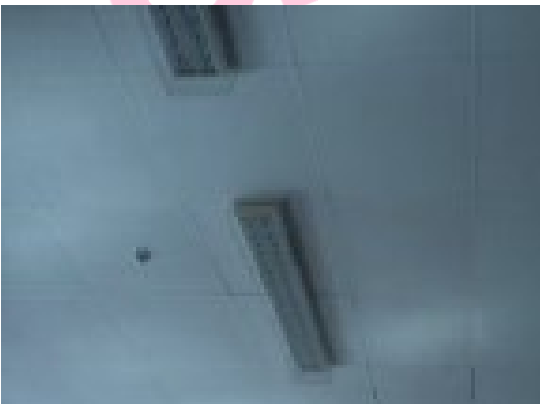
Item 65 – Ref: AS006336

The debris behind ceiling tiles in the assembly Hall/R2 does not contain asbestos.

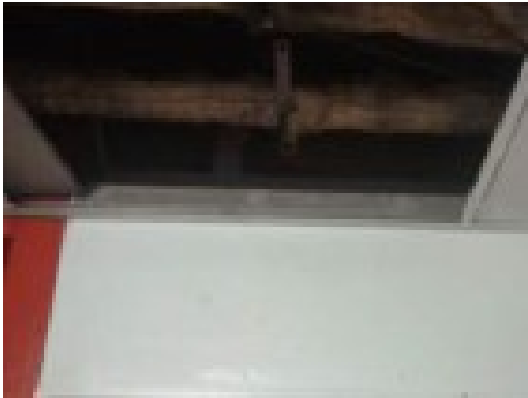
Item 66 – Ref: AS006369

The panel to the wall in the Hall Store Room/R5 does not contain asbestos.

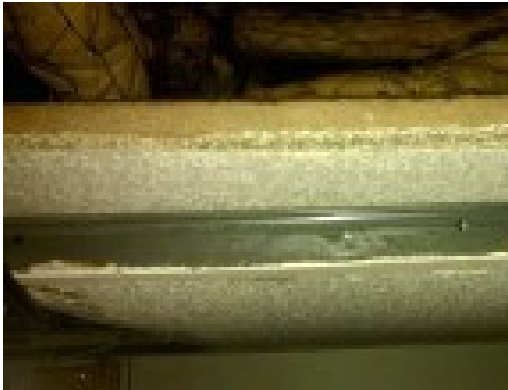
Item 69 – Ref: As AS006371

The ceiling tiles in the Corridor/R1 does not contain asbestos.

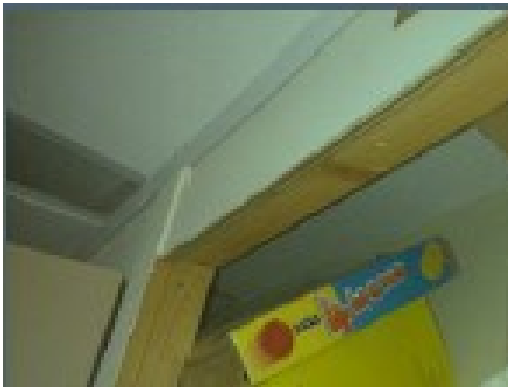
Item 70 – Ref: AS006372

The partition wall in the corridor/R1 does not contain asbestos.

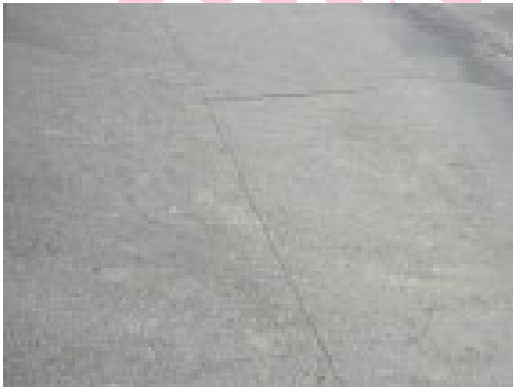
Item 74 – Ref: AS006329

The felt to flat roof (External/R2) does not contain asbestos.

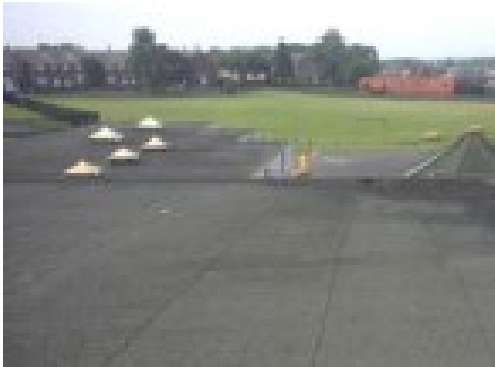
Item 75 – Ref: AS006330

The felt to flat roof
(External/R2) does not contain
asbestos.

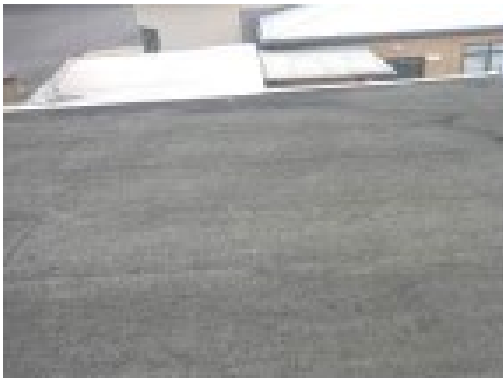
Item 76 – Ref: AS006331

The felt to flat roof
(External/R2) does not contain
asbestos.

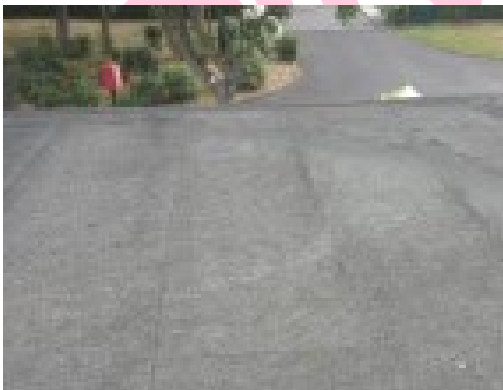
Item 77 – Ref: AS006332

The felt to flat roof
(External/R2) does not contain
asbestos.

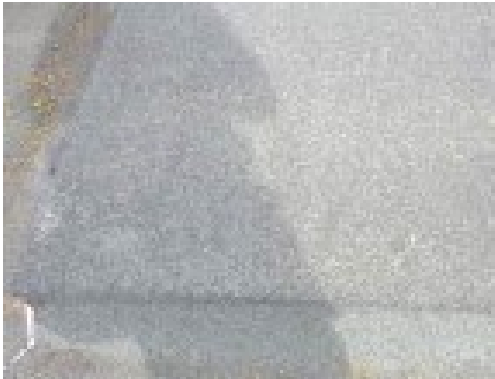
Item 78 – Ref: AS006333

The felt to flat roof hatch (External/R2) does not contain asbestos.

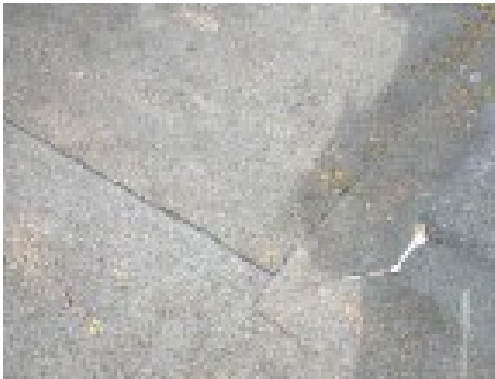
Item 79 – Ref: AS006334

The mastic sealant to hatch to roof (External/R2) does not contain asbestos.

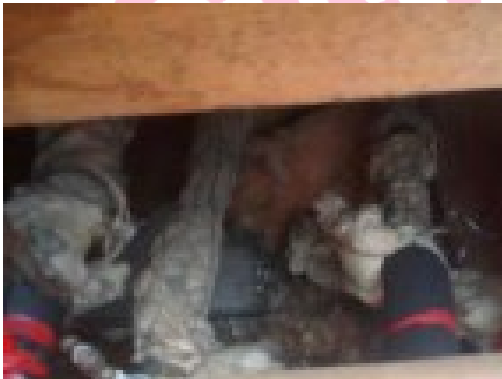
Item 80 – Ref: AS006335

The insulation to pipe run within roof hatch (External/R2) does not contain asbestos.

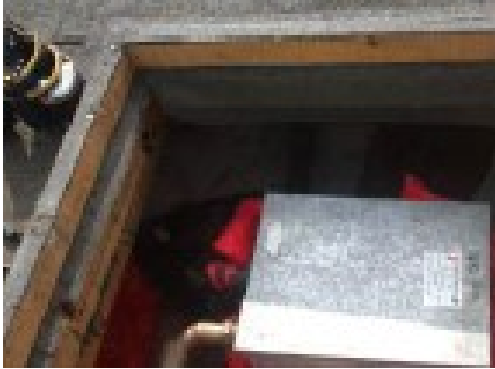
Item 81 – Ref: AS006336

The debris within roof hatch (External/R2) does not contain asbestos.

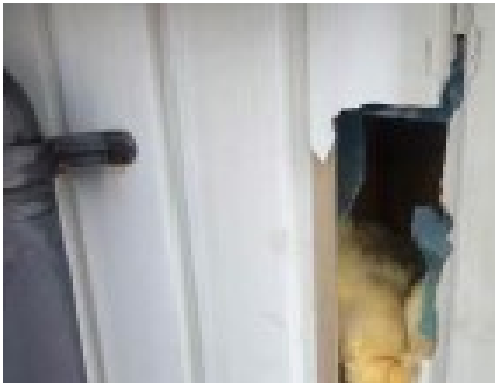
Item 82 – Ref: AS006337

The residue to timber upstand panels behind external plastic cladding (External/R2) does not contain asbestos.

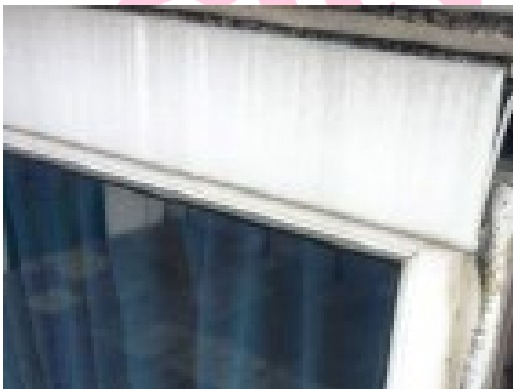
Item 83 – Ref: AS006338

The gal panels behind plastic cladding and PVCU window frames (External/R2) does not contain asbestos.

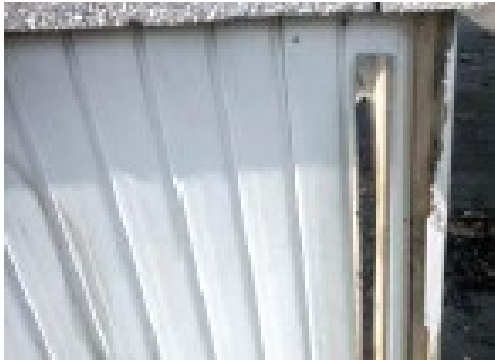
Item 84 – Ref: AS006339

The felt packer to plastic cladding corner piece (External/R2) does not contain asbestos.

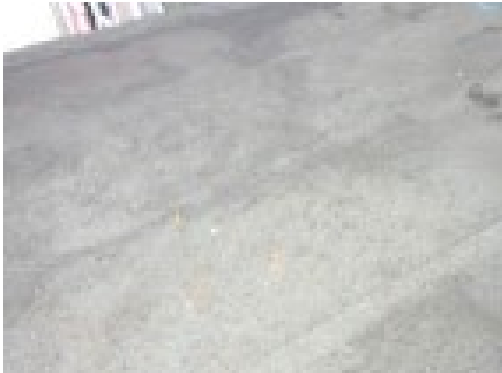
Item 87 – Ref: AS006342

The felt to flat roof
(External/R4) does not contain
asbestos.

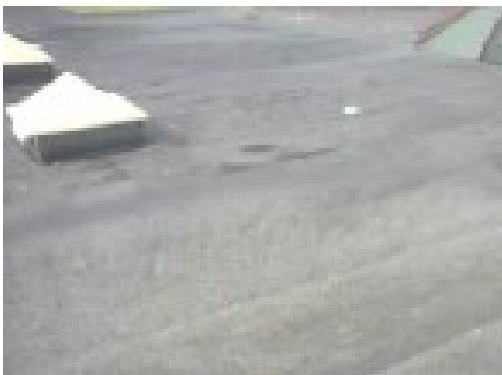
Item 88 – Ref: AS006343

The felt to flat roof
(External/R4) does not contain
asbestos.

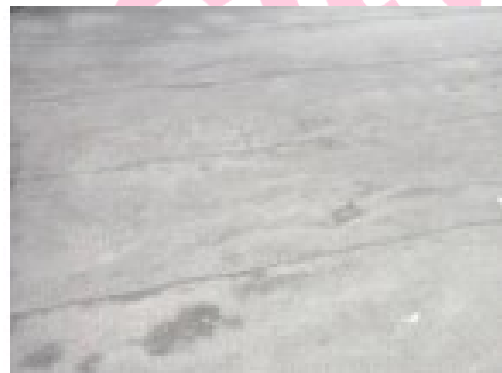
Item 89 – Ref: AS006344

The felt to flat roof
(External/R4) does not contain
asbestos.

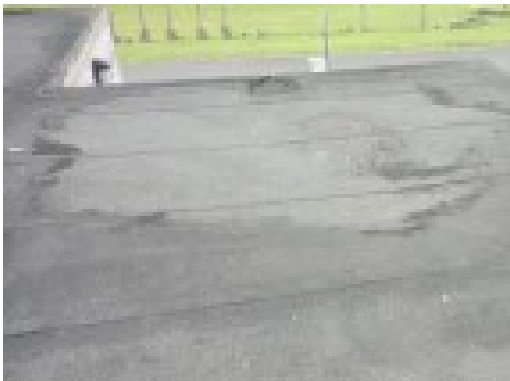
Item 91 – Ref: AS006346

The felt to flat roof
(External/R4) does not contain
asbestos.

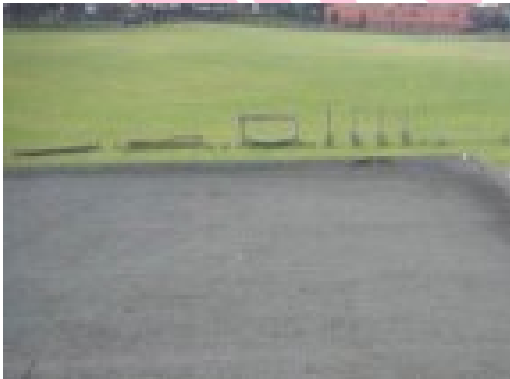
Item 92 – Ref: AS006347

The felt to flat roof
(External/R4) does not contain
asbestos.

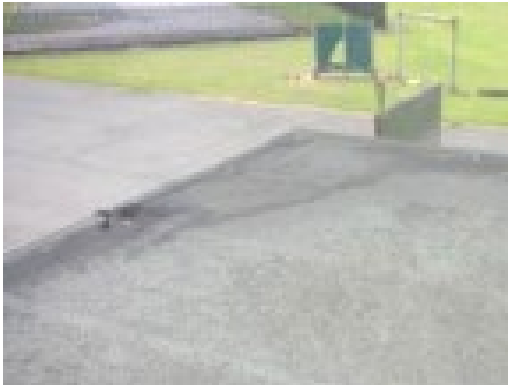
Item 93 – Ref: AS006348

The felt to flat roof
(External/R4) does not contain
asbestos.

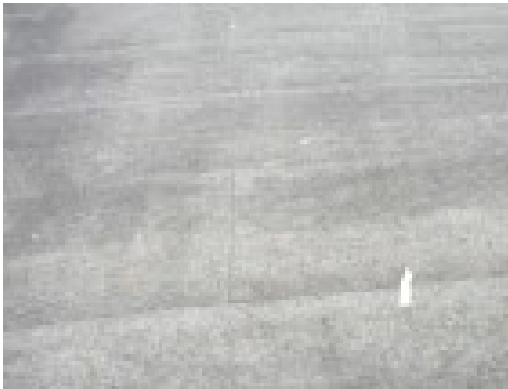
Item 94 – Ref: AS006349

The felt to flat roof
(External/R4) does not contain
asbestos.

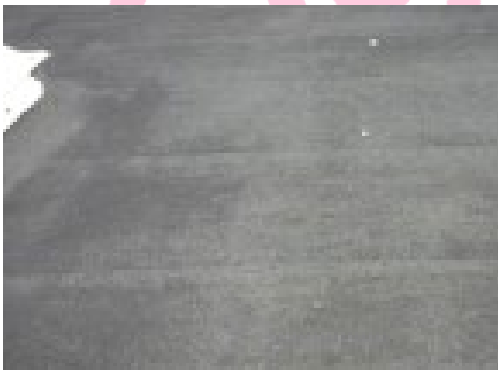
Item 95 – Ref: AS006350

The felt to flat roof
(External/R4) does not contain
asbestos.

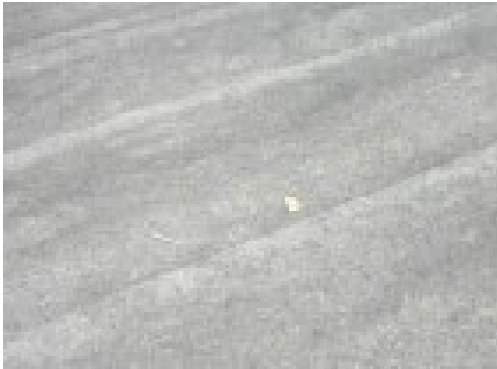
Item 96 – Ref: AS006351

The felt to flat roof
(External/R4) does not contain
asbestos.

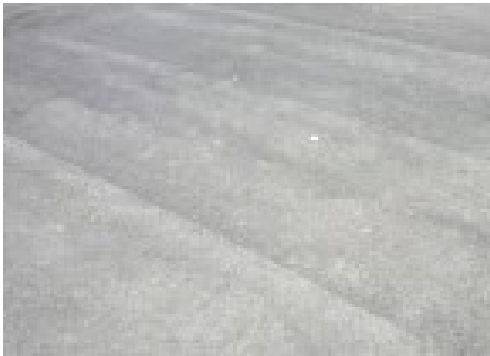
Item 97 – Ref: AS006352

The felt to flat roof
(External/R4) does not contain
asbestos.

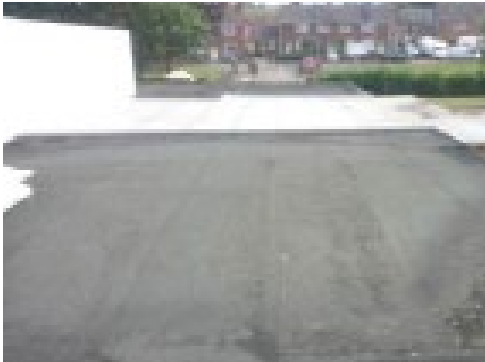
Item 99 – Ref: AS006354

The felt to flat roof
(External/R4) does not contain
asbestos.

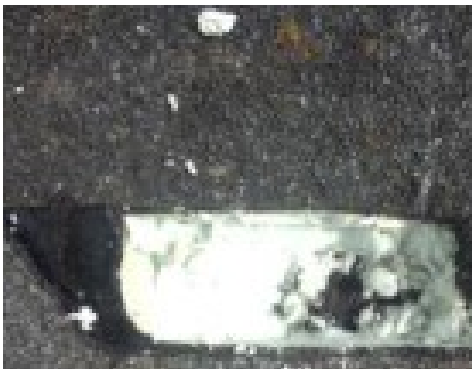
Item 100 – Ref: AS006355

The felt to flat roof
(External/R4) does not contain
asbestos.

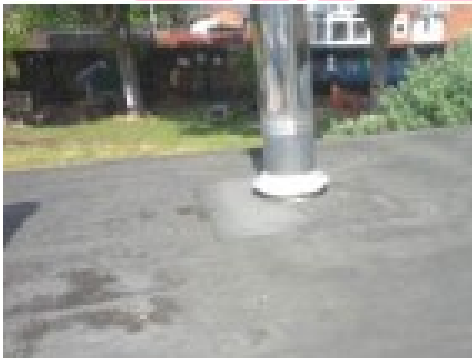
Item 101 – Ref: AS006356

The felt to flat roof
(External/R1) does not contain
asbestos.

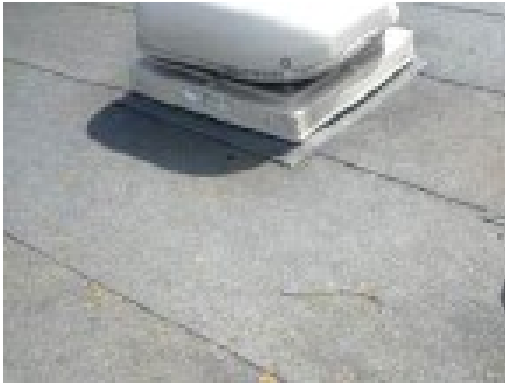
Item 102 – Ref: AS006357

The felt to flat roof
(External/R1) does not contain
asbestos.

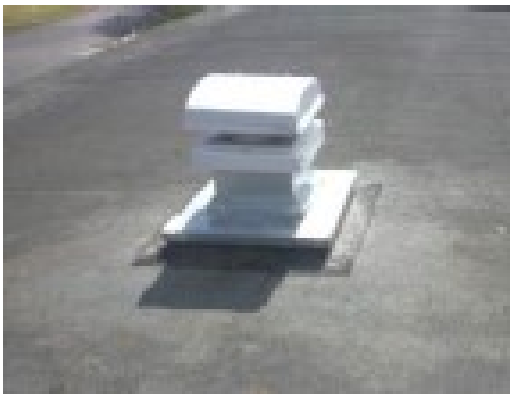
Item 103 – Ref: AS006358

The felt to flat roof
(External/R1) does not contain
asbestos.

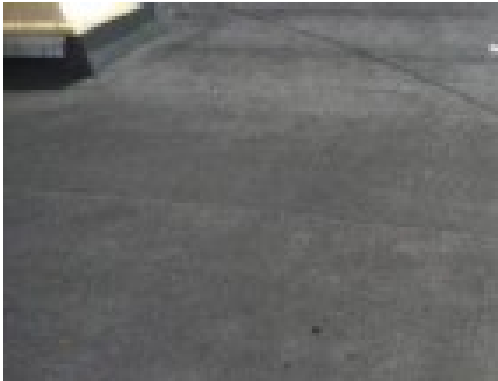
Item 105 – Ref: AS006360

The felt to flat roof
(External/R1) does not contain
asbestos.

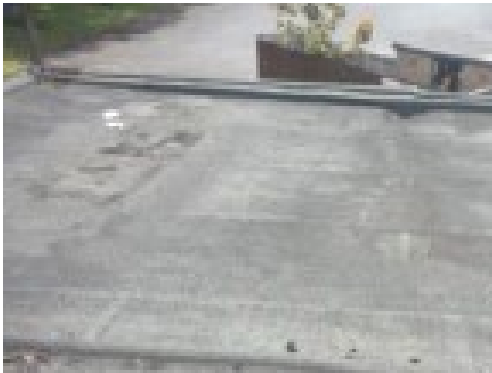
Item 106 – Ref: AS006361

The felt to flat roof
(External/R1) does not contain
asbestos.

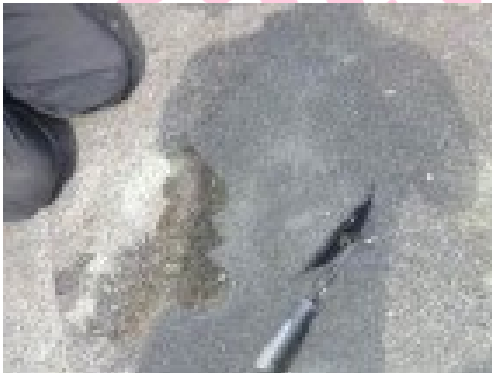
Item 107 – Ref: AS006362

The felt to flat roof
(External/R5) does not contain
asbestos.

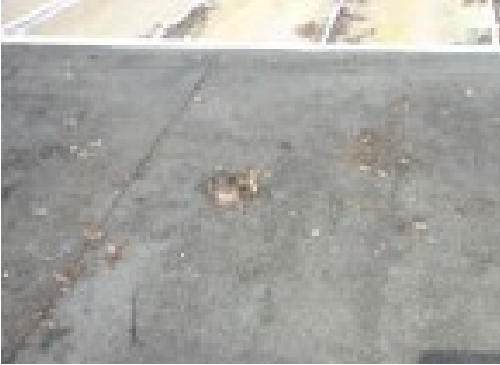
Item 108 – Ref: AS006363

The bitumen base layer between timber and foam (External/R5) does not contain asbestos.

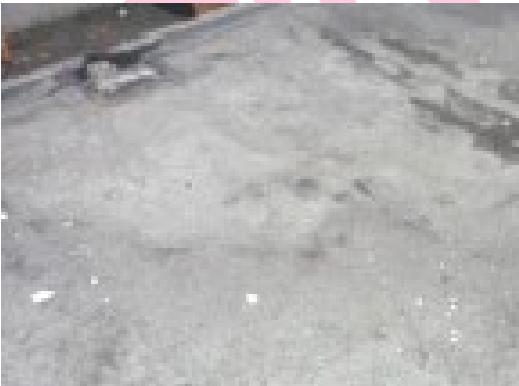
Item 110 – Ref: AS006365

The felt to flat roof (External/R6) does not contain asbestos.

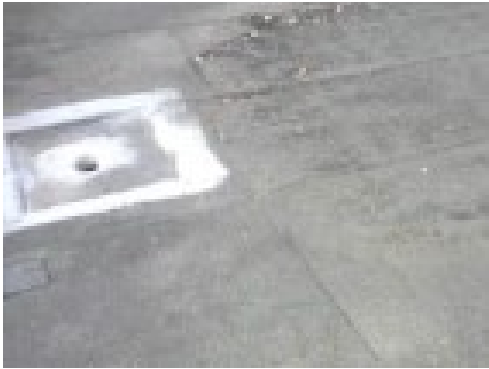
Item 111 – Ref: AS006366

The felt to flat roof
(External/R6) does not contain
asbestos.

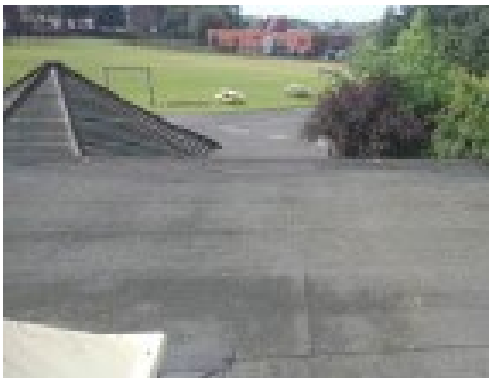
Item 112 – Ref: AS006367

The felt to flat roof
(External/R6) does not contain
asbestos.

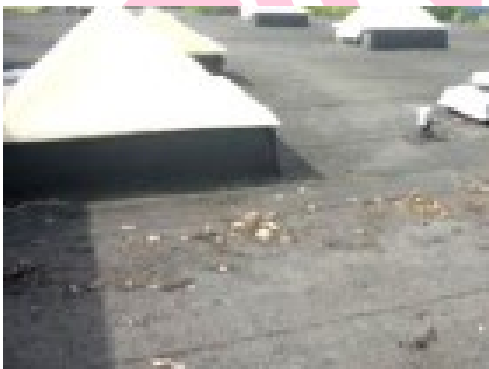
Item 113 – Ref: AS006368

The bitumen to the base layer
(External/R6) does not contain
asbestos.

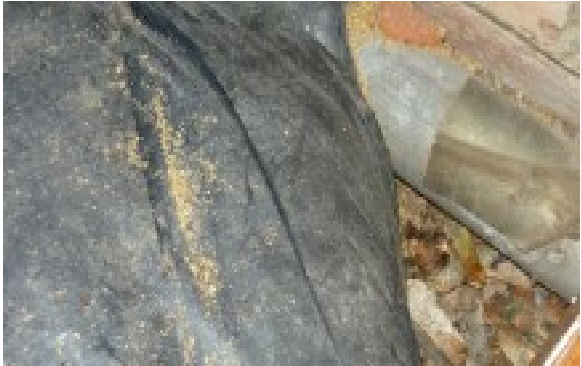
Item 117 – Ref: AW0733/11

The debris to the floor in the gas main room does contain asbestos.

This was removed July 2011.

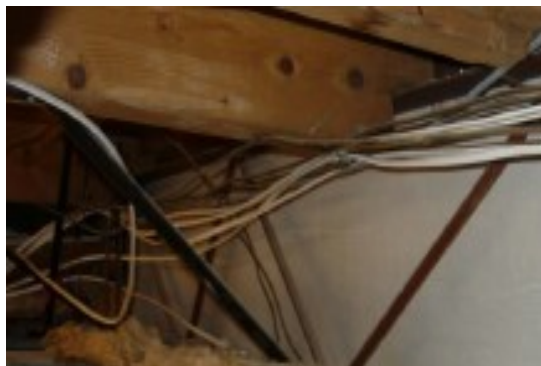
Item 122 – Ref: AW0729/11

The pipework flange gasket in the ceiling void in the office (Rm 011) is presumed to contain asbestos.

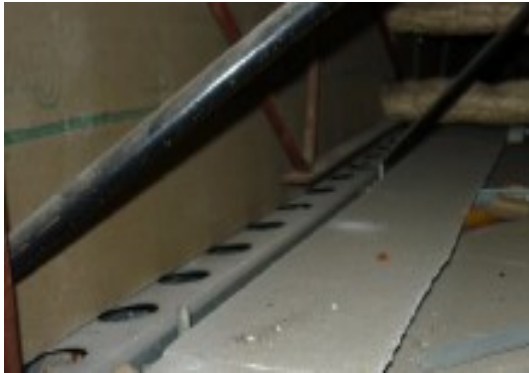
Item 123 – Ref: AW0730/11

The remains of insulation board in the classroom ceiling void (Rm 033) does contain asbestos.

This was removed July 2011.

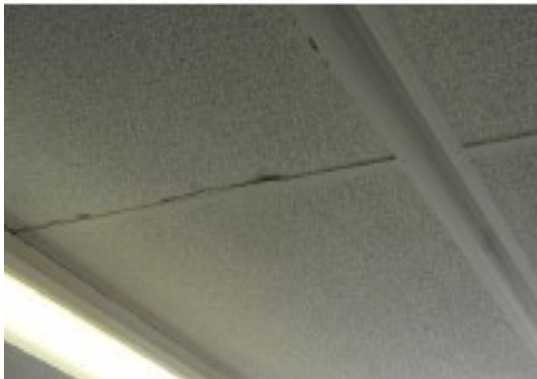
Item 124 – Ref: AW0731/11

The horizontal panel in the corridor (Rm 041) does contain asbestos.

Advised by school – removed 2018 – no WCN paperwork

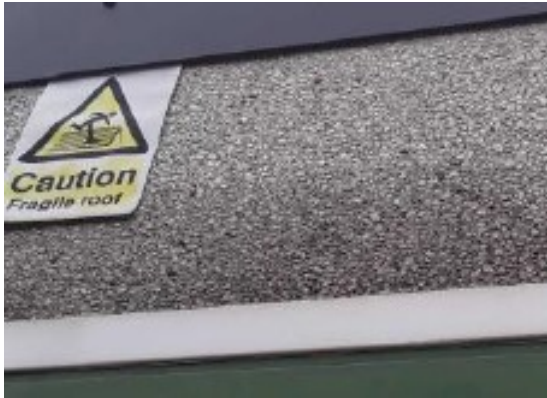
Item 126 – Ref: 21-39203-1

The mastic to concrete panel jointing compound to walls (Area 2/External) does not contain asbestos.

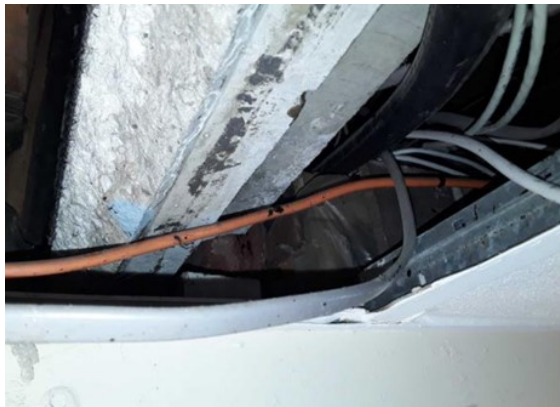
Item 127 – Ref: Presumed

The lining inside clasp columns in the fire exit hallway (Area 5) is presumed to contain asbestos.

Any change in appearance should be reported to Property Services.

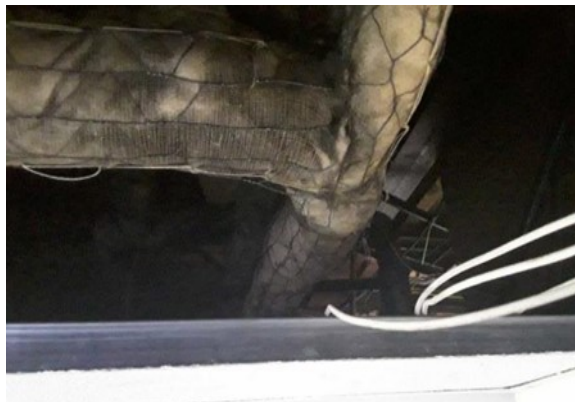
Item 146 – Ref: 22-50659-3

The string wrap to mmmf lagged pipes in the store cupboard (Area 11) does not contain asbestos.

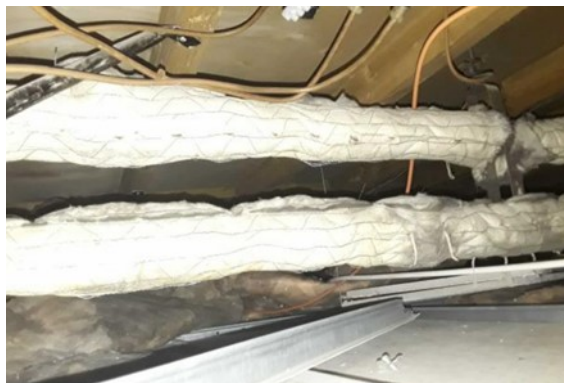
Item 155 – Ref: 22-50659-3

The string wrap to mmmf lagged pipes in the corridor (Area 13) does not contain asbestos.

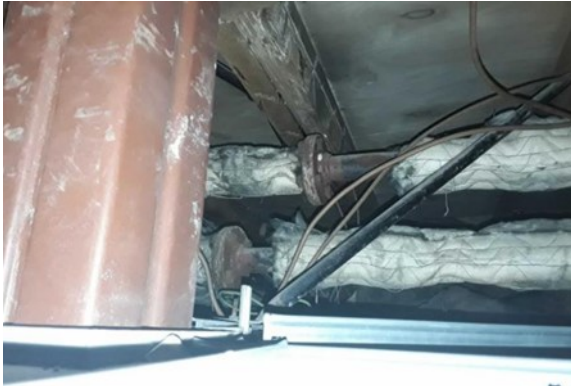
Item 156 – Ref: Presumed

The pipe flanges (gaskets) in the headteachers office (Area 14) is presumed to contain asbestos.

Any change in appearance should be reported to Property Services.

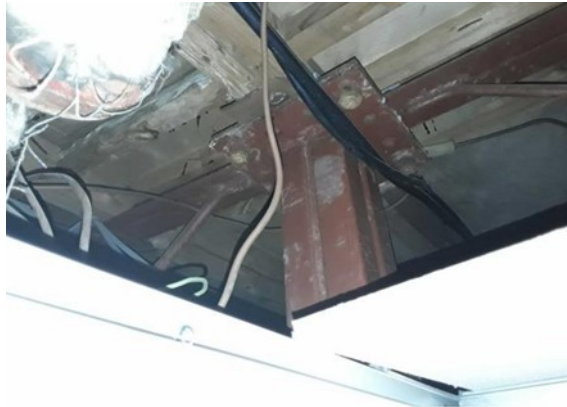
Item 157 – Ref: Presumed

The lining inside clasp cupboards in the headteachers store (Area 15) is presumed to contain asbestos.

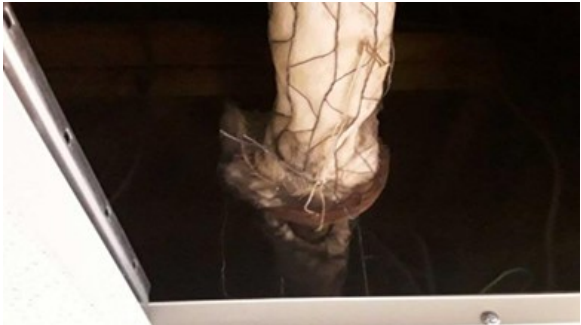
Item 159 – Ref: Presumed

The pipe flanges (gaskets) in the headteachers store (Area 15) is presumed to contain asbestos.

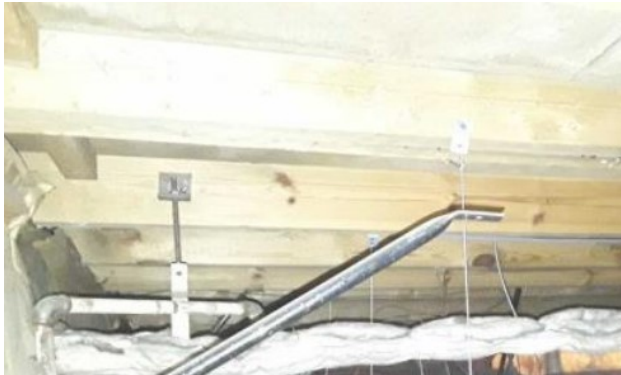
Item 168 – Ref: 22-50659-3

The string wrap to mmmf lagged pipes in the Year 2 Classroom and cupboards (Area 18) does not contain asbestos.

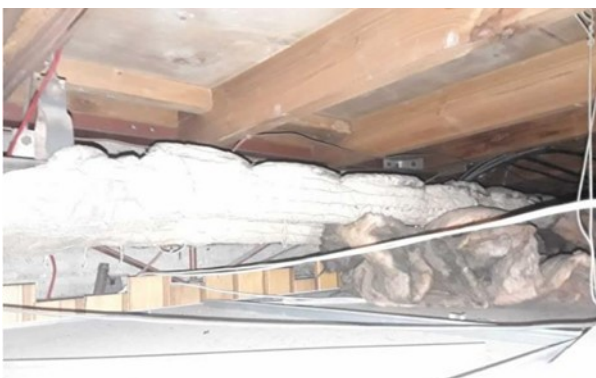
Item 188 – Ref: 22-50659-

The string wrap to mmmf lagged pipes in the hall (Area 27) does not contain asbestos.

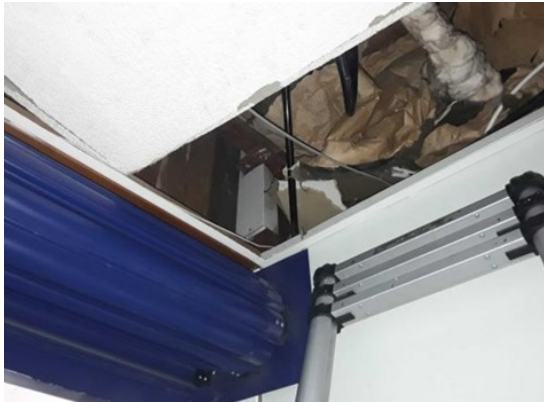
Item 189 – Ref: Presumed

The lining inside clasp columns in the hall store 1 (Area 28) is presumed to contain asbestos.

Any change in appearance should be reported to Property Services.

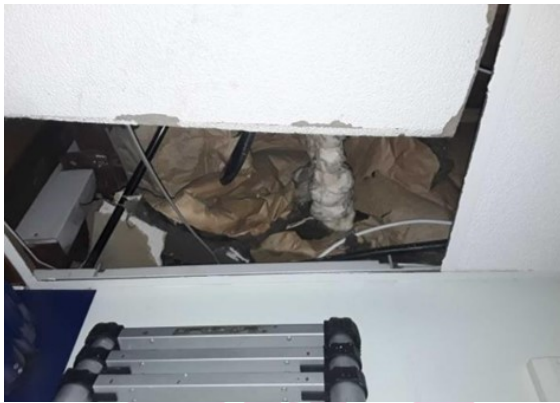
Item 190 – Ref: 22-50659-3

The string wrap to mmmf lagged pipes in the hall store 1 (Area 28) does not contain asbestos.
