ASBESTOS SURVEY REPORT FOR BURNSIDE ACADEMY, BURNSIDE ESTATE, HOUGHTON LE SPRING

**BURNSIDE ACADEMY, BURNSIDE ESTATE, HOUGHTON LE
SPRING**

Date: 18th June 2025

Burnside Academy - Last updated 18/06/2025 – Version 2

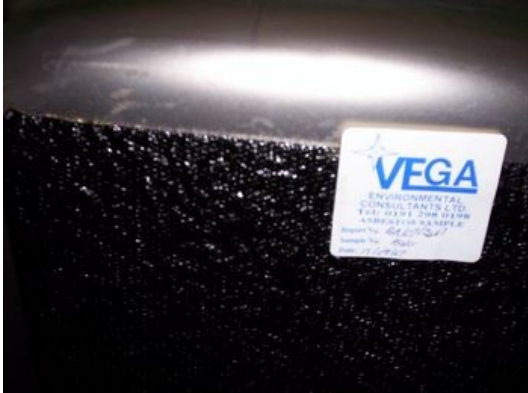
Item 1 Ref: BS/01

The sink pad to the staff room does not contain asbestos.

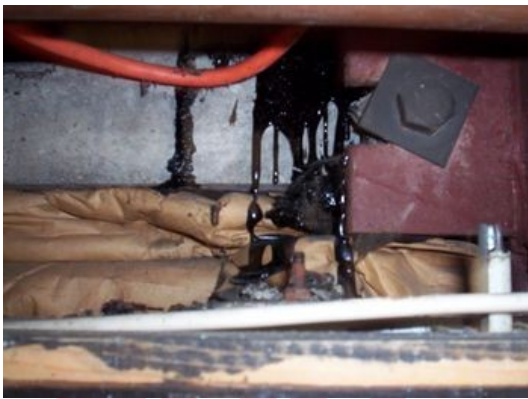
Item 2 - Ref: BS/02

The bitumen overspray to the void above the staff room does not contain asbestos.

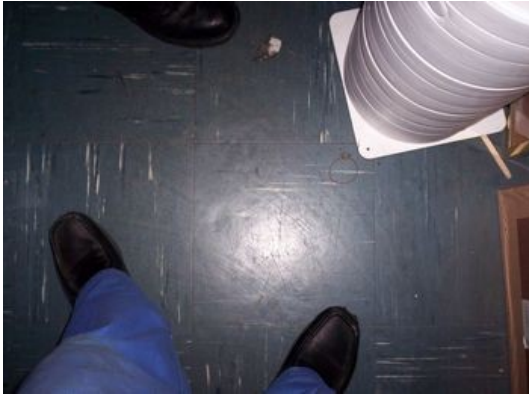
Item 4 - Ref: BS/03

The vinyl floor tile to the Stock Room 1 does not contain asbestos.

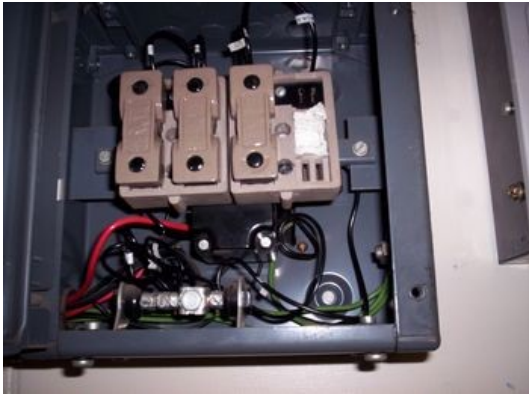
Item 12 - Ref: BS/06

The fuse flash guards to the cloakroom do not contain asbestos.

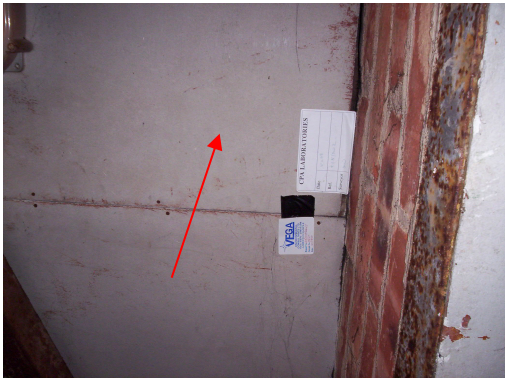
Item 18 – Ref: BS/07

The ceiling panel to the gas house contains asbestos.

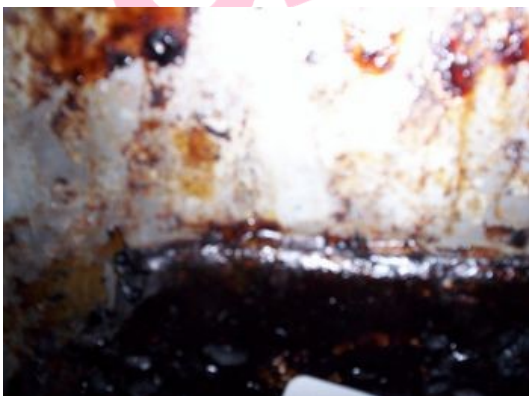
Item 20 – BS/08

The sink pad in the kitchen contains asbestos.

Any change in its appearance should be recorded and passed to Property Services.

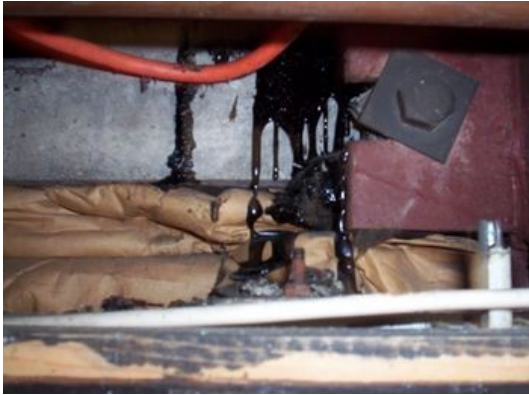
Item 21 – As BS/07

The bitumen overspray in the void above the kitchen does not contain asbestos.

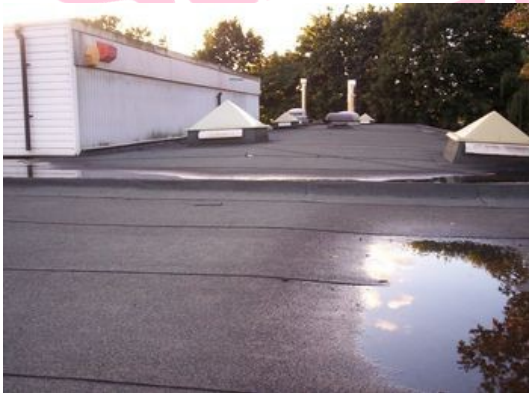
Item 23 – Ref: BS/02

The roof felt to the exterior does not contain asbestos.

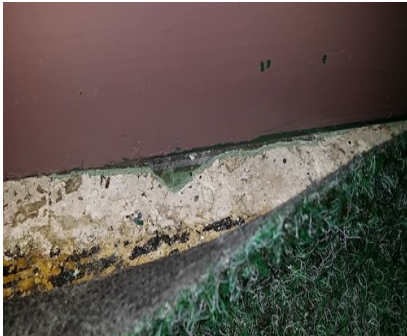
Item 24 – As 78145-1

The remnant floor covering trapped below the heater cabinet in the headteacher office contains asbestos.

Any change in its appearance should be recorded and passed to Property Services.

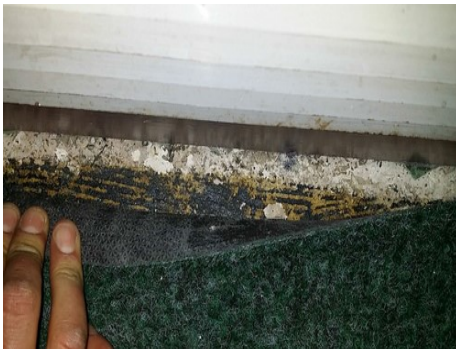
Item 25 – As 78145-2

The remnant floor adhesive to the head teachers office contains asbestos.

Any change in its appearance should be recorded and passed to Property Services.

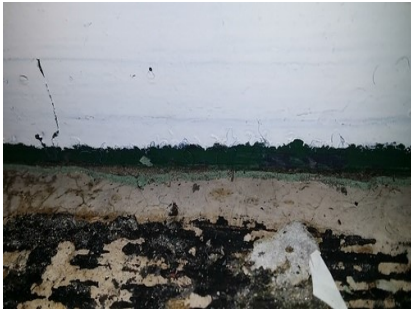
Item 27 – Ref: 78145-1

The remnant floor covering trapped below the heater cabinet in the ICT Room (previously library) contains asbestos.

Any change in its appearance should be recorded and passed to Property Services.

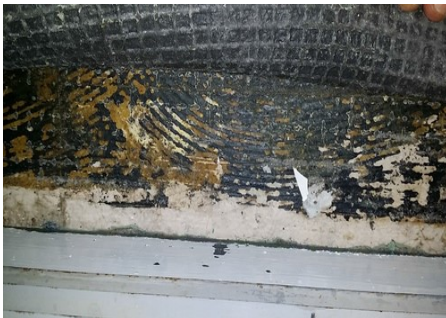
Item 28 – Ref: 78145-2

The remnant floor adhesive to the ICT Room (previously library) contains asbestos.

Any change in its appearance should be recorded and passed to Property Services.

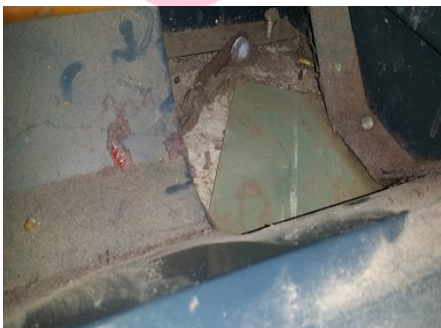
Item 29 – As 78145-1

The remnant floor covering trapped below the heater cabinet in the classroom contains asbestos.

Any change in its appearance should be recorded and passed to Property Services.

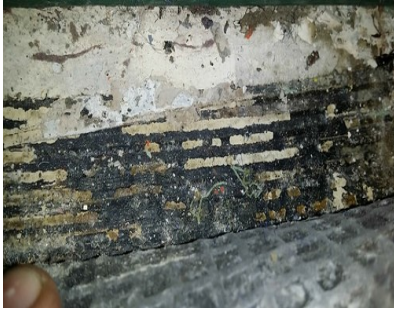
Item 30 – As 78145-2

The remnant floor adhesive to the classroom contains asbestos.

Any change in its appearance should be recorded and passed to Property Services.

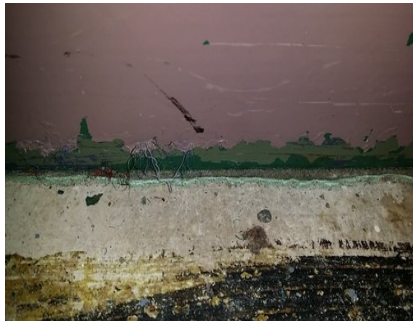
Item 31 – Ref: 78145-1

The remnant floor covering trapped below the heater cabinet in the classroom contains asbestos.

Any change in its appearance should be recorded and passed to Property Services.

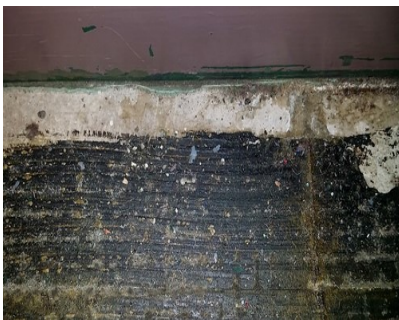
Item 32 – As 78145-2

The remnant floor adhesive to the classroom contains asbestos.

Any change in its appearance should be recorded and passed to Property Services.

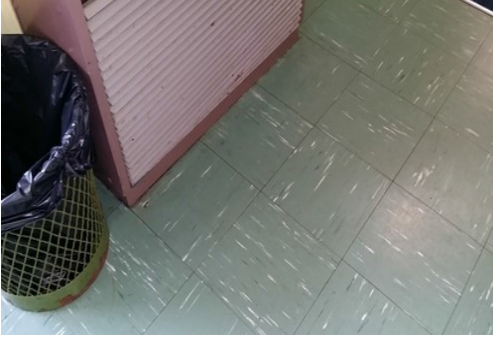
Item 33 – Ref: 78145-3

The remnant floor covering trapped below the heater cabinet in the corridor contains asbestos.

Removed March 2018.

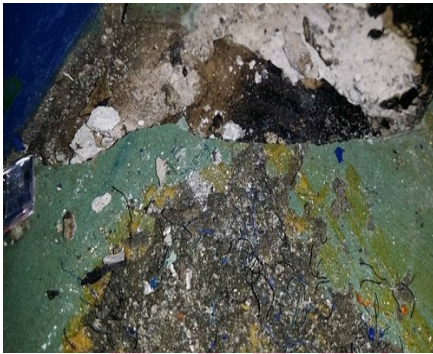
Item 34 – As 78145-2

The remnant floor adhesive to the corridor contains asbestos.

Removed March 2018.

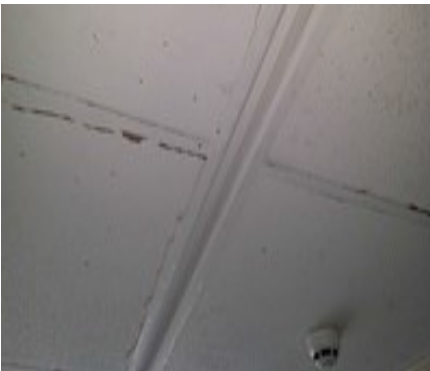
Item 35 – As 78145-4

The horizontal strip in the suspended ceiling to the corridor contained asbestos.

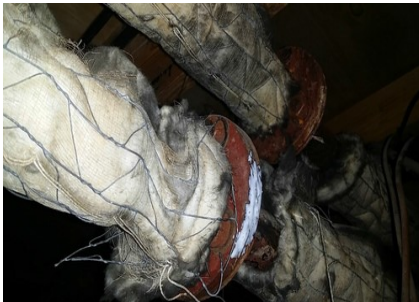
Item 37 – Ref: 78145-5

The flange gaskets to the pipework in the ceiling void to the corridor contain asbestos.

Any change in its appearance should be recorded and passed to Property Services.

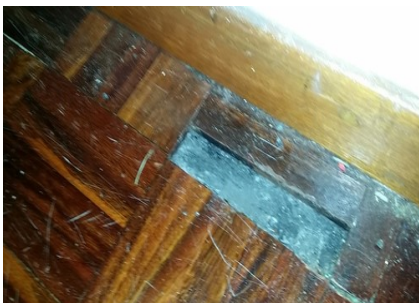
Item 38 – Ref: 78145-7

The adhesive to the wood parquet flooring in the hall does not contain asbestos.

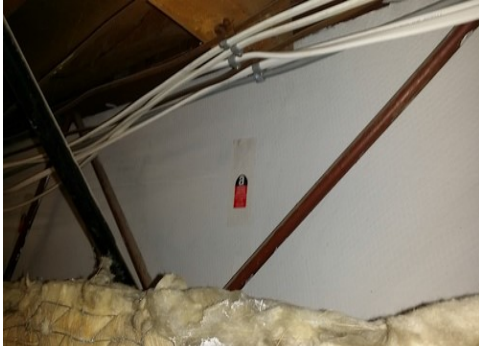
Item 39 – Ref: 78145-8

The fire break to the North West wall in the hall (ceiling void) contains asbestos.

Any change in its appearance should be recorded and passed to Property Services.

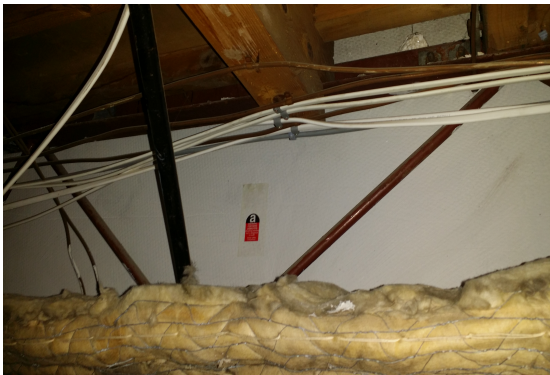
Item 40 – Ref 139157-1

The insulation to the WC ceiling void contains asbestos.

Any change in its appearance should be recorded and passed to Property Services.

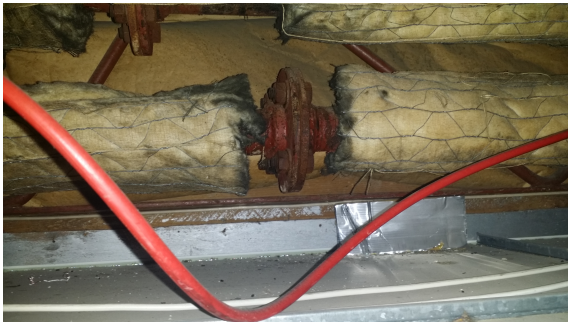
Item 41 – Ref Presumed

The gasket to the pipework in the void above the kitchen is presumed to contain asbestos.

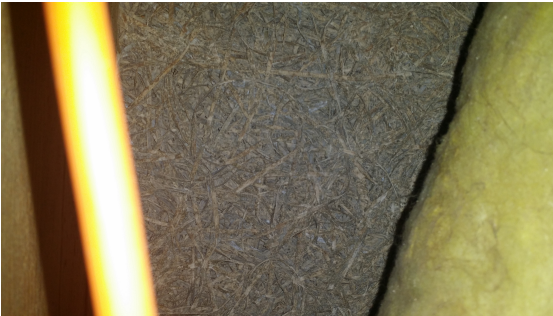
Item 42 – Ref: 139157-2

The insulation board to the void above the corridor does not contain asbestos.

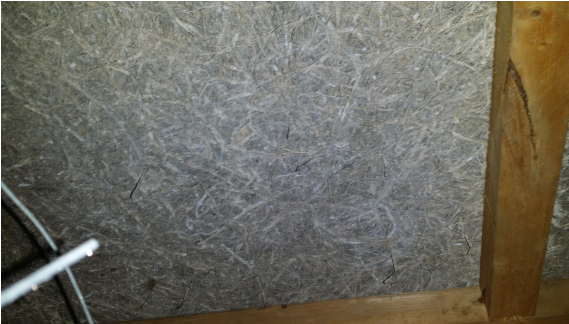
Item 43 – Ref As 139157-2

The insulation board to the void above the staff room does not contain asbestos.

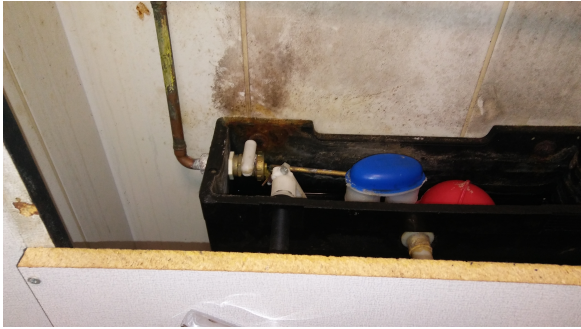
Item 45 – Ref: 271309-2

The toilet cistern in the kitchen staff toilet and cloakroom (Room 006b) contains asbestos.

Any change in its appearance should be recorded and passed to Property Services.

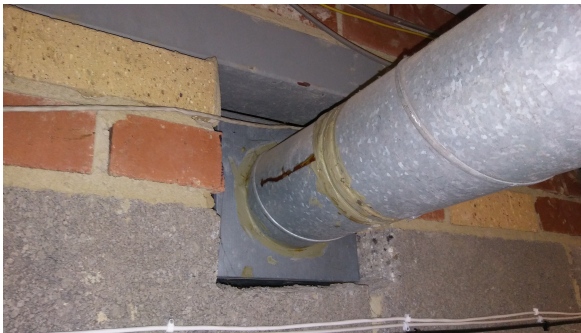
Item 46 – Ref: 303561-1

The sealant to the ductwork in the KS2 Boiler Room (Room 028) does not contain asbestos.

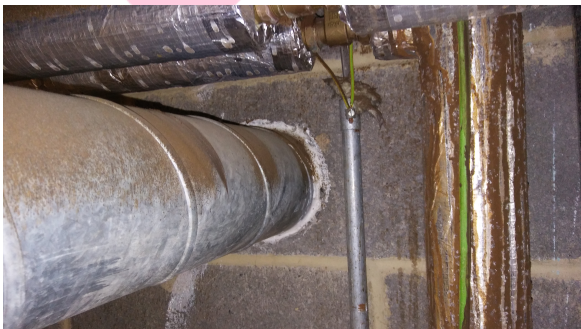
Item 47 – Ref: 303561-2

The packing to the ductwork penetration to the wall in the KS2 Boiler Room (Room 028) does not contain asbestos.

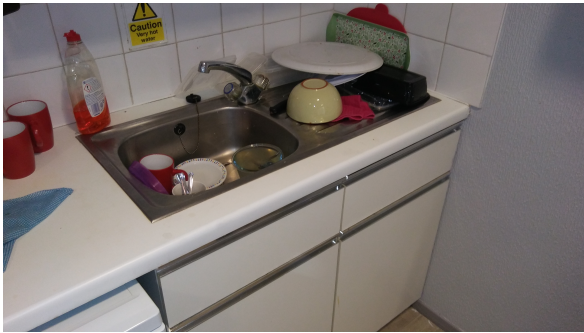
Item 48 – Ref: 345636-3

The acoustic sink pad in the staff room (Room 008) does not contain asbestos.

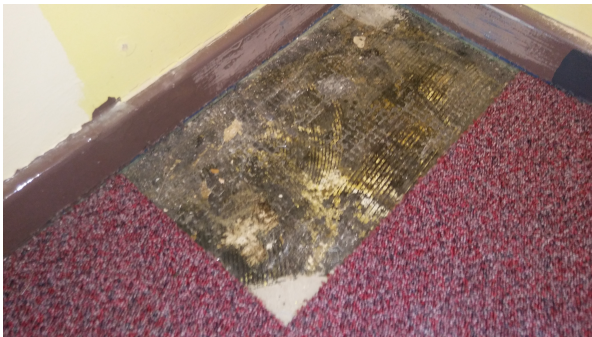
Item 49 – Ref: 345636-1

The remnant adhesive to the floor in classroom (room 020) does contain asbestos.

Any change in appearance should be reported to Property Services.

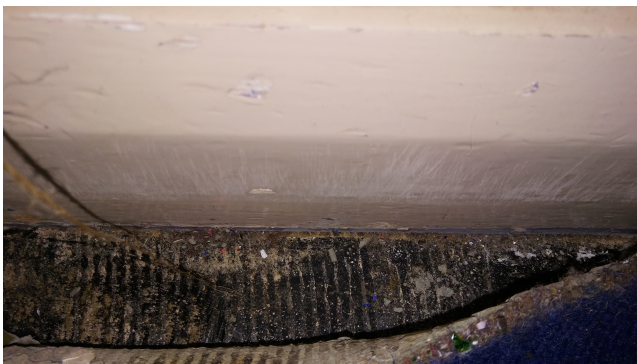
Item 53 – Ref: 345636-2

The remnant adhesive to the floor in classroom (room 029) does contain asbestos.

Any change in appearance should be reported to Property Services.

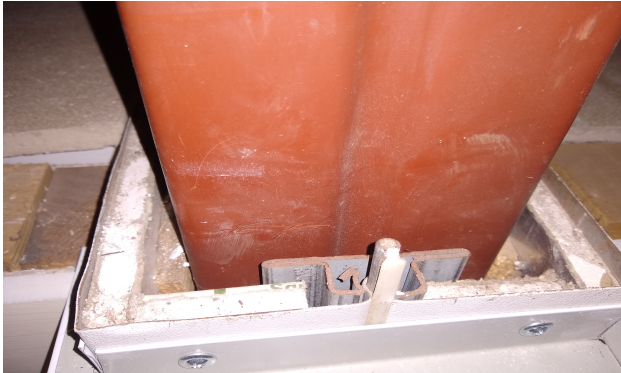
Item 54 – Ref: As 366050-2

The lining to column in classroom (Rm 020) void above suspended ceiling does not contain asbestos.

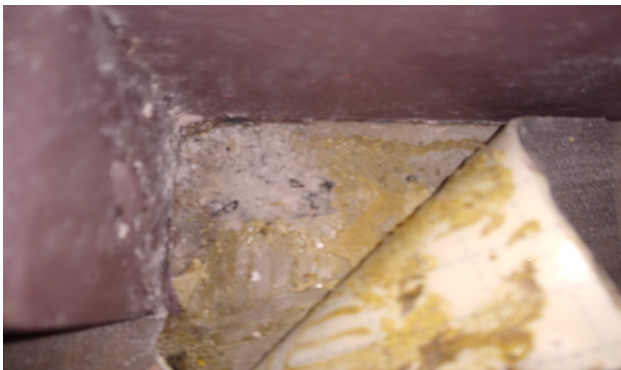
Item 56 – Ref: 366050-1

The remnant adhesive to the floor in corridor (room 021) does contain asbestos.

(Screeded over Oct 22 – But residual still in place)

Any change in appearance should be reported to Property Services.

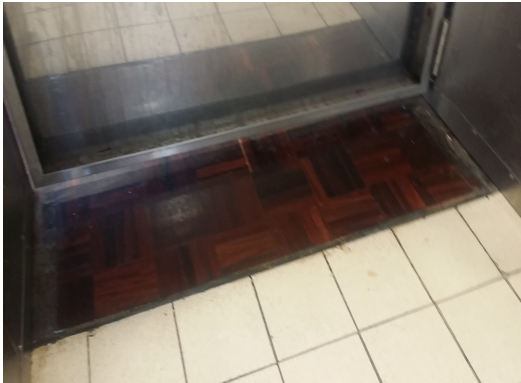
Item 60 – Ref: 209851-2

The bitumen underside of wooden parquet and concrete floor in adj hall in Kitchen (Room 001) does not contain asbestos.

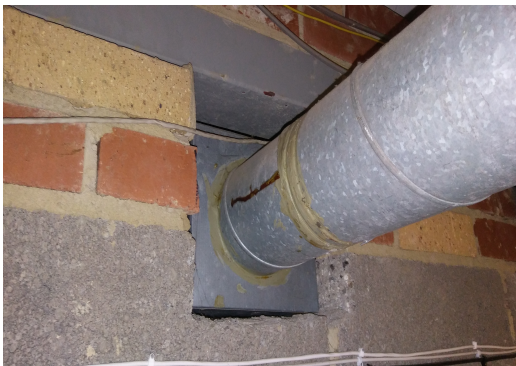
Item 62 – Ref: 303561-1

The sealant to ductwork in the KS2 boiler room (Room 028) does not contain asbestos.

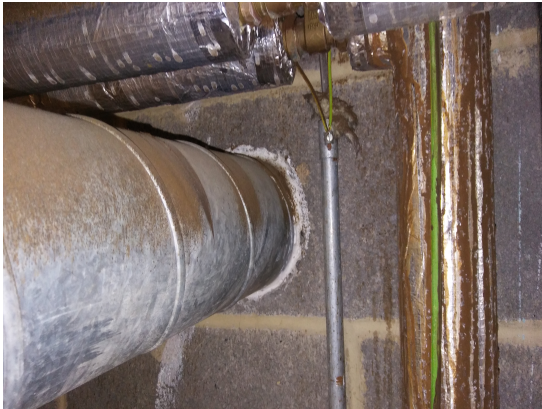
Item 63 – Ref: 303561-2

The packing to ductwork penetration to wall in the KS2 boiler house (Room 028) does not contain asbestos.

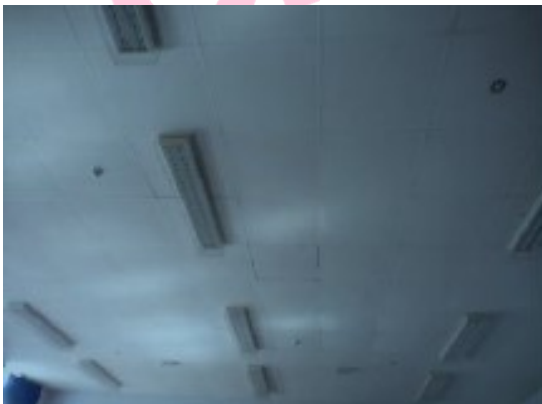
Item 65 – Ref: AS006336

The debris beyond ceiling tiles in the assembly Hall/R2 does not contain asbestos.

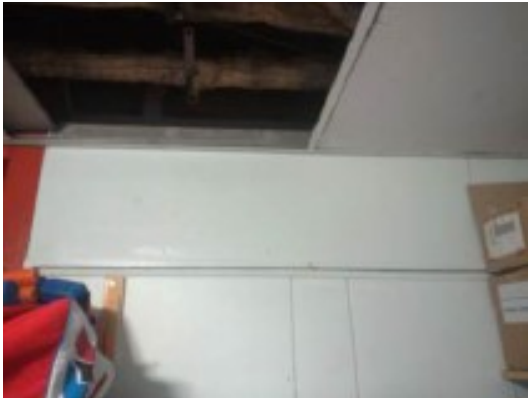
Item 66 – Ref: AS006369

The panel to the wall in the Hall Store Room/R5 does not contain asbestos.

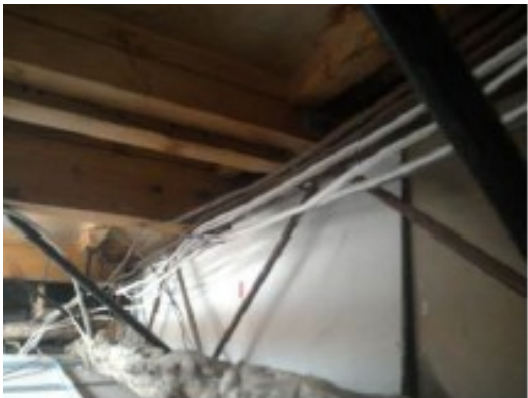
Item 67 – Ref: AS006370

The fire break within ceiling void in the Nursery Classroom/R6 does contain asbestos.

No access to this area and this must be removed if works in this area.

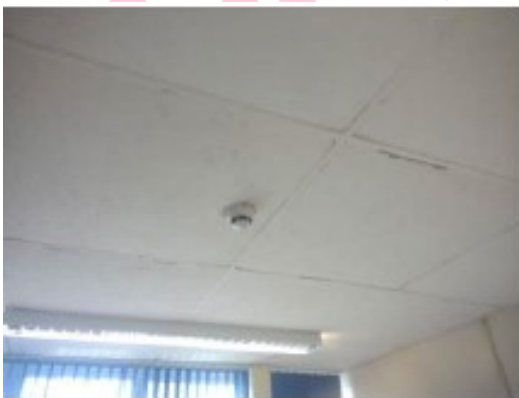
Item 68 – Ref: AS006371

The ceiling tiles in the Office/R1 does not contain asbestos.

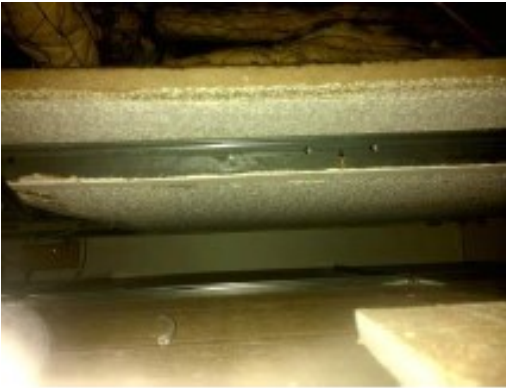
Item 69 – Ref: As AS006371

The ceiling tiles in the Corridor/R1 does not contain asbestos.

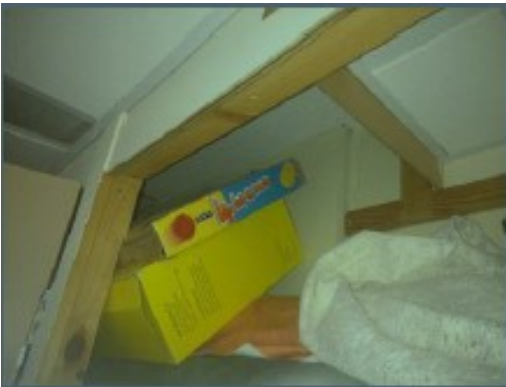
Item 70 – Ref: AS006372

The partition wall in the corridor/R1 does not contain asbestos.

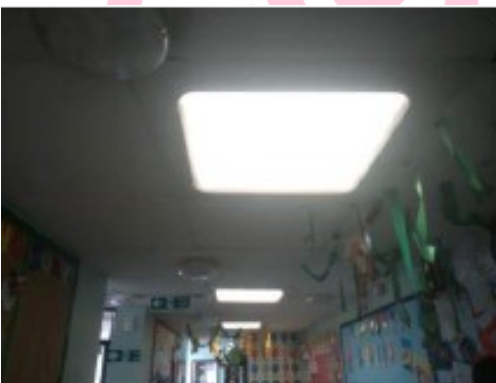
Item 71 – Ref: AS006373

The ceiling tiles in the Corridor/R4 does not contain asbestos.

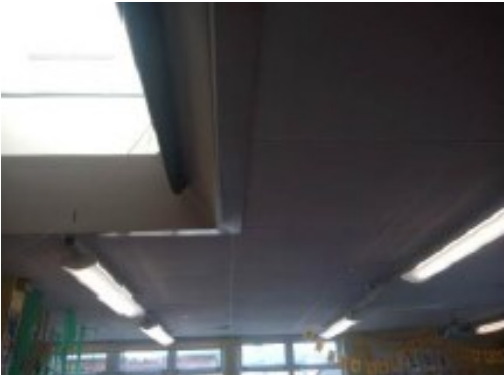
Item 72 – Ref: As AS006373

The ceiling tiles in the Classroom/R4 does not contain asbestos.

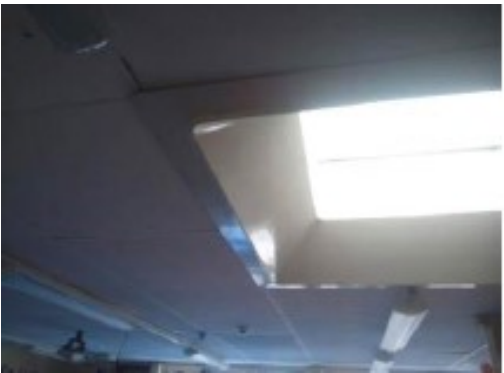
Item 73 – Ref: As AS006373

The ceiling tiles Classroom/R4 does not contain asbestos.

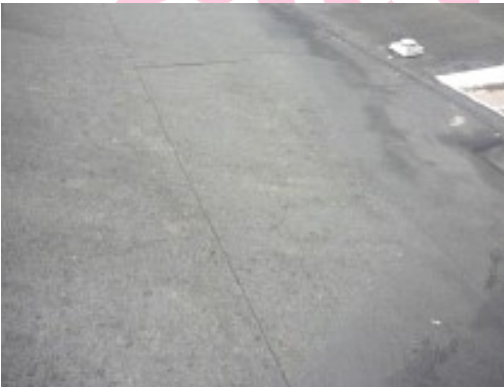
Item 74 – Ref: AS006329

The felt to flat roof (External/R2) does not contain asbestos.

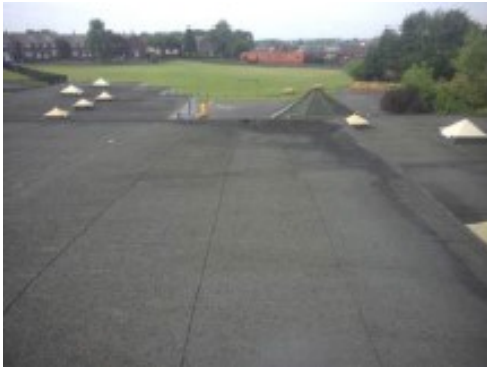
Item 75 – Ref: AS006330

The felt to flat roof
(External/R2) does not contain
asbestos.

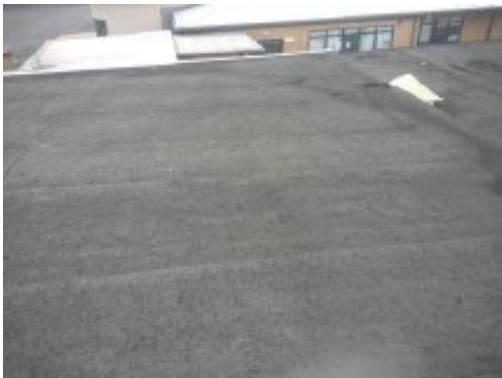
Item 76 – Ref: AS006331

The felt to flat roof
(External/R2) does not contain
asbestos.

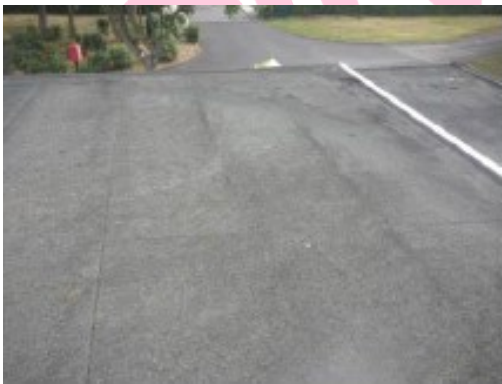
Item 77 – Ref: AS006332

The felt to flat roof
(External/R2) does not contain
asbestos.

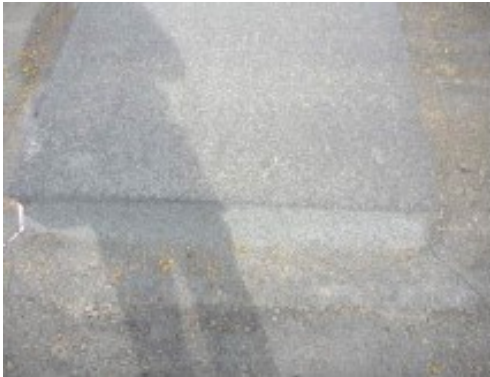
Item 78 – Ref: AS006333

The felt to flat roof hatch (External/R2) does not contain asbestos.

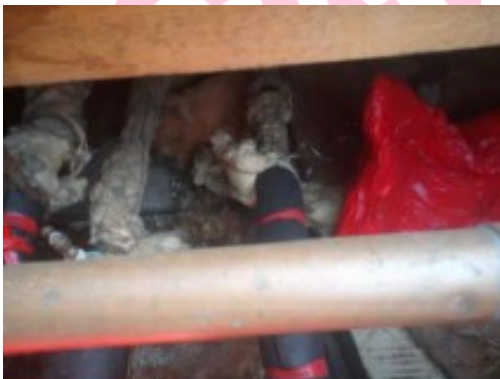
Item 80 – Ref: AS006335

The insulation to pipe run within roof hatch (External/R2) does not contain asbestos.

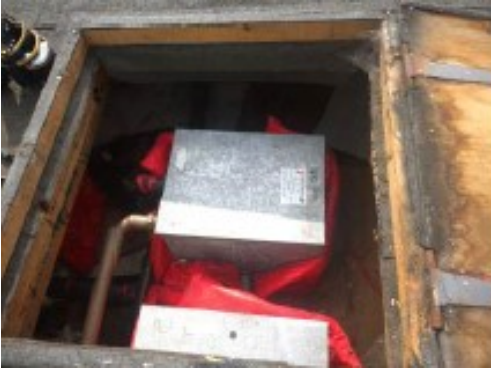
Item 81 – Ref: AS006336

The debris within roof hatch (External/R2) does not contain asbestos.

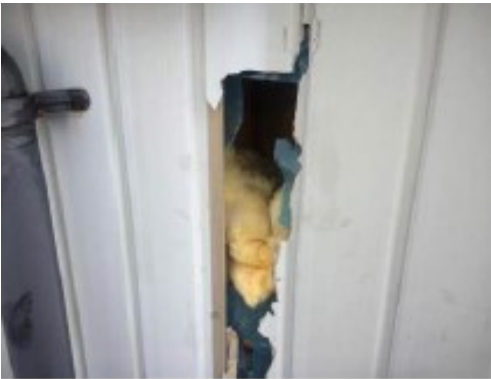
Item 82 – Ref: AS006337

The residue to timber upstand panels behind external plastic cladding (External/R2) does not contain asbestos.

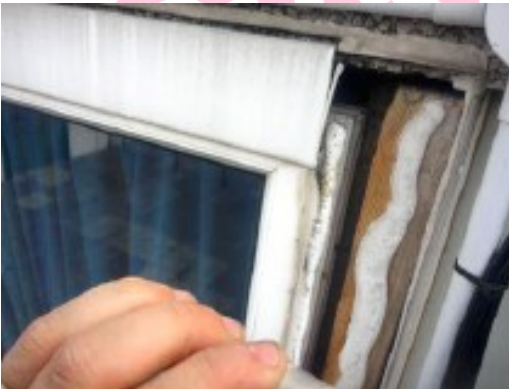
Item 83 – Ref: AS006338

The gal panels behind plastic cladding and PVCU window frames (External/R2) does not contain asbestos.

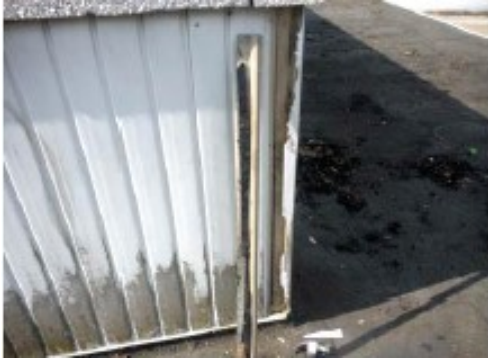
Item 84 – Ref: AS006339

The felt packer to plastic cladding corner piece (External/R2) does not contain asbestos.

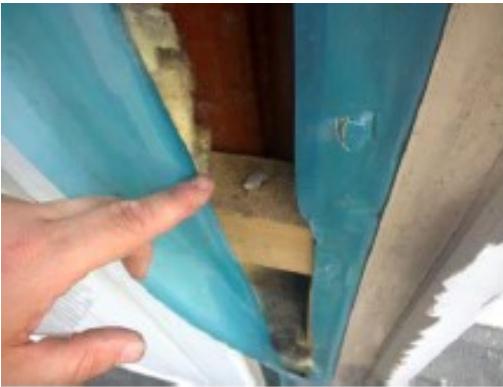
Item 85 – Ref: AS006340

The debris to timber beam behind plastic cladding (External/R2) does not contain asbestos.

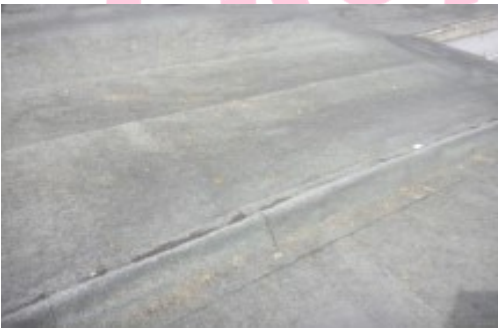
Item 86 – Ref: AS006341

The felt to flat roof (External/R4) does not contain asbestos.

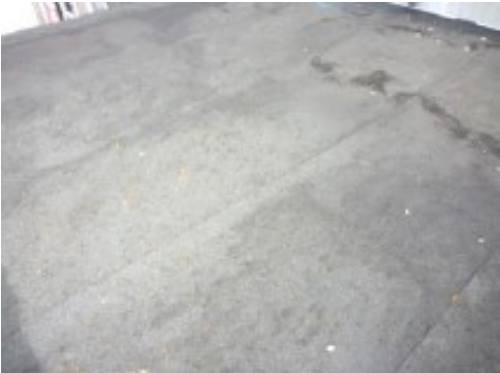
Item 87 – Ref: AS006342

The felt to flat roof
(External/R4) does not contain
asbestos.

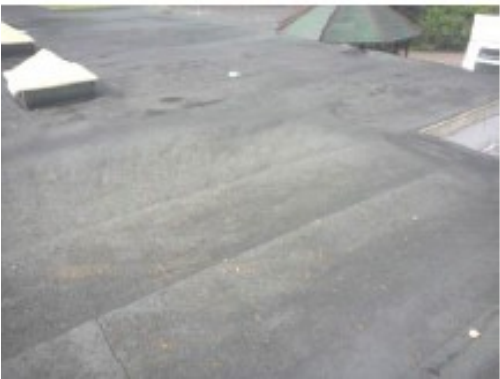
Item 88 – Ref: AS006343

The felt to flat roof
(External/R4) does not contain
asbestos.

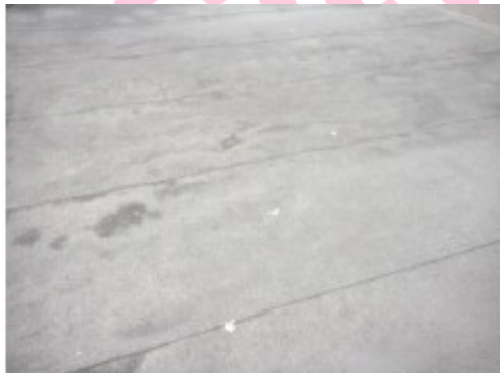
Item 89 – Ref: AS006344

The felt to flat roof
(External/R4) does not contain
asbestos.

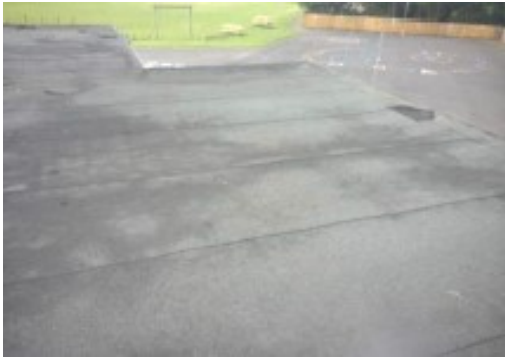
Item 90 – Ref: AS006345

The felt to flat roof
(External/R4) does not contain
asbestos.

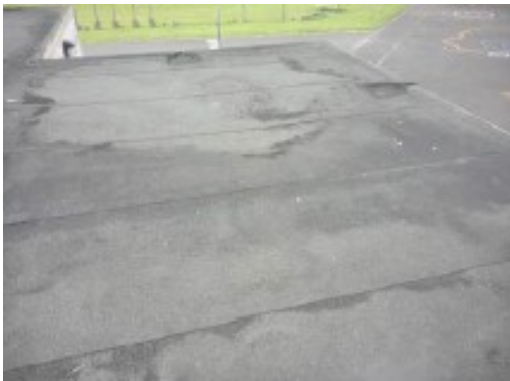
Item 91 – Ref: AS006346

The felt to flat roof
(External/R4) does not contain
asbestos.

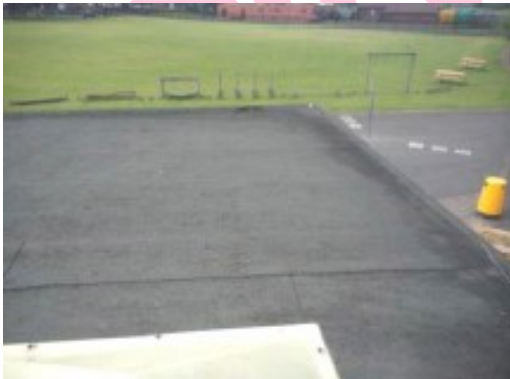
Item 92 – Ref: AS006347

The felt to flat roof
(External/R4) does not contain
asbestos.

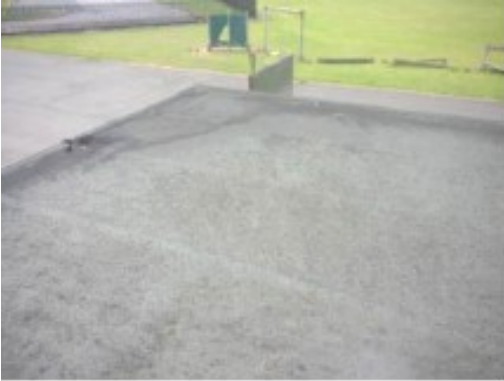
Item 93 – Ref: AS006348

The felt to flat roof
(External/R4) does not contain
asbestos.

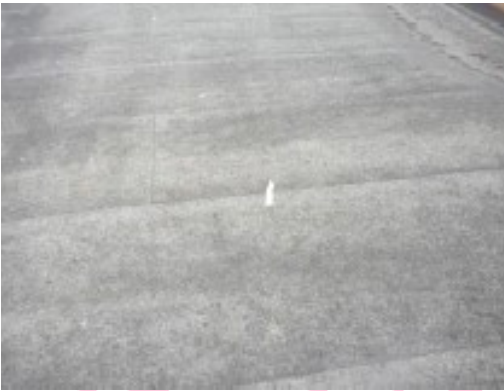
Item 94 – Ref: AS006349

The felt to flat roof
(External/R4) does not contain
asbestos.

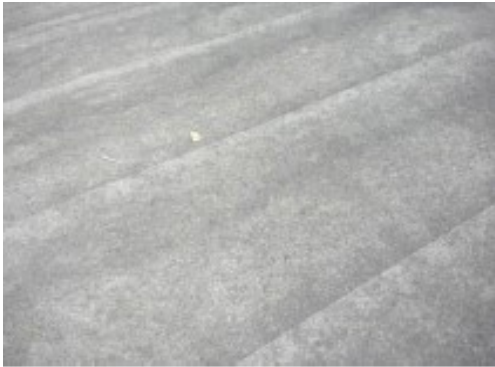
Item 96 – Ref: AS006351

The felt to flat roof
(External/R4) does not contain
asbestos.

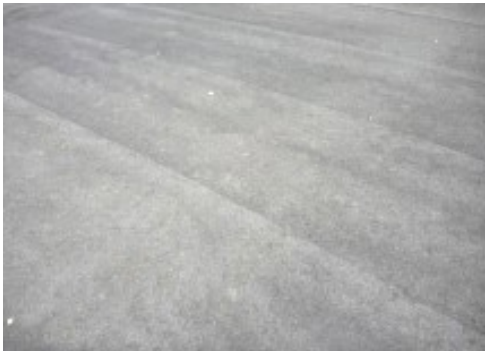
Item 97 – Ref: AS006352

The felt to flat roof
(External/R4) does not contain
asbestos.

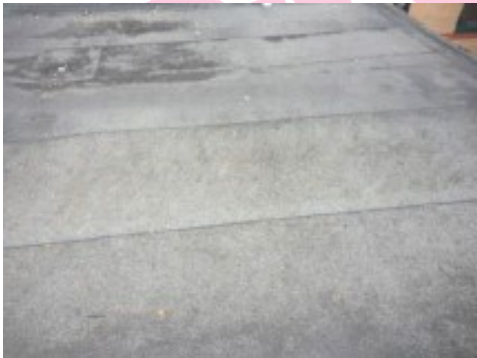
Item 98 – Ref: AS006353

The felt to flat roof
(External/R4) does not contain
asbestos.

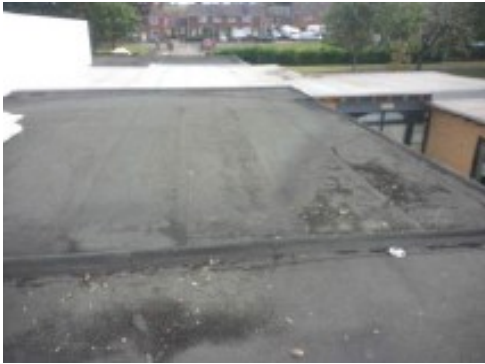
Item 99 – Ref: AS006354

The felt to flat roof
(External/R4) does not contain
asbestos.

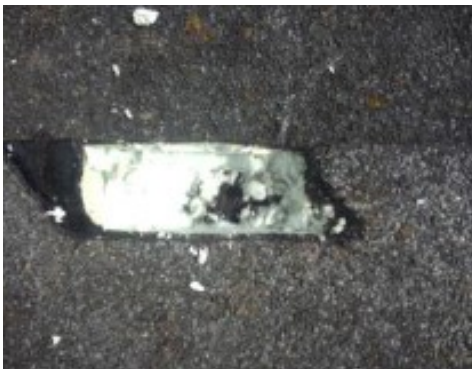
Item 100 – Ref: AS006355

The felt to flat roof
(External/R4) does not contain
asbestos.

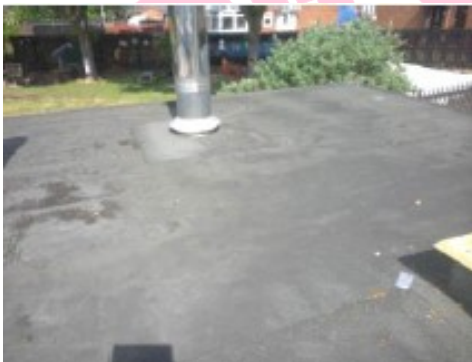
Item 101 – Ref: AS006356

The felt to flat roof
(External/R1) does not contain
asbestos.

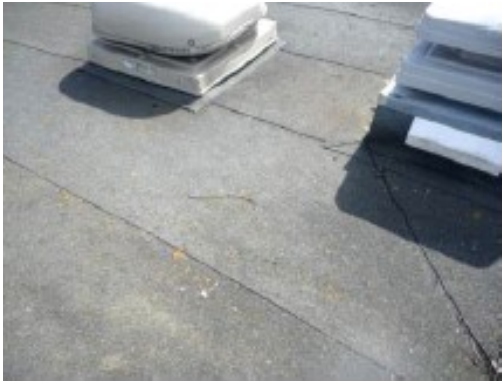
Item 102 – Ref: AS006357

The felt to flat roof
(External/R1) does not contain
asbestos.

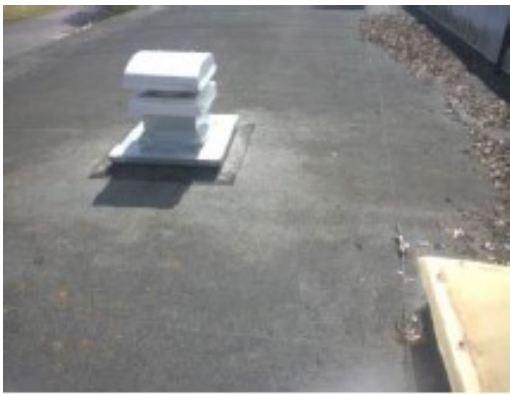
Item 103 – Ref: AS006358

The felt to flat roof
(External/R1) does not contain
asbestos.

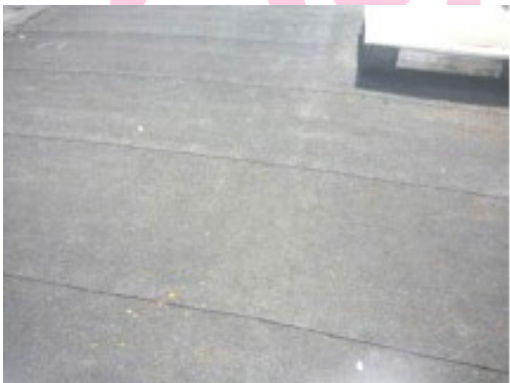
Item 104 – Ref: AS006359

The felt to flat roof
(External/R1) does not contain
asbestos.

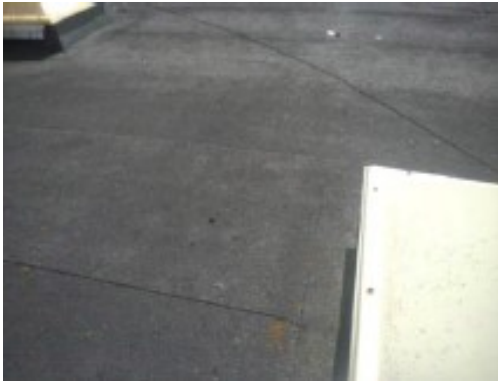
Item 105 – Ref: AS006360

The felt to flat roof
(External/R1) does not contain
asbestos.

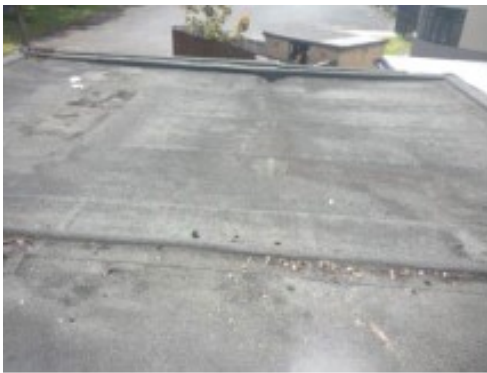
Item 106 – Ref: AS006361

The felt to flat roof
(External/R1) does not contain
asbestos.

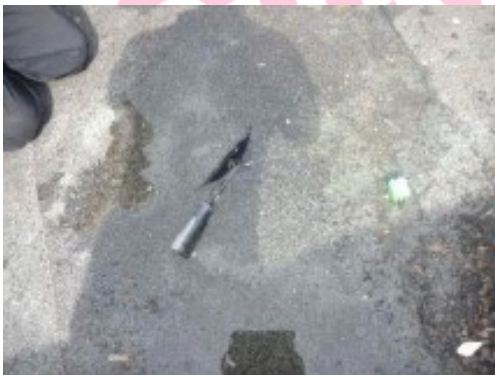
Item 107 – Ref: AS006362

The felt to flat roof
(External/R5) does not contain
asbestos.

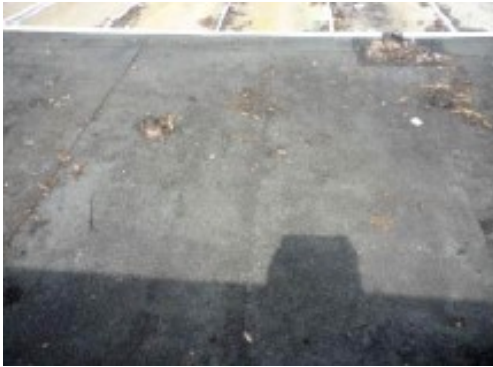
Item 108 – Ref: AS006363

The bitumen base layer between timber and foam (External/R5) does not contain asbestos.

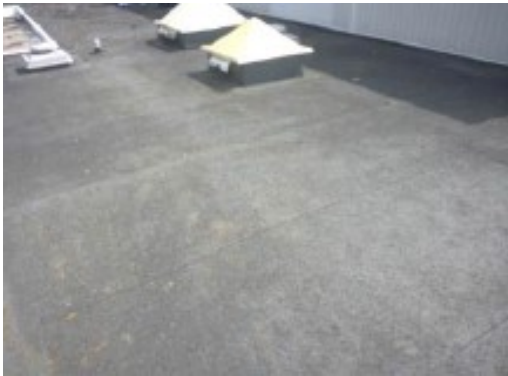
Item 109 – Ref: AS006364

The felt to flat roof (External/R6) does not contain asbestos.

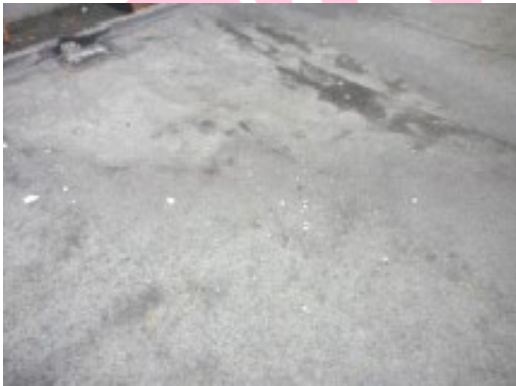
Item 110 – Ref: AS006365

The felt to flat roof (External/R6) does not contain asbestos.

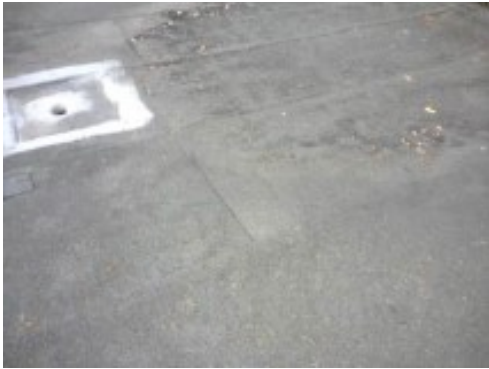
Item 111 – Ref: AS006366

The felt to flat roof
(External/R6) does not contain
asbestos.

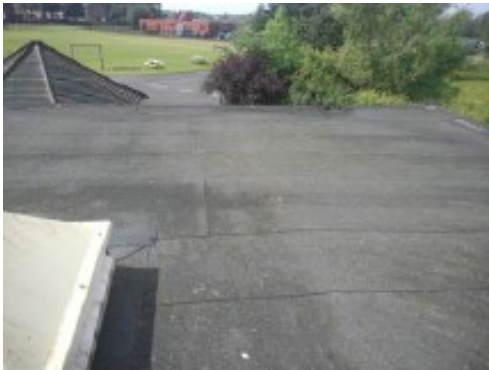
Item 112 – Ref: AS006367

The felt to flat roof
(External/R6) does not contain
asbestos.

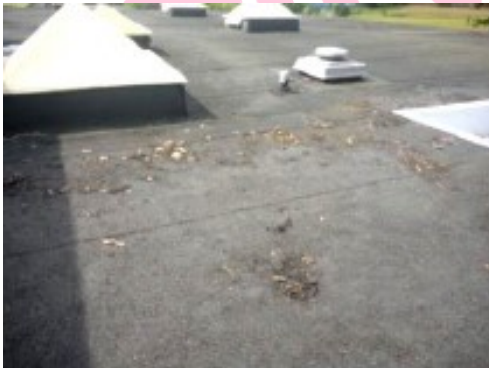
Item 113 – Ref: AS006368

The bitumen to the base layer
(External/R6) does not contain
asbestos.

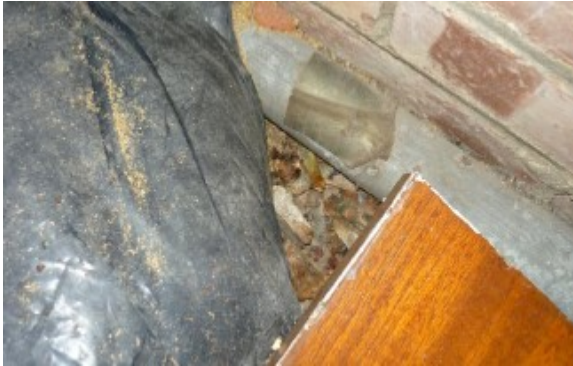
Item 117 – Ref: AW0733/11

The debris to the floor in the gas main room does contain asbestos.

This was removed July 2011.

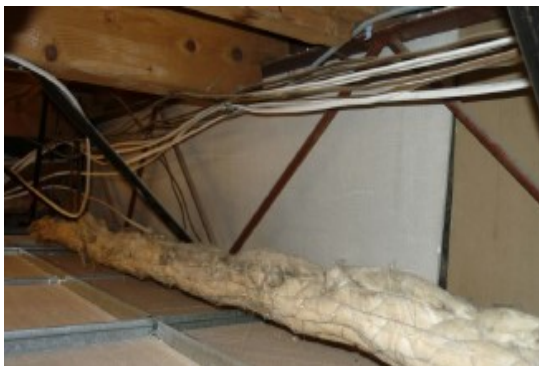
Item 122 – Ref: AW0729/11

The pipework flange gasket in the ceiling void in the office (Rm 011) is presumed to contain asbestos.

Further investigation is required before works should be carried out in this area.

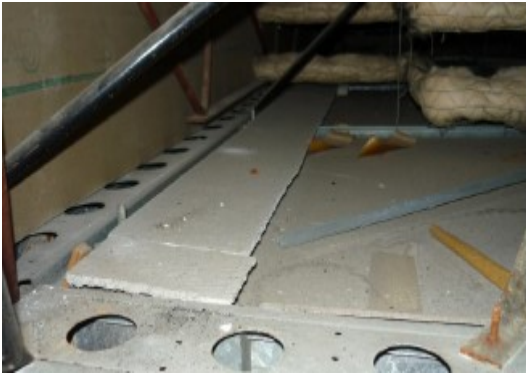
Item 123 – Ref: AW0730/11

The remains of insulation board in the classroom ceiling void (Rm 033) does contain asbestos.

This was removed July 2011.

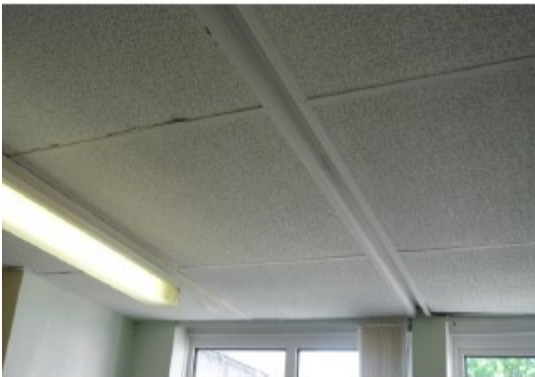
Item 124 – Ref: AW0731/11

The horizontal panel in the corridor (Rm 041) does contain asbestos.

Advised by school – removed 2018 – no WCN paperwork

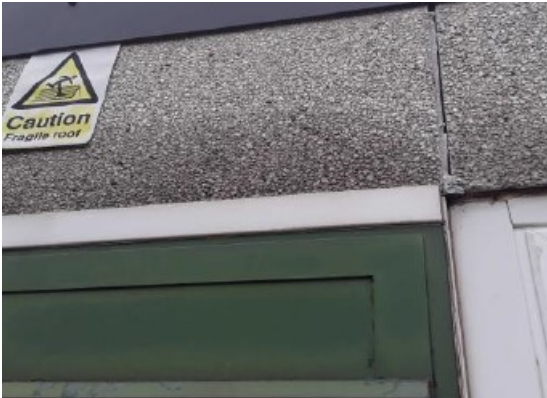
Item 126 – Ref: 21-39203-1

The mastic to concrete panel jointing compound to walls (Area 2/External) does not contain asbestos.

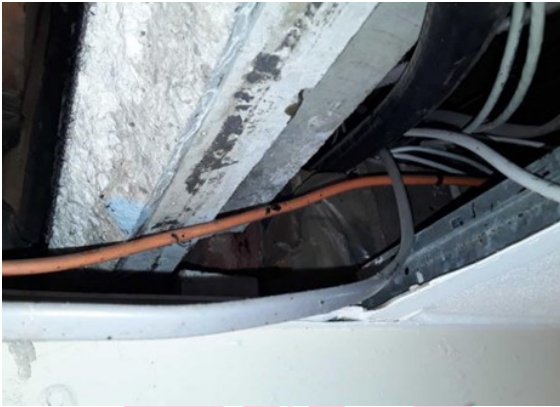
Item 127 – Ref: Presumed

The lining inside clasp columns in the fire exit hallway (Area 5) is presumed to contain asbestos.

Any change in appearance should be reported to Property Services.

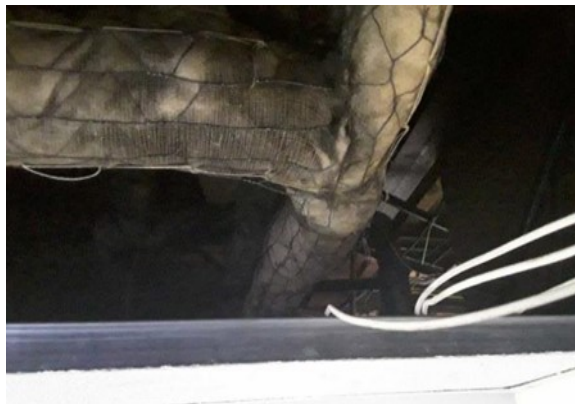
Item 146 – Ref: 22-50659-3

The string wrap to mmmf lagged pipes in the store cupboard (Area 11) does not contain asbestos.

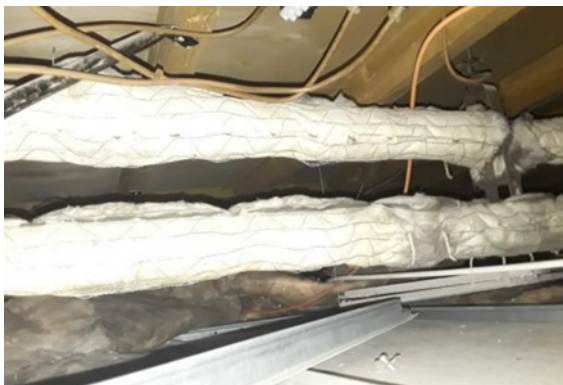
Item 155 – Ref: 22-50659-3

The string wrap to mmmf lagged pipes in the corridor (Area 13) does not contain asbestos.

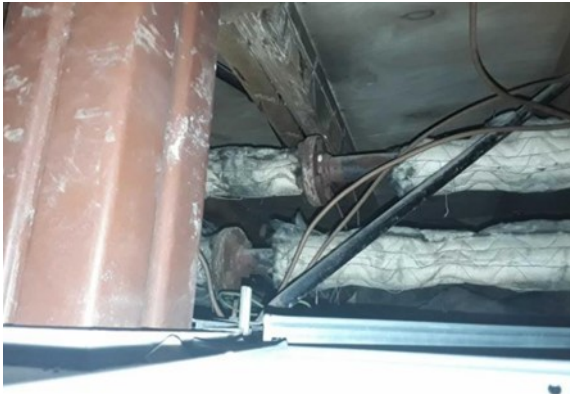
Item 156 – Ref: Presumed

The pipe flanges (gaskets) in the headteachers office (Area 14) is presumed to contain asbestos.

Any change in appearance should be reported to Property Services.

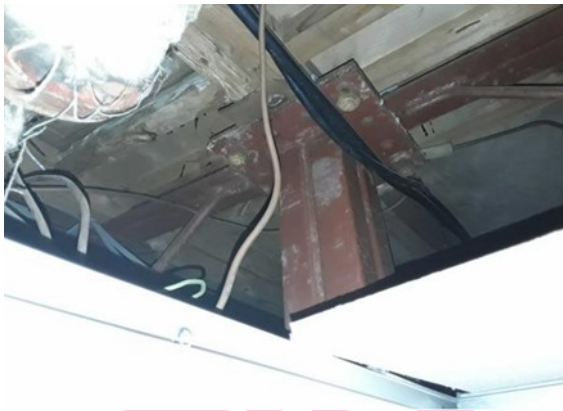
Item 157 – Ref: Presumed

The lining inside clasp columns in the headteachers store cupboard (Area 15) is presumed to contain asbestos.

Any change in appearance should be reported to Property Services.

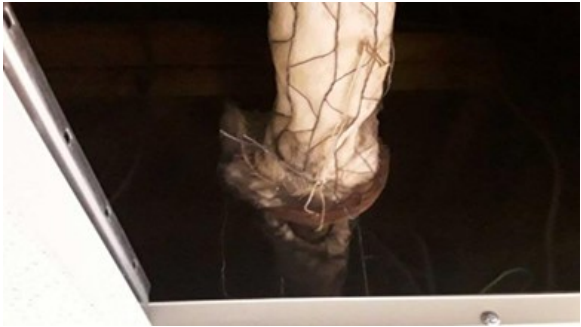
Item 159 – Ref: Presumed

The pipe flanges (gaskets) in the headteachers store (Area 15) is presumed to contain asbestos.

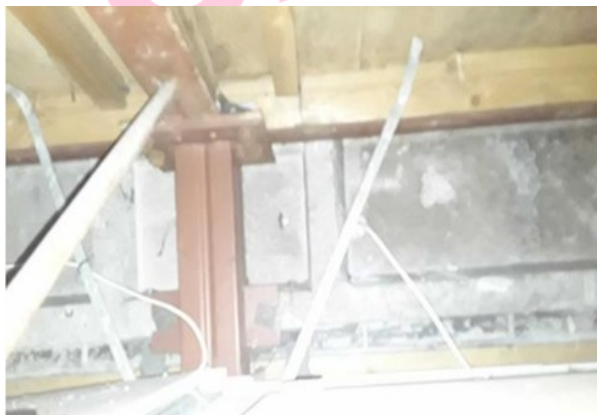
Item 161 – Ref: Presumed

The lining inside clasp columns in the deputy headteachers office and cupboard (Area 16) is presumed to contain asbestos.

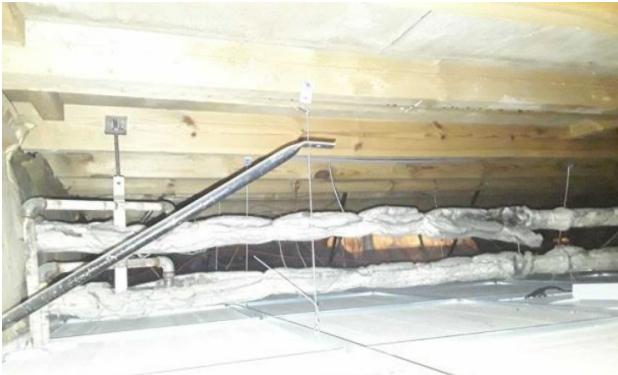
Item 168 – Ref: 22-50659-3

The string wrap to mmmf lagged pipes in the Year 2 Classroom and cupboards (Area 18) does not contain asbestos.

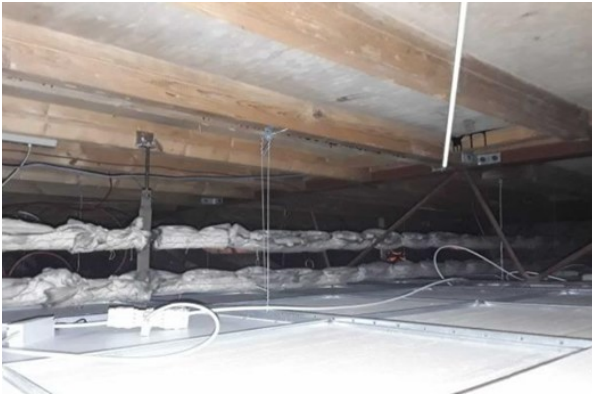
Item 171 – Ref: 22-50659-3

The string wrap to mmmf lagged pipes in the Year 2 Classroom and cupboards (Area 18) does not contain asbestos.

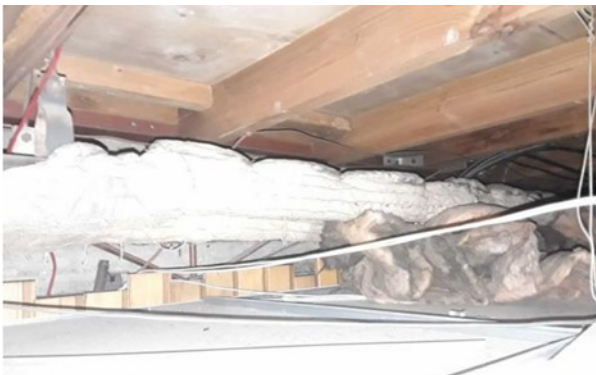
Item 188 – Ref: 22-50659-

The string wrap to mmmf lagged pipes in the hall (Area 27) does not contain asbestos.

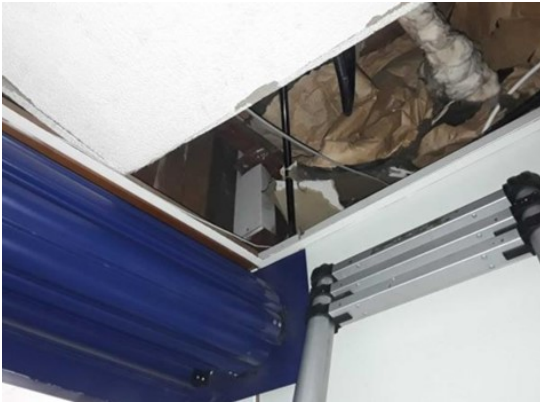
Item 189 – Ref: Presumed

The lining inside clasp columns in the hall store 1 (Area 28) is presumed to contain asbestos.

Any change in appearance should be reported to Property Services.

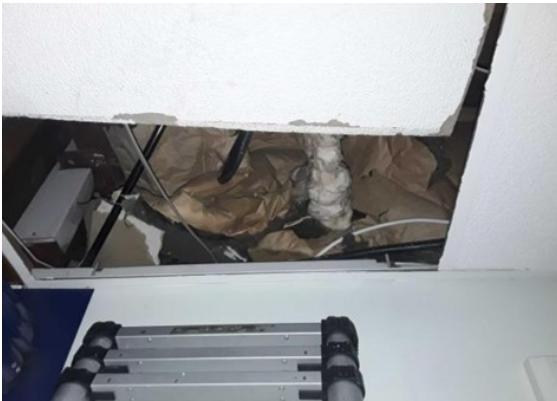
Item 190 – Ref: 22-50659-3

The string wrap to mmmf lagged pipes in the hall store 1 (Area 28) does not contain asbestos.
