ASBESTOS SURVEY REPORT FOR FARRINGDON ACADEMY SCHOOL, SUNDERLAND

Asbestos Register for

**FARRINGTON ACADEMY SCHOOL,
SUNDERLAND**

Date: 31 July 2025

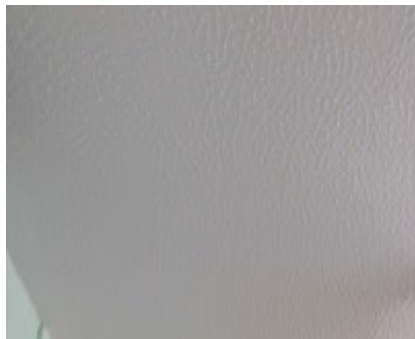
Item 1 Ref: 101894-1

101894-1 – Textured coating (Rm 001) (Item 1) - Low Risk

The textured coating to the ceiling in the lobby of the behaviour unit (Rm 001) contains asbestos.

Any change in its appearance should be recorded and passed to Property Services.

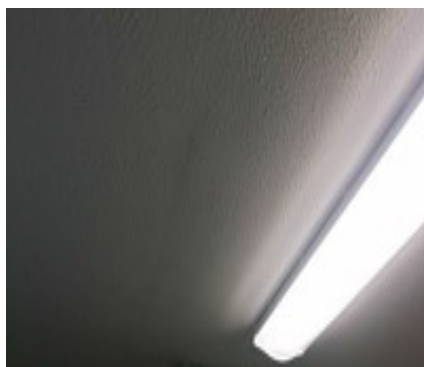
Item 2 – As 101894-1

As 101894-1 – Textured coating (Rm 002) (Item 2) – Very Low Risk

The textured coating to the ceiling in the kitchen (Room 002) contains asbestos.

Any change in its appearance should be recorded and passed to Property Services.

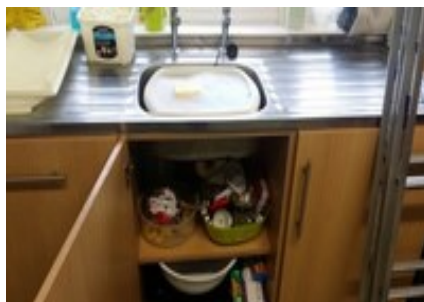
Item 3 Ref: 101894-2

The sink pad to the kitchen the behaviour unit (Rm 002) does not contain asbestos.

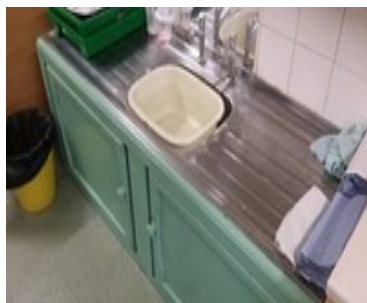
Item 7 As: 101894-2

The sink pad to the classroom of the behaviour unit (Rm 005) does not contain asbestos.

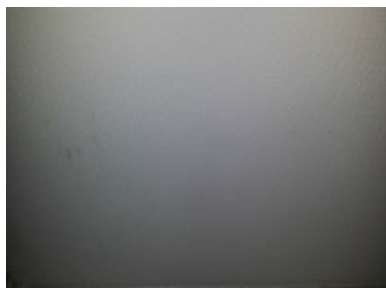
Item 8 As: 101894-1

As 101894-1 – Textured coating (Rm 006) (Item 8) - Very Low Risk

The textured coating to the ceiling in the store cupboard in the behaviour unit (Rm 006) contains asbestos.

Any change in its appearance should be recorded and passed to Property Services.

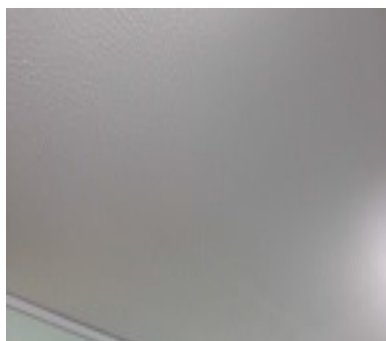
Item 9 As: 101894-1

As 101894-1 – Textured coating (Rm 007) (Item 9) - Low Risk

The textured coating to the ceiling in the office in the behaviour unit (Rm 007) contains asbestos.

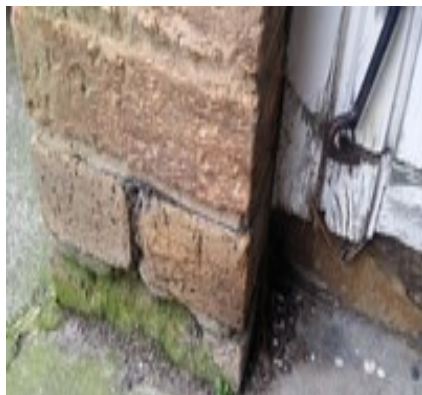
Item 13 Ref: 101894-5

101894-5 – Damp proof course (External) (Item 13) - Very Low Risk

The damp proof course to the behaviour unit (External) contains asbestos.

Any change in its appearance should be recorded and passed to Property Services.

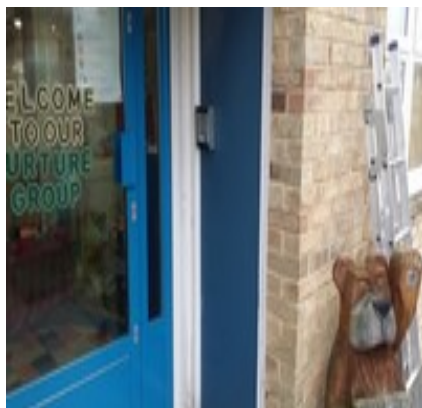
Item 14 Ref: 101894-6

101894-6 – Panels to side of door (External) (Item 14) - Very Low Risk

The panels to the side of the door to the behaviour unit (External) contain asbestos.

Any change in its appearance should be recorded and passed to Property Services.

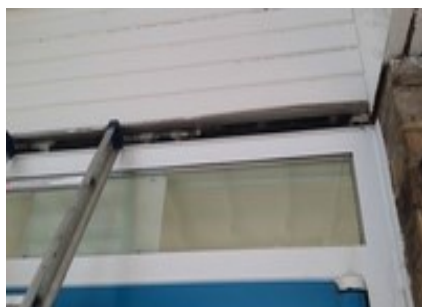
Item 15 Ref: 101894-7

The membrane behind the fascia to the external of the behaviour unit does not contain asbestos.

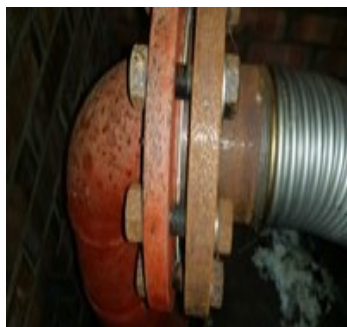
Item 16 Ref: 101894-8

The flange gasket to the pipework in the gas meter house does not contain asbestos.

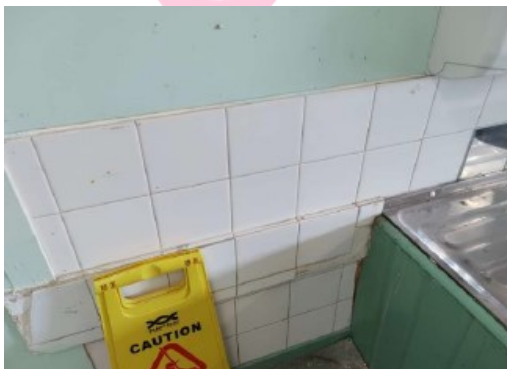
Item 157 Ref: 21-34101-2

The adhesive behind ceramic tiles (Area 1/Main Room) does not contain asbestos.

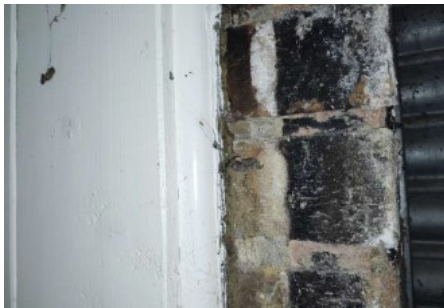
Item 165 Ref: 21-34101-8

The sealant between wood cladding and brickwork (Area 6/Side Lobby) does not contain asbestos.

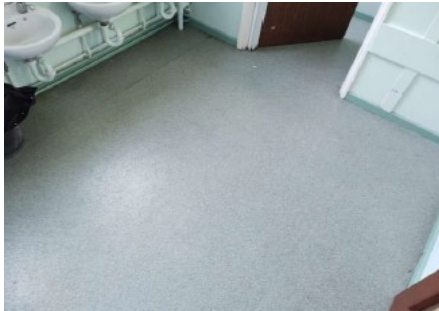
Item 170 Ref: 21-34101-4

The composite floor (Area 7/WC) does not contain asbestos.

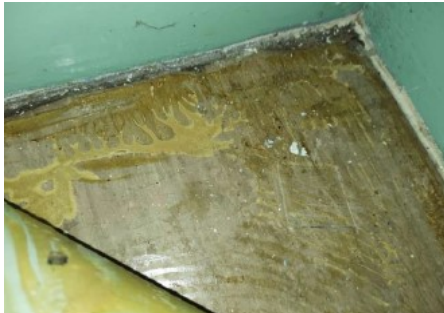
Item 173 Ref: 21-34101-6

21-34101-6 - Beige vinyl floor covering (Area 8/Staff WC) (Item 173) – Low Risk

The beige vinyl floor covering (Area 8/Staff WC) contains asbestos.

Any change in its appearance should be recorded and passed to Property Services.

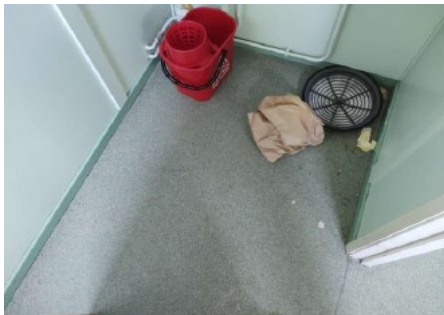
Item 174 Ref: 21-34101-4

The composite floor (Area 8/Staff WC) does not contain asbestos.

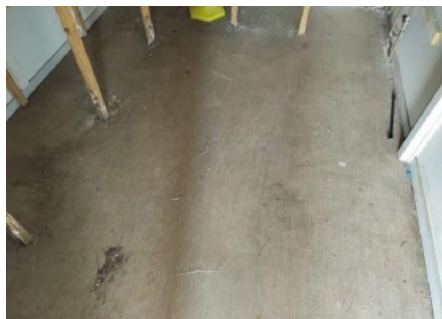
Item 176 Ref: 21-34101-6

The beige vinyl floor covering (Area 9/Boiler Room) contains asbestos.

Any change in its appearance should be recorded and passed to Property Services.

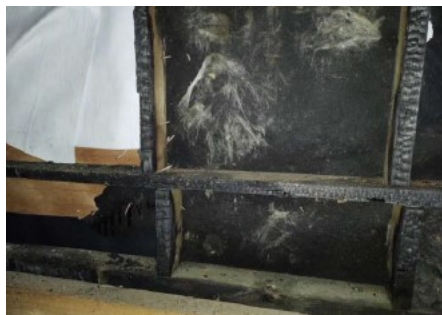
Item 177 Ref: 21-34101-12

The bitumen felt lining to wood walls (Area 10/Ceiling void) does not contain asbestos.

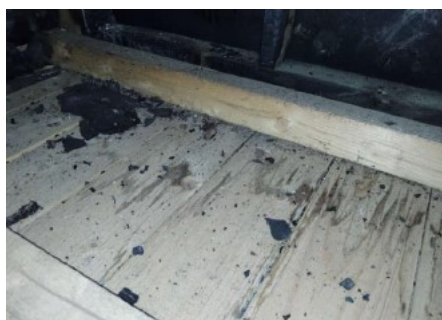
Item 178 Ref: 21-34101-12

The bitumen felt lining to wood walls (Area 10/Ceiling void) does not contain asbestos.

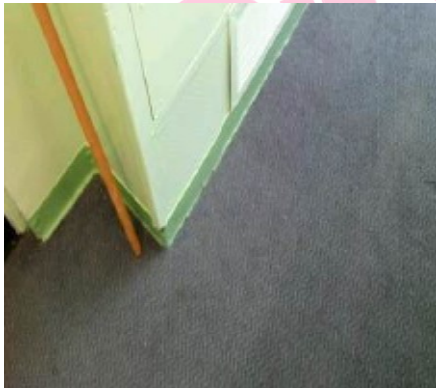
Item 21 - Ref: AW0439/08

The wall kick protection to the classroom (Rm 0/02) contained asbestos.

This was removed in July 2015.

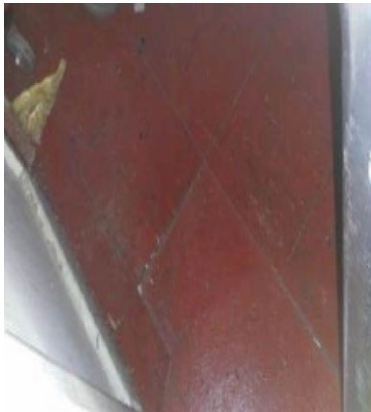
Item 23 - Ref: AW0441/08

The black floor tiles (painted red) to the store room (Rm 0/25) contain asbestos.

Any change in its appearance should be recorded and passed to Property Services.

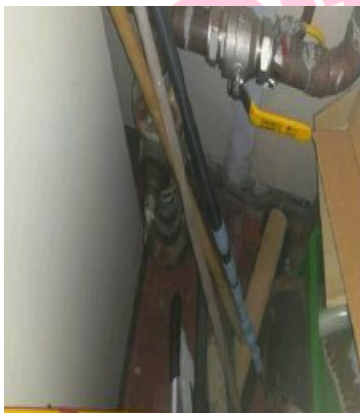
Item 24 - Ref: Presumed

The gaskets to the pipework in the store room (Rm 0/25) are presumed to contain asbestos.

Any change in its appearance should be recorded and passed to Property Services.

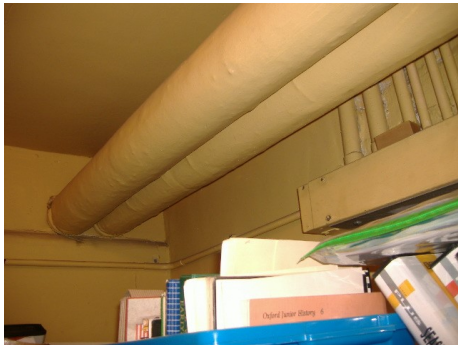
Item 27 - Ref: AW0443/08

The pipework insulation to the store room (Rm 0/45) contains asbestos.

Any change in its appearance should be recorded and passed to Property Services.

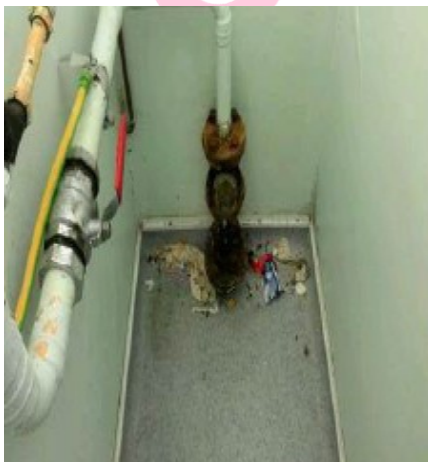
Item 28 - Ref: Presumed

The gaskets to the female toilets (Rm 0/48) are presumed to contain asbestos.

Any change in its appearance should be recorded and passed to Property Services.

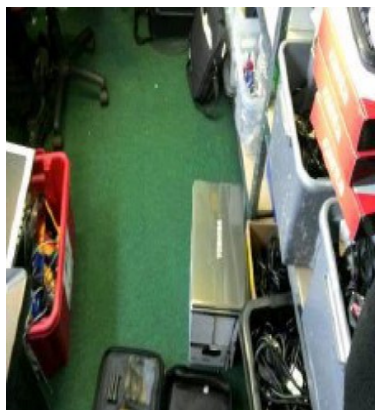
Item 29- Ref: AW0444/08

The grey floor tiles to the ICT office (Rm 0/50) contain asbestos.

Any change in its appearance should be recorded and passed to Property Services.

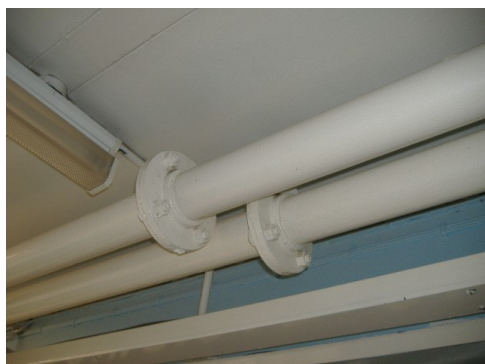
Item 30 - Ref: Presumed

The gaskets to corridor (Rm 0/59) are presumed to contain asbestos.

Any change in its appearance should be recorded and passed to Property Services.

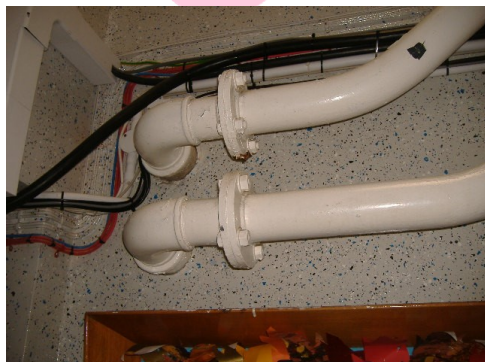
Item 31 - Ref: Presumed

The gaskets to corridor (Rm 0/83) are presumed to contain asbestos.

Any change in its appearance should be recorded and passed to Property Services.

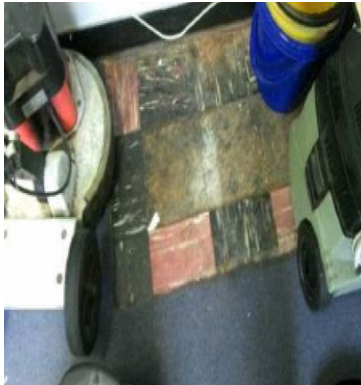
Item 32 - Ref: WC0473/08

The black/red floor tiles to the store room (Rm 0/85) contained asbestos.

These were removed in July 2015.

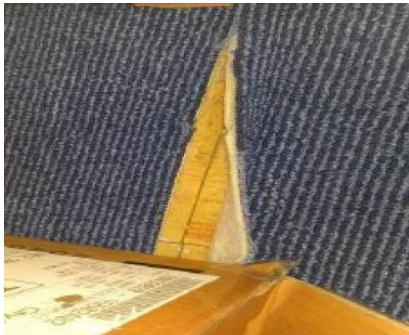
Item 33 - Ref: WC0474/08

The beige floor tiles to the office (Rm 0/86) contained asbestos.

These were removed in May 2016.

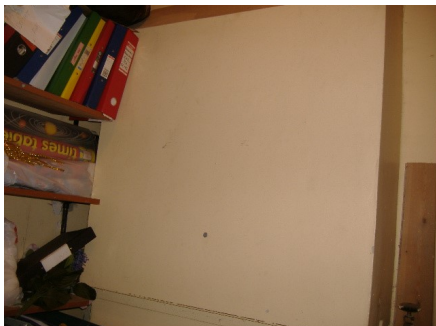
Item 34 - Ref:WC0475/08

The boxing to the rear of the heater in the store room (Rm 0/92) contains asbestos.

Any change in its appearance should be recorded and passed to Property Services.

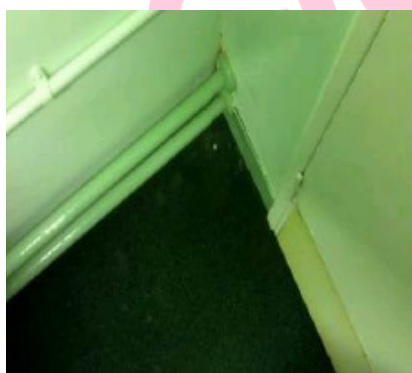
Item 37 - Ref: WC0478/08

The wall kick protection to the office (Rm 0/105) contains asbestos.

This was removed in February 2016.

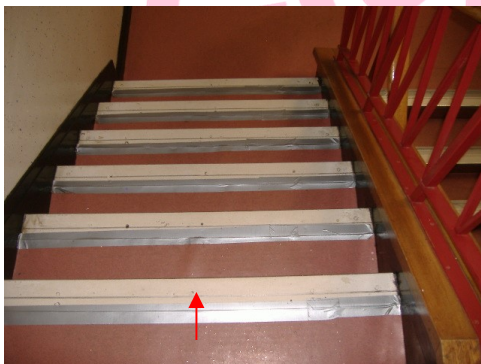
Item 40 - Ref:WC0480/08

The stair nosing to the stairwell (Rm 0/111) contained asbestos.

These were removed in November 2015.

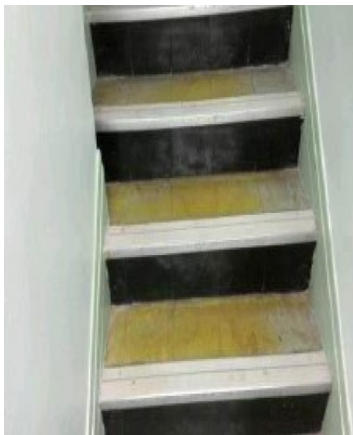
Item 42 - Ref: WC0481/08

The stair nosing to the stairwell (Rm 0/112) contains asbestos.

Any change in its appearance should be recorded and passed to Property Services.

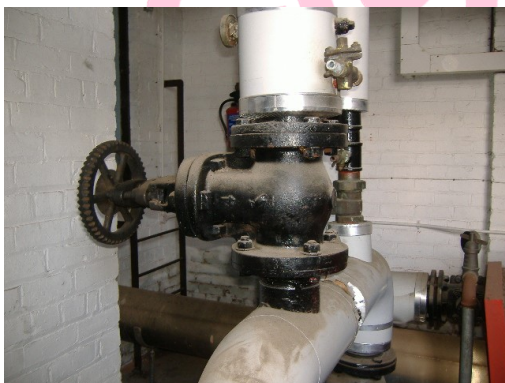
Item 43 - Ref: Presumed

The gaskets to the boiler room (Rm 0/113) were presumed to contain asbestos.

These have been removed and replaced.

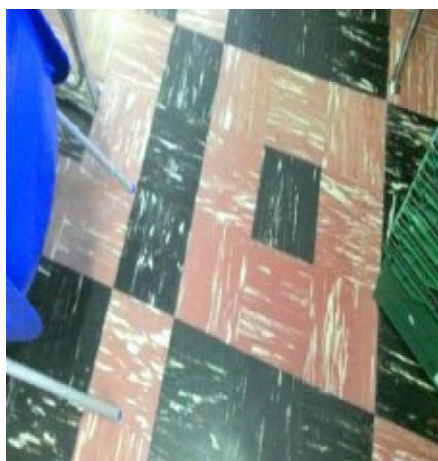
Item 45 - Ref: Presumed

The black/red floor tiles to the store room (Rm 1/06) are presumed to contain asbestos.

Any change in its appearance should be recorded and passed to Property Services.

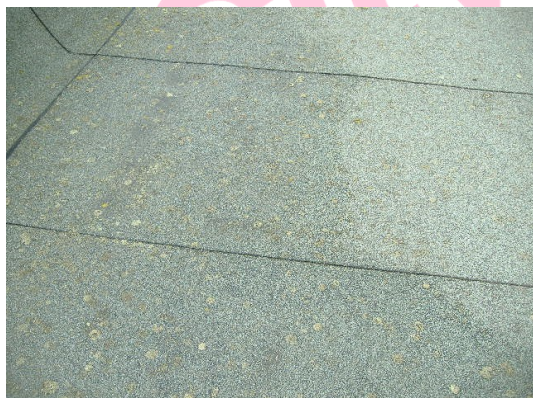
Item 46- Ref: WC0484/08

The roof felt to the exterior of the building does not contain asbestos.

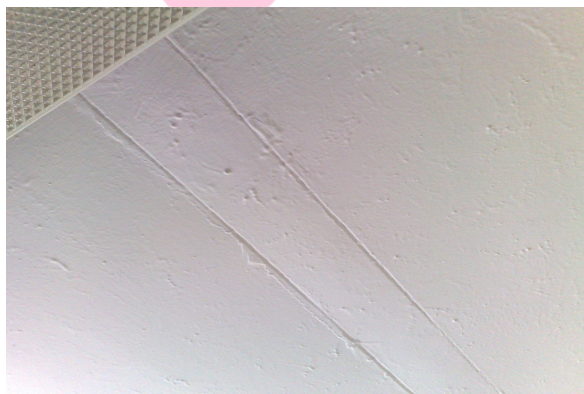
Item 94 - Ref: KR09/46

The textured coating to the ceiling in the craft area (Room 0/48) contains asbestos.

Any change in its appearance should be recorded and passed to Property Services.

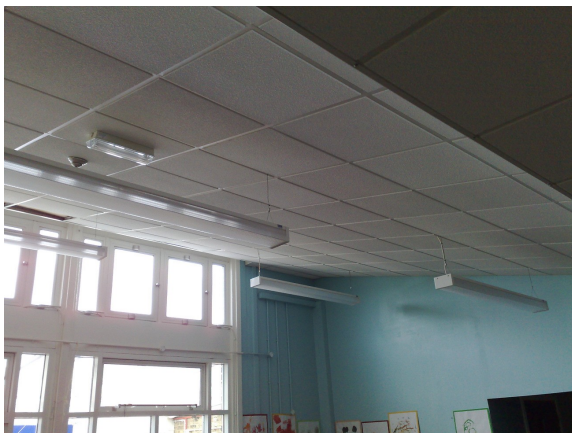
Item 126 - Ref: KR09/69

The suspended ceiling tiles in the Nursery and cloakroom (Room 0/97) does not contain asbestos.

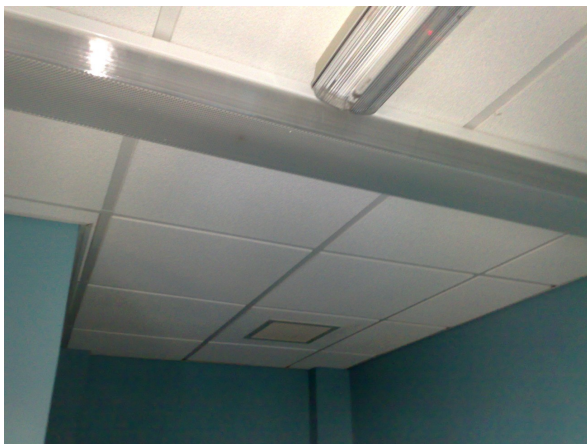
Item 127 - Ref: KR09/73

The suspended ceiling tiles in the Nursery toilet (Room 0/98) does not contain asbestos.

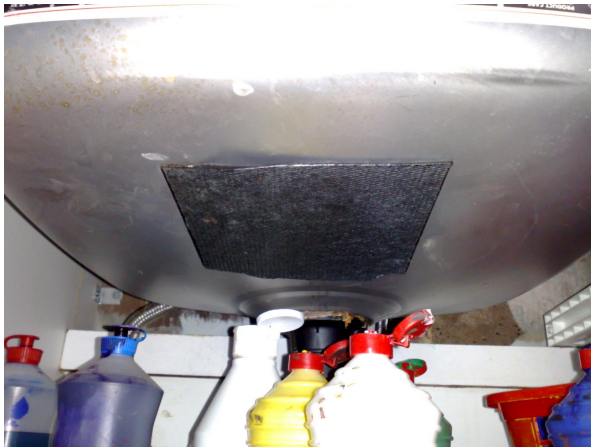
Item 133 - Ref: KR09/64

The sink pad in the toilet (Room 0/81) does not contain asbestos.

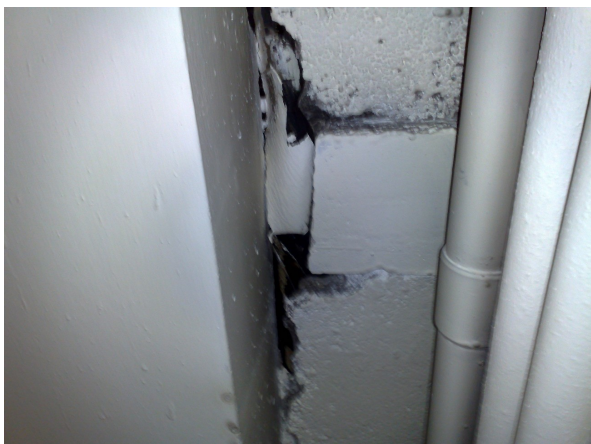
Item 134 - Ref: KR09/66

The bitumen material to ceiling above door in under stairs store (Room 0/83) does not contain asbestos.

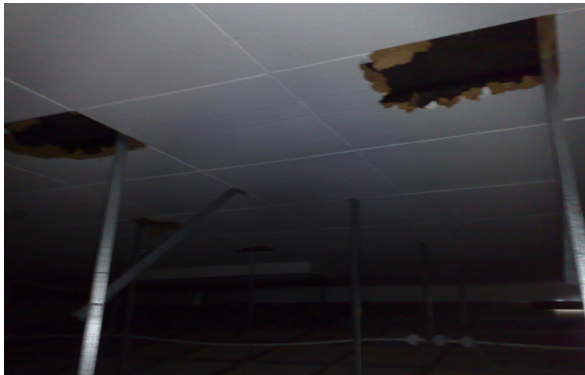
Item 136 - Ref: KR09/70

The ceiling tiles above suspended ceiling in the Nursery and cloakroom (Room 0/97) does not contain asbestos.

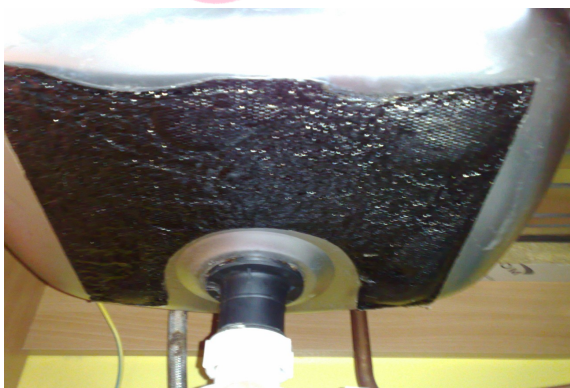
Item 138 - Ref: KR09/71

The sink pad in the Nursery and cloakroom (Room 0/97) does not contain asbestos.

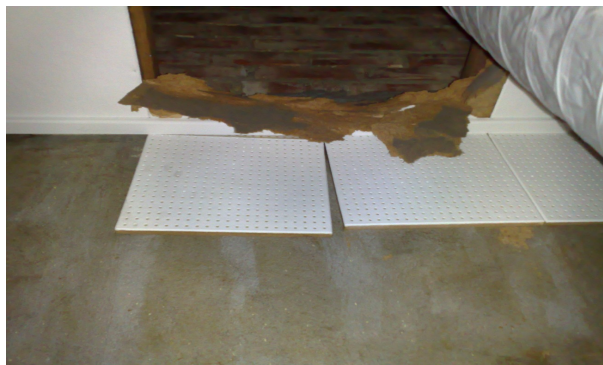
Item 139 - Ref: KR09/72

The acoustic tiles in the Nursery and Cloakroom (Room 0/97) does not contain asbestos.

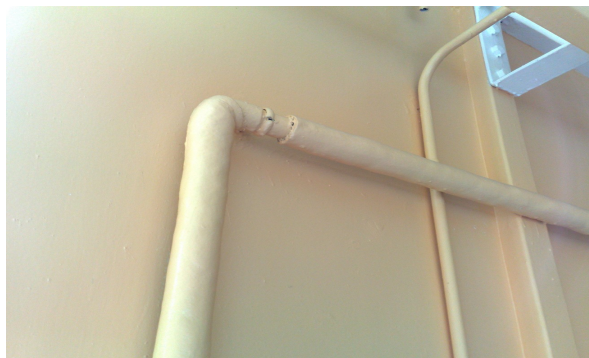
Item 140 - Ref: KR09/74

The pipe insulation in the extended school kitchen club (Room 0/101) does not contain asbestos.

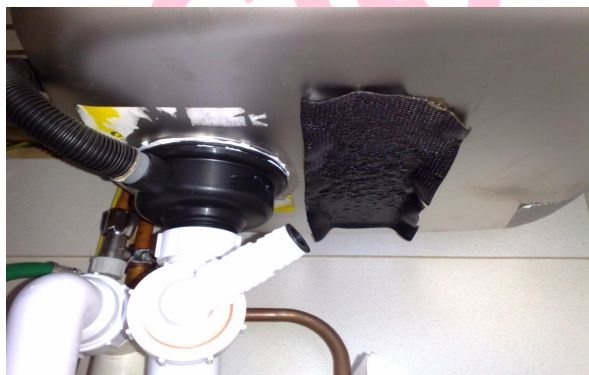
Item 141 - Ref: KR09/75

The sink pad in the extended school kitchen club (Room 0/101) does not contain asbestos.

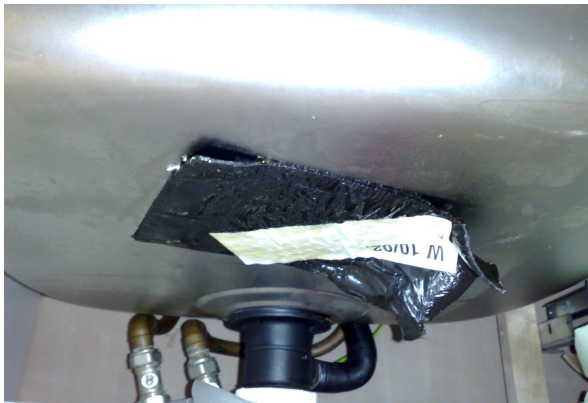
Item 143 - Ref: KR09/51

The sink pad in the kitchen (Room 0/021) does not contain asbestos.

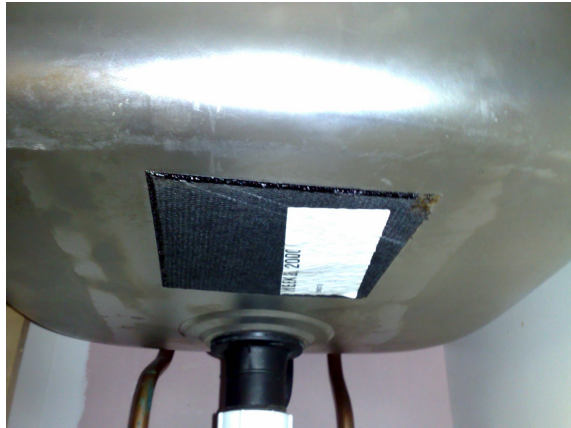
Item 145 - Ref: KR09/57

The sink pad in the Staff Room (Room 0/062) does not contain asbestos.

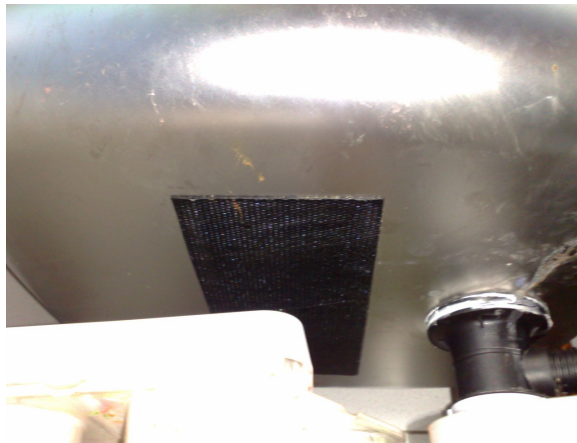
Item 146 - Ref: KR09/50

The sink pad in the Art Room (Room 0/016) does not contain asbestos.

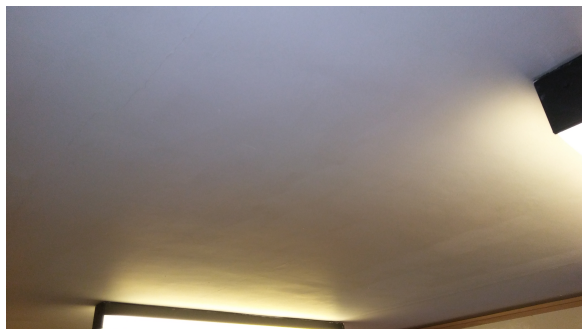
Item 153 - Ref: 383326-1

The ceiling in 005/Music Room does not contain asbestos.

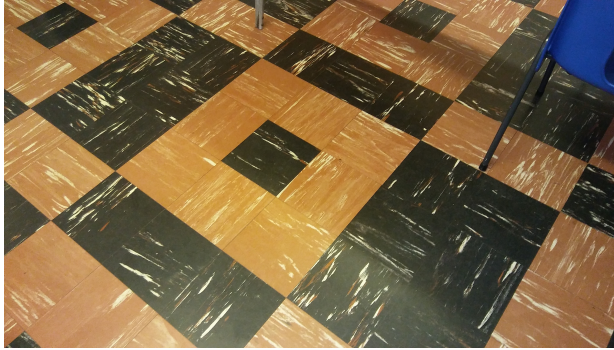
Item 154 - Ref: 383326-2

The floor covering in 005/Music Room contains asbestos.

Any change in its appearance should be recorded and passed to Property Services.

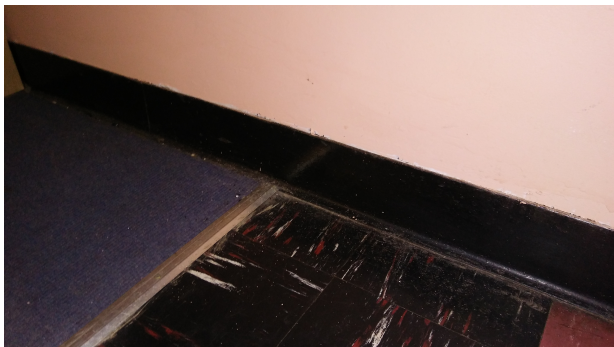
Item 155 - Ref: 383326-3

The skirting board in 005/Music Room contains asbestos.

Any change in its appearance should be recorded and passed to Property Services.

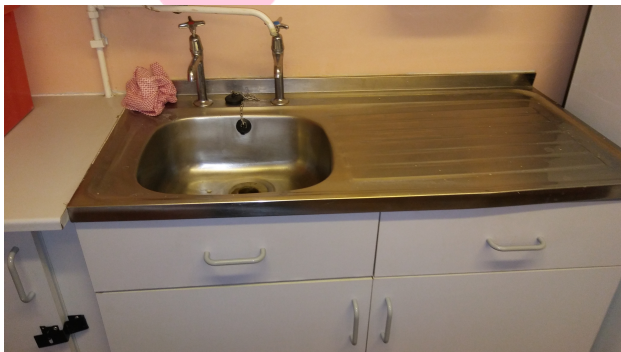
Item 156 - Ref: 383326-4

The sealant to pipe beneath sink in 005/Music Room does not contain asbestos.

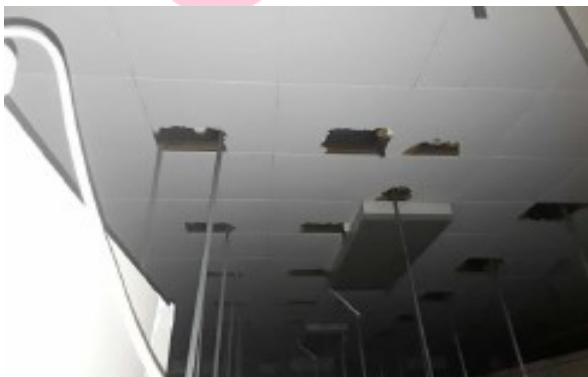
Item 181 - Ref: 22-45169-2

The fibreboard ceiling in Area 2 Classroom Reception ceiling void does not contain asbestos.

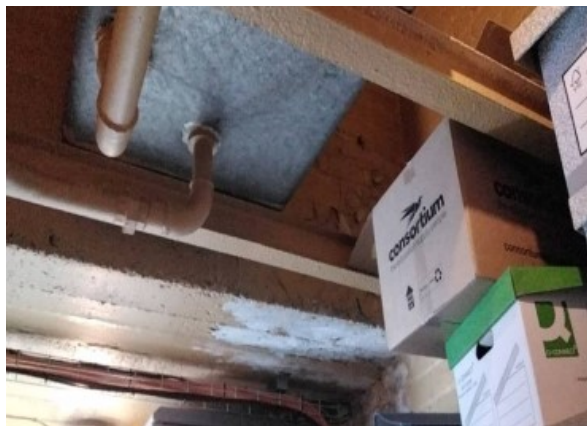
Item 189 - Ref: NO000640

The wall coating in the Store Room (Rm 1/001) does not contain asbestos.

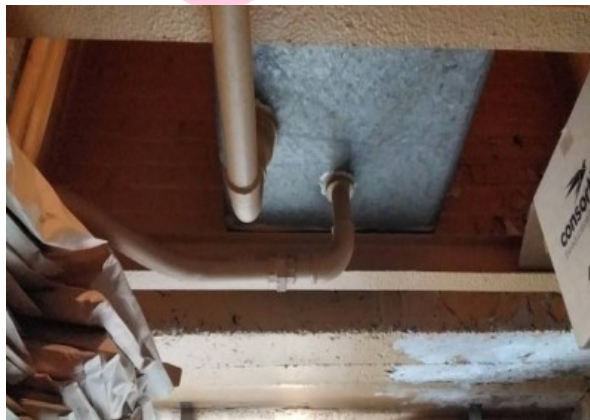
Item 190 - Ref: NO000641

The wall coating to tank support girders in the Store Room (Rm 1/001) does not contain asbestos.

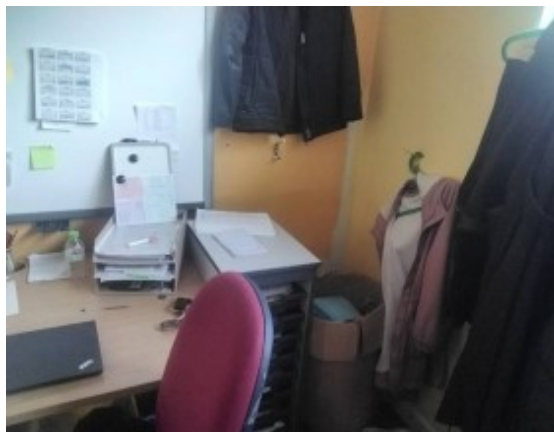
Item 192 - Ref: NG002302

The wall coating in the Canteen Office (Rm G/002) does not contain asbestos.

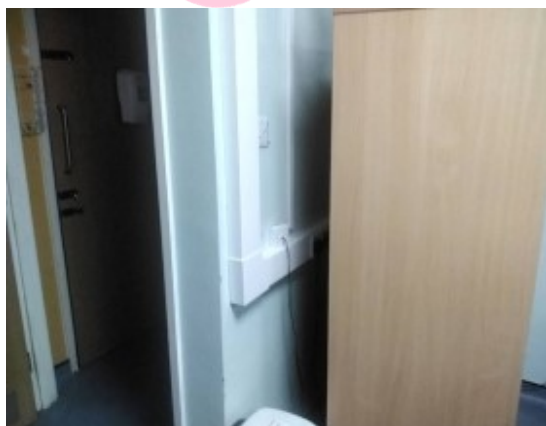
Item 193 - Ref: NG002303

The wall coating in the Caretakers Room (Rm G/003) does not contain asbestos.

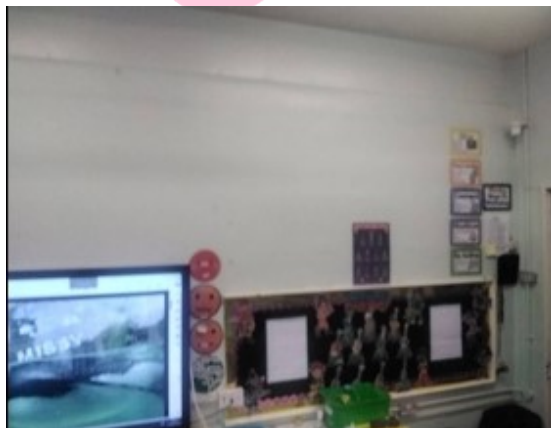
Item 196 - Ref: NG002288

The wall coating in the Year 3 Classroom (Rm G/006) does not contain asbestos.

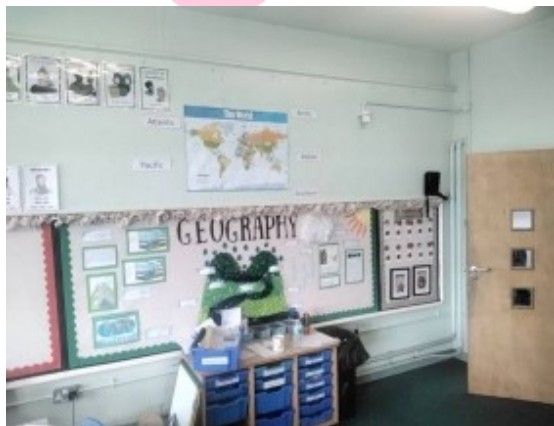
Item 199 - Ref: NG002291

The wall coating in the 5A Classroom (Rm G/009) does not contain asbestos.

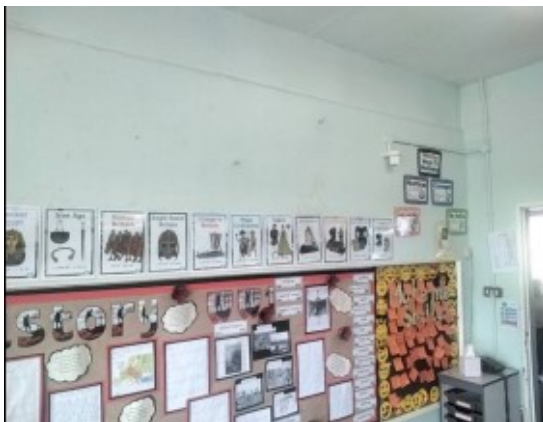
Item 201 - Ref: NG0023293

The wall coating in the 6A Classroom (Rm G/011) does not contain asbestos.

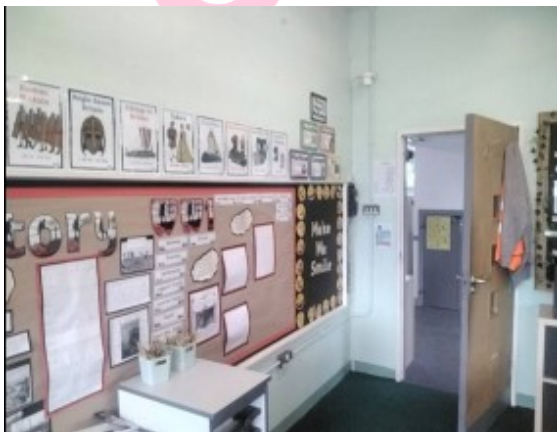
Item 202 - Ref: NG002294

The wall coating in the 6B Classroom (Rm G/012) does not contain asbestos.

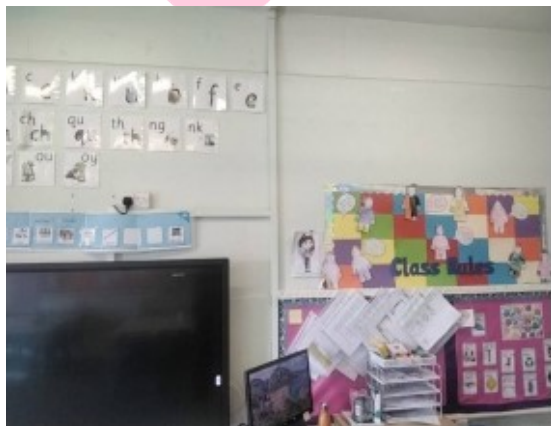
Item 205 - Ref: NG002298

The wall coating in the 1B Classroom (Rm G/015) does not contain asbestos.

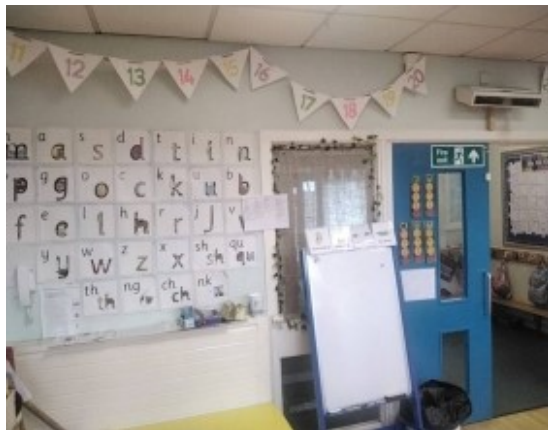
Item 207 - Ref: NG0023300

The wall coating in the Reception Classroom (Rm G/017) does not contain asbestos.

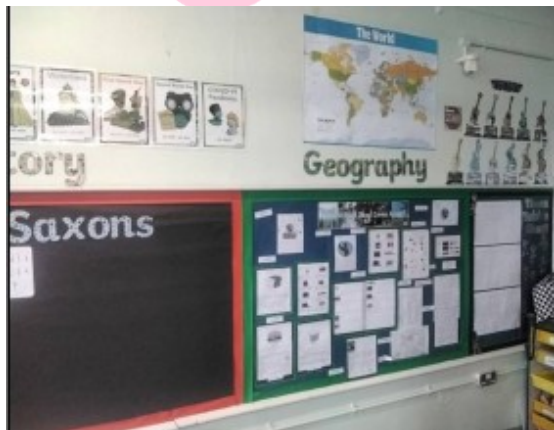
Item 208 - Ref: NG002304

The wall coating in the 4B Classroom (Rm G/018) does not contain asbestos.

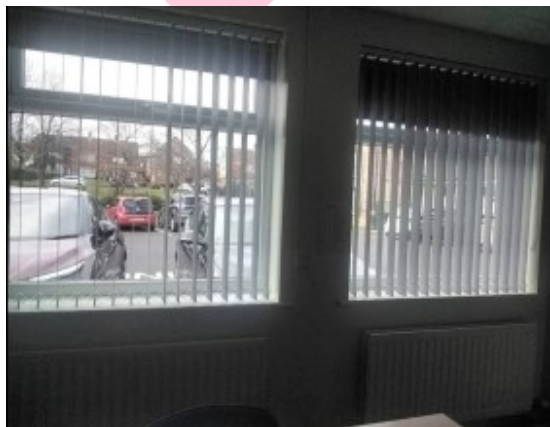
Item 211 - Ref: NG002307

The wall coating in the TLR Room (Rm G/021) does not contain asbestos.

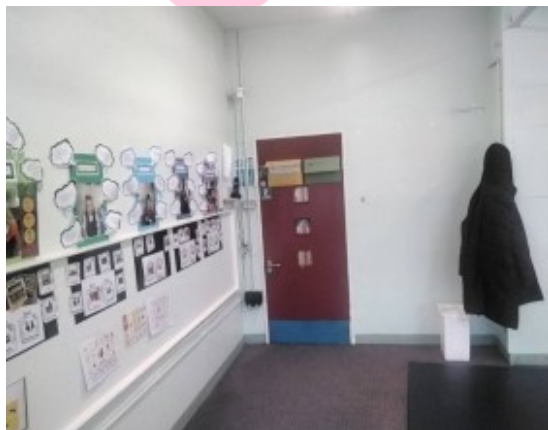
Item 214 - Ref: NG002285

The wall coating in the Soft Play (Rm G/024) does not contain asbestos.

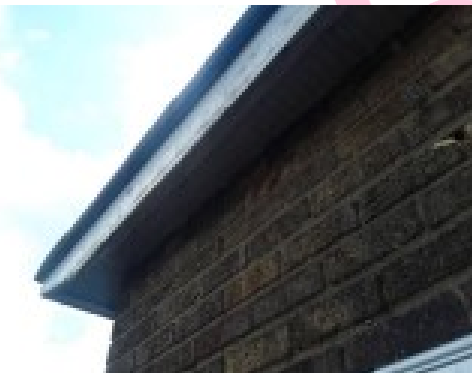
Item 222 - Ref: As NZ001566

The Soffits (External area 3
Roof E/004).

Any change in appearance
should be reported to Property
Services.

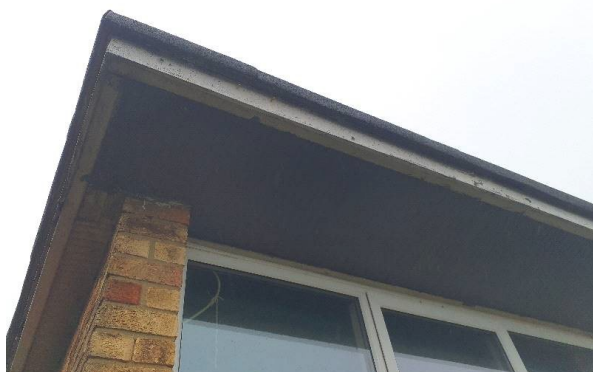
Item 228 - Ref: OU003191

The Cement Soffits (External E/001) contain asbestos.

Any change in appearance should be reported to Property Services.

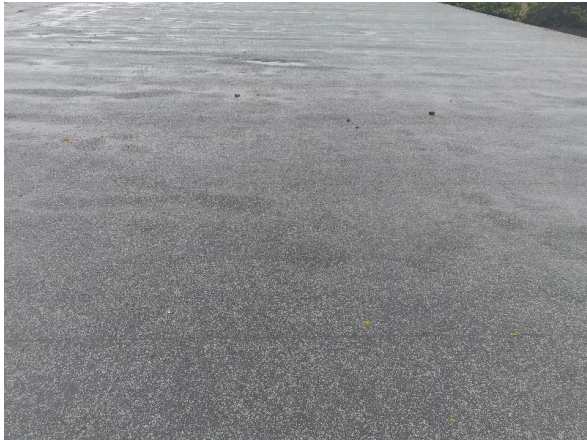
Item 233 - Ref: OU003177

The bitumen lining roof (External E/001) does not contain asbestos.

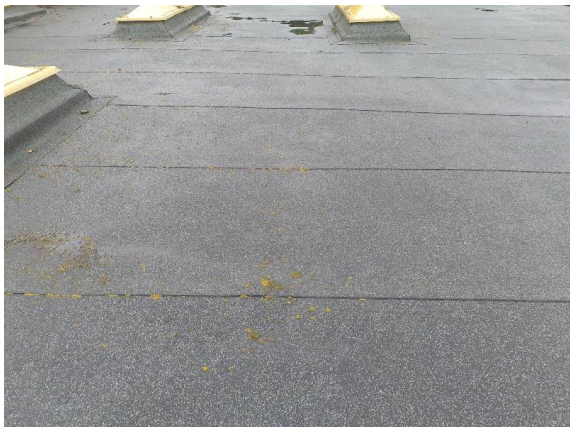
Item 241 - Ref: OU003185

The bitumen lining roof
(External E/001) does not
contain asbestos.

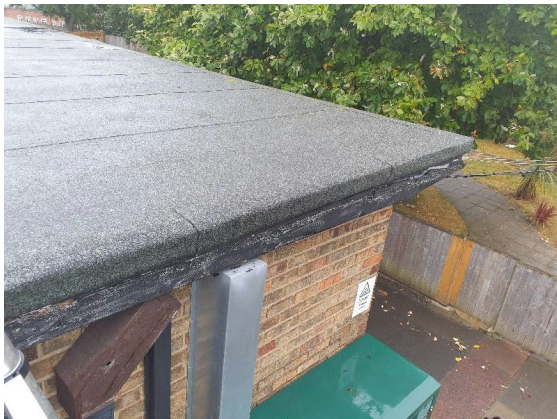
Item 243 - Ref: OU003188

The sealant around timber fascias (External E/001) does not contain asbestos.
