ASBESTOS SURVEY REPORT FOR FARRINGDON ACADEMY SCHOOL, SUNDERLAND

Asbestos Register for

**FARRINGTON ACADEMY SCHOOL,
SUNDERLAND**

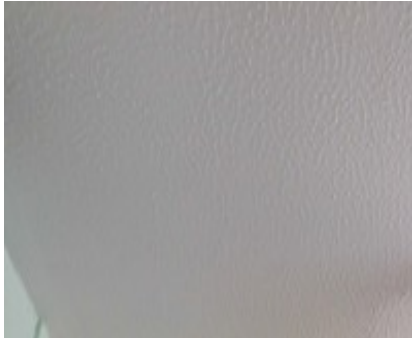
Item 1 Ref: 101894-1

The textured coating to the ceiling in the lobby of the behaviour unit (Rm 001) contains asbestos.

Any change in its appearance should be recorded and passed to Property Services.

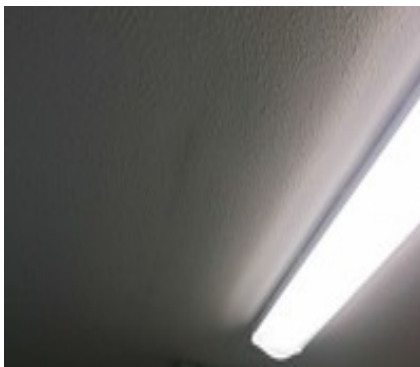
Item 2 – As 101894-1

The textured coating to the ceiling in the kitchen (Room 002) contains asbestos.

Any change in its appearance should be recorded and passed to Property Services.

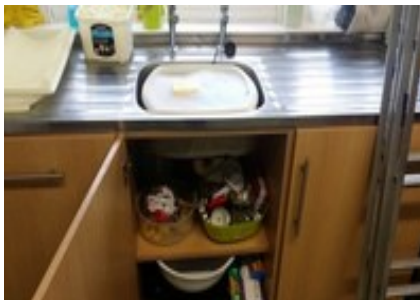
Item 3 Ref: 101894-2

The sink pad to the kitchen the behaviour unit (Rm 002) does not contain asbestos.

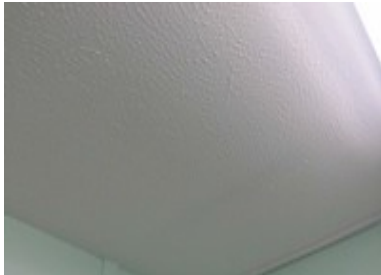
Item 4 As: 101894-1

The textured coating to the ceiling in the toilet of the behaviour unit (Rm 003) contains asbestos.

Any change in its appearance should be recorded and passed to Property Services.

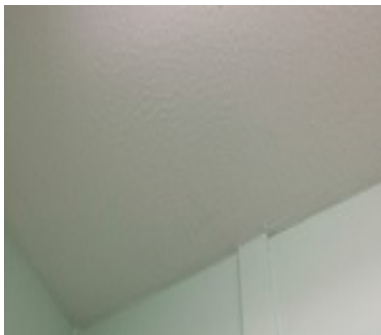
Item 5 As: 101894-1

The textured coating to the ceiling in the staff toilet of the behaviour unit (Rm 004) contains asbestos.

Removed October 2024

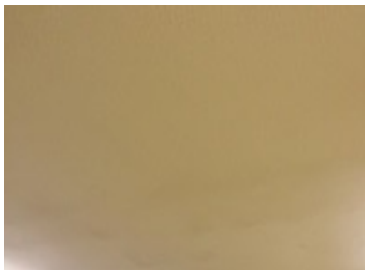
Item 6 As: 101894-1

The textured coating to the ceiling in the classroom of the behaviour unit (Rm 005) contains asbestos.

Removed October 2024

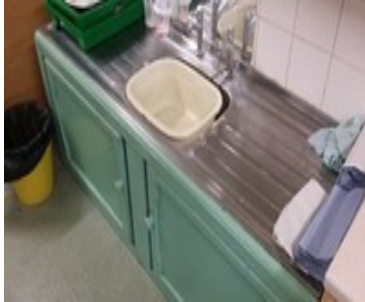
Item 7 As: 101894-2

The sink pad to the classroom of the behaviour unit (Rm 005) does not contain asbestos.

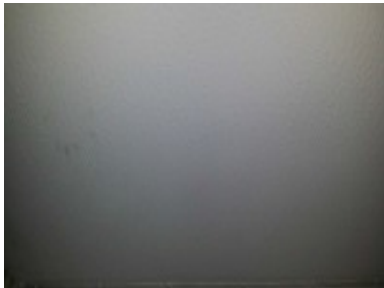
Item 8 As: 101894-1

The textured coating to the ceiling in the store cupboard in the behaviour unit (Rm 006) contains asbestos.

Any change in its appearance should be recorded and passed to Property Services.

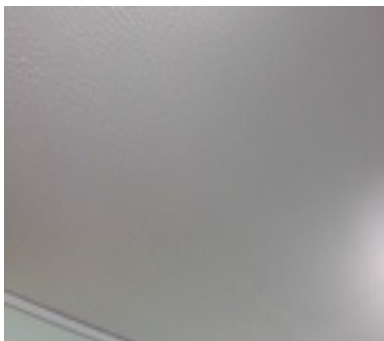
Item 9 As: 101894-1

The textured coating to the ceiling in the office in the behaviour unit (Rm 007) contains asbestos.

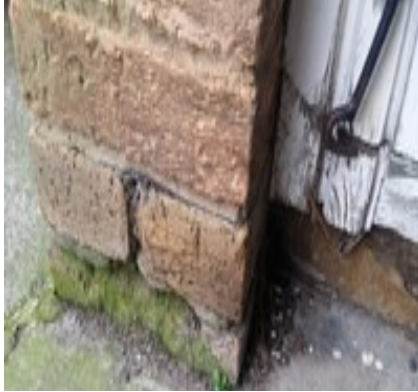
Item 13 Ref: 101894-5

The damp proof course to the behaviour unit (External) contains asbestos.

Any change in its appearance should be recorded and passed to Property Services.

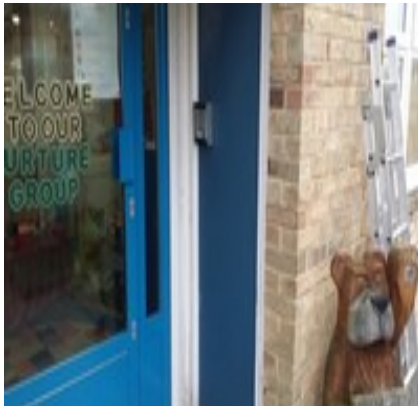
Item 14 Ref: 101894-6

The panels to the side of the door to the behaviour unit (External) contain asbestos.

Any change in its appearance should be recorded and passed to Property Services.

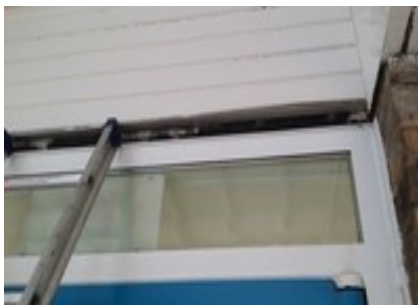
Item 15 Ref: 101894-7

The membrane behind the fascia to the external of the behaviour unit does not contain asbestos.

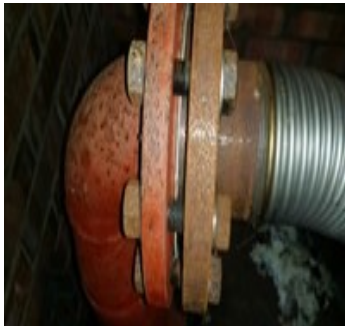
Item 16 Ref: 101894-8

The flange gasket to the pipework in the gas meter house does not contain asbestos.

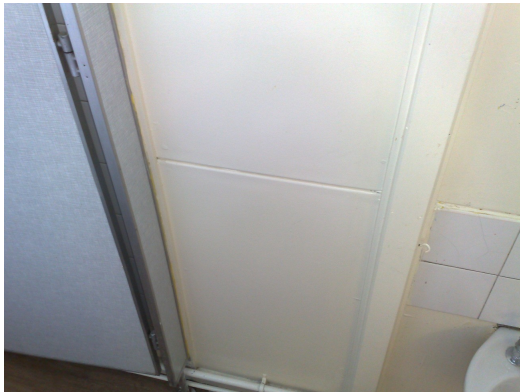
Item 146 Ref: KR09/76

The wall panels in the Behaviour Unit do not contain asbestos.

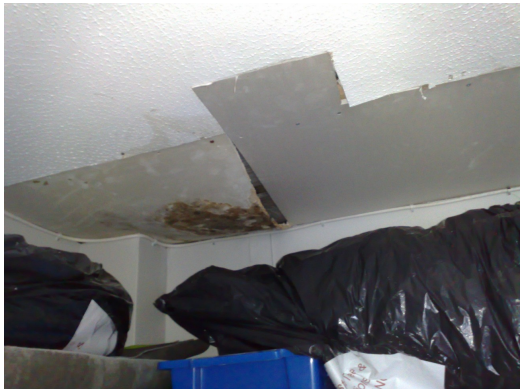
Item 147 Ref: KR09/78

The ceiling panels in the Behaviour Unit do not contain asbestos.

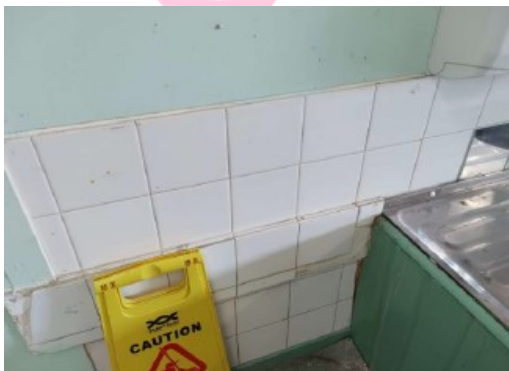
Item 157 Ref: 21-34101-2

The adhesive behind ceramic tiles (Area 1/Main Room) does not contain asbestos.

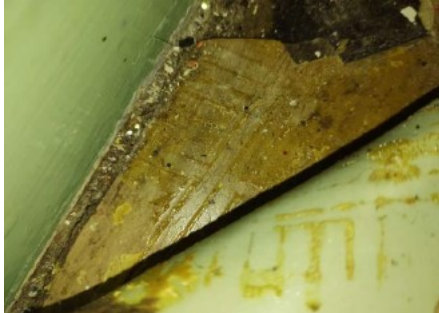
Item 158 Ref: 21-34101-3

The brown vinyl floor tile (Area 1/Main Room) contains asbestos.

Any change in its appearance should be recorded and passed to Property Services.

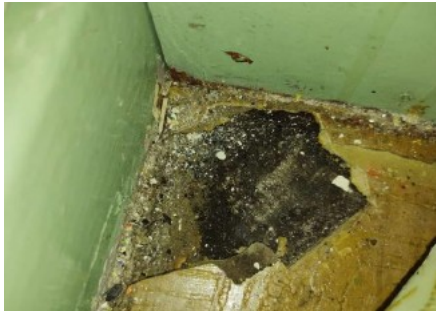
Item 159 Ref: 21-34101-4

The composite floor (Area 1/Main Room) does not contain asbestos.

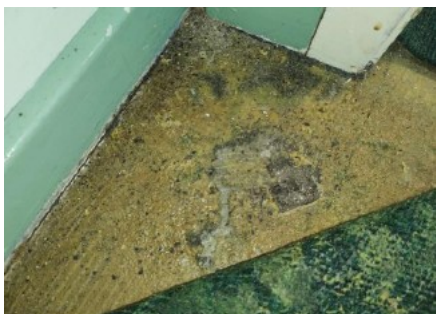
Item 160 Ref: 21-34101-4

The composite floor (Area 2/Back Office) does not contain asbestos.

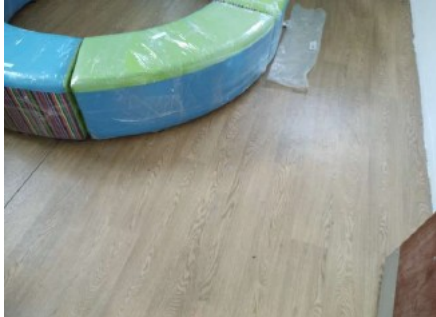
Item 161 Ref: 21-34101-4

The composite floor (Area 3/Side Office) does not contain asbestos.

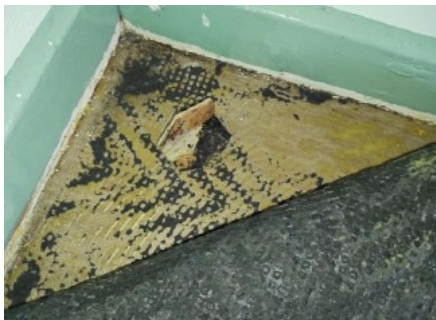
Item 162 Ref: 21-34101-4

The composite floor (Area 4/Entrance Lobby) does not contain asbestos.

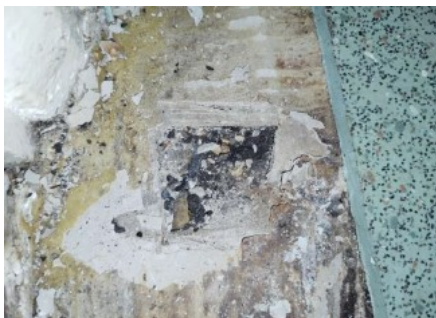
Item 163 Ref: 21-34101-4

The composite floor (Area 5/Kitchen) does not contain asbestos.

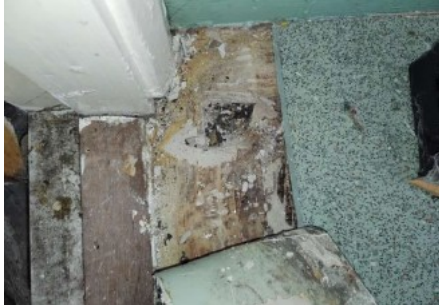
Item 164 Ref: 21-34101-6

The beige vinyl floor covering (Area 5/Kitchen) contains asbestos.

Any change in its appearance should be recorded and passed to Property Services.

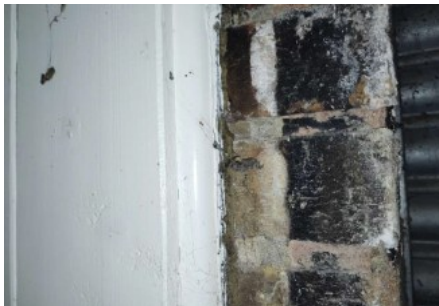
Item 165 Ref: 21-34101-8

The sealant between wood cladding and brickwork (Area 6/Side Lobby) does not contain asbestos.

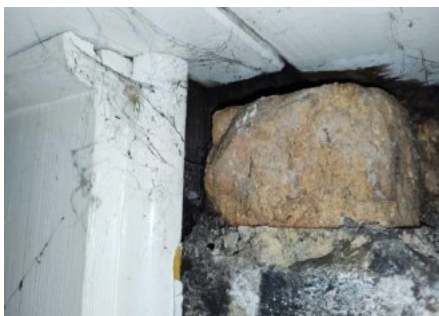
Item 166 Ref: 21-34101-9

The DPC behind brickwork at doorway (Area 6/Side Lobby) does not contain asbestos.

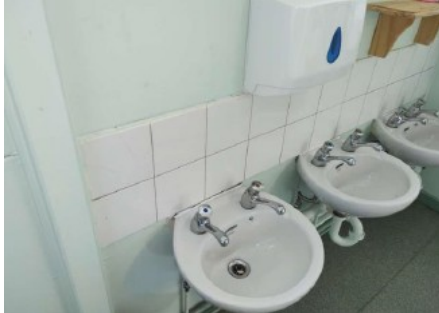
Item 167 Ref: 21-34101-10

The adhesive behind ceramic tiles (Area 7/WC) does not contain asbestos.

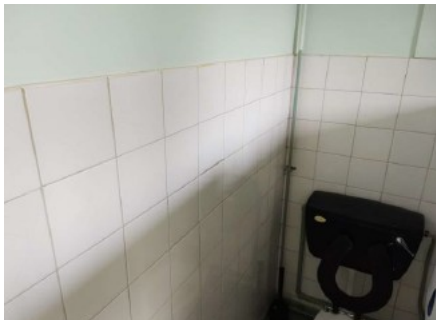
Item 168 Ref: 21-34101-10

The adhesive behind ceramic tiles (Area 7/WC) does not contain asbestos.

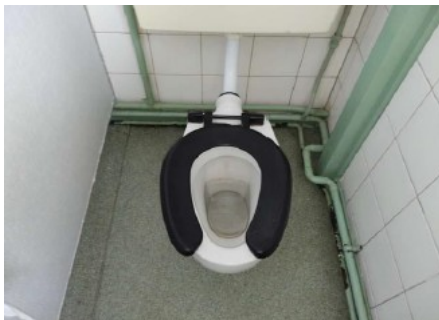
Item 169 Ref: 21-34101-11

The resin toilet seats (Area 7/WC) do not contain asbestos.

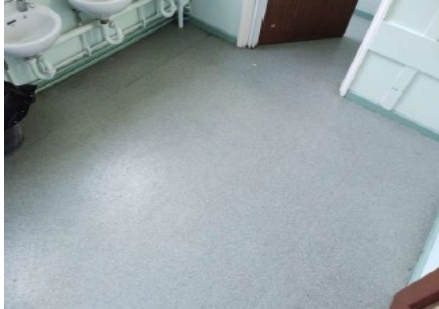
Item 170 Ref: 21-34101-4

The composite floor (Area 7/WC) does not contain asbestos.

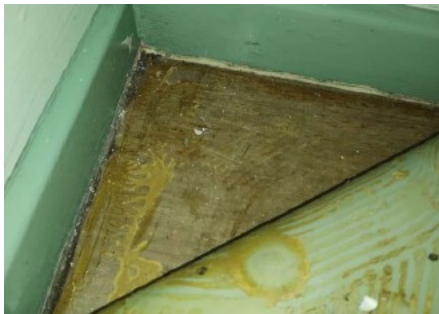
Item 171 Ref: 21-34101-6

The beige vinyl floor covering (Area 7/WC) contains asbestos.

Any change in its appearance should be recorded and passed to Property Services.

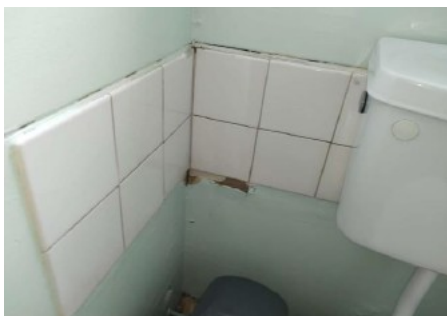
Item 172 Ref: 21-34101-10

The adhesive behind ceramic tiles (Area 8/Staff WC) does not contain asbestos.

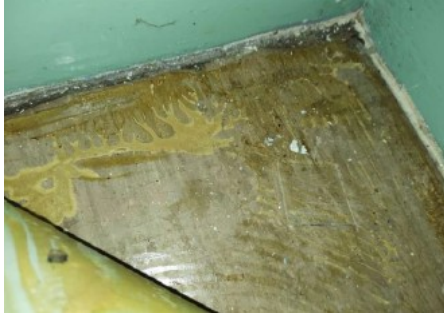
Item 173 Ref: 21-34101-6

The beige vinyl floor covering (Area 8/Staff WC) contains asbestos.

Any change in its appearance should be recorded and passed to Property Services.

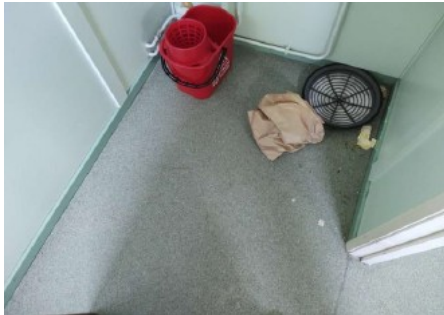
Item 174 Ref: 21-34101-4

The composite floor (Area 8/Staff WC) does not contain asbestos.

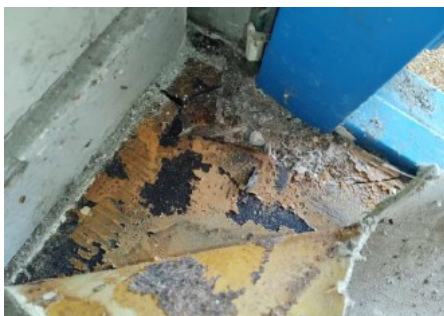
Item 175 Ref: 21-34101-4

The composite floor (Area 9/Boiler Room) does not contain asbestos.

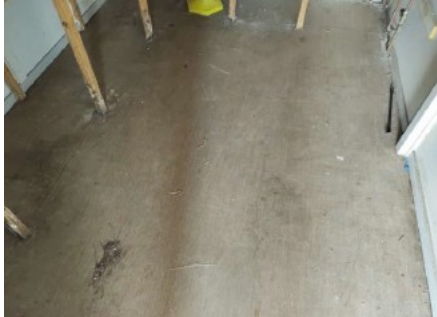
Item 176 Ref: 21-34101-6

The beige vinyl floor covering (Area 9/Boiler Room) contains asbestos.

Any change in its appearance should be recorded and passed to Property Services.

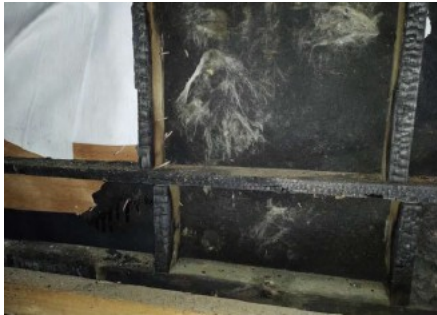
Item 177 Ref: 21-34101-12

The bitumen felt lining to wood walls (Area 10/Ceiling void) does not contain asbestos.

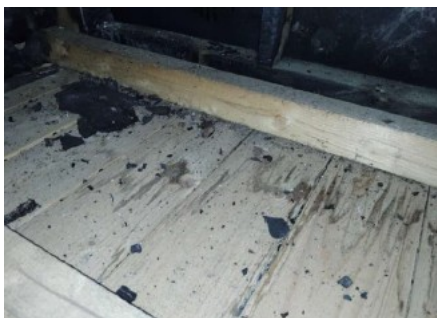
Item 178 Ref: 21-34101-12

The bitumen felt lining to wood walls (Area 10/Ceiling void) does not contain asbestos.

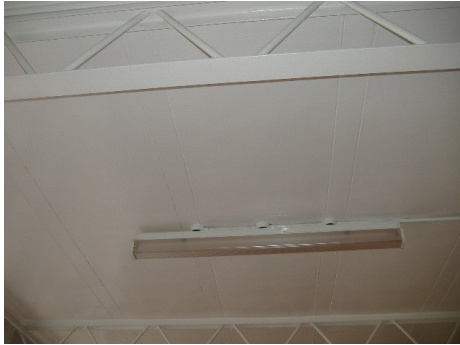
Item 19 - Ref: AW0435/08

The ceiling coating to the lobby (Rm 0/01) does not contain asbestos.

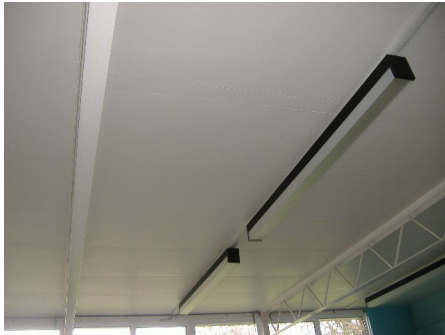
Item 20 - Ref: AW0438/08

The ceiling coating to the classroom (Rm 0/02) does not contain asbestos.

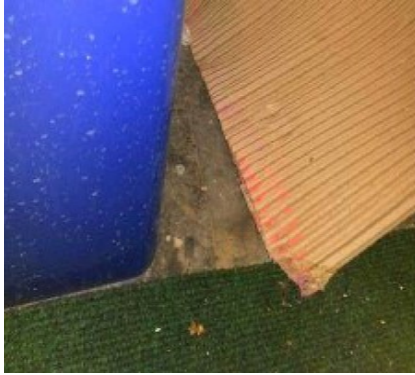
Item 21 - Ref: AW0439/08

The wall kick protection to the classroom (Rm 0/02) contained asbestos.

This was removed in July 2015.

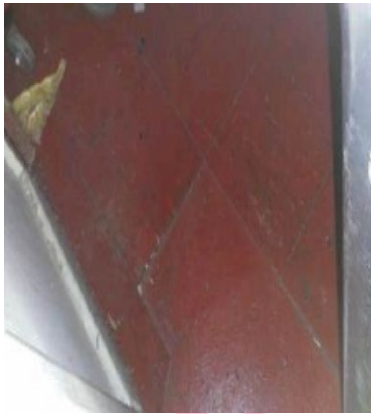
Item 22 - Ref: AW0440/08

The floor tiles to the fire hose cupboards in the corridor (Rm 0/18) contain asbestos.

Any change in its appearance should be recorded and passed to Property Services.

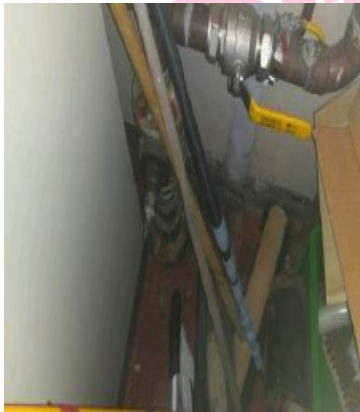
Item 23 - Ref: AW0441/08

The black floor tiles (painted red) to the store room (Rm 0/25) contain asbestos.

Any change in its appearance should be recorded and passed to Property Services.

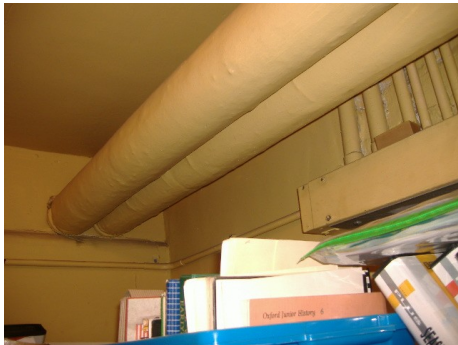
Various- Ref: AW0442/08

The pipework insulation to the store room (Rm 0/43) contains asbestos.

Similar insulation is located in Rm 0/44.

Any change in its appearance should be recorded and passed to Property Services.

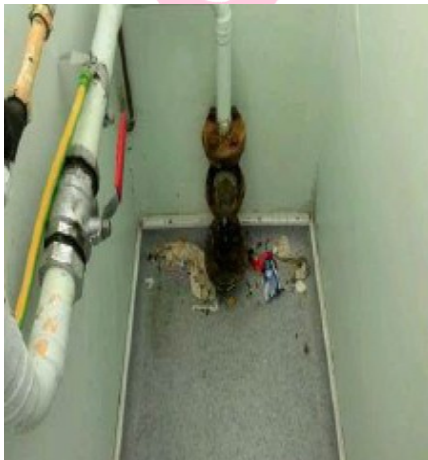
Item 27 - Ref: AW0443/08

The pipework insulation to the store room (Rm 0/45) contains asbestos.

Any change in its appearance should be recorded and passed to Property Services.

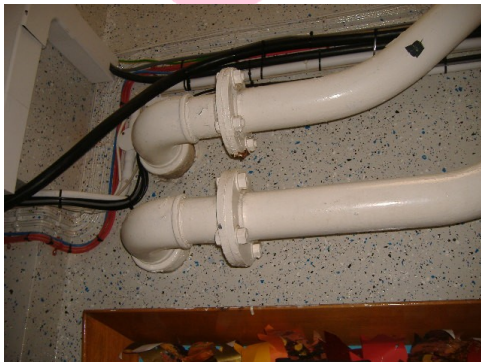
Item 30 - Ref: Presumed

The gaskets to corridor (Rm 0/59) are presumed to contain asbestos.

Any change in its appearance should be recorded and passed to Property Services.

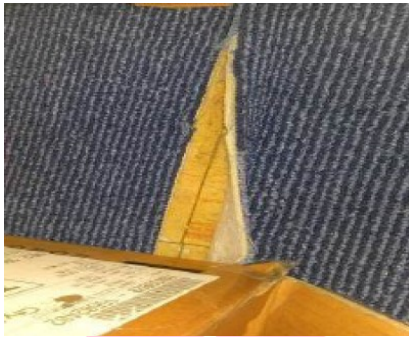
Item 32 - Ref: WC0473/08

The black/red floor tiles to the store room (Rm 0/85) contained asbestos.

These were removed in July 2015.

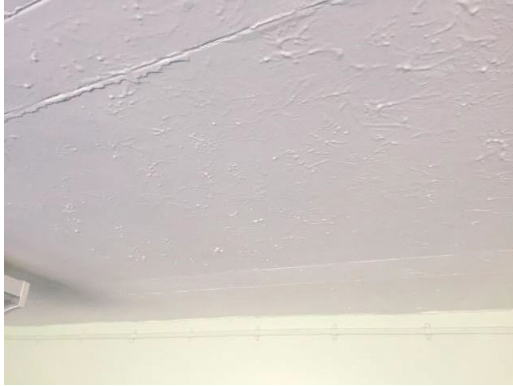
Item 49 – Ref: 741267-2

The ceiling in the Switch Room does not contain asbestos.

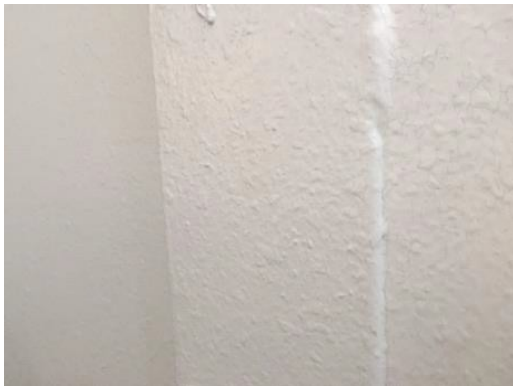
Item 50 - Ref: 741267-3

The textured coating to the stramit contains asbestos.

Any change in its appearance should be recorded and passed to Property Services.

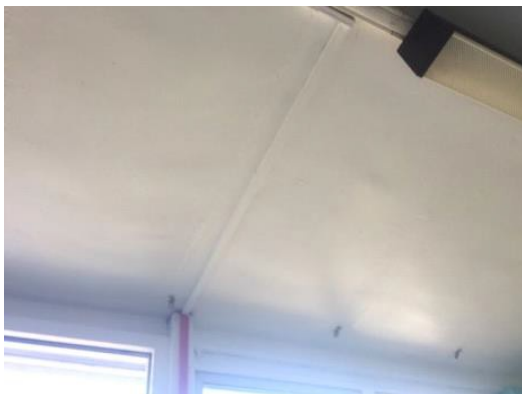
Item 51 – Ref: 741269-4

The coating to the wall in the Corridor does not contain asbestos.

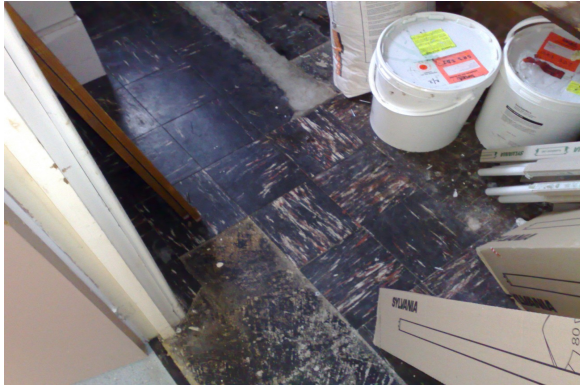
Item 111 - Ref: KR09/62

The floor tiles and adhesive in Chemical Store B (Room 0/70) contains asbestos.

Any change in its appearance should be recorded and passed to Property Services.

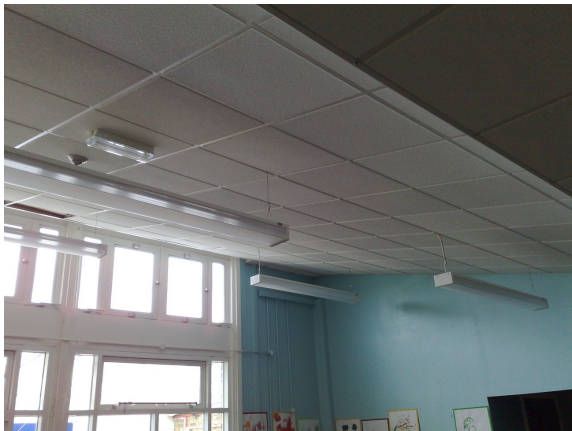
Item 126 - Ref: KR09/69

The suspended ceiling tiles in the Nursery and cloakroom (Room 0/97) does not contain asbestos.

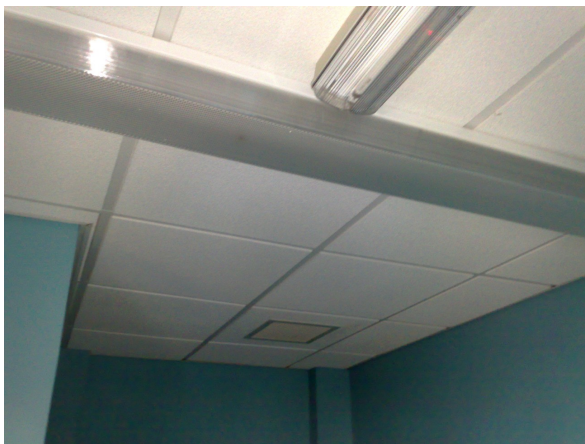
Item 127 - Ref: KR09/73

The suspended ceiling tiles in the Nursery toilet (Room 0/98) does not contain asbestos.

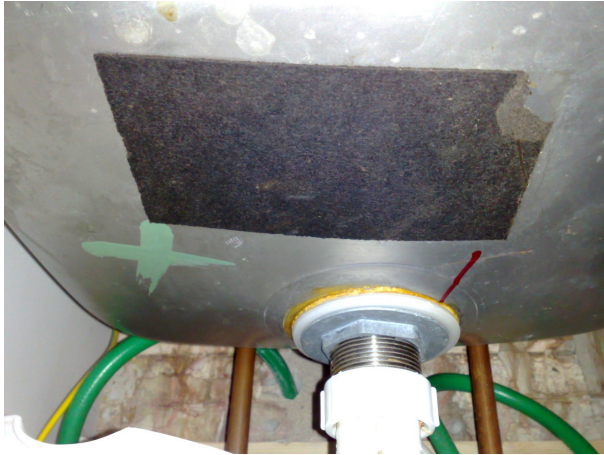
Item 132 - Ref: KR09/61

The sink pad in the kitchen area corridor (Room 0/69) does not contain asbestos.

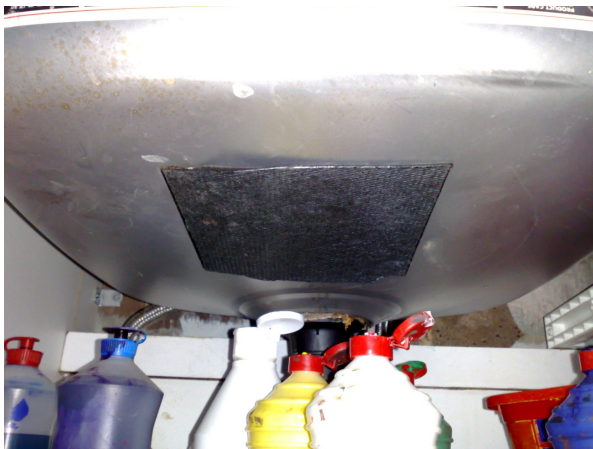
Item 133 - Ref: KR09/64

The sink pad in the toilet (Room 0/81) does not contain asbestos.

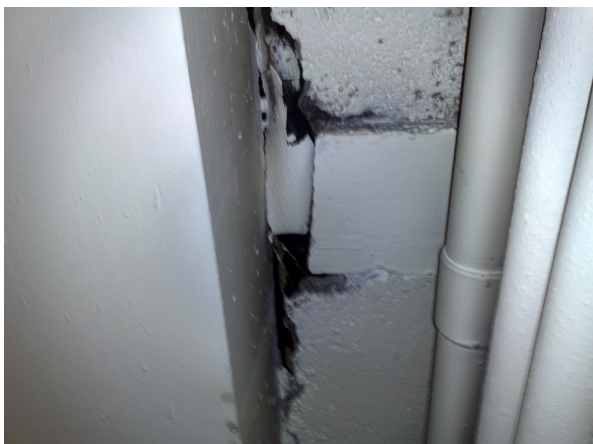
Item 134 - Ref: KR09/66

The bitumen material to ceiling above door in under stairs store (Room 0/83) does not contain asbestos.

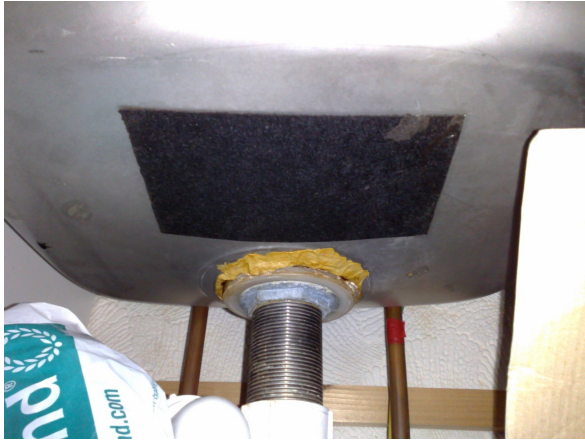
Item 135 - Ref: KR09/67

The sink pad in the clothes store/sink room (Room 1/085) does not contain asbestos.

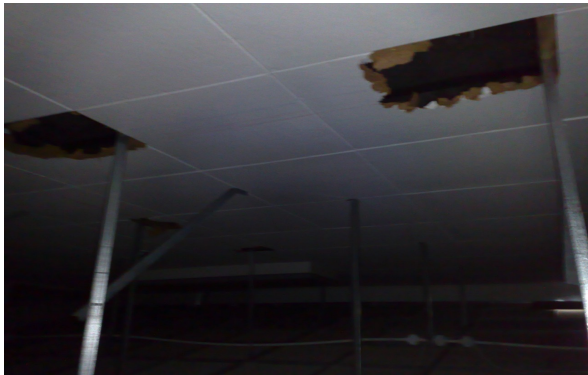
Item 136 - Ref: KR09/70

The ceiling tiles above suspended ceiling in the Nursery and cloakroom (Room 0/97) does not contain asbestos.

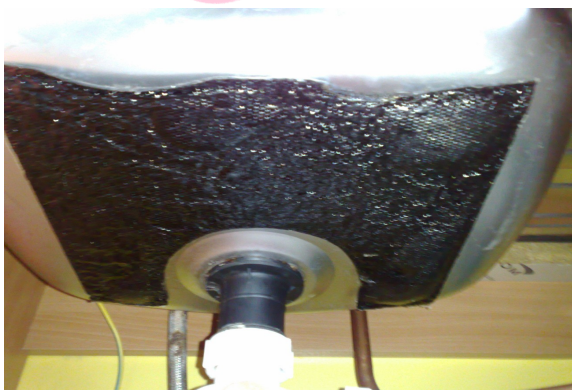
Item 138 - Ref: KR09/71

The sink pad in the Nursery and cloakroom (Room 0/97) does not contain asbestos.

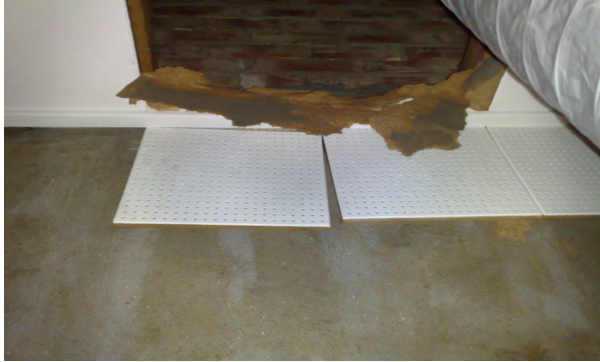
Item 139 - Ref: KR09/72

The acoustic tiles in the Nursery and Cloakroom (Room 0/97) does not contain asbestos.

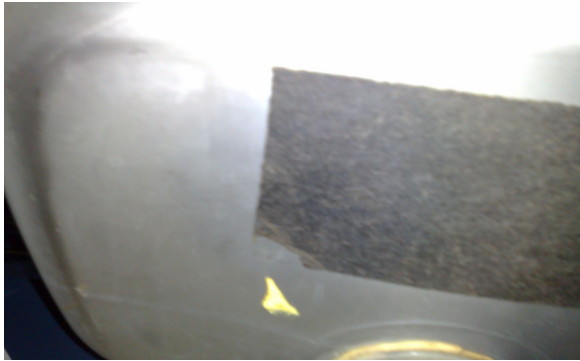
Item 141 - Ref: KR09/75

The sink pad in the extended school kitchen club (Room 0/101) does not contain asbestos.

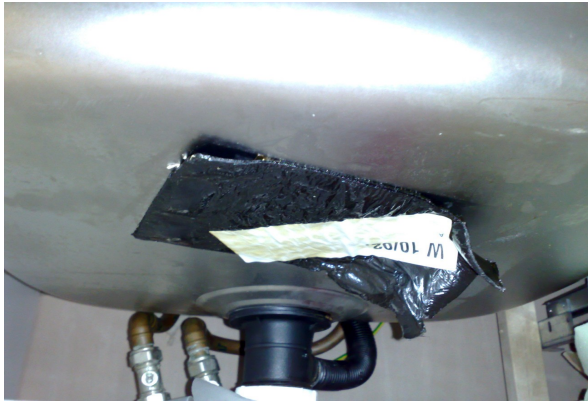
Item 142 - Ref: KR09/48

The sink pad in class 7 (Room 0/010) does not contain asbestos.

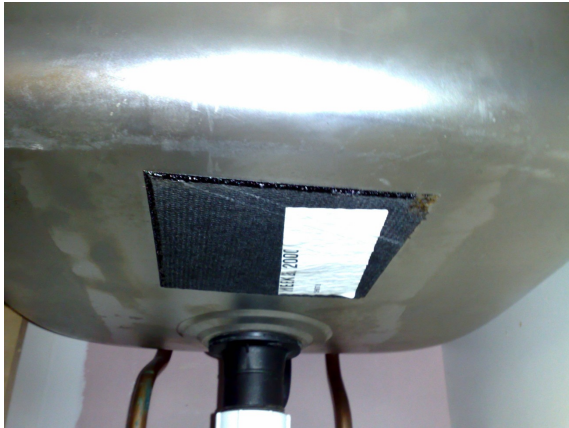
Item 145 - Ref: KR09/57

The sink pad in the Staff Room (Room 0/062) does not contain asbestos.

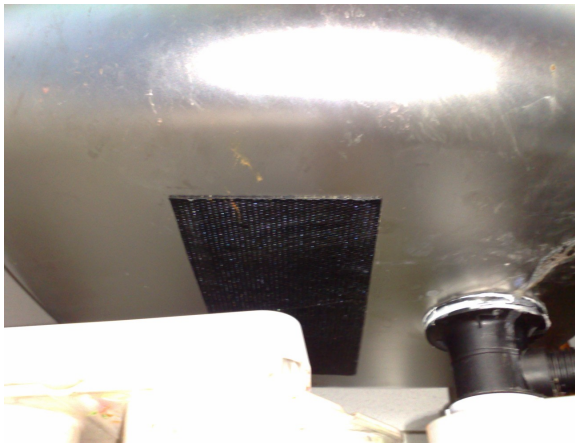
Item 146 - Ref: KR09/50

The sink pad in the Art Room (Room 0/016) does not contain asbestos.

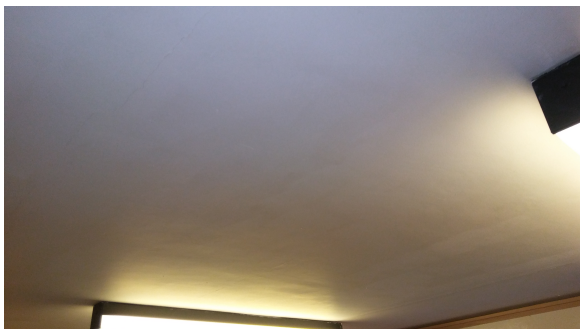
Item 153 - Ref: 383326-1

The ceiling in 005/Music Room does not contain asbestos.

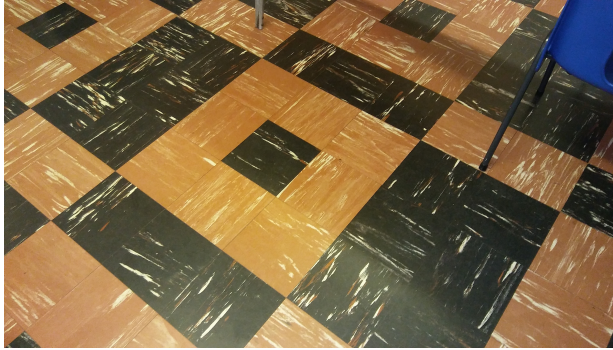
Item 154 - Ref: 383326-2

The floor covering in 005/Music Room contains asbestos.

Any change in its appearance should be recorded and passed to Property Services.

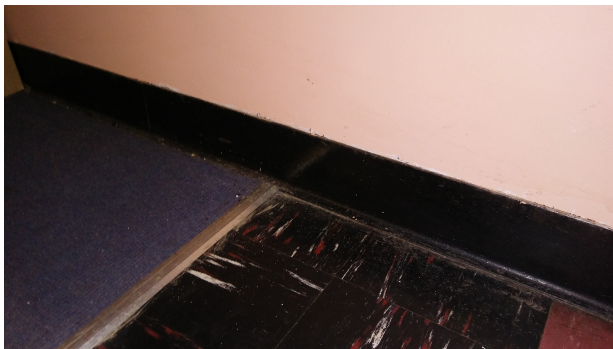
Item 155 - Ref: 383326-3

The skirting board in 005/Music Room contains asbestos.

Any change in its appearance should be recorded and passed to Property Services.

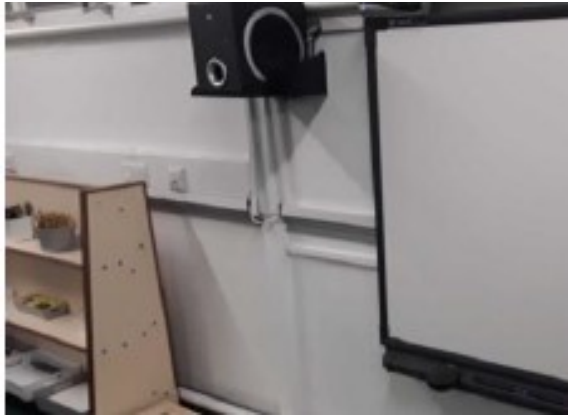
Item 179 - Ref: 22-42251-1

The textured coating to walls in Year 6 Learning Zone does not contain asbestos.

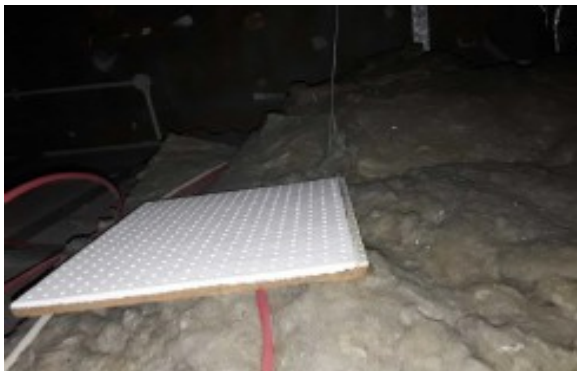
Item 180 - Ref: 22-45169-1

The fibreboard debris in Area 2 Classroom Reception ceiling void does not contain asbestos.

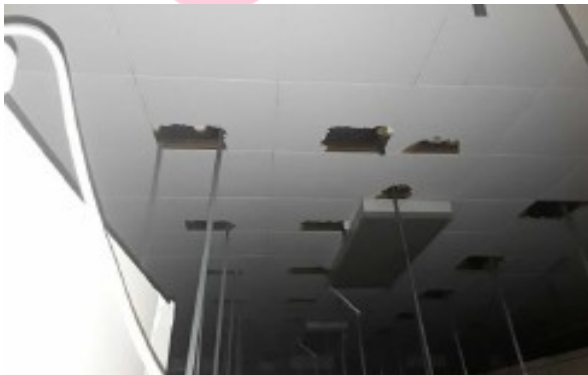
Item 181 - Ref: 22-45169-2

The fibreboard ceiling in Area 2 Classroom Reception ceiling void does not contain asbestos.

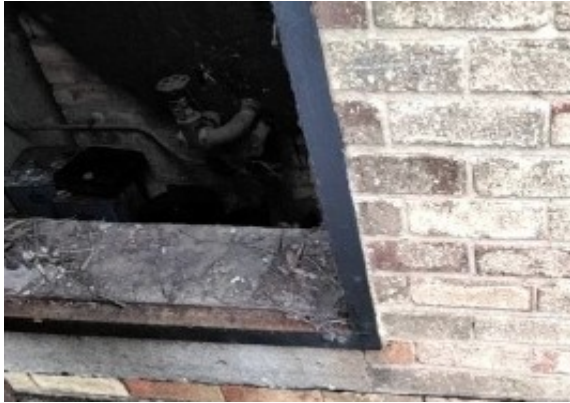
Item 182 - Ref: SC005256

The damp proof course in the Boiler Room (External) does not contain asbestos.

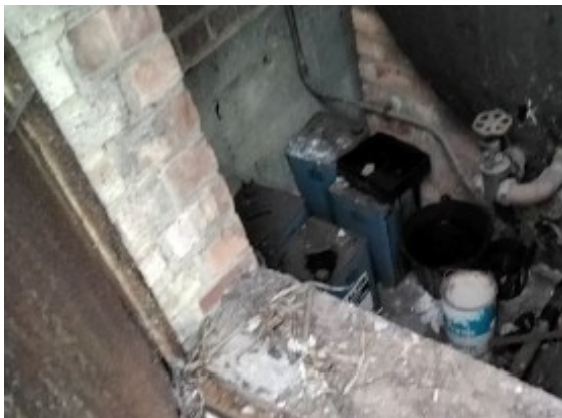
Item 183 - Ref: SC005253

The debris to access step in the Boiler Room (External) does not contain asbestos.

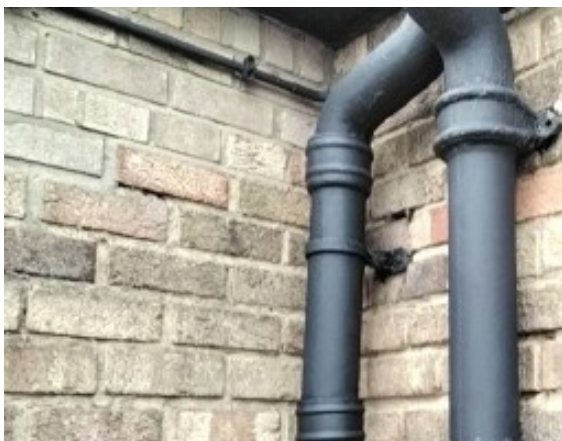
Item 187 - Ref: SC005255

The pipe joints caulking/packing in the Boiler Room (External) does not contain asbestos.

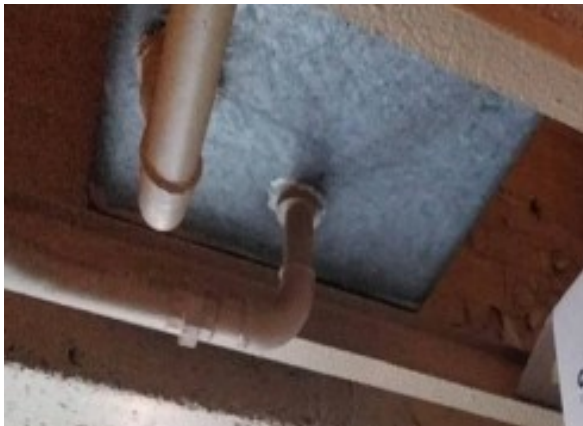
Item 189 - Ref: NO000640

The wall coating in the Store Room (Rm 1/001) does not contain asbestos.

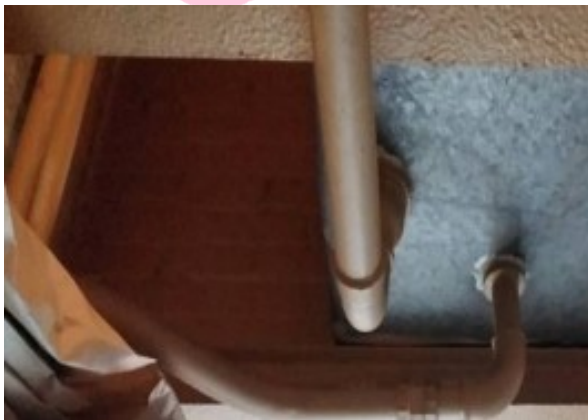
Item 190 - Ref: NO000641

The wall coating to tank support girders in the Store Room (Rm 1/001) does not contain asbestos.

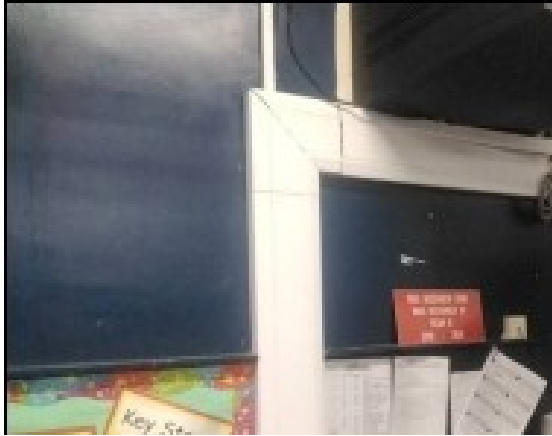
Item 191 - Ref: NG002283

The wall coating in the ITC Room (Rm G/001) does not contain asbestos.

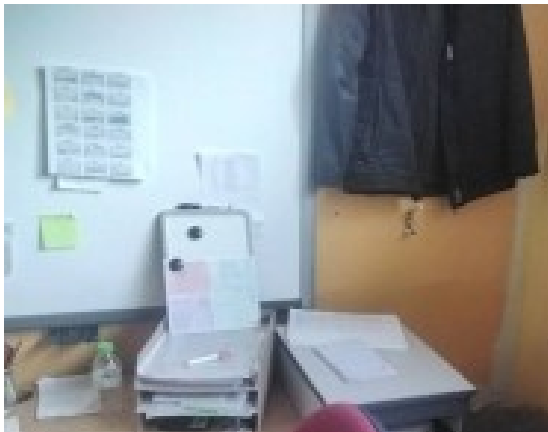
Item 192 - Ref: NG002302

The wall coating in the Canteen Office (Rm G/002) does not contain asbestos.

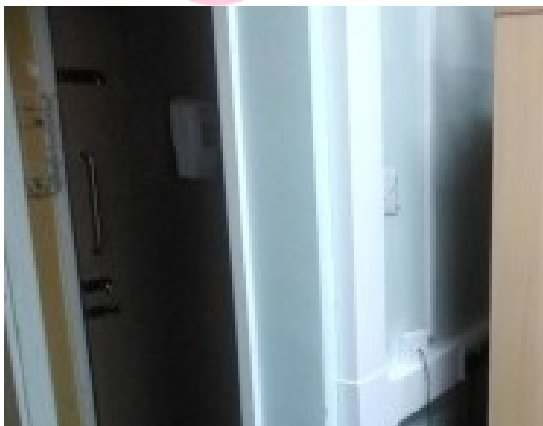
Item 193 - Ref: NG002303

The wall coating in the Caretakers Room (Rm G/003) does not contain asbestos.

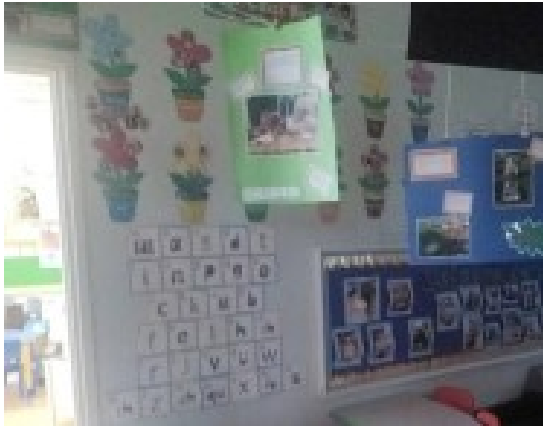
Item 194 - Ref: NG002286

The wall coating in Nursery 1 (Rm G/004) does not contain asbestos.

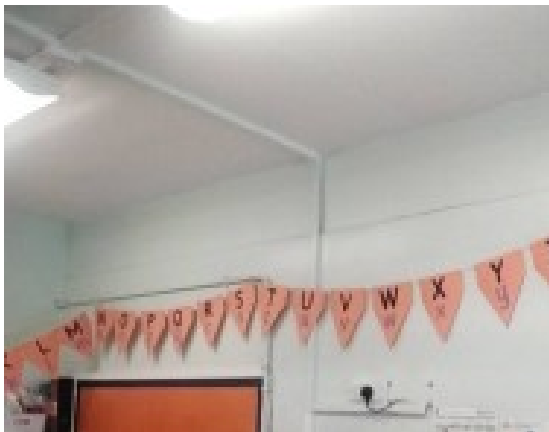
Item 195 - Ref: NG0023287

The wall coating in Nursery 2 (Rm G/005) does not contain asbestos.

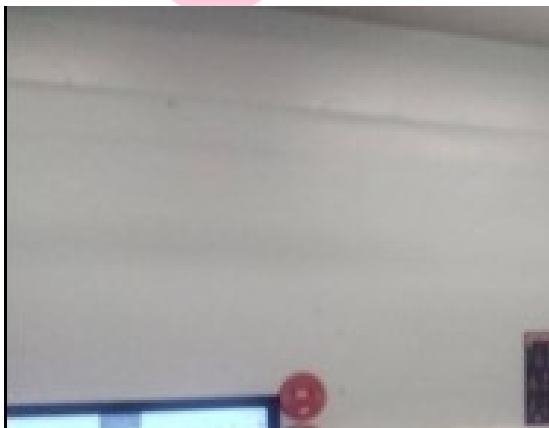
Item 196 - Ref: NG002288

The wall coating in the Year 3 Classroom (Rm G/006) does not contain asbestos.

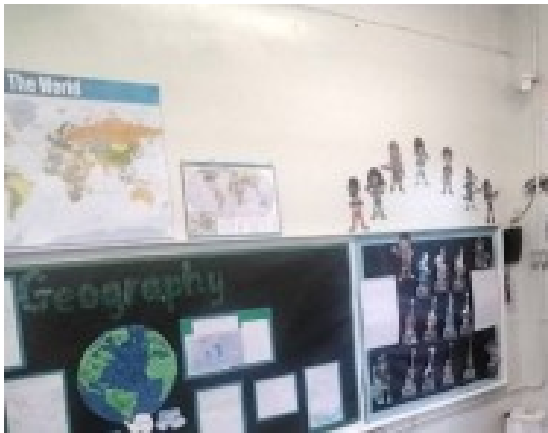
Item 197 - Ref: NG002289

The wall coating in the Year 3B Classroom (Rm G/007) does not contain asbestos.

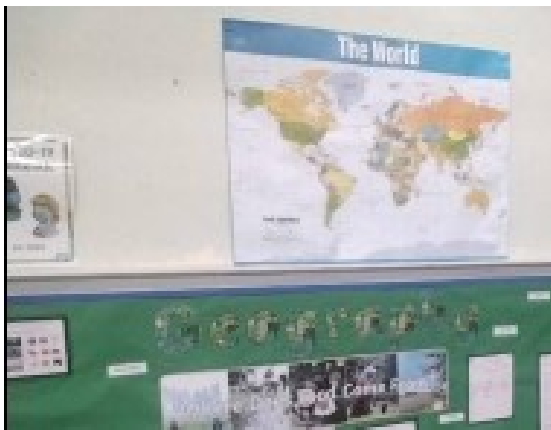
Item 198 - Ref: NG0023290

The wall coating in the 4A Classroom (Rm G/008) does not contain asbestos.

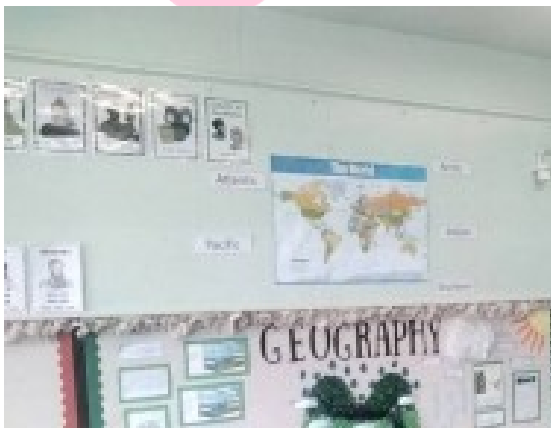
Item 199 - Ref: NG002291

The wall coating in the 5A Classroom (Rm G/009) does not contain asbestos.

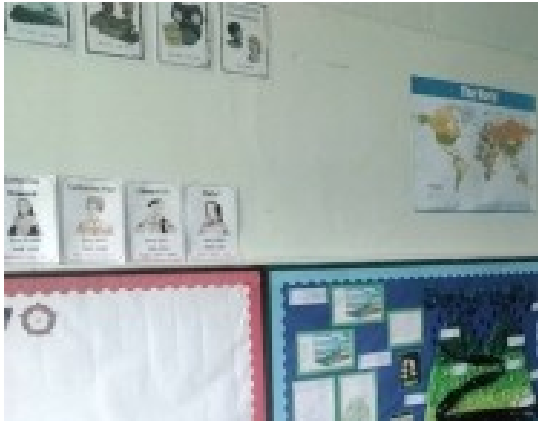
Item 200 - Ref: NG002292

The wall coating in the 5B Classroom (Rm G/010) does not contain asbestos.

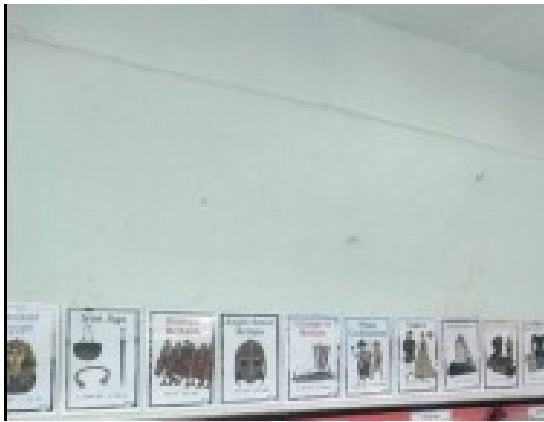
Item 201 - Ref: NG0023293

The wall coating in the 6A Classroom (Rm G/011) does not contain asbestos.

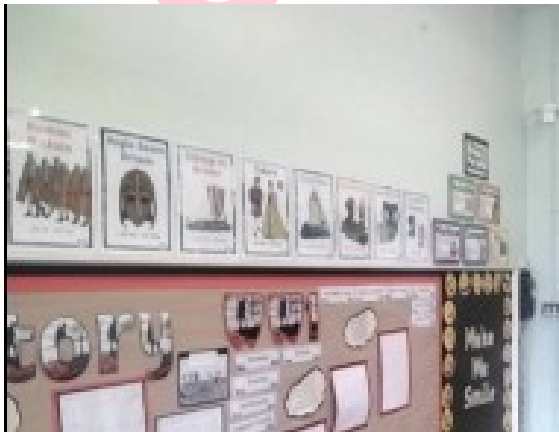
Item 202 - Ref: NG002294

The wall coating in the 6B Classroom (Rm G/012) does not contain asbestos.

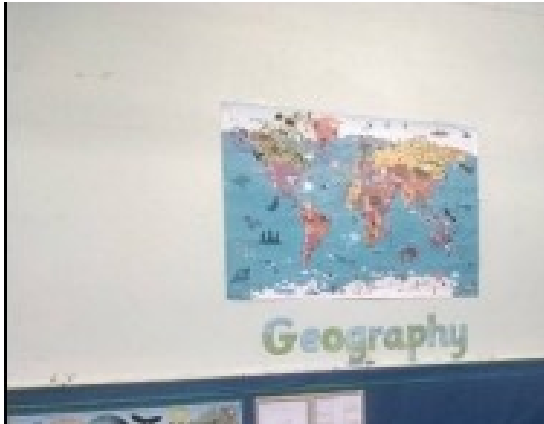
Item 203 - Ref: NG002296

The wall coating in the 2B Classroom (Rm G/013) does not contain asbestos.

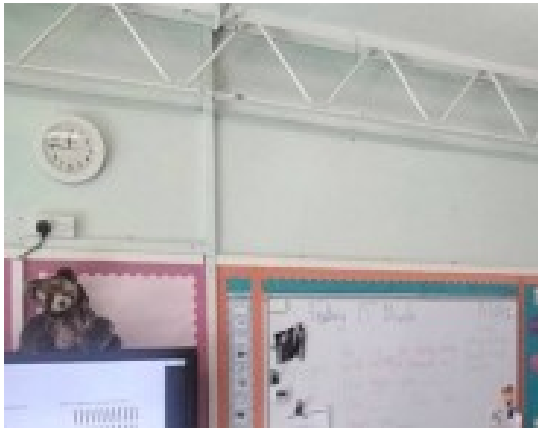
Item 204 - Ref: NG0023297

The wall coating in the 2A Classroom (Rm G/014) does not contain asbestos.

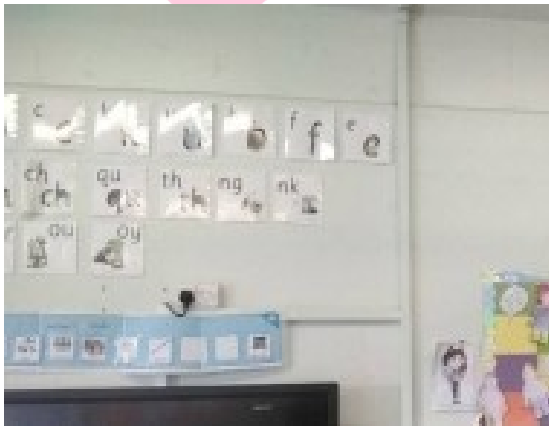
Item 205 - Ref: NG002298

The wall coating in the 1B Classroom (Rm G/015) does not contain asbestos.

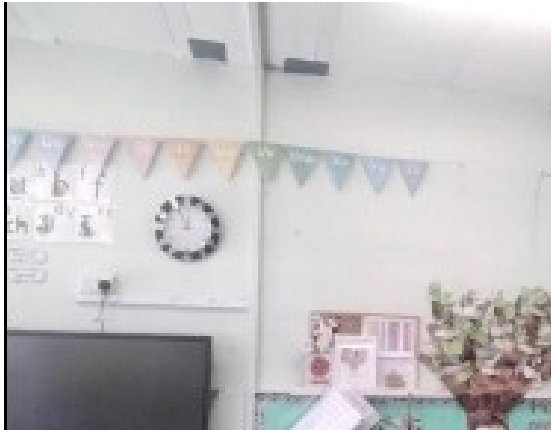
Item 206 - Ref: NG002299

The wall coating in the 1A Classroom (Rm G/016) does not contain asbestos.

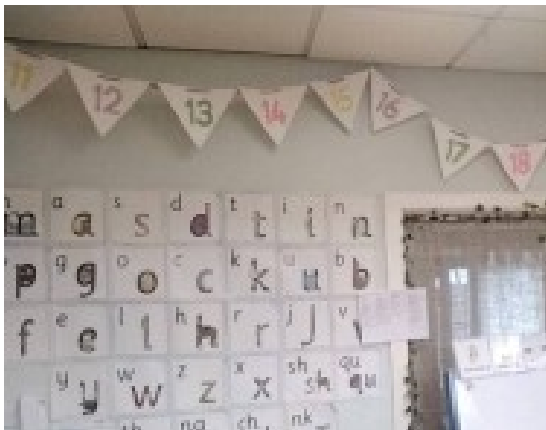
Item 207 - Ref: NG0023300

The wall coating in the Reception Classroom (Rm G/017) does not contain asbestos.

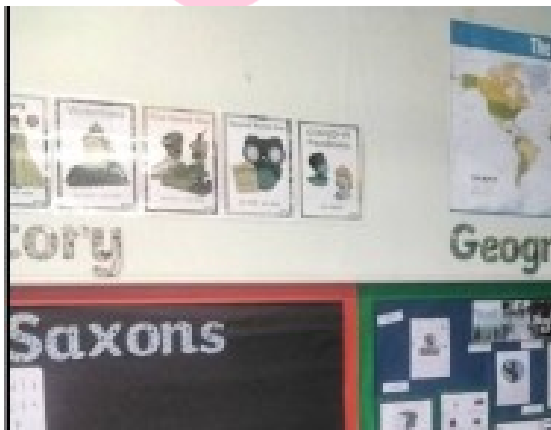
Item 208 - Ref: NG002304

The wall coating in the 4B Classroom (Rm G/018) does not contain asbestos.

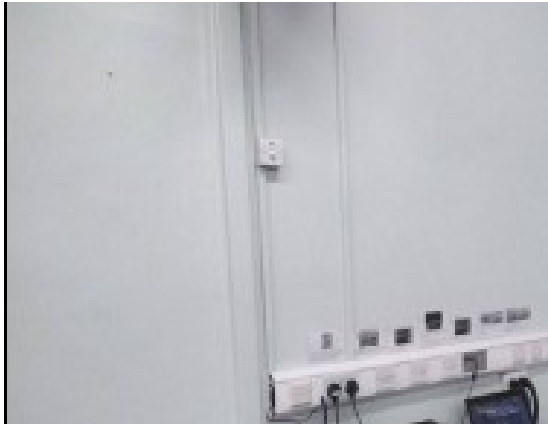
Item 209 - Ref: NG002305

The wall coating in the Main Hall (Rm G/019) does not contain asbestos.

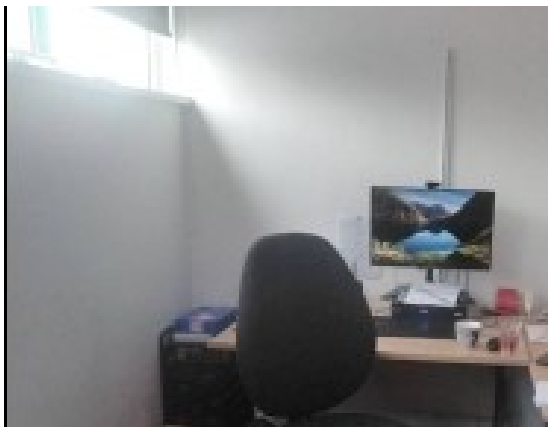
Item 210 - Ref: NG0023306

The wall coating in the Assistant Heads Office (Rm G/020) does not contain asbestos.

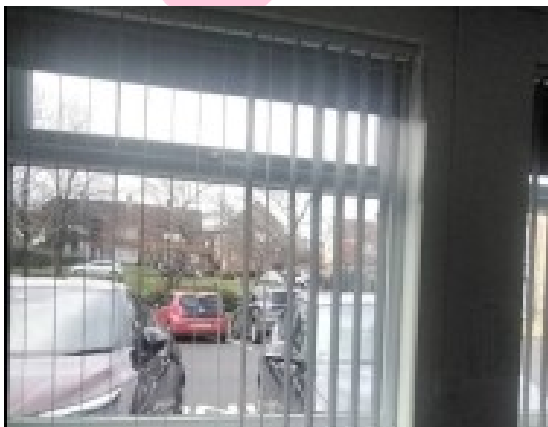
Item 211 - Ref: NG002307

The wall coating in the TLR Room (Rm G/021) does not contain asbestos.

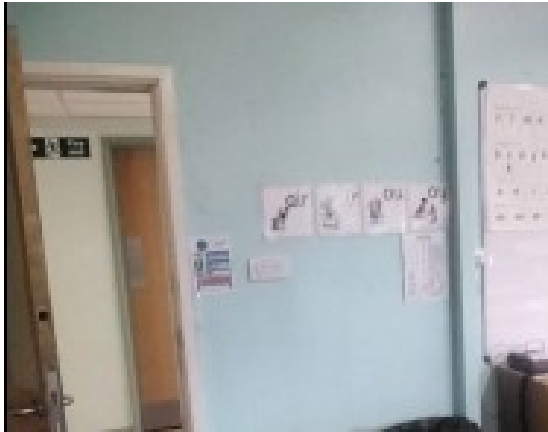
Item 212 - Ref: NG002301

The wall coating in the Art Room (Rm G/022) does not contain asbestos.

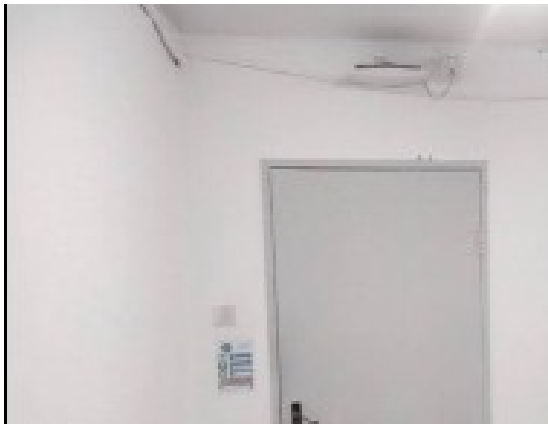
Item 213 - Ref: NG0023284

The wall coating in the Phonics Room (Rm G/023) does not contain asbestos.

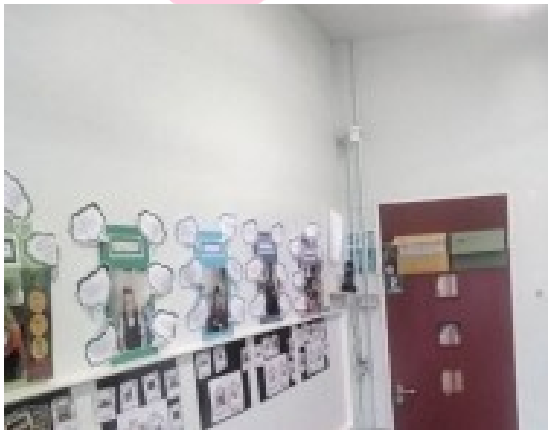
Item 214 - Ref: NG002285

The wall coating in the Soft Play (Rm G/024) does not contain asbestos.

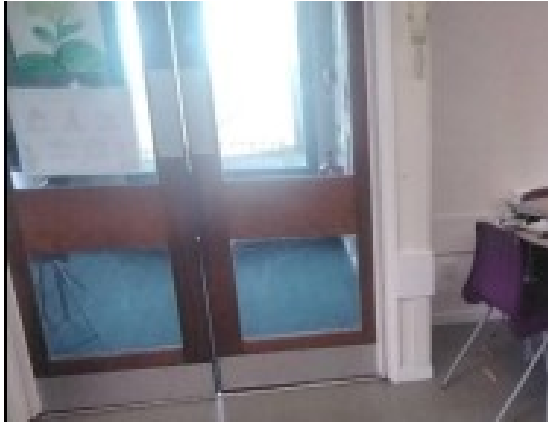
Item 215 - Ref: NG002295

The wall sheet/cladding in the Nurture Room (Rm G/001) does not contain asbestos.

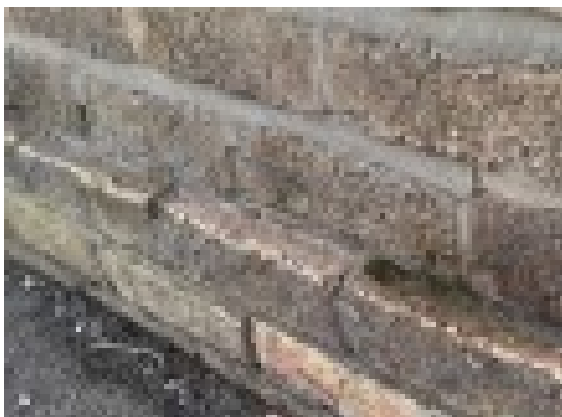
Item 217 - Ref: NZ001565

The Damp proof course (External area 2 pointing E/002).

Any change in appearance should be reported to Property Services.

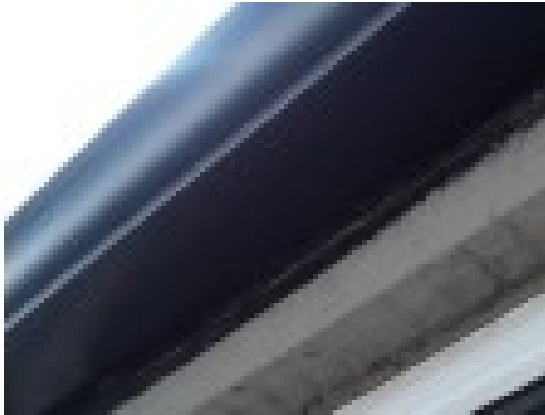
Item 218 - Ref: NZ001566

The Soffits (External area 2 pointing E/002).

Any change in appearance should be reported to Property Services.
