ASBESTOS SURVEY REPORT FOR FARRINGDON ACADEMY SCHOOL, SUNDERLAND

Asbestos Register for

**FARRINGTON ACADEMY SCHOOL,
SUNDERLAND**

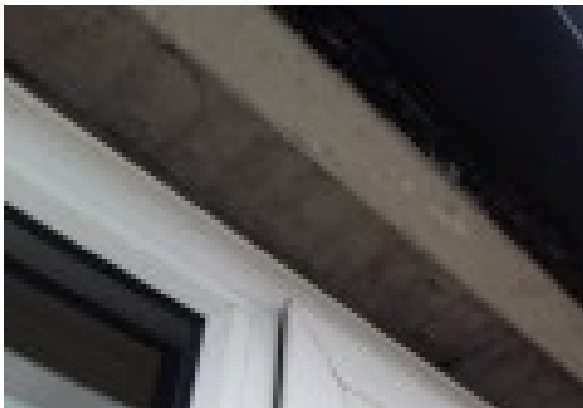
Item 220 - Ref: As NZ001566

The Soffits (External area 1 pointing E/003).

Any change in appearance should be reported to Property Services.

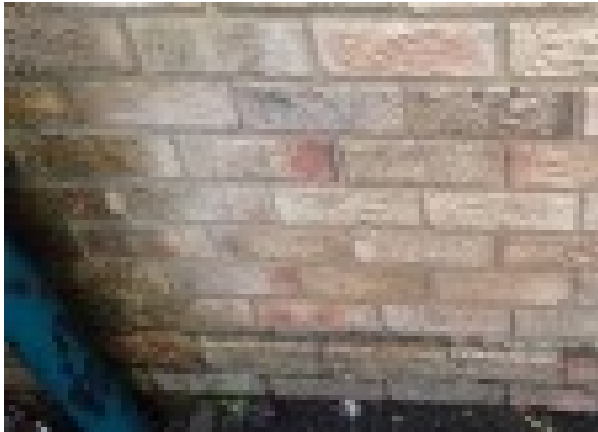
Item 221 - Ref: AS NZ001567

The Damp proof course
(External area 3 Roof E/004).

Any change in appearance
should be reported to Property
Services.

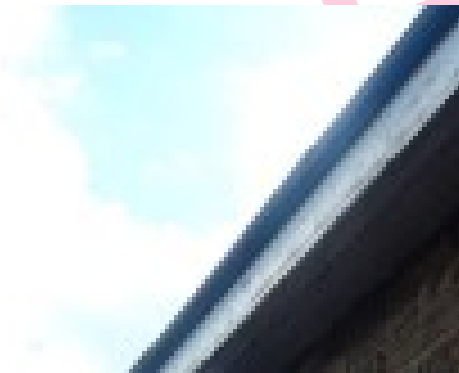
Item 222 - Ref: As NZ001566

The Soffits (External area 3
Roof E/004).

Any change in appearance
should be reported to Property
Services.

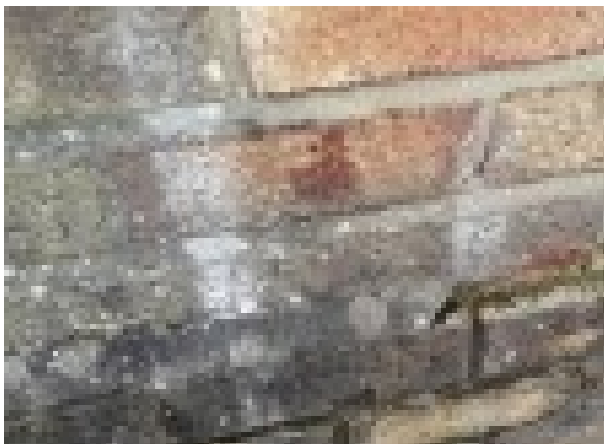
Item 223 - Ref: As NZ001565

The Damp proof course
(External area 4 Roof E/005).

Any change in appearance
should be reported to Property
Services.

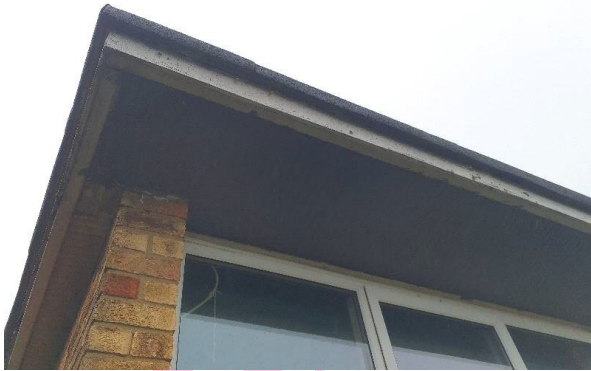
Item 228 - Ref: OU003191

The Cement Soffits (External E/001) contain asbestos.

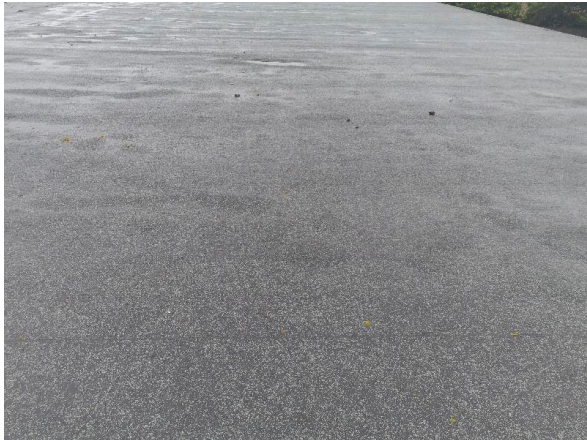
Item 233 - Ref: OU003177

The bitumen lining roof (External E/001) does not contain asbestos.

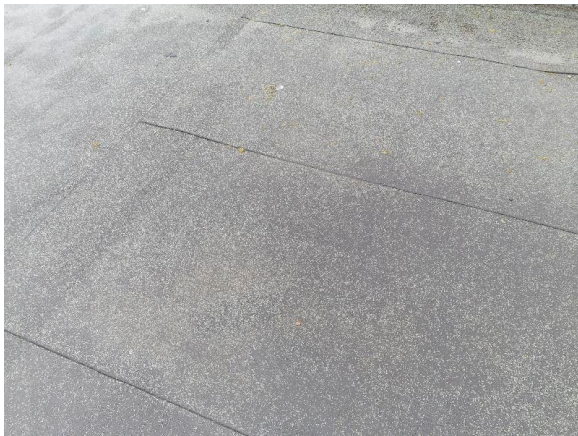
Item 234 - Ref: OU003178

The bitumen lining roof (External E/001) does not contain asbestos.

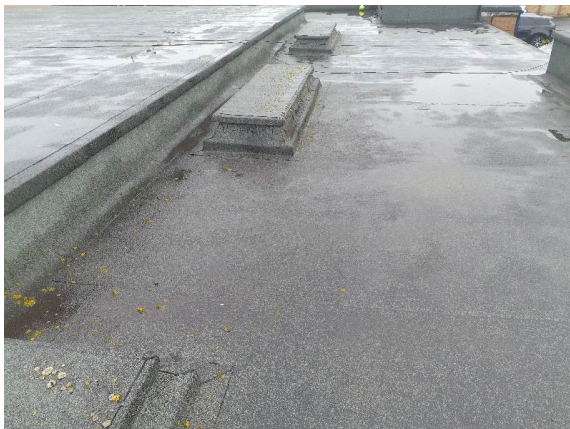
Item 235 - Ref: OU003179

The bitumen sealant around covered skylights (External E/001) does not contain asbestos.

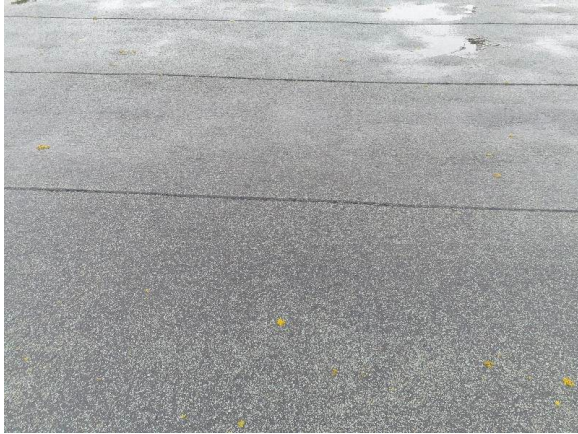
Item 236 - Ref: OU003180

The bitumen lining roof (External E/001) does not contain asbestos.

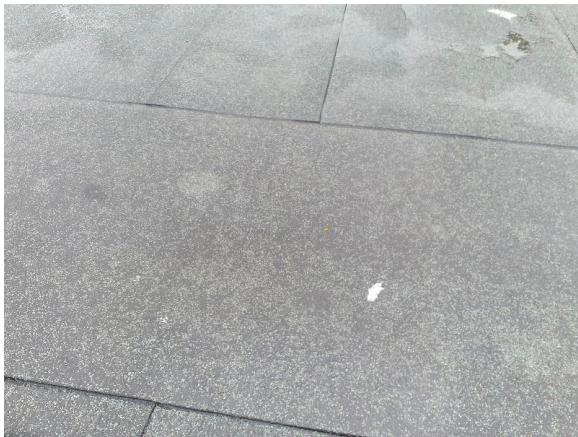
Item 237 - Ref: OU003181

The bitumen lining roof (External E/001) does not contain asbestos.

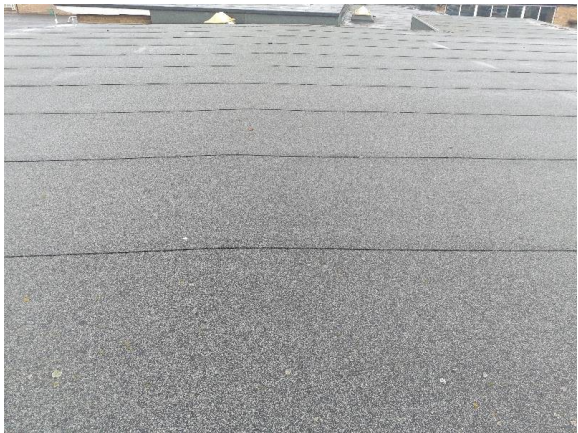
Item 238 - Ref: OU003182

The bitumen lining roof (External E/001) does not contain asbestos.

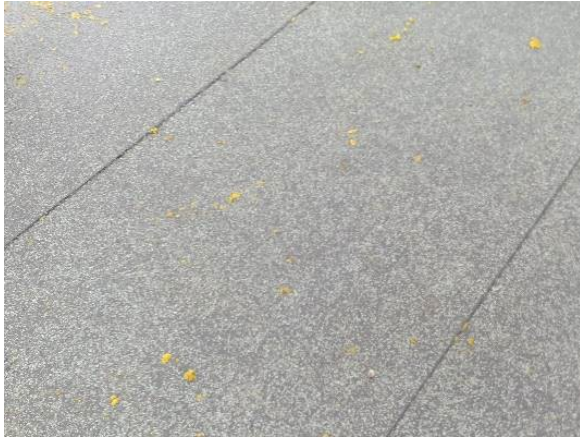
Item 239 - Ref: OU003183

The bitumen lining roof (External E/001) does not contain asbestos.

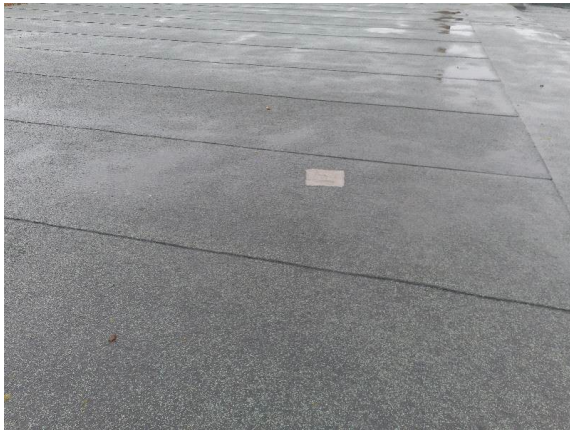
Item 240 - Ref: OU003184

The bitumen lining roof (External E/001) does not contain asbestos.

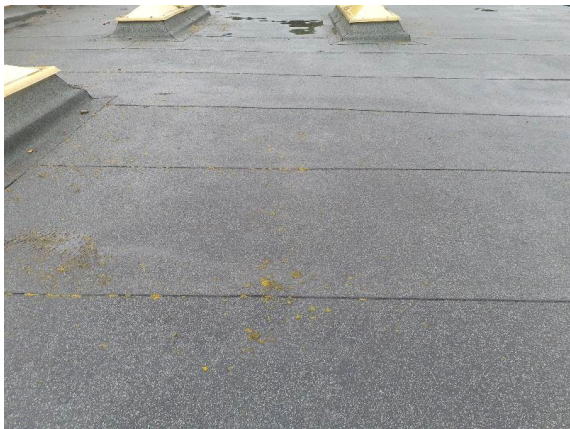
Item 241 - Ref: OU003185

The bitumen lining roof (External E/001) does not contain asbestos.

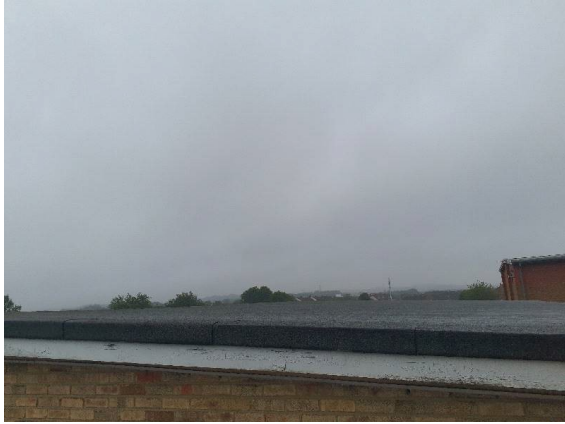
Item 242 - Ref: OU003186

The bitumen lining roof (External E/001) does not contain asbestos.

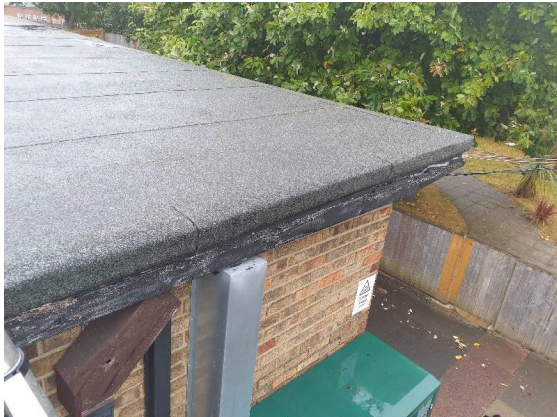
Item 243 - Ref: OU003188

The sealant around timber fascias (External E/001) does not contain asbestos.

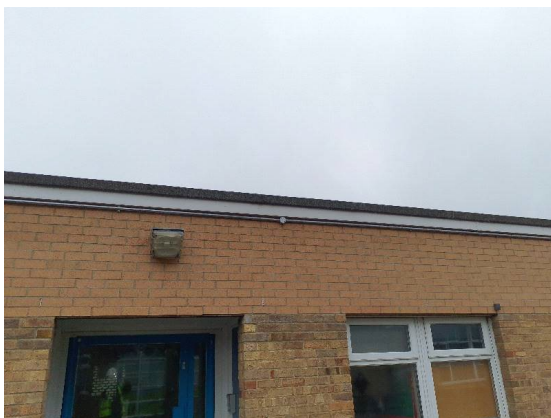
Item 244 - Ref: OU003196

The bitumen lining roof (External E/001) does not contain asbestos.
