ASBESTOS SURVEY REPORT FOR GILLAS LANE PRIMARY SCHOOL, HOUGHTON

**GILLAS LANE PRIMARY SCHOOL
HOUGHTON**

Date: 08 January 2025

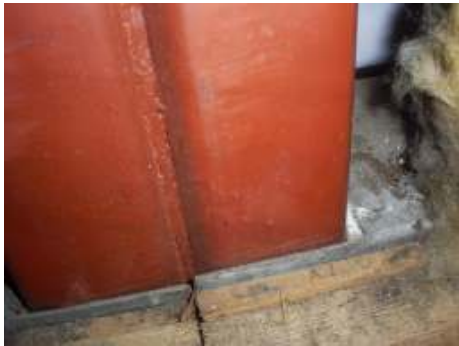
Various Ref: NO08/650

The column insulation to the ceiling void above class 3 does not contain asbestos.

Similar column insulation is located in IT Room, School office, class 4, class 5, girls wc, boys wc, girls wc 2, craft room, class 2, reception, class 2 wash area and kitchen.

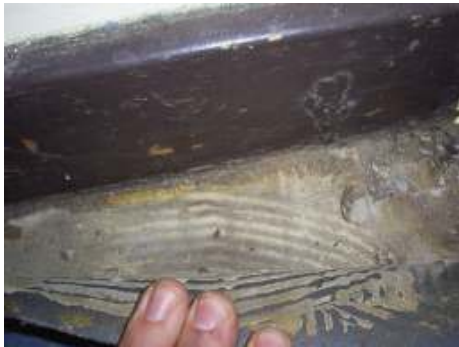
Item 2 - Ref: NO08/651

The floor tiles to class 3 do not contain asbestos.

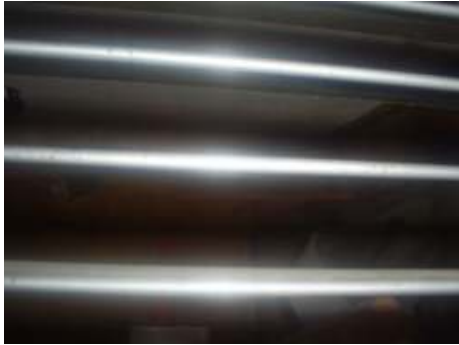
Various - Ref: NO08/653

The lining to the heaters in Class 3 does not contain asbestos.

Similar lining is located in Class 4, Class 5, Class 2 and Reception.

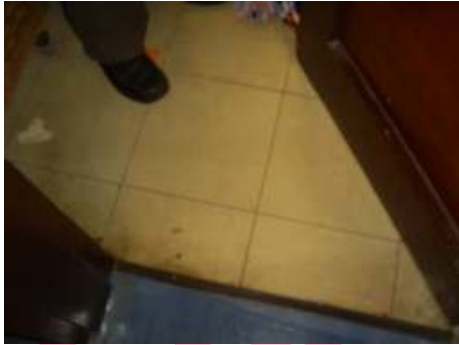
Various - Ref: NO08/654

The floor tiles to store 1 do not contain asbestos.

Similar flooring is located in store 2.

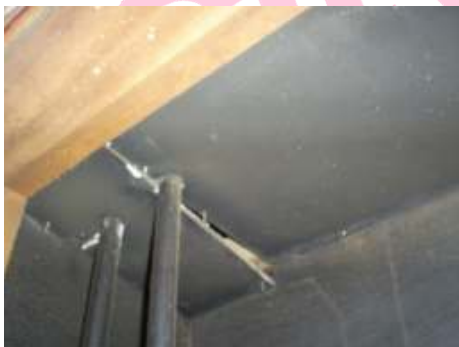
Item 7 - Ref: NO08/655

The ceiling to store 2 contains asbestos.

Please note this was removed in December 2013.

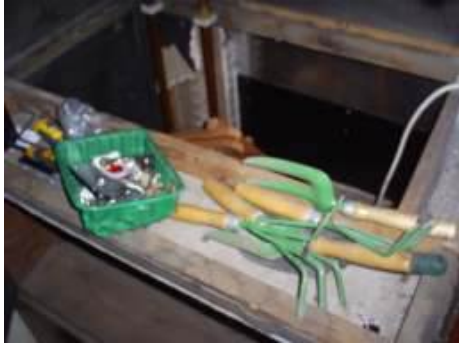
Item 8 - Ref: NO08/656

The shelving to store 2 contains asbestos.

Please note this shelving has now been over boarded but the asbestos remains.

Any change in its appearance should be recorded, and passed to Property Services.

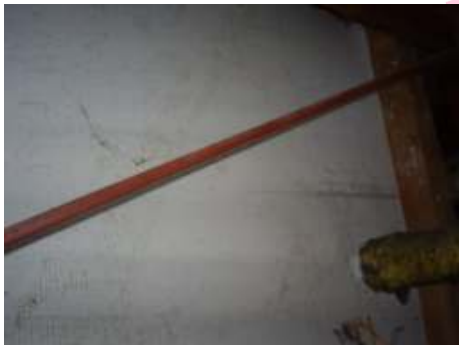
Item 11 - Ref: NO08/657

The insulation boards to the ceiling void between the office and the store contain asbestos.

Any change in its appearance should be recorded, and passed to Property Services.

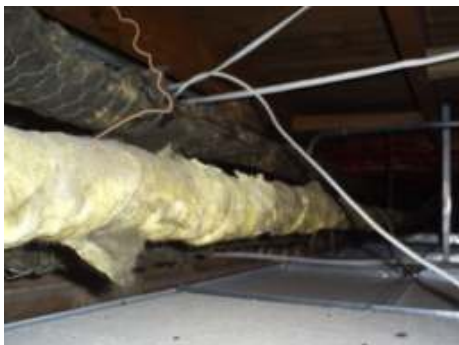
Item 12 - Ref: NO08/658

The pipe insulation to the ceiling void between the office and the store does not contain asbestos.

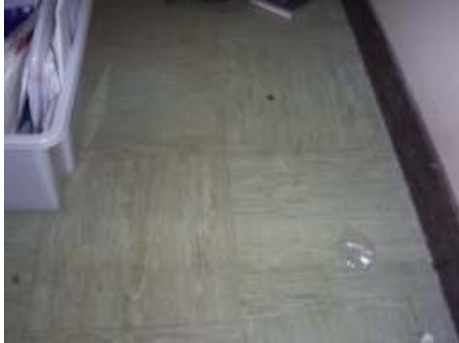
Item 23 - Ref: NO08/659

The floor tiles to the library store do not contain asbestos.

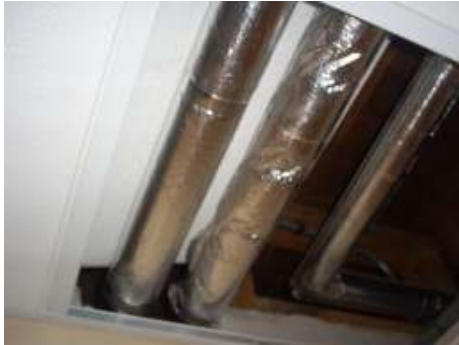
Item 24 - Ref: NO08/660

The pipe insulation in the ceiling void of the new build does not contain asbestos.

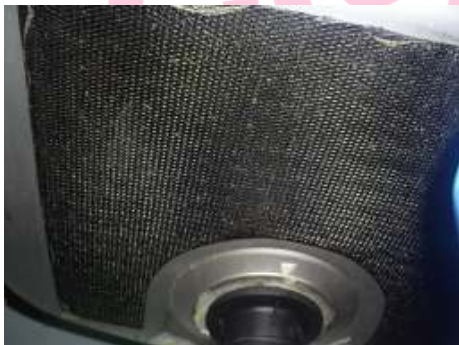
Item 25 - Ref: NO08/661

The sink pad to class 6 does not contain asbestos.

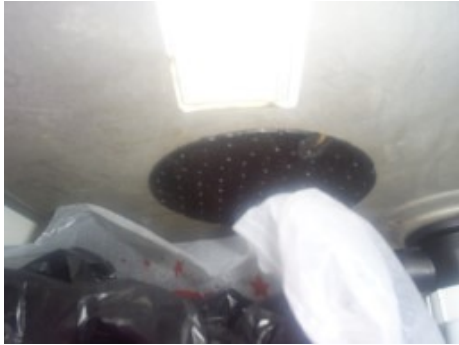
Item 26 - Ref: NO08/662

The sink pad to the staff room does not contain asbestos.

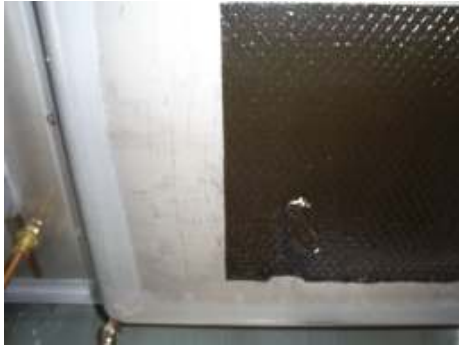
Item 35 - Ref: NO08/663

The sink pad to the kitchen does not contain asbestos.

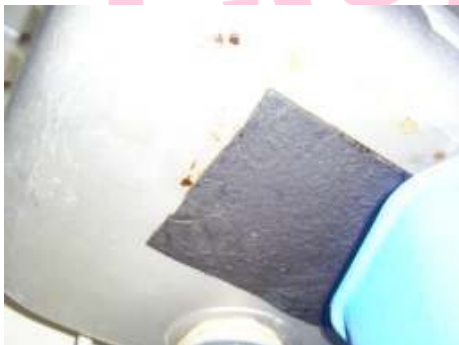
Item 36 - Ref: NO08/664

The sink pad to the kitchen does not contain asbestos.

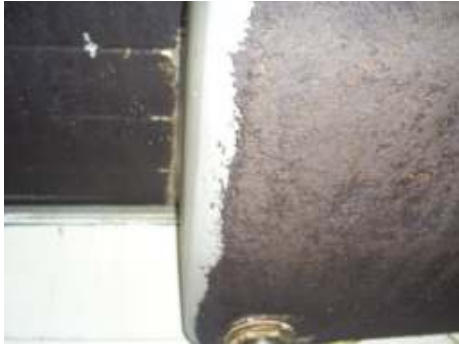
Item 37 - Ref: NO08/665

The sink pad to the kitchen does not contain asbestos.

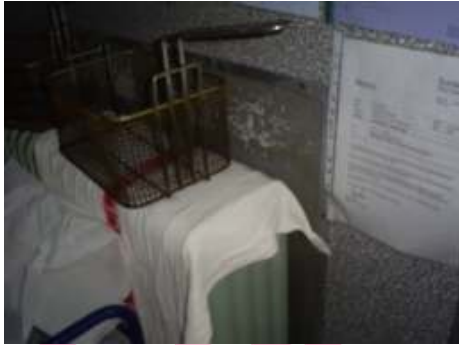
Item 39 - Ref: NO08/666

The board to the radiator in the kitchen contains asbestos.

Any change in its appearance should be recorded, and passed to Property Services.

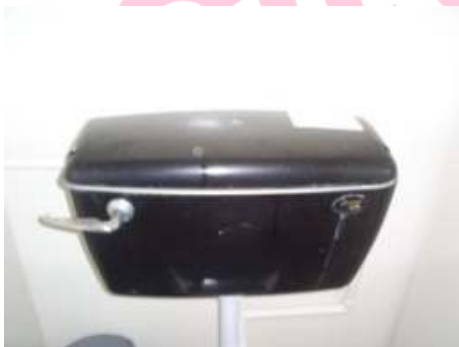
Item 40 - Ref: NO08/667

The toilet cisterns to the kitchen contain asbestos.

Any change in its appearance should be recorded, and passed to Property Services.

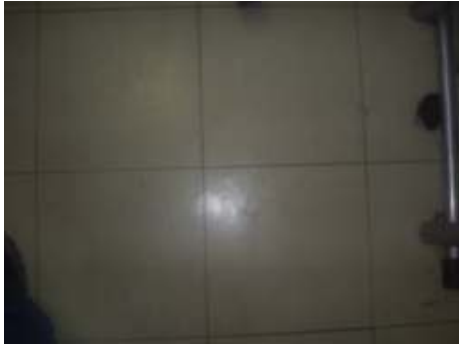
Various - Ref: NO08/668

The floor tiles to hall store 1 contain asbestos.

Similar flooring is located in hall store 2.

Any change in its appearance should be recorded, and passed to Property Services.

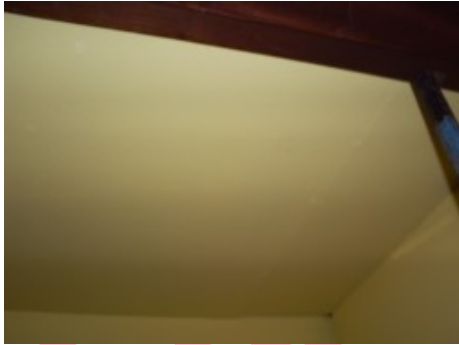
Item 43 - Ref: NO08/669

The ceiling to the hall store 2 contains asbestos.

This was removed in January 2016.

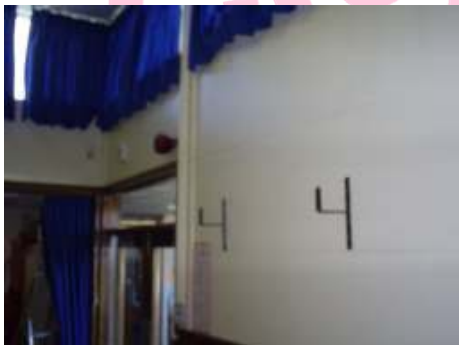
Item 44 - Ref: NO08/670

The wall panels to the hall contain asbestos.

Please note these wall boards have now been over boarded but the asbestos remains.

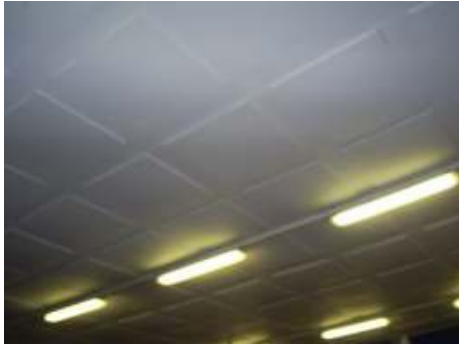
Item 45 - Ref: NO08/671

The ceiling to the hall does not contain asbestos.

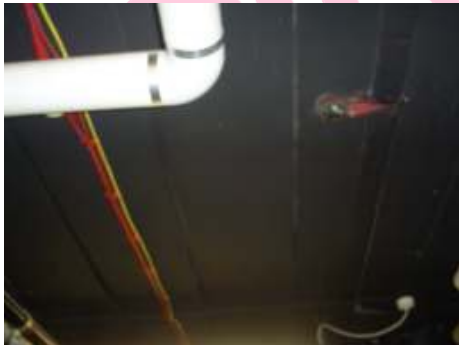
Various - Ref: NO08/674

The ceiling to the boiler room contains asbestos (Removed August 2023).

Similar ceiling is located in the boiler room store (Removed August 2023).

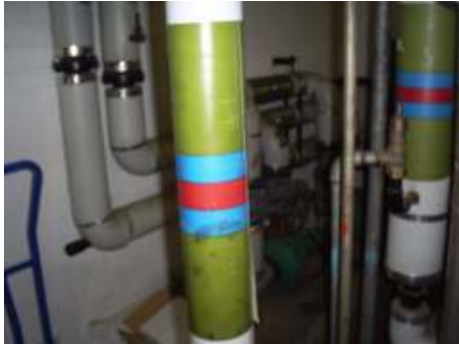
Item 48 - Ref: NO08/675

The pipe and calorifier insulation to the boiler room does not contain asbestos.

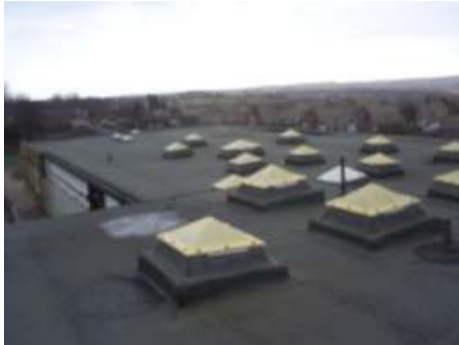
Item 50 - Ref: NO08/683

The roof felt to the external does not contain asbestos.

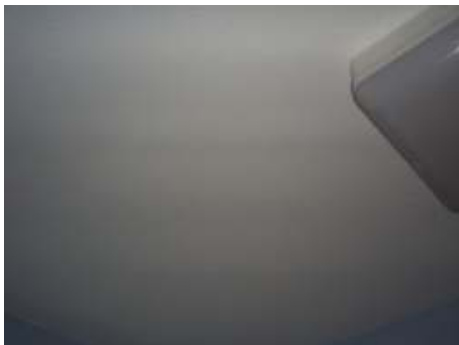
Various – Ref:NO08/677

The textured coating to the ceiling in the shower room contains asbestos.

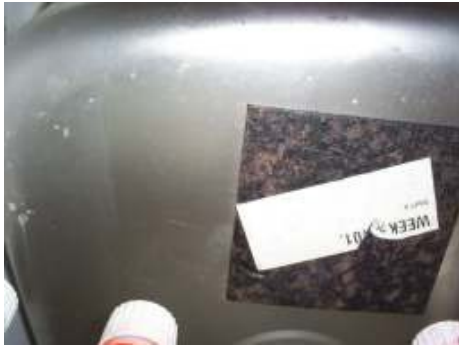
Item 53 - Ref: NO08/678

The sink pad to the main area does not contain asbestos.

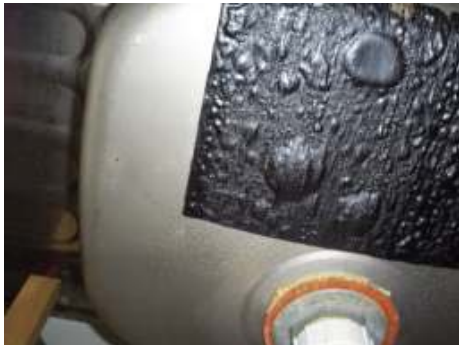
Item 56 – Ref:NO08/679

The sink pad to the kitchen does not contain asbestos.

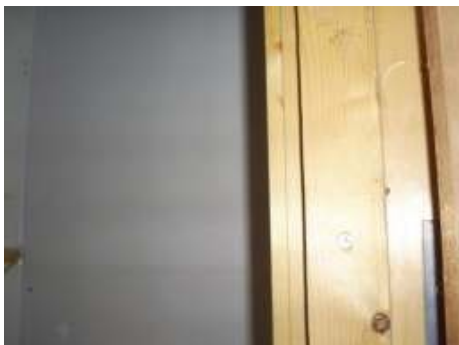
Item 59 - Ref: NO08/680

The lining boards to the electrical intake do not contain asbestos.

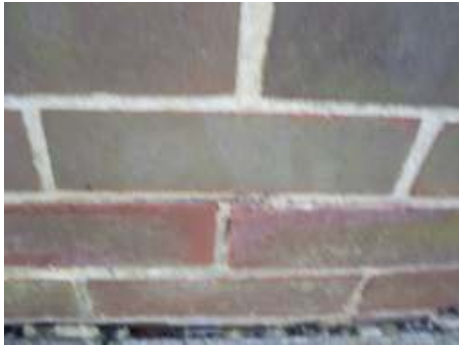
Item 60 - Ref: NO08/681

The external damp proof course does not contain asbestos.

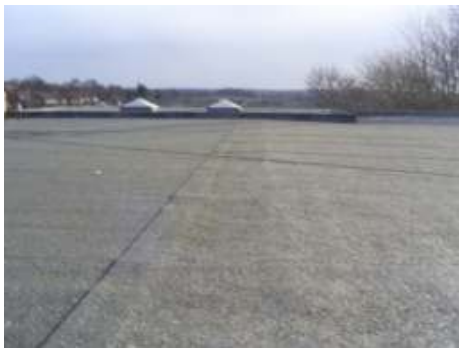
Item 61 – Ref:NO08/682

The felt to the roof does not contain asbestos.

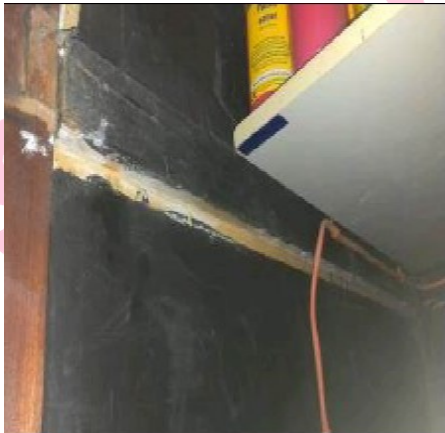
Item 68 - Ref: EA000901

Residue to timber supports from previous shelving was identified in the Room 7 (Store). This does contain asbestos.

Removed August 2023

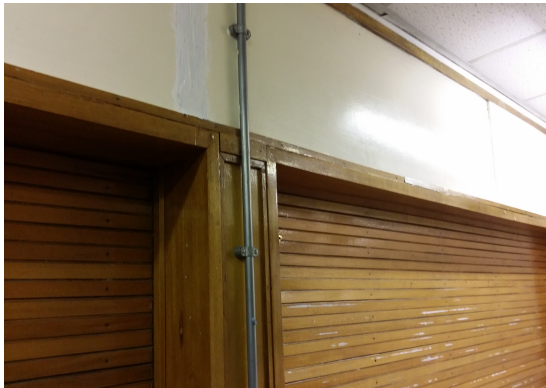
Item 69 - Presumed

Insulation board behind the column claddings in the kitchen area. This is presumed to contain asbestos.

Any change should be recorded and passed to Property Services.

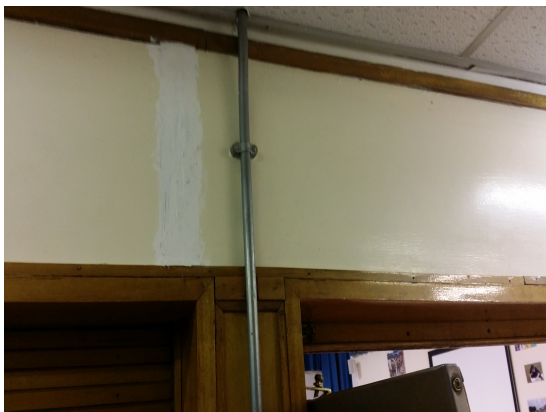
Item 70 - Presumed

Insulation board within roller shutter housing in the kitchen area. This is presumed to contain asbestos.

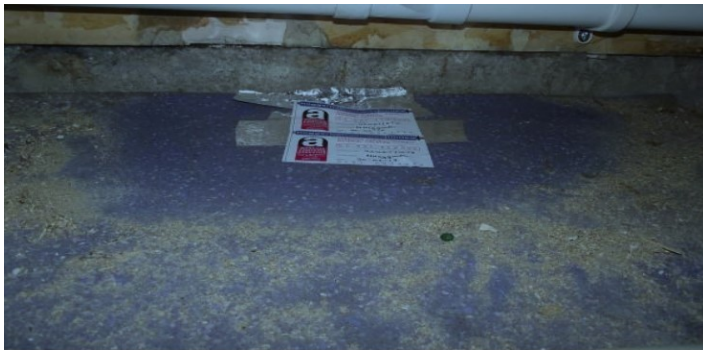
Item 82 – AB487192 474

The floor covering in KS1 Toilets do not contain asbestos.

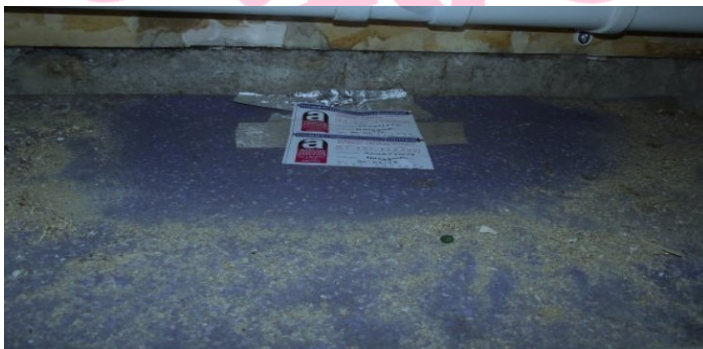
Item 83 – AB487192 475

The adhesive and screed in KS1 Toilets do not contain asbestos.

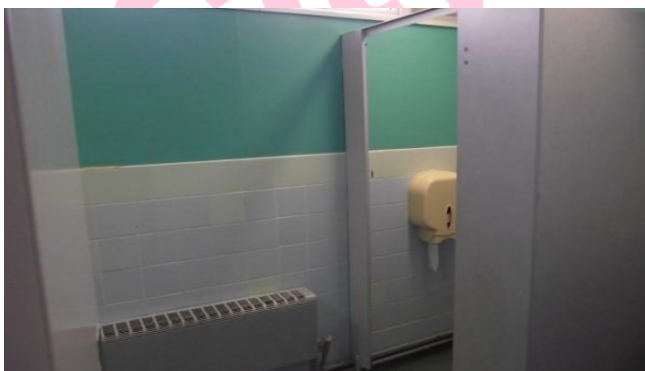
Item 95 – As AB487192481

The vinyl sheet in the KS2 Boys WC's does not contain asbestos.

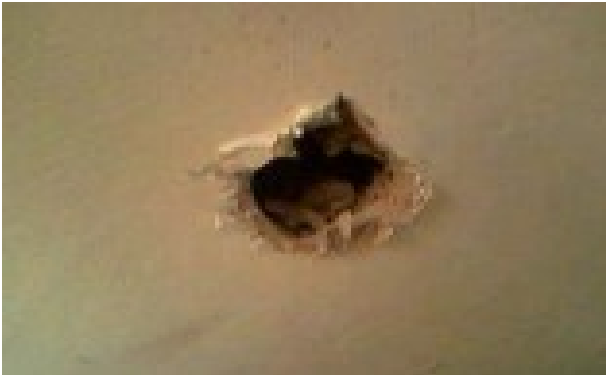
Item 100 – AM000798

The plasterboard wall in Boys WC/Rm 1 does not contain asbestos.

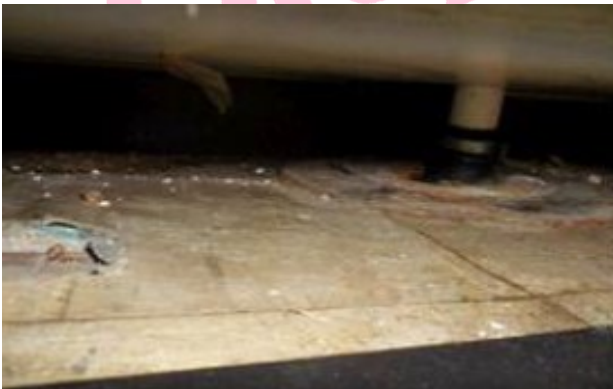
Item 101 – VP004232

The vinyl floor tiles and bitumen adhesive below in Classroom 2/Rm 1 does not contain asbestos.

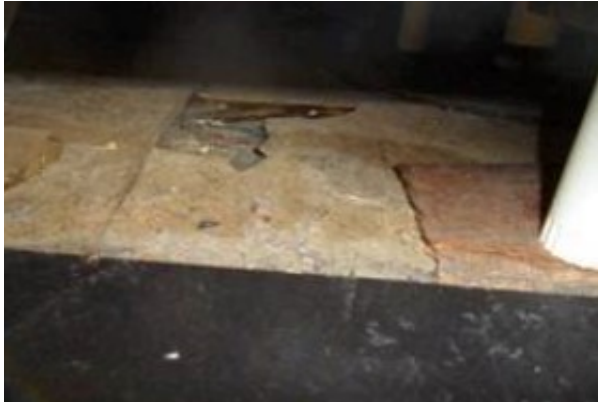
Item 102 – As VP004232

The vinyl floor tiles and bitumen adhesive below in Reception Class/Rm 2 does not contain asbestos.

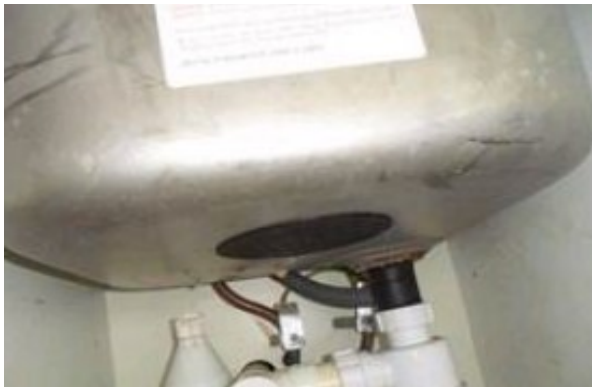
Item 103 – VP004234

The sink pads in Year 1 Classroom/Rm 3 does not contain asbestos.

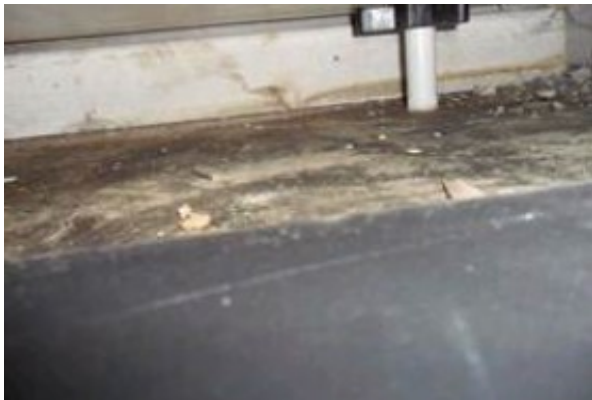
Item 104 – VP004235

The bitumen adhesive to floor in Year 1 Classroom/Rm 3 does not contain asbestos.

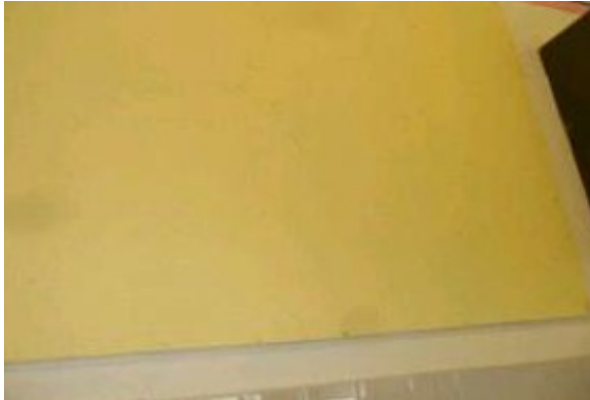
Item 105 – VP004236

The pinboard to wall in Year 1 Classroom/Rm 3 does not contain asbestos.

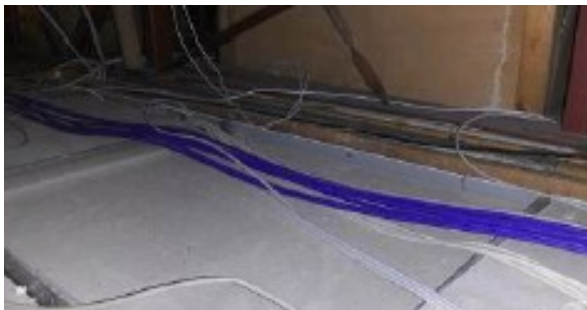
Item 106 – EA003944

The debris to top of wall in School Office/Rm 1 does not contain asbestos.

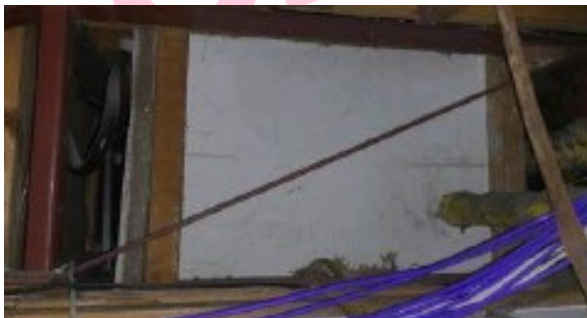
Item 107 – EA003945

The skylight boxing in School Office/Rm 1 contains asbestos.

Any change should be recorded and passed to Property Services.

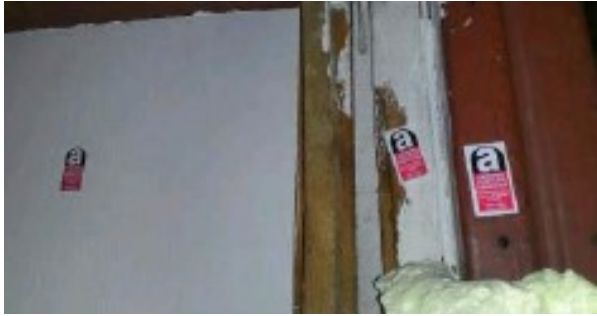
Item 108 – EA003946

The firebreak in the Foyer/Rm 2 contains asbestos.

Any change should be recorded and passed to Property Services.

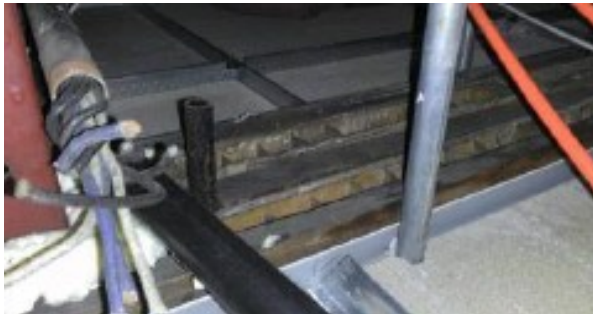
Item 109 – EA003947

The debris to wall in the Foyer/Rm 2 does not contain asbestos.

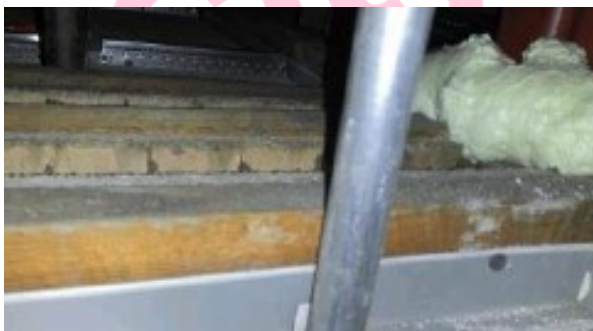
Item 110 – EA003948

The debris to wall in the Foyer/Rm 2 does not contain asbestos.

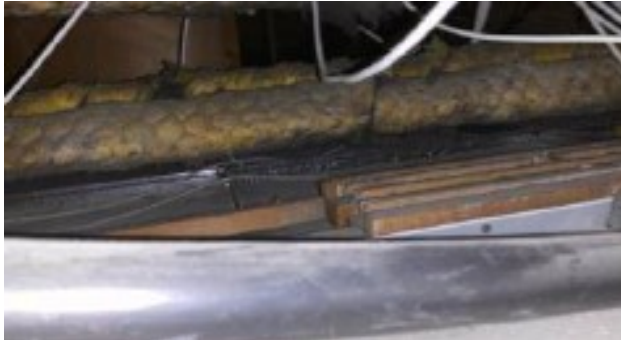
Item 111 – EA003949

The debris to wall in the Foyer/Rm 2 does not contain asbestos.

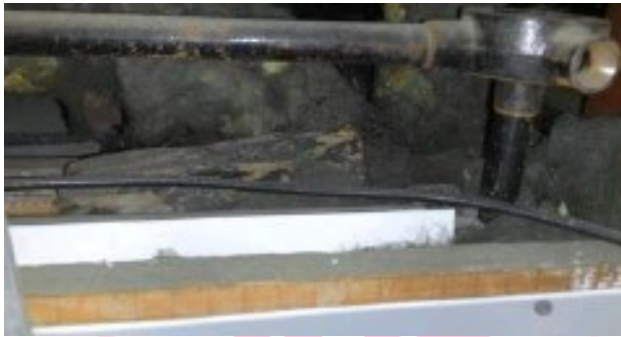
Item 112 – EA003950

The debris to wall in the Foyer/Rm 2 does not contain asbestos.

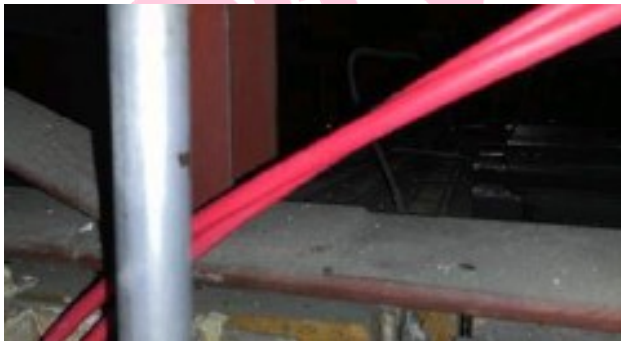
Item 113 – EA003951

The debris to wall in the Foyer/Rm 2 does not contain asbestos.

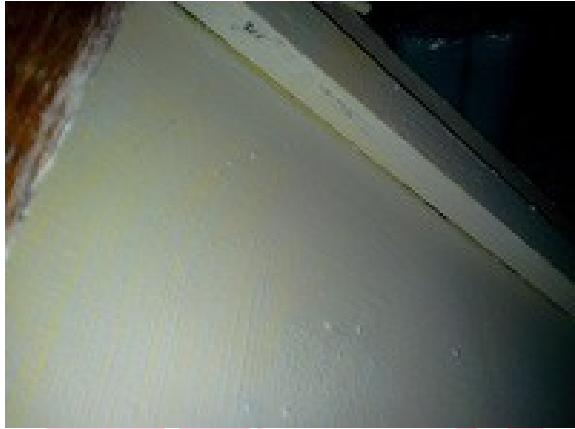
Item 130 – Presumed

The debris in nail holes to battens in the Former heater cupboard/Rm 043 is presumed to contain asbestos.

Removed 2014

Any change should be recorded and passed to Property Services.

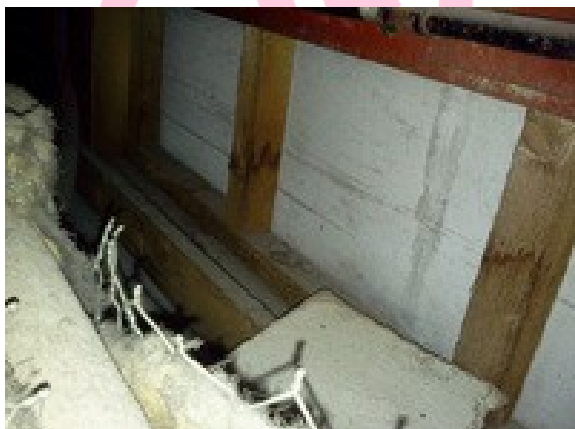
Item 131 – As 47413-7

The unsealed board to rear of main hall wall in the Former heater cupboard/Rm 043 contains asbestos.

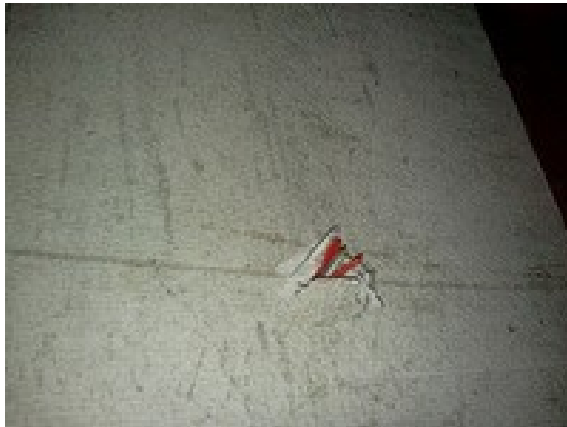
Item 139 – As 47413-7

The unsealed board to rear of main hall wall in the Kitchen void above/Rm 049 contains asbestos.

Any change should be recorded and passed to Property Services.

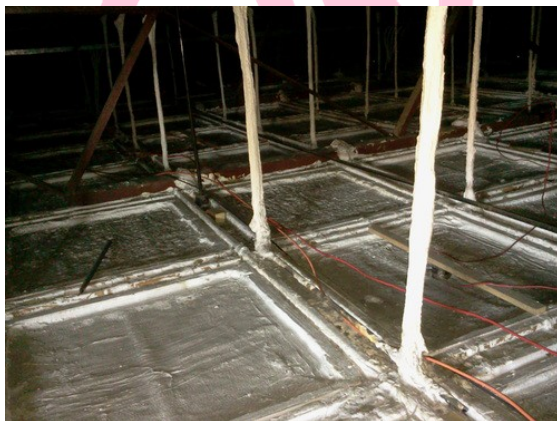
Item 140 – As 47413-8

The suspended ceiling to room below in the Hall void above/Rm 050 does not contain asbestos.

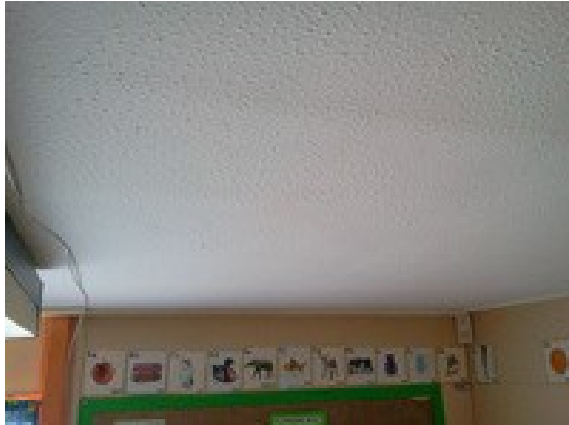
Item 142 – As 47413-13

The coating to plasterboard ceiling in the Office/Rm 001 contains asbestos.

Any change should be recorded and passed to Property Services.

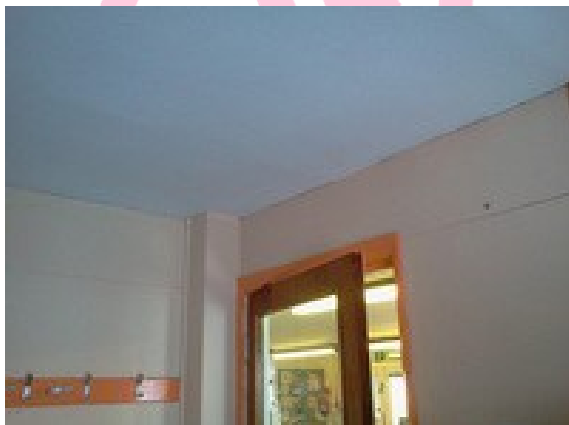
Item 143 – Presumed

The void above fixed ceiling in the Office/Rm 001 is presumed to contain asbestos.

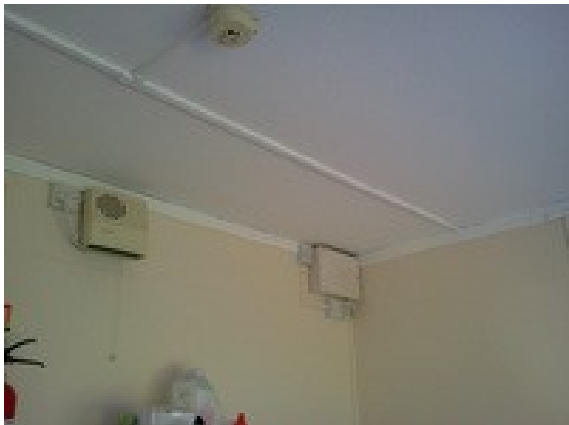
Item 146 – As 47413-13

The coating to plasterboard ceiling in the Kitchen/Rm 003 contains asbestos.

Any change should be recorded and passed to Property Services.

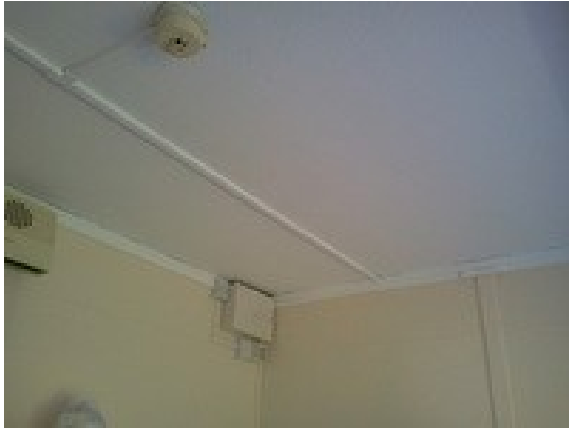
Item 147 – Presumed

The void above fixed ceiling (Kitchen/Rm 003 is presumed to contain asbestos.

Any change should be recorded and passed to Property Services.

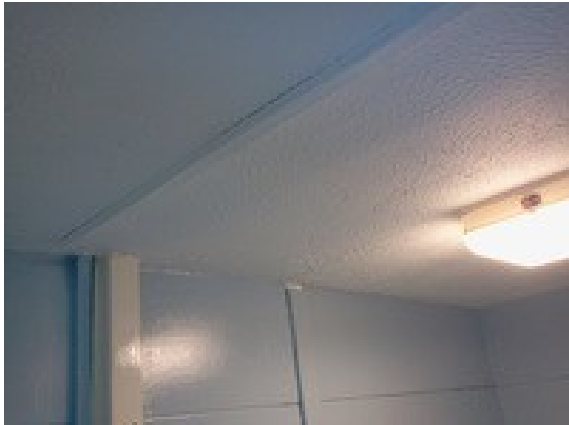
Item 148 – As 47413-12

The coating to plasterboard ceiling in the Rear lobby/Rm 004 contains asbestos.

Any change should be recorded and passed to Property Services.

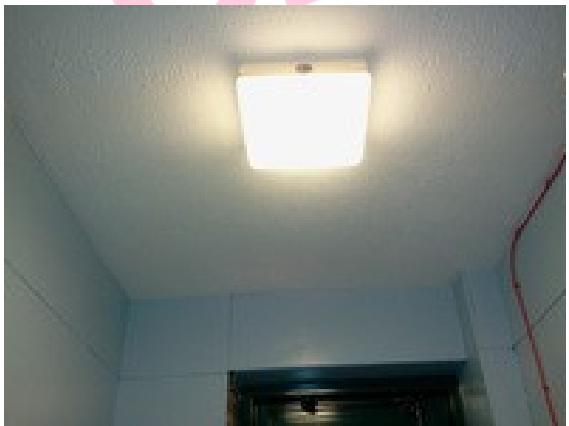
Item 149 – Presumed

The void above fixed ceiling in the Rear lobby/Rm 004 is presumed to contain asbestos.

Any change should be recorded and passed to Property Services.

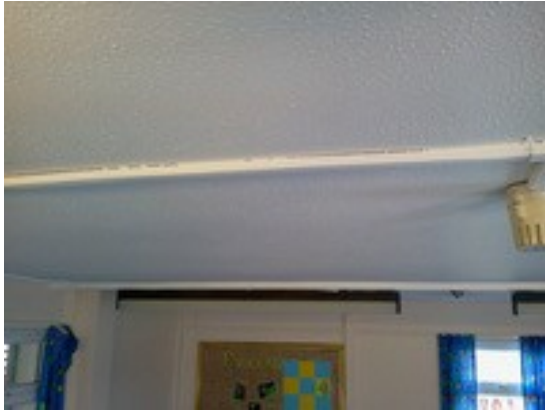
Item 150 – As 47413-12

The coating to plasterboard ceiling in the Teaching Area/Rm 005 contains asbestos.

Any change should be recorded and passed to Property Services.

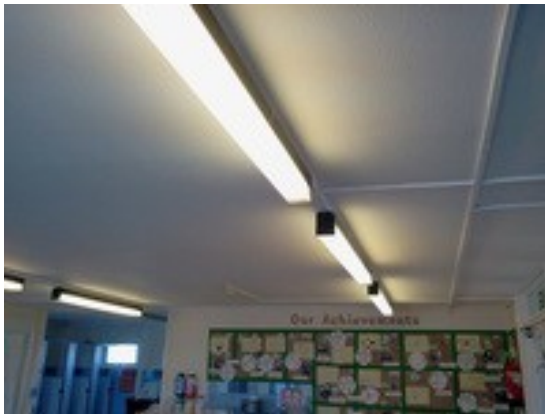
Item 151 – Presumed

The void above fixed ceiling in the Teaching Area/Rm 005 is presumed to contain asbestos.

Any change should be recorded and passed to Property Services.

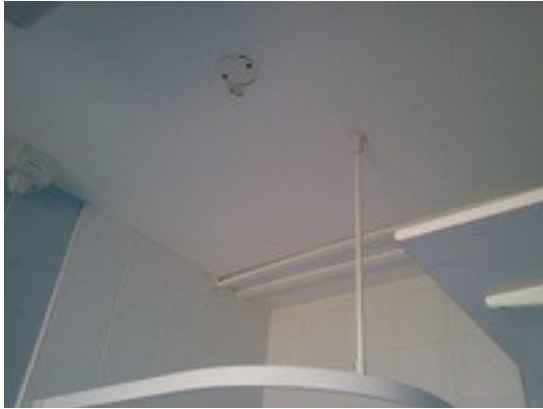
Item 153 – Presumed

The void above fixed ceiling in the WC and Shower/Rm 006 is presumed to contain asbestos.

Any change should be recorded and passed to Property Services.

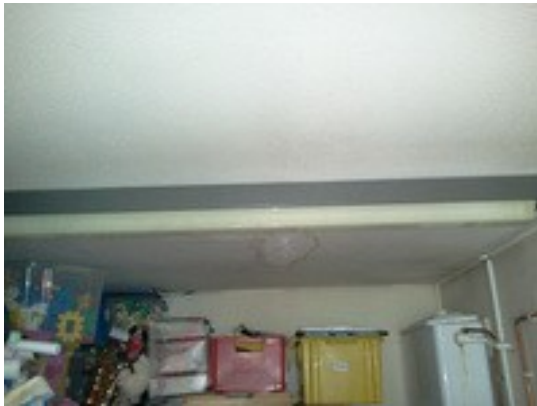
Item 154 – As 47413-11

The coating to plasterboard ceiling in the Toy Store/Rm 007 contains asbestos.

Any change should be recorded and passed to Property Services.

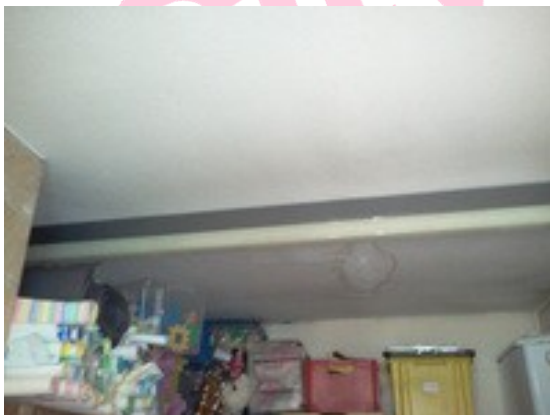
Item 155 – Presumed

The void above fixed ceiling in the Toy Store/Rm 007 is presumed to contain asbestos.

Any change should be recorded and passed to Property Services.

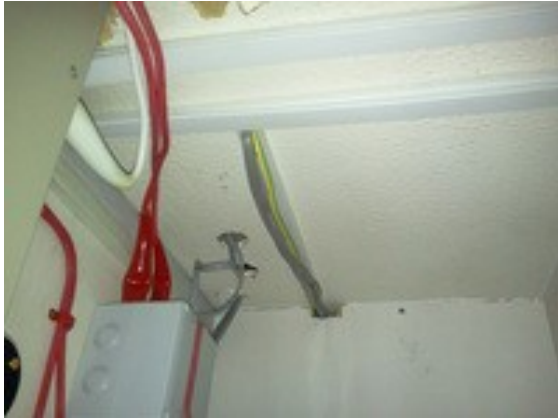
Item 156 – 47413-11

The coating to plasterboard ceiling in the Switch cupboard/Rm 009 contains asbestos.

Any change should be recorded and passed to Property Services.

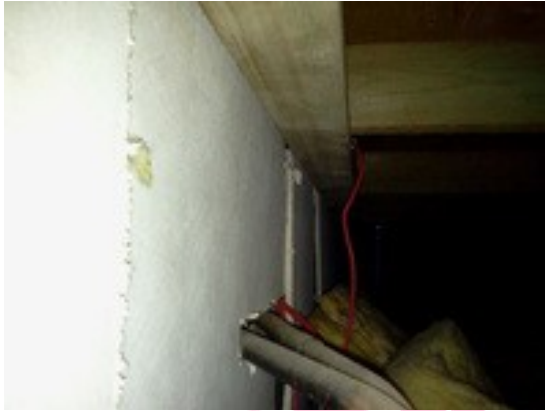
Item 157 – 47413-9

The firebreak in the switch cupboard void above/Rm 009 contains asbestos.

Any change should be recorded and passed to Property Services.

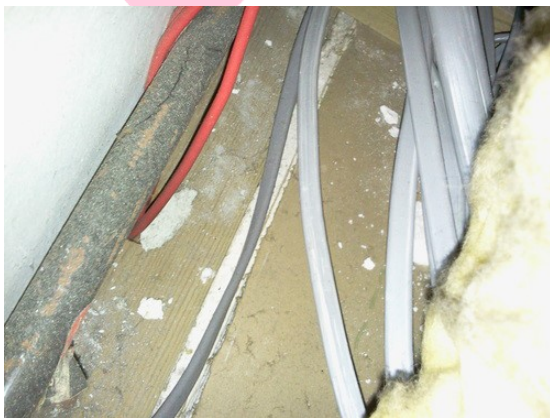
Item 158 – 47413-10

The debris to studwork and top side of fixed ceiling in the switch cupboard void above/Rm 009 contains asbestos.

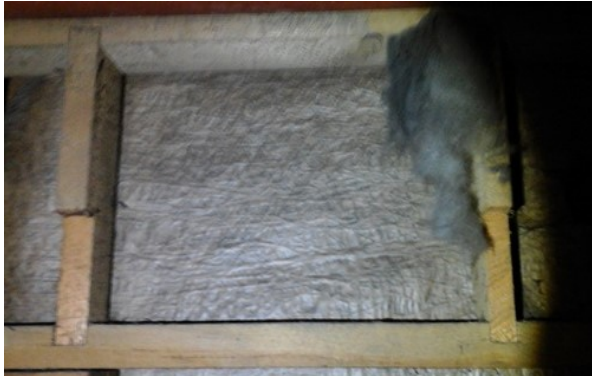
Item 162 – 74282-3

The coated paper vertical damp proof course in the Classroom/ Rm 029 does not contain asbestos.

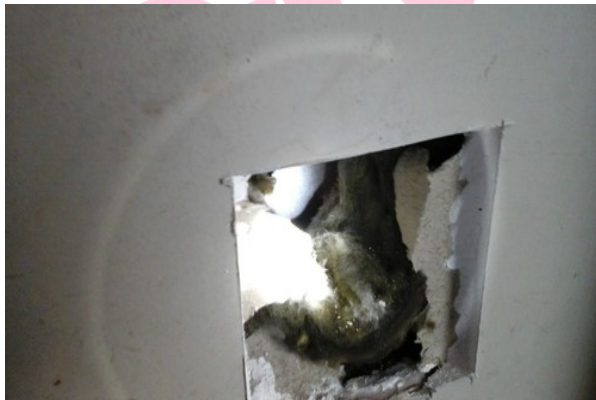
Item 163 – Presumed

The fire break above door way in the corridor void above/Rm 037 is presumed to contain asbestos.

Any change should be recorded and passed to Property Services.

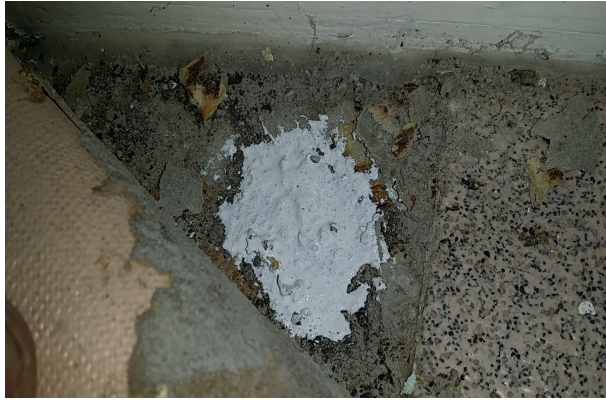
Item 164 – 74282-4

The vertical damp proof course within wall in the Toy Store/Rm 008 does not contain asbestos.

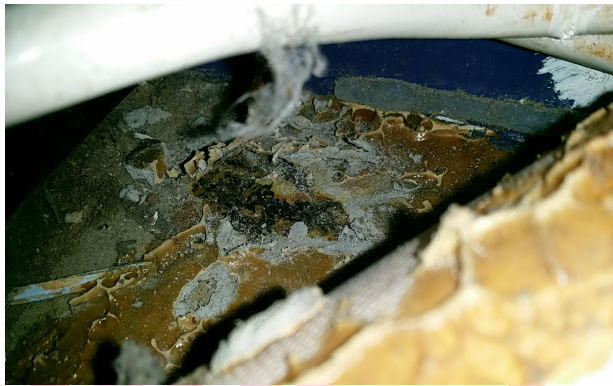
Item 165 – 110187-2

The remnant bitumen to concrete floor in the Kitchen/Rm 003 does not contain asbestos.

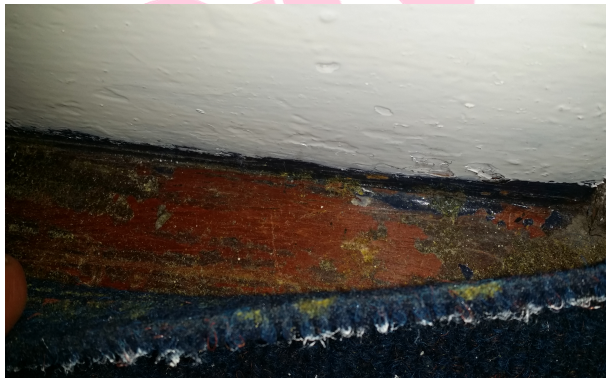
Item 166 – As 110187-2

The remnant bitumen to concrete floor in the Teaching area/Rm 005 does not contain asbestos.

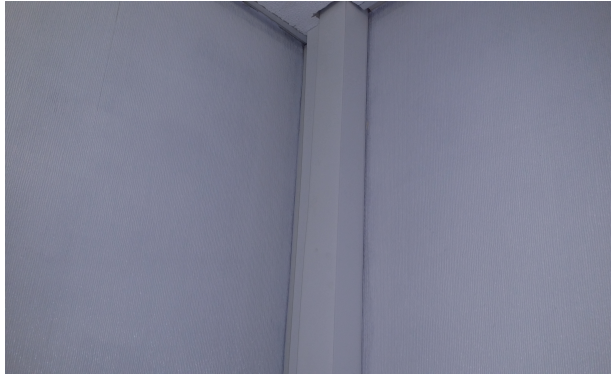
Item 167 – Presumed

The adhesive to parquet flooring in the Headteachers office/Rm 001 is presumed to contain asbestos.

Any change should be recorded and passed to Property Services.

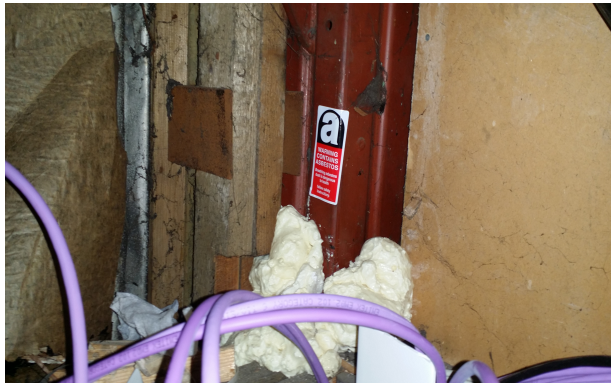
Item 168 – As 230423-1

The cladding to columns behind plasterboard walls in the Headteachers office/Rm 001 contains asbestos.

Any change should be recorded and passed to Property Services.

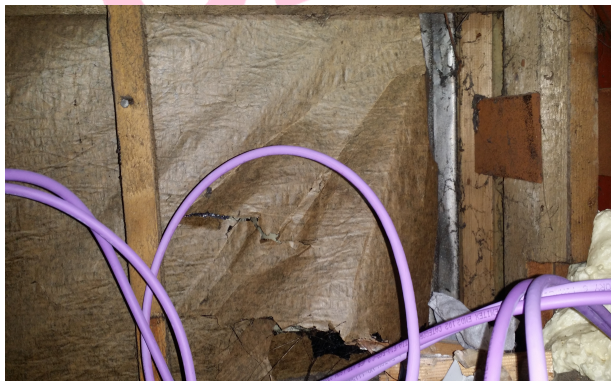
Item 169 – 230423-1

The cladding to columns in the Headteachers office void above/Rm 001 contains asbestos.

Any change should be recorded and passed to Property Services.

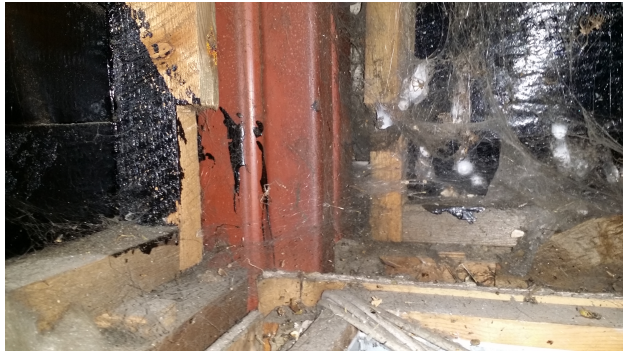
Item 171 – As 230423-1

The cladding to columns behind plasterboard walls in the Corridor/Rm 008 contains asbestos.

Any change should be recorded and passed to Property Services.

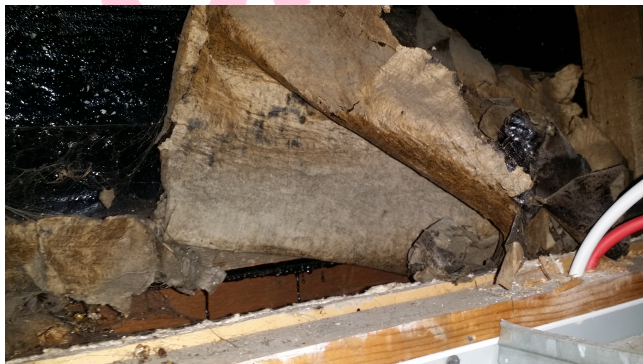
Item 172 – As 230423-1

The cladding to columns in the Corridor void above/Rm 008 contains asbestos.

Any change should be recorded and passed to Property Services.

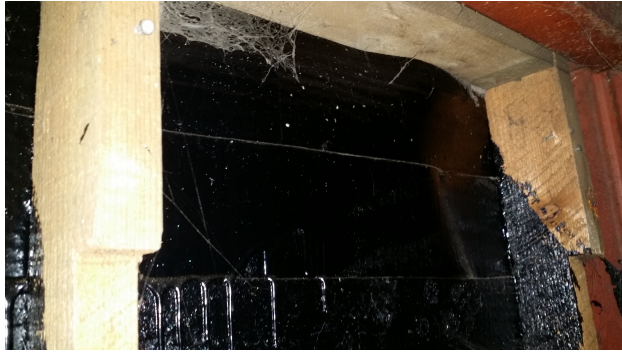
Item 173 – 230423-2

The lining to top of walls in the Corridor void above/Rm 008 does not contain asbestos.

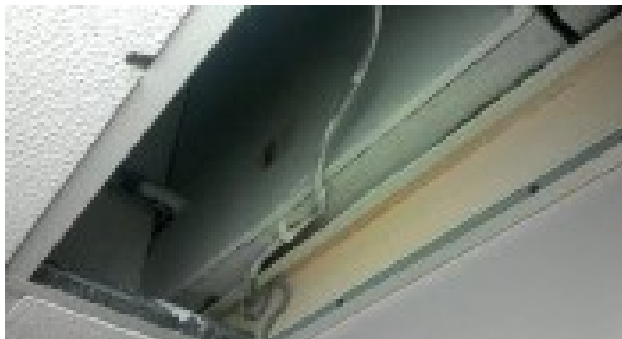
Item 174 – 230423-3

The damp proof membrane in the Corridor void above/Rm 008 does not contain asbestos.
