### ASBESTOS SURVEY REPORT FOR RICHARD AVENUE PRIMARY SCHOOL, SUNDERLAND

**RICHARD AVENUE PRIMARY SCHOOL**

**Date: 14 April 2025**

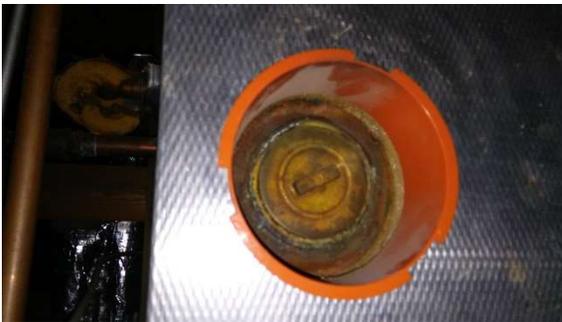
### **Item 1 - Ref: 369924-5**

The screed under modern screed (001/nursery) does not contain asbestos.

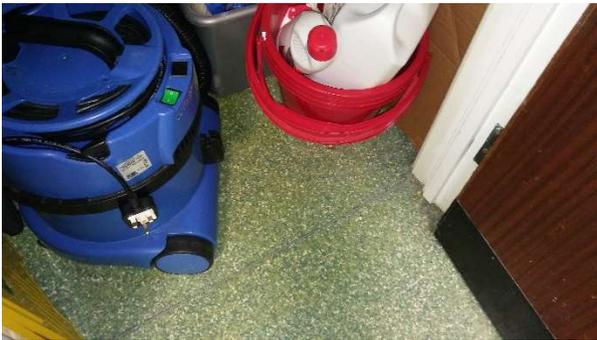
### **Item 22 - Ref: 369924-6**

The floor screed beneath modern screed (015A/ corridor) does not contain asbestos.

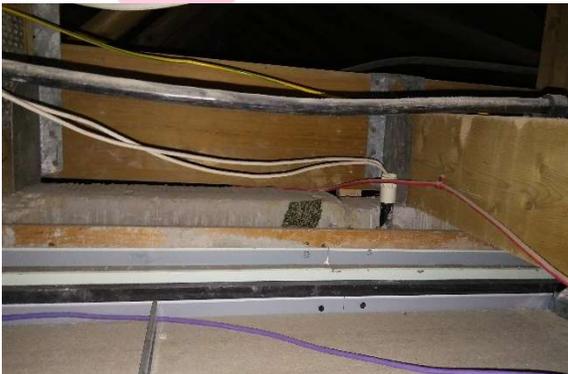
### **Item 32 - Ref: As 369924-5**

The screed under modern screed (024/classroom) does not contain asbestos.

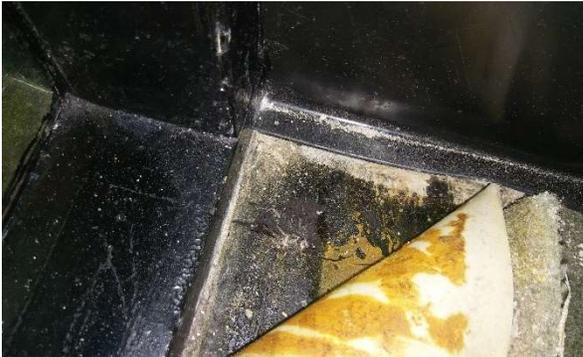
### **Item 34 - Ref: 369924-7**

The screed to floor below floor covering (025/corridor) does not contain asbestos.

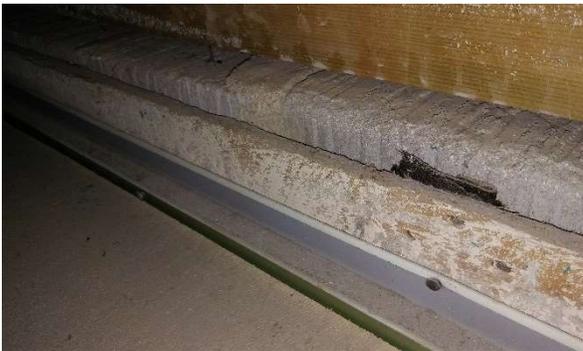
### **Item 35 - Ref: 369924-8**

The felt packers old ceiling tracking (025/classroom-void above) does not contain asbestos.

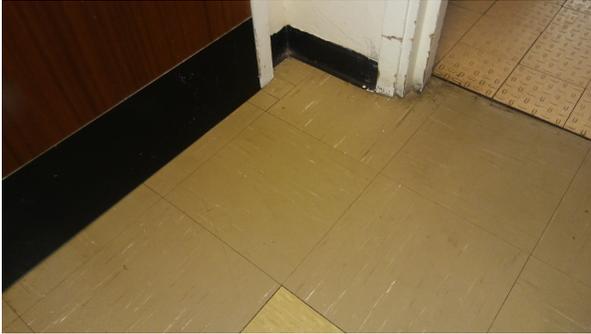
**Item 58 - Ref: As 369924-9**

The floor covering (046/lobby) does not contain asbestos.

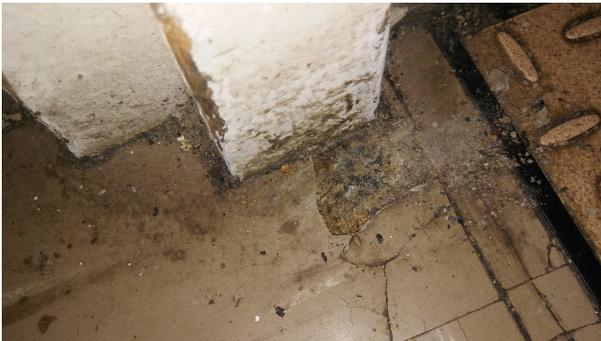
**Item 59 - Ref: As 369924-7**

The screed to floor below tiles (046/lobby) does not contain asbestos.

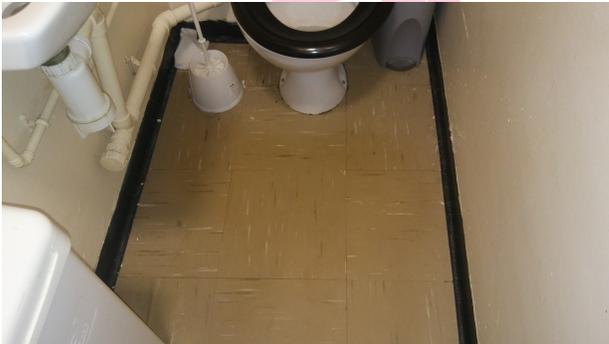
**Item 60 - Ref: As 369924-9**

The floor covering (047/WC) does not contain asbestos.

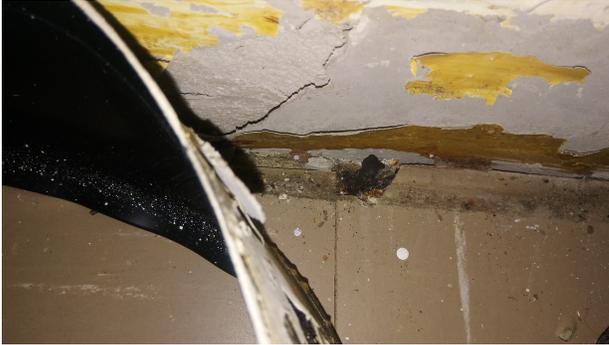
### **Item 61 - Ref: As 369924-7**

The screed to floor below tiles (047/WC) does not contain asbestos.

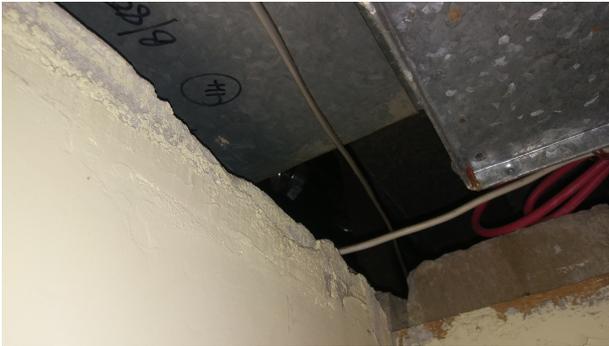
### **Item 62 - Ref: 369924-12**

The red mastic to ductwork (047/WC-void above) contains asbestos.

Any change in its appearance should be recorded and passed to Property Services.

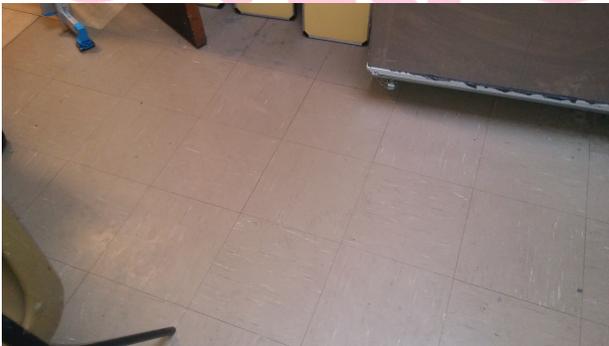
### **Item 63 - Ref: As 369924-9**

The floor covering (048/store) does not contain asbestos.

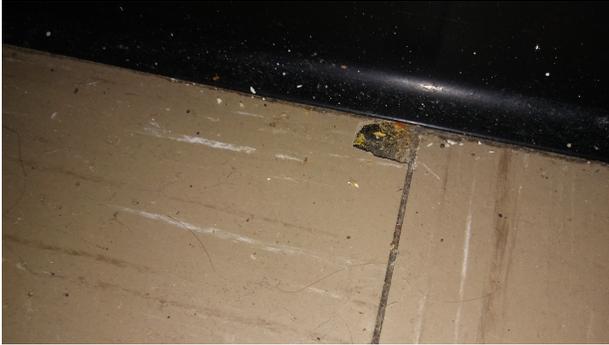
### **Item 64 - Ref: As 369924-7**

The screed to floor below tiles (048/store) does not contain asbestos.

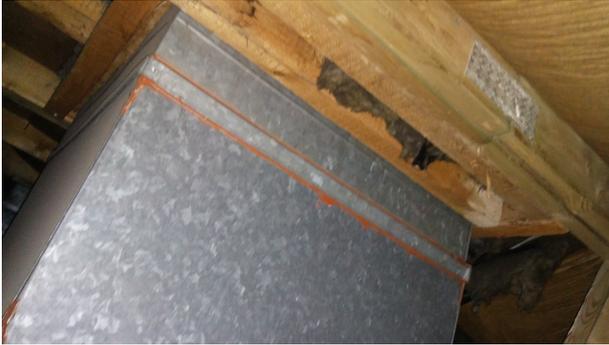
### **Item 67 - Ref: 369924-11**

The red mastic to ductwork (052/store) does not contain asbestos.

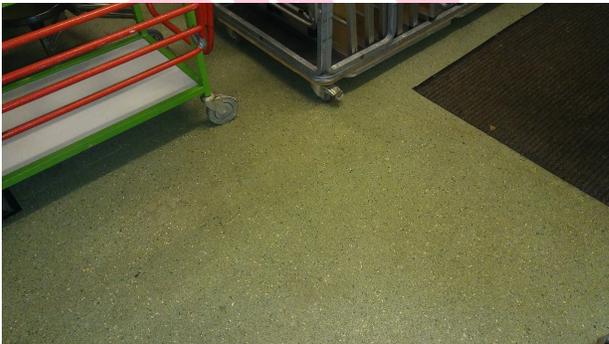
### **Item 69 - Ref: As 369924-5**

The screed under modern screed to perimeter (053/hall store area) does not contain asbestos.

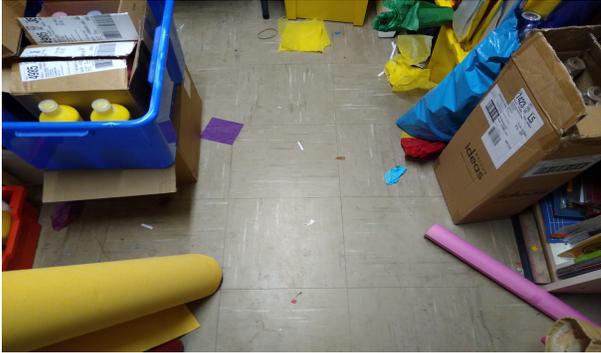
### **Item 70 - Ref: As 369924-9**

The floor covering (054/store) does not contain asbestos.

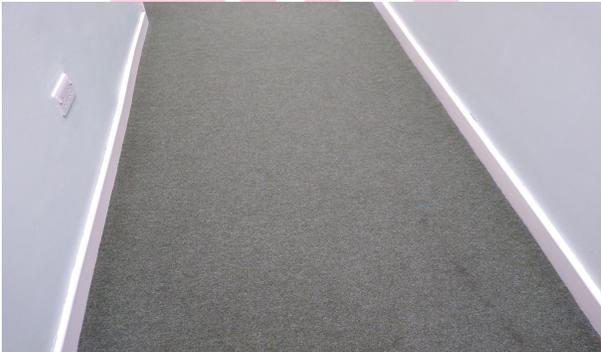
### **Item 72 - Ref: As 369924-13**

The screed under modern screed (055/corridor) does not contain asbestos.

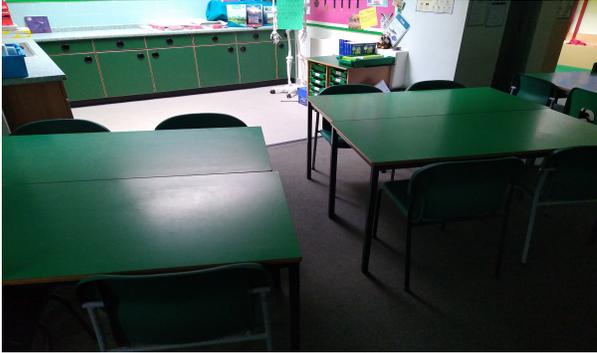
### **Item 73 - Ref: As 369924-13**

The floor covering (056/classroom) does not contain asbestos.

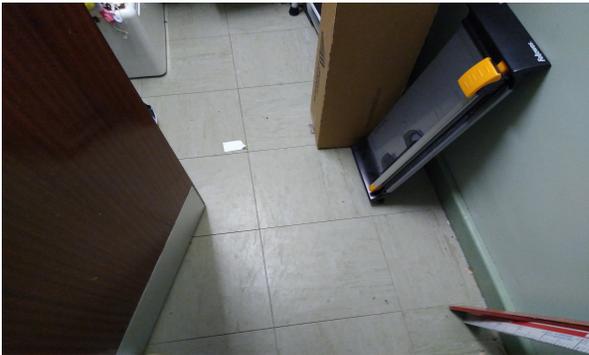
### **Item 74 - Ref: As 369924-13**

The floor covering (057/store) does not contain asbestos.

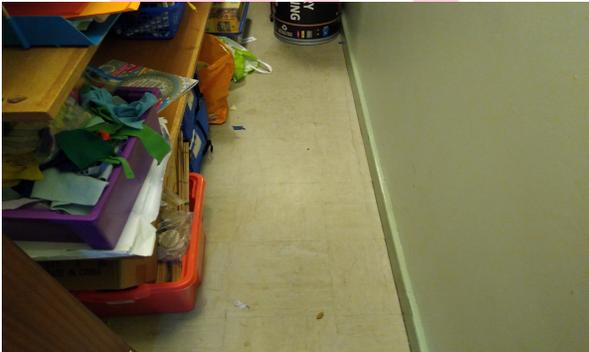
### **Item 75 - Ref: As 369924-13**

The floor covering (058/store) does not contain asbestos.

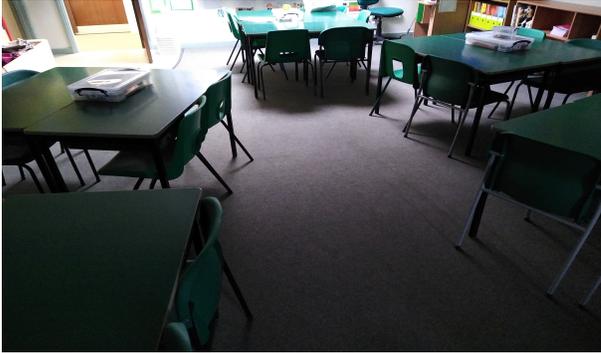
### **Item 76 - Ref: As 369924-13**

The floor covering  
(059/classroom) does not  
contain asbestos.

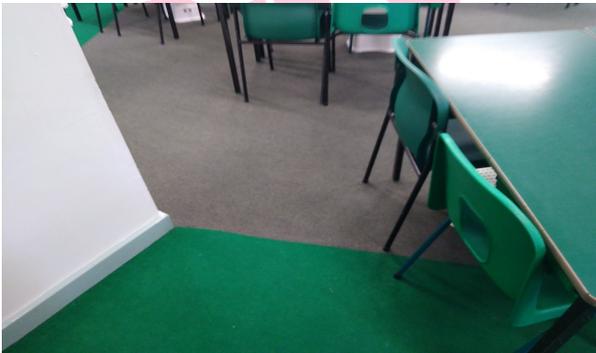
### **Item 78 - Ref: As 369924-13**

The floor covering  
(061/classroom) does not  
contain asbestos.

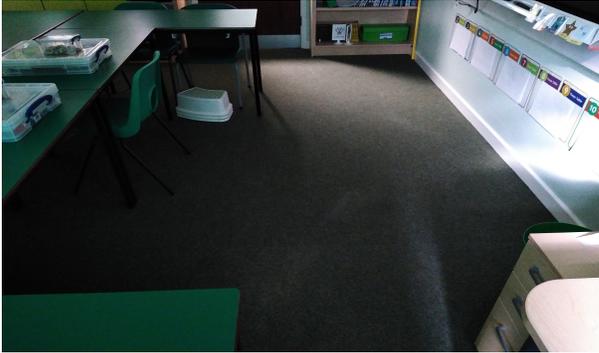
### **Item 79 - Ref: As 369924-13**

The screed under modern screed (062/classroom) does not contain asbestos.

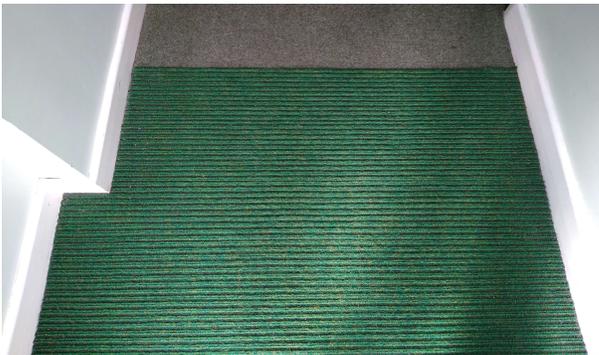
### **Item 80 - Ref: As 369924-13**

The screed under modern screed (063/lobby) does not contain asbestos.

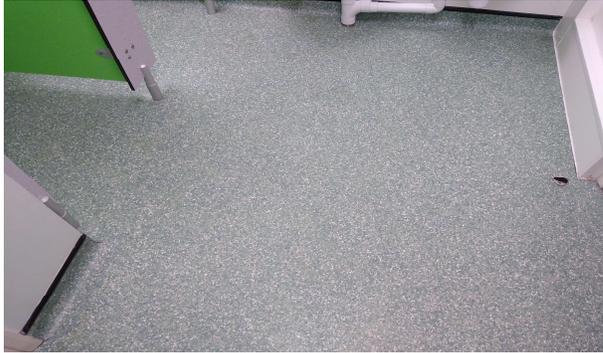
### **Item 82 - Ref: As 369924-13**

The screed under modern screed (065/male WC) does not contain asbestos.

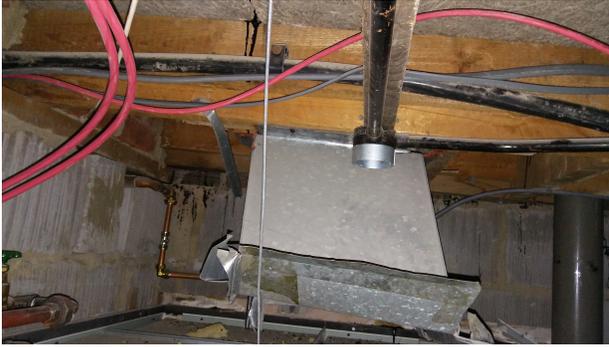
### **Item 88 - Ref: As 369924-11**

The red mastic to ductwork (071/accessible WC-void above) does not contain asbestos.

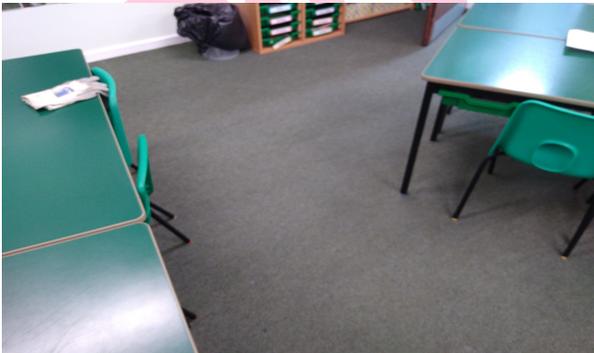
### **Item 90 - Ref: As 369924-13**

The screed under modern screed (072/classroom) does not contain asbestos.

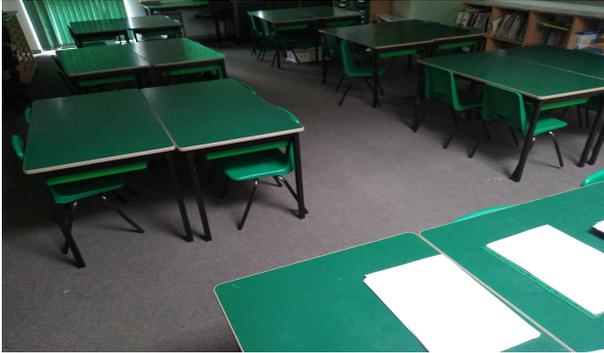
### **Item 91 - Ref: As 369924-13**

The screed under modern screed (073/classroom) does not contain asbestos.

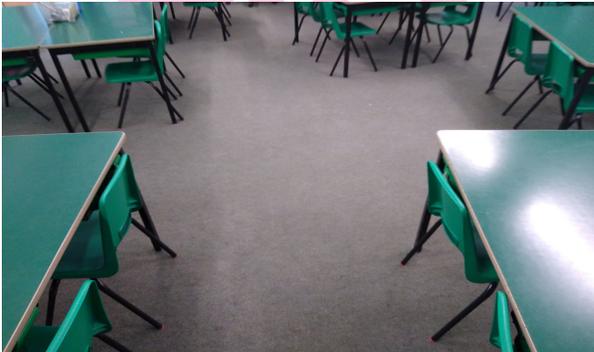
### **Item 93 - Ref: As 369924-13**

The screed under modern screed (075/classroom) does not contain asbestos.

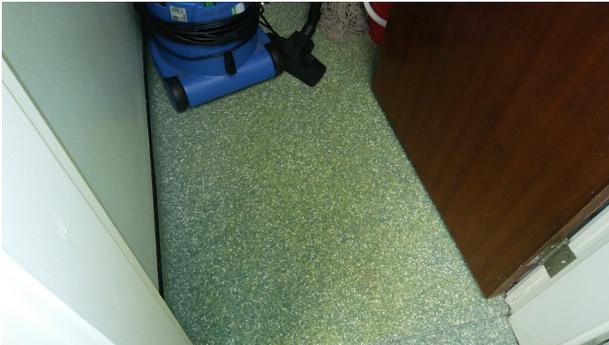
### **Item 95 - Ref: As 369924-13**

The screed under modern screed (077/cleaners store) does not contain asbestos.

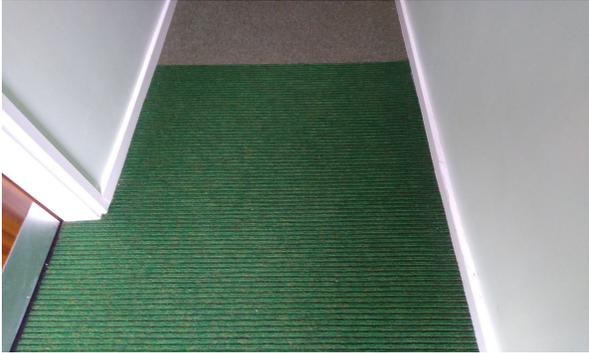
### **Item 97 - Ref: As 369924-13**

The screed under modern screed (079/lobby) does not contain asbestos.

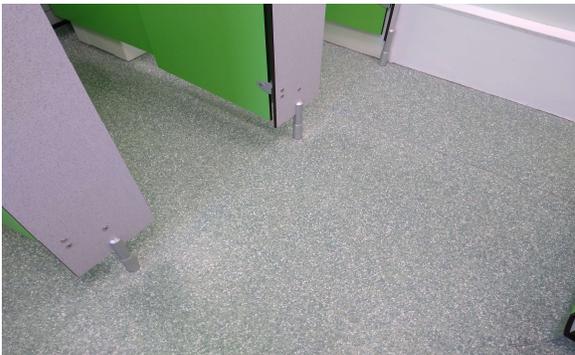
### **Item 98 - Ref: As 369924-13**

The screed under modern screed (079/lobby) does not contain asbestos.

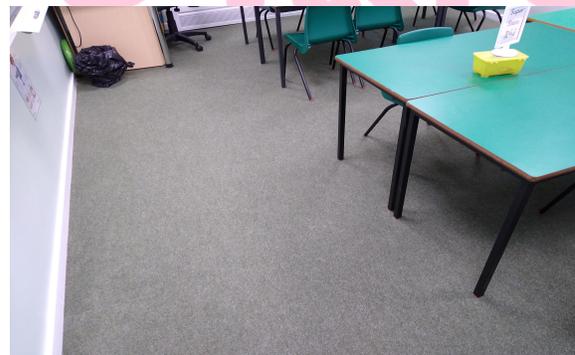
### **Item 99 - Ref: As 369924-13**

The screed under modern screed (080/classroom-void above) does not contain asbestos.

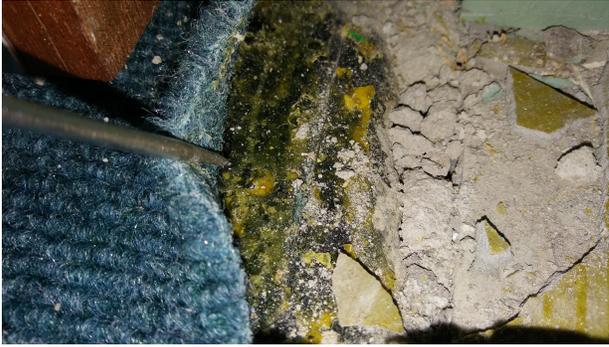
### **Item 100 - Ref: As 369924-13**

The screed under modern screed (081/ICT suite) does not contain asbestos.

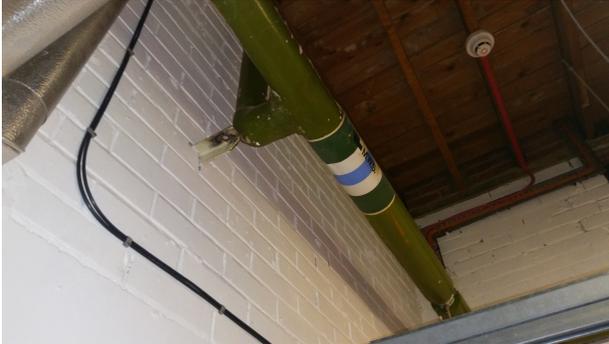
**Item 103 - Ref: 369924-1**

The pipe lagging (084/boiler room) does not contain asbestos.

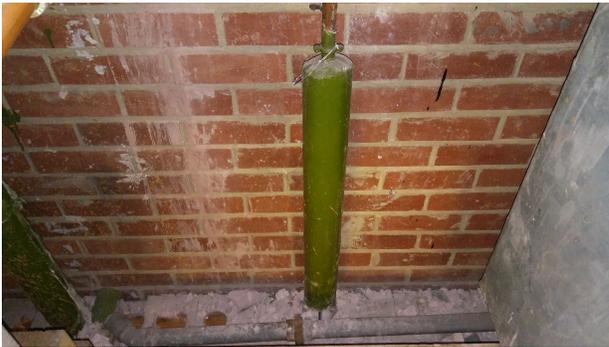
**Item 107 - Ref: 369924-22**

The pipe lagging (084/boiler room – void above) does not contain asbestos.

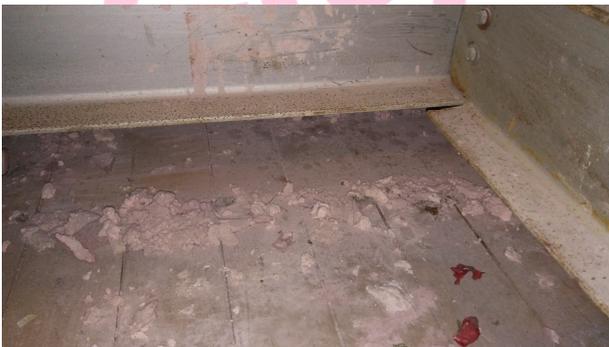
**Item 108 - Ref: As 369924-22**

The debris to floor (084/boiler room – void above) does not contain asbestos.

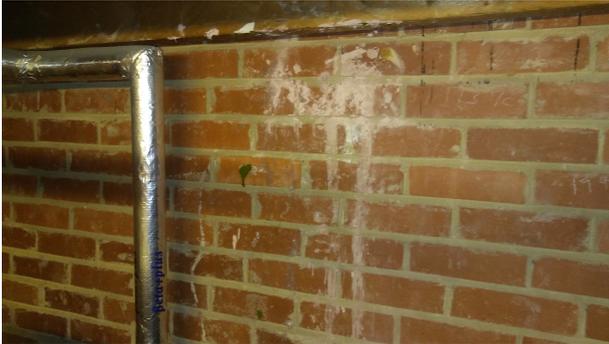
### **Item 109 - Ref: As 369924-22**

The debris to walls (084/boiler room – void above) does not contain asbestos.

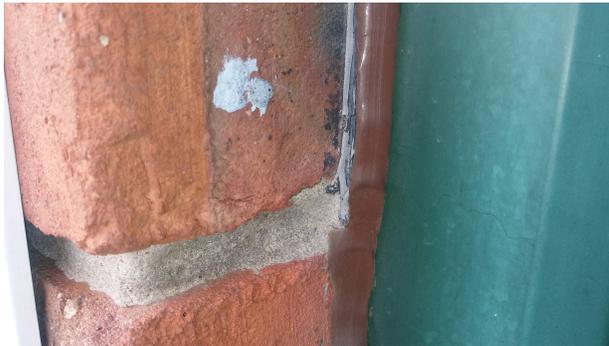
### **Item 110 - Ref: 369924-15**

The grey window sealant behind modern brown mastic (externals) contains asbestos.

Any change in its appearance should be recorded and passed to Property Services.

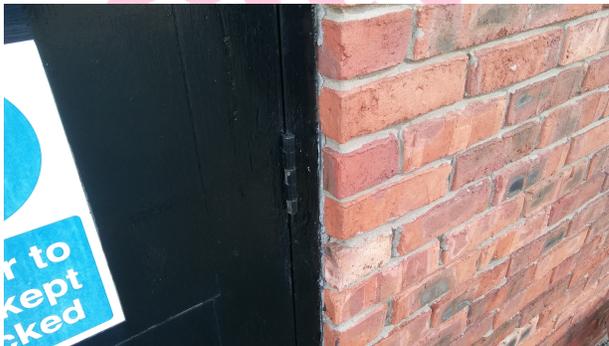
### **Item 111 - Ref: 369924-16**

The sealant to boiler room door frame (externals) contains asbestos.

Any change in its appearance should be recorded and passed to Property Services.

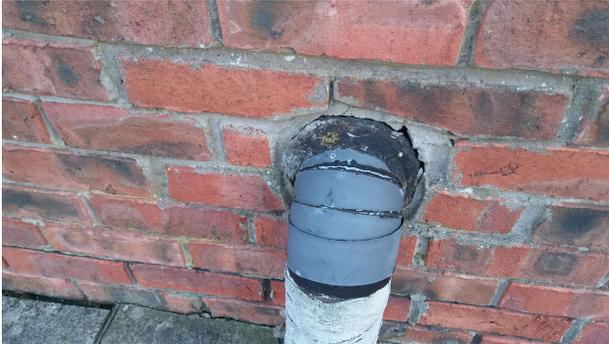
### **Item 112 - Ref: 369924-17**

The sealant to pipe penetration leading into 0/083 (externals) does not contain asbestos.
