ASBESTOS SURVEY REPORT FOR BIDDICK PRIMARY SCHOOL, KIRKHAM BIDDICK VILLAGE, WASHINGTON

Asbestos Register for Biddick Primary School

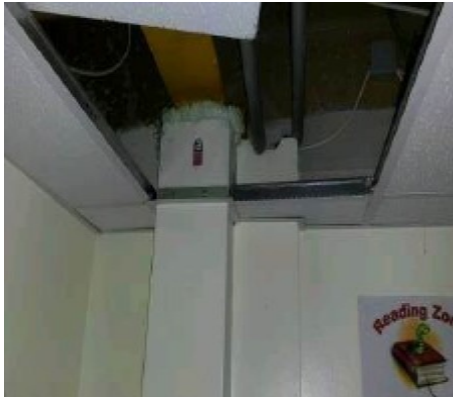
Item 1 As EB002449

The insulating board cladding to the metal columns within Classroom 11 (Room 1) contain asbestos.

Any change in its appearance should be noted and reported to Property Services.

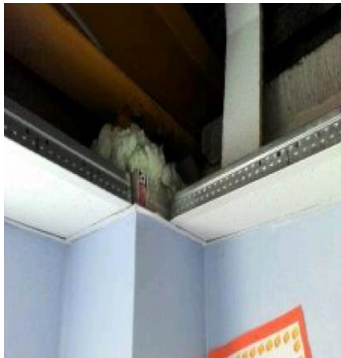
Item 7 As EB002449

The insulating board cladding to the metal columns within the cloak room (Room 5) contain asbestos.

Any change in its appearance should be noted and reported to Property Services.

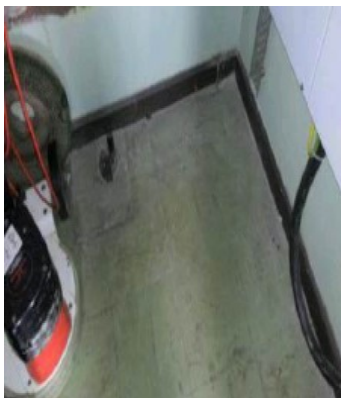
Item 9 As: EB0024501

The green floor tiles to the electrical cupboard (Room 6) do not contain asbestos.

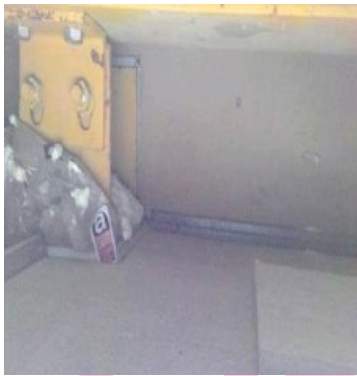
Item 11 As: EB002449

The insulating board cladding to the metal columns within the Girls WC (Room 8) contains asbestos.

Any change in its appearance should be noted and reported to Property Services.

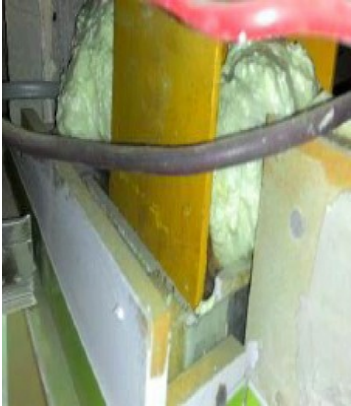
Item 13 As EB002449

The insulating board cladding to the metal columns within the Cloak area (Room 10) contains asbestos.

Any change in its appearance should be noted and reported to Property Services.

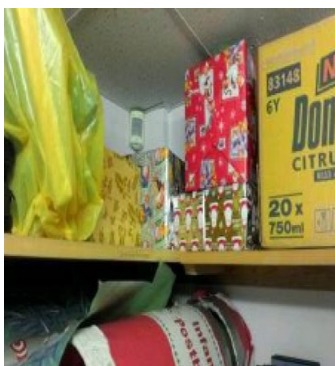
Item 18 As: EB002449

The insulating board cladding to the metal columns within the store (Room 14) contains asbestos.

Any change in its appearance should be noted and reported to Property Services.

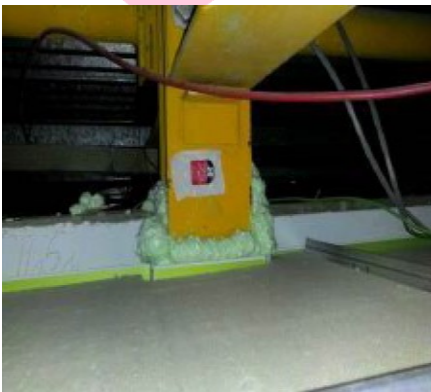
Item 21 As: EB002449

The insulating board cladding to the metal columns within Classroom 8 (Room 16) contains asbestos.

Any change in its appearance should be noted and reported to Property Services.

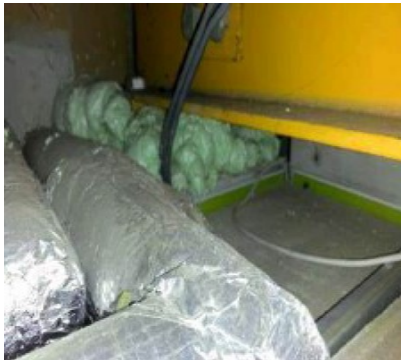
Item 26 As EB002449

The insulating board cladding to the metal columns within Classroom 7 (Room 18) contains asbestos.

Any change in its appearance should be noted and reported to Property Services.

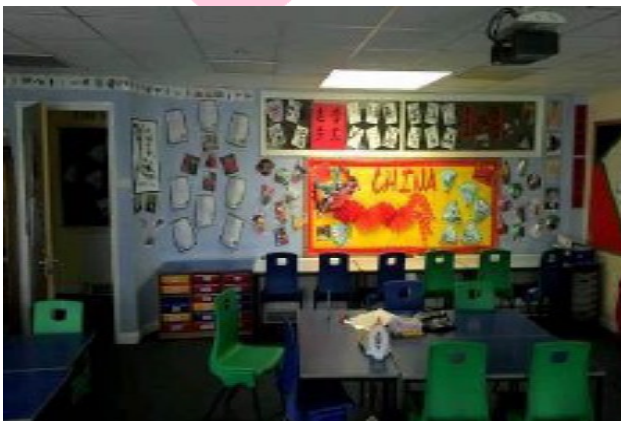
Item 30 As: EB002452

The insulating board panels to the partition wall in Classroom 7 (Room 18) do not contain asbestos.

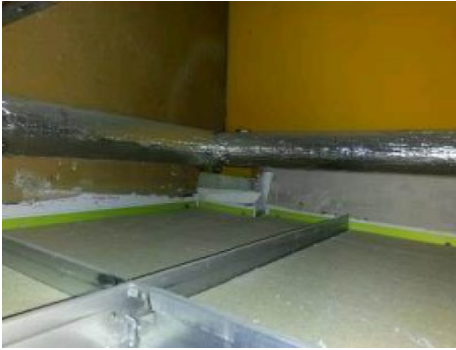
Item 31 As EB002449

The insulating board cladding to the metal columns within the store (Room 19) contains asbestos.

Any change in its appearance should be noted and reported to Property Services.

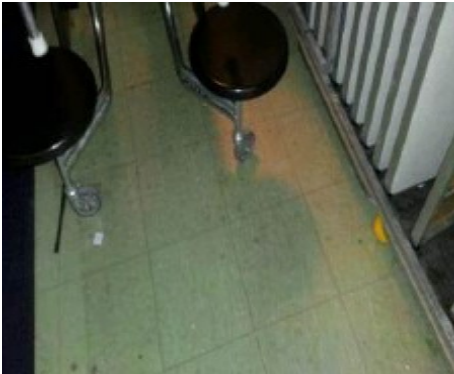
Item 34 Ref: EB002455

The green vinyl floor tiles to the chair store (Room 38) do not contain asbestos.

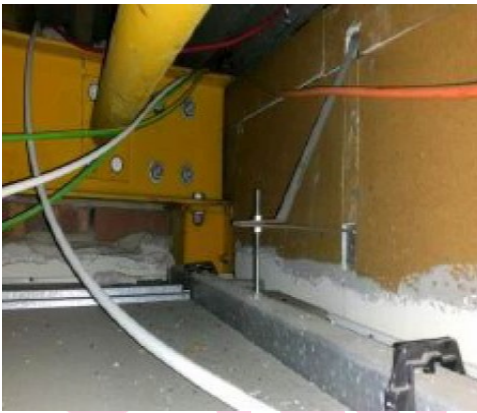
Item 35 Ref: EB002453

The insulating board cladding to the metal columns within the PE store (Room 39) contains asbestos.

Any change in its appearance should be noted and reported to Property Services.

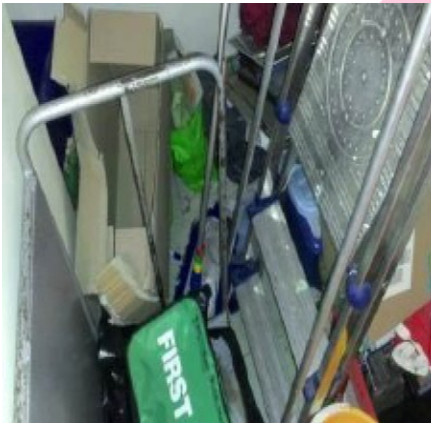
Item 41 Ref: EB002457

The grey vinyl floor tiles to the store (Room 43) do not contain asbestos.

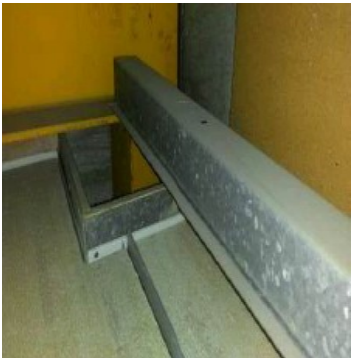
Item 43 Ref: EB002453

The insulating board cladding to the metal columns within the Ladies WC (Room 44) contains asbestos.

Any change in its appearance should be noted and reported to Property Services.

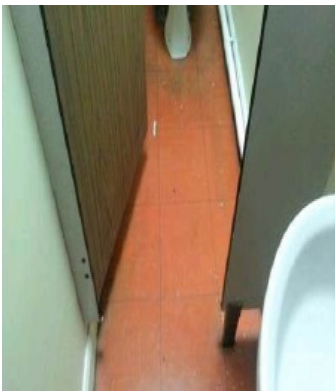
Item 45 As: EB002459

The orange vinyl floor tiles to the Gents WC (Room 46) do not contain asbestos.

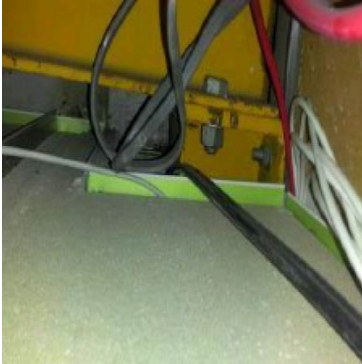
Item 46 Ref: EB002453

The insulating board cladding to the metal columns within the Office (Room 47) contains asbestos.

Any change in its appearance should be noted and reported to Property Services.

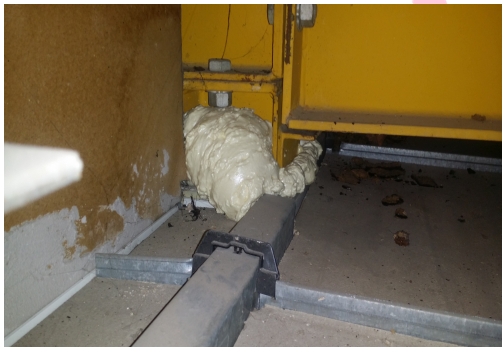
Item 53 Ref: As 203580-1

The insulating board in the girls toilet ceiling void (Room 016) contains asbestos.

This has been partially encapsulated. Any change in its appearance should be reported to Property Services.

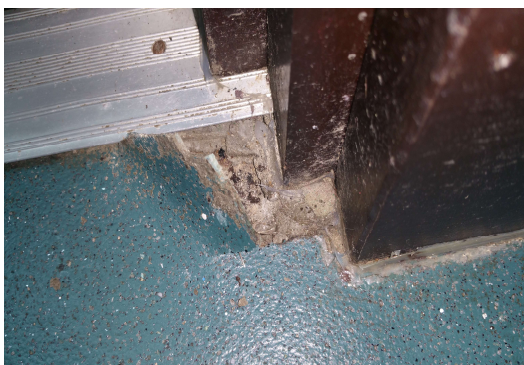
Item 54 Ref: 208189-1

The Subfloor Covering (020/Corridor) does not contain asbestos.

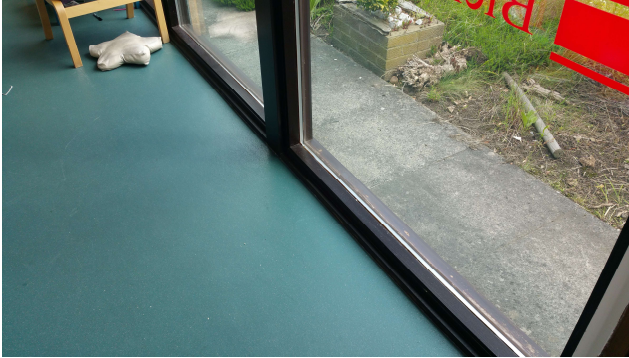
Item 55 Ref: As 208189-1

The Subfloor Covering (032/Corridor) does not contain asbestos.

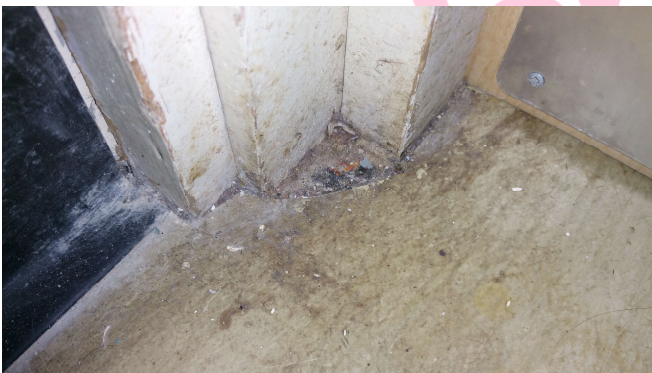
Item 56 Ref: As 208189-1

The Subfloor Covering (090/Caretakers Store) does not contain asbestos.

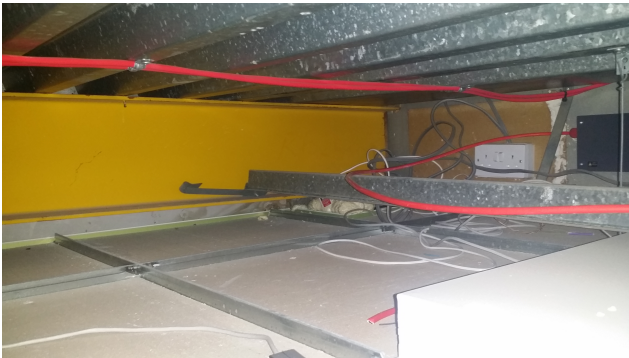
Item 61 Ref: Presumed

The lining to columns in the void above the Head teachers Room (Room 047) is presumed to contain asbestos.

Do not inspect. However any change in appearance should be reported to Property Services.

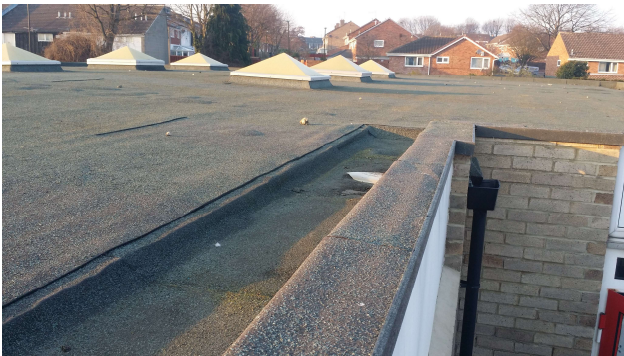
Item 62 Ref: 316836-2

The flat roof core sample (External) does not contain asbestos.

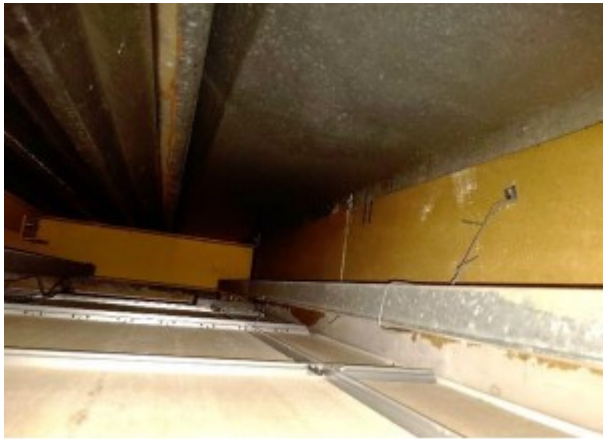
Item 64 Ref: Presumed

The lining to columns in the void above the Ladies toilets (Area 1) is presumed to contain asbestos.

Do not inspect. However any change in appearance should be reported to Property Services.

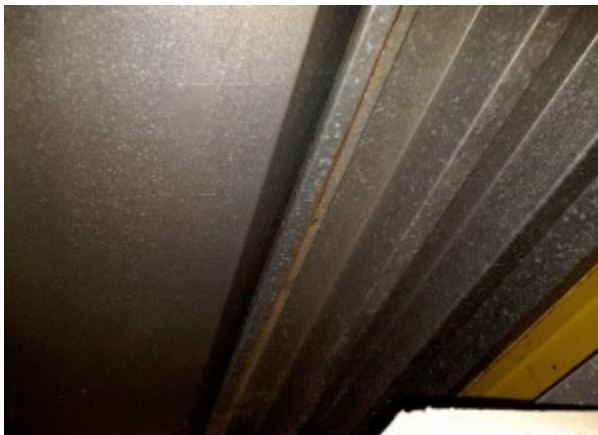
Item 65 Ref: 21-31381-2

The mastic to the metal deck on the ceiling void above the ladies toilet (Area 1) does not contain asbestos.

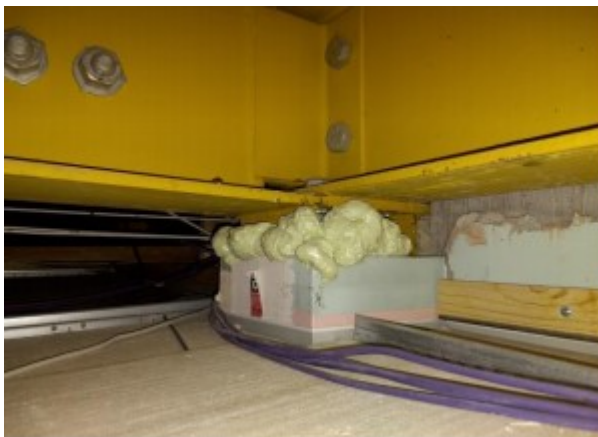
Item 66 Ref: Presumed

The lining to columns in the void above the Ladies toilets (Area 1) is presumed to contain asbestos.

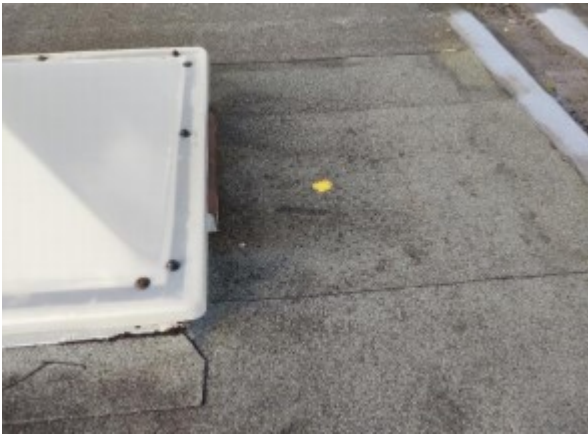
Item 67 Ref: 21-31381-5

The bitumen on the roof areas of extraction installation locations above 26 (Area 4) does not contain asbestos.

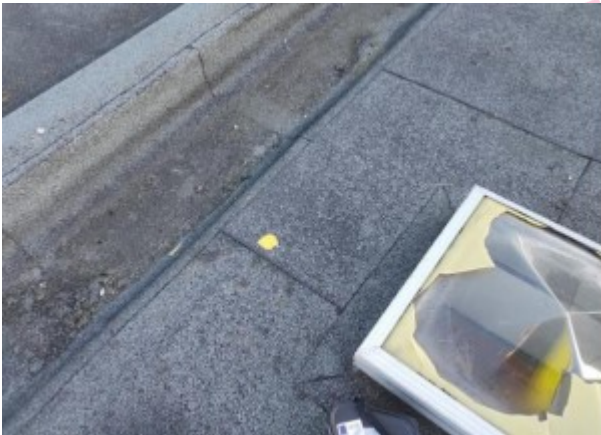
Item 68 Ref: 21-31381-6

The bitumen on the roof areas of extraction installation locations above ladies toilets (Area 4) does not contain asbestos.

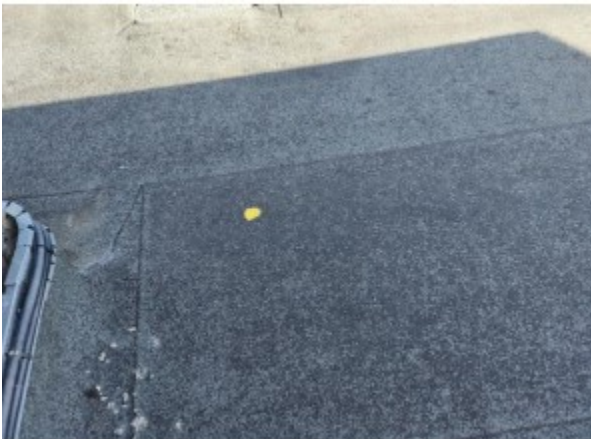
Item 69 Ref: 21-31381-7

The bitumen on the roof areas of extraction installation locations above gents toilets (Area 4) does not contain asbestos.

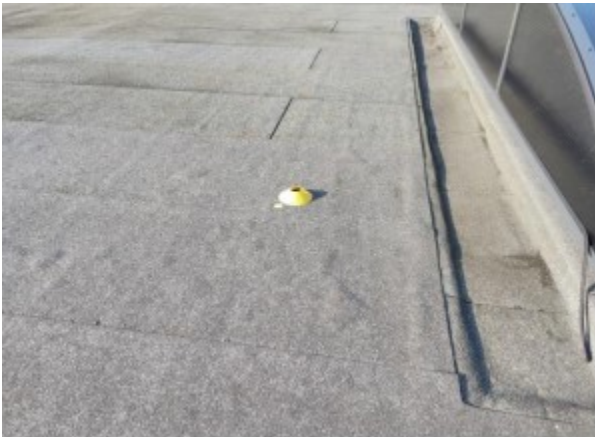
Item 70 Ref: 21-31381-8

The bitumen on the roof areas of extraction installation locations above girls toilets year 3 and 4 (Area 4) does not contain asbestos.

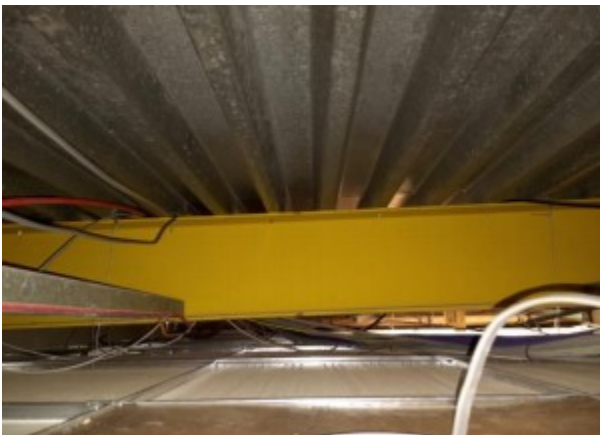
Item 71 Ref: Presumed

The lining to columns in the void above the girls toilets year 3 and 4 (Area 5) is presumed to contain asbestos.

Do not inspect. However any change in appearance should be reported to Property Services.

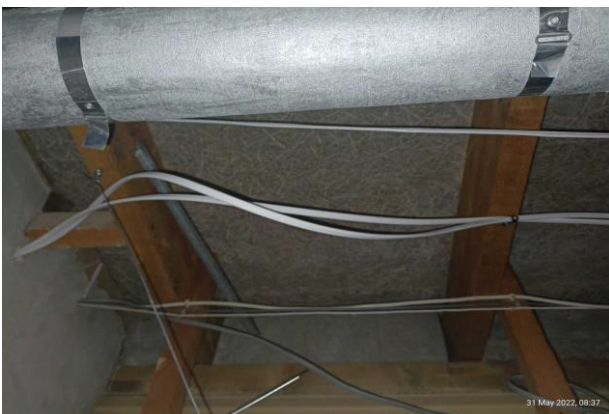
Item 72 Ref: 22-47235-1

The ceiling (Strawboard) (Corridor G0/20 False ceiling void/Area 1) does not contain asbestos.

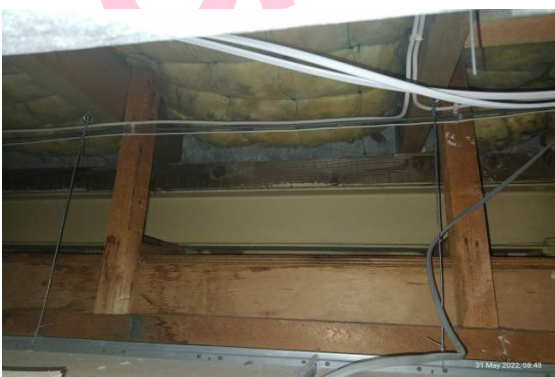
Item 75 Ref: 22-47235-2

The firebreaks (Lobby G0/27 False ceiling void/Area 2) do not contain asbestos.

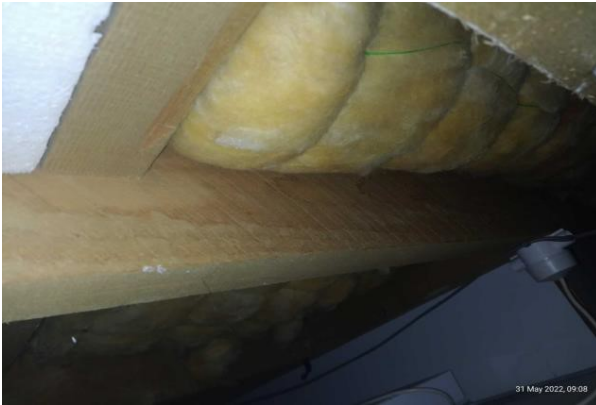
Item 79 Ref: 22-47235-1

The ceiling (Strawboard)
(Classroom 4 G0/29 False
ceiling void/Area 6) does not
contain asbestos.

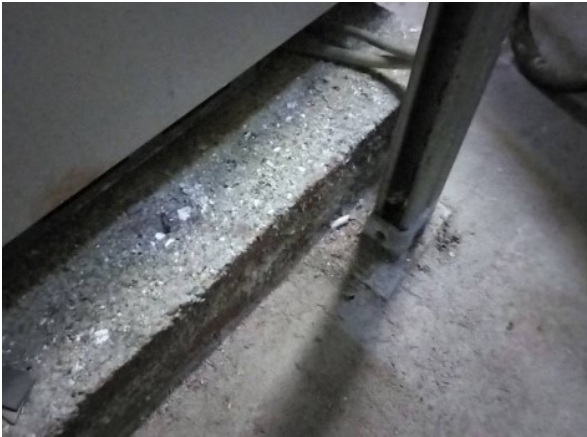
Item 80 Ref: AW005493

The floor debris in the boiler
room (Rm G/001) does not
contain asbestos.

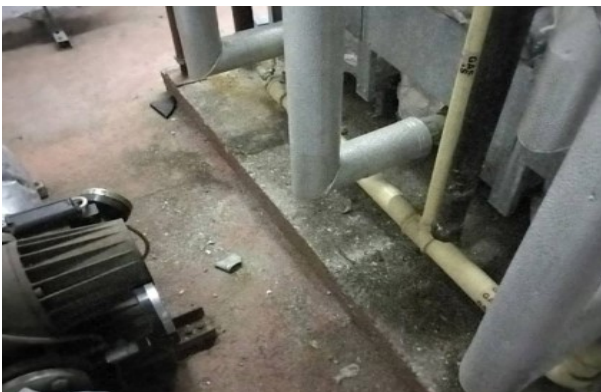
Item 81 Ref: AW005494

The floor debris in the boiler
room (Rm G/001) does not
contain asbestos.

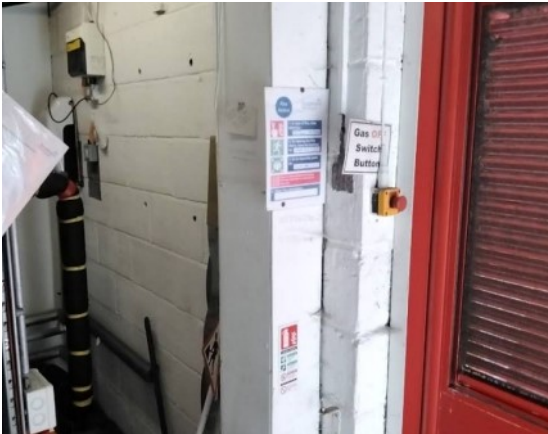
Item 82 Ref: AW005495

The column cladding in the boiler room (Rm G/001) does not contain asbestos.

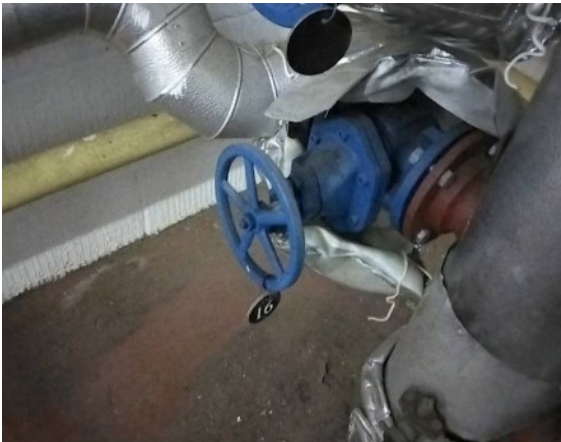
Item 83 Ref: AW005496

The pipework gaskets in the boiler room (Rm G/001) does not contain asbestos.

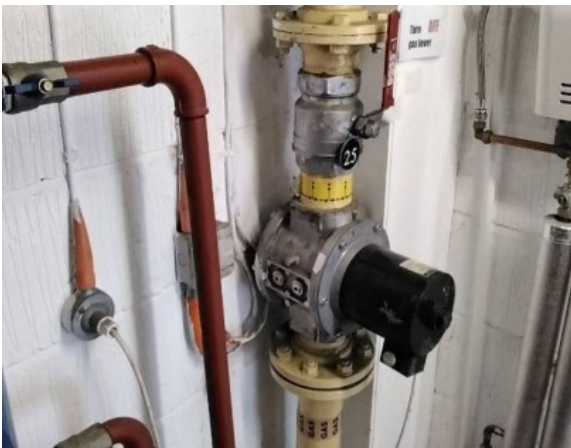
Item 84 Ref: AW005497

The pipework gaskets gas main in the boiler room (Rm G/001) does not contain asbestos.

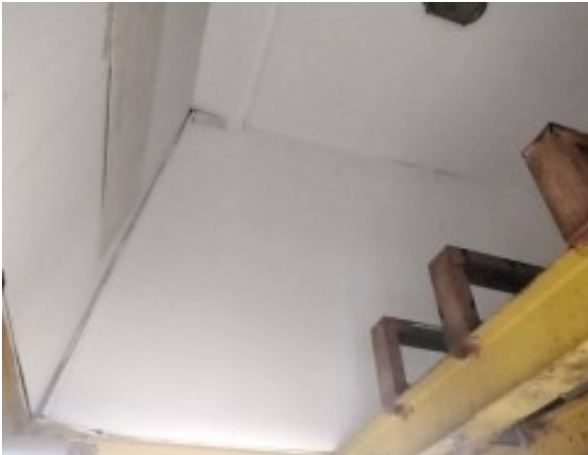
Item 85 Ref: AW005498

The upstands to raised roof area in the boiler room (G/001) contain asbestos.

Any change in appearance should be reported to Property Services.

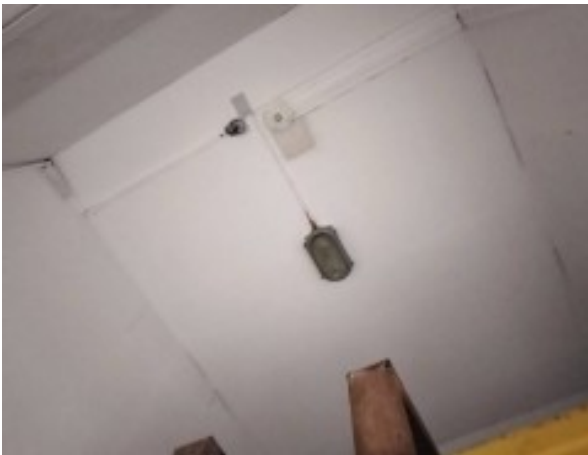
Item 86 Ref: Presumed

The sealant to glass cover on ceiling mounted light fitting in the boiler room (G/001) is presumed to contain asbestos.

Any change in appearance should be reported to Property Services.

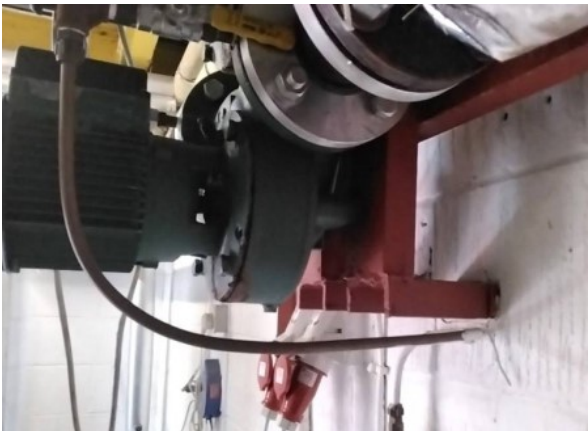
Item 87 Ref: AW005501

The debris to pipework brackets in the boiler room (Rm G/001) does not contain asbestos.

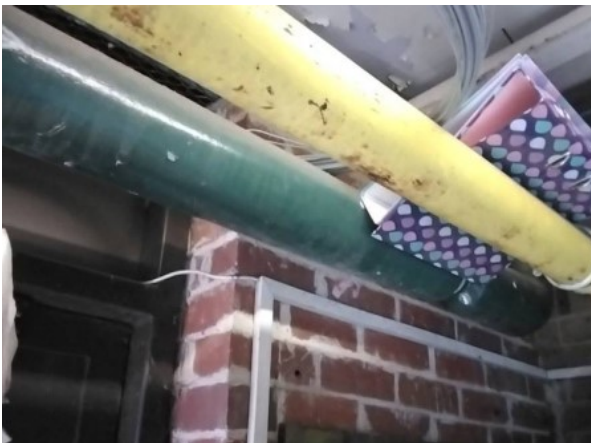
Item 89 Ref: AW005503

The pipework insulation in the Store Room (G/002) does not contain asbestos.

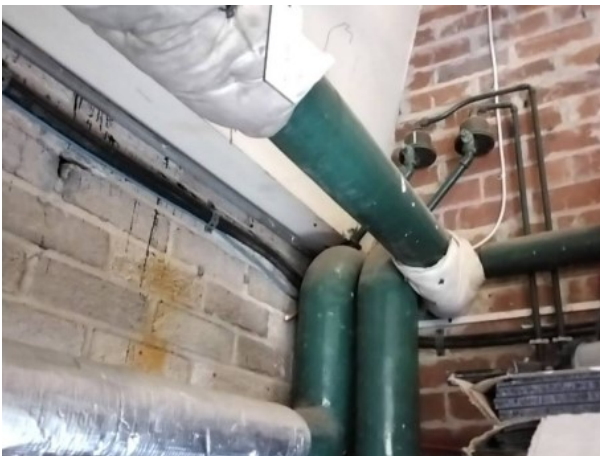
Item 90 Ref: AW005504

The pipework insulation in the Store Room (G/002) does not contain asbestos.

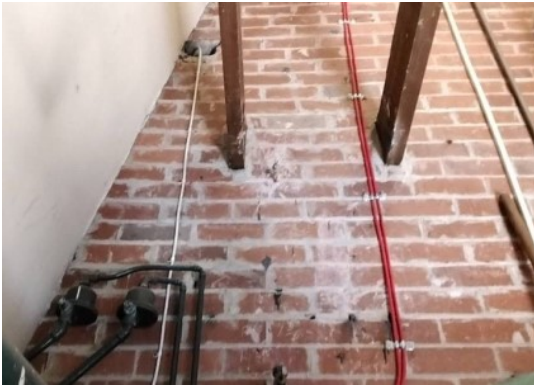
Item 91 Ref: AW005505

The wall debris in the Store Room (G/002) does not contain asbestos.

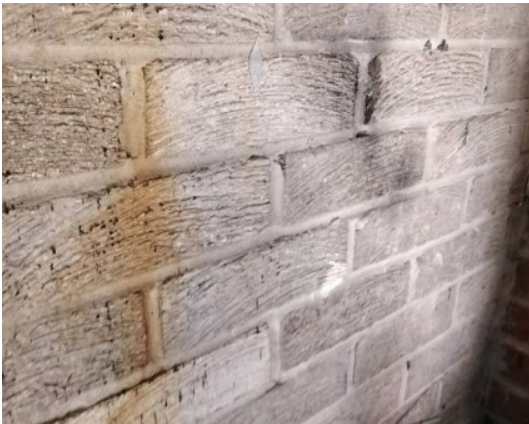
Item 92 Ref: AW005506

The wall debris in the Store Room (G/002) does not contain asbestos.

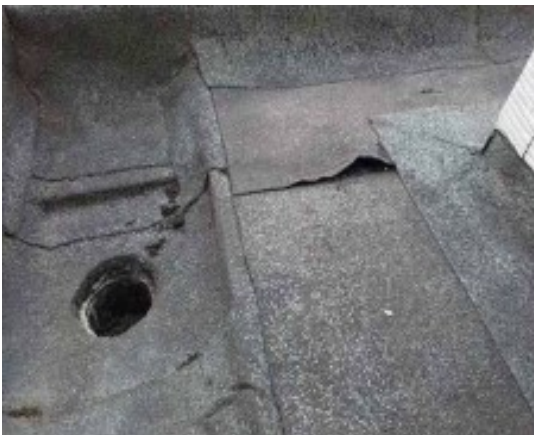
Item 93 Ref: OQ000544

The roof insulation to the felt flat roof (External E/001) does not contain asbestos.

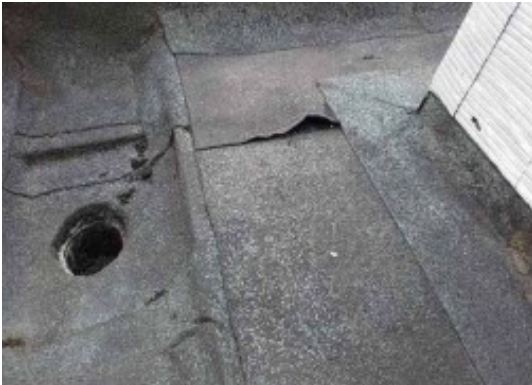
Item 94 Ref: OQ000543

The roof felt top layer to the felt flat roof (External E/001) does not contain asbestos.

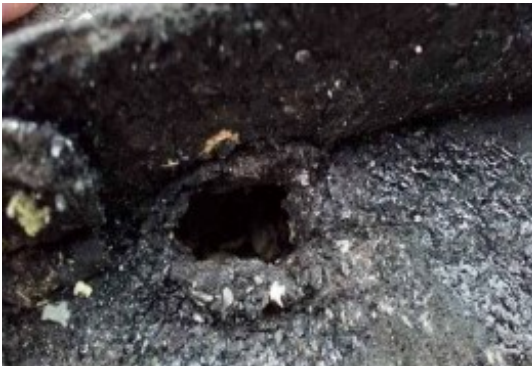
Item 95 Ref: OQ000545

The roof felt bottom layer, beneath insulation to the felt flat roof (External E/001) does not contain asbestos.

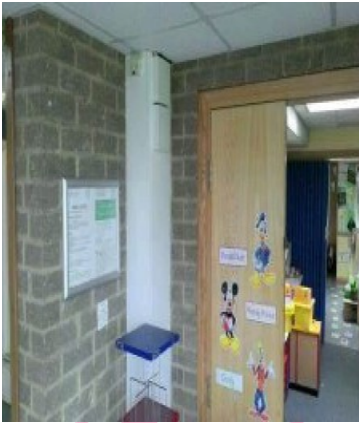
The wood boxing to the corridor (Room 20) was accessed and no suspected materials were found.

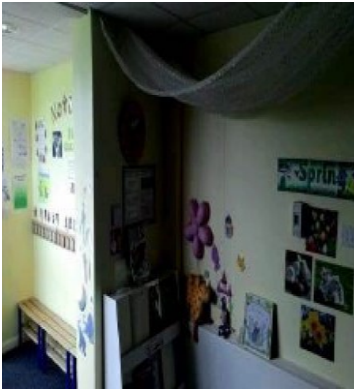
The wood boxing to Classroom 1 and lobby (Room 21) was accessed and no suspected materials were found.

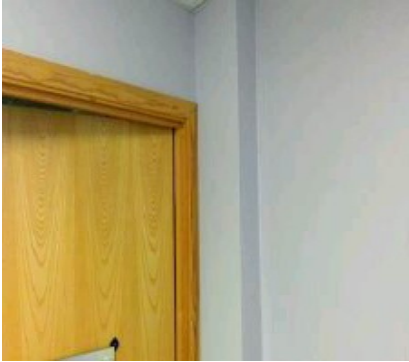
The wood boxing to the Disabled WC (Room 22) was accessed and no suspected materials were found.

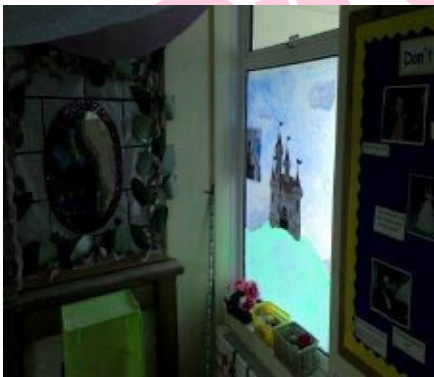
The wood boxing to Classroom 3 (Room 23) was accessed and no suspected materials were found.

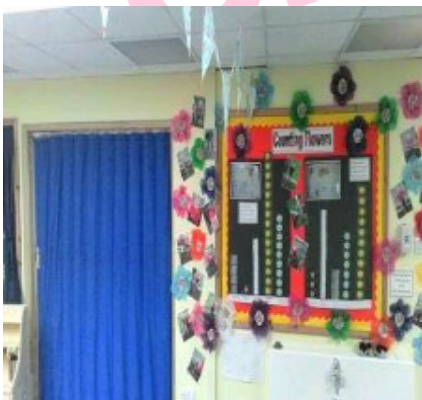
The wood boxing to classroom 3 (Room 23) was accessed and no suspected materials were found.

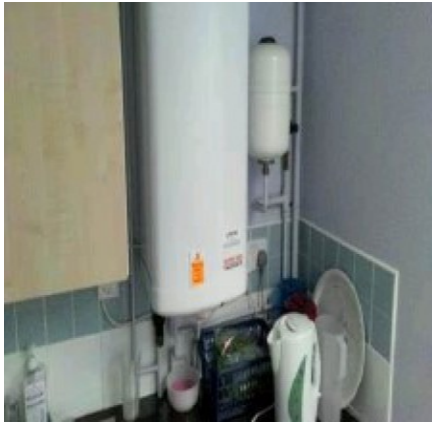
The modern boiler to the staff room (Room 24) was accessed and no suspected materials were found.

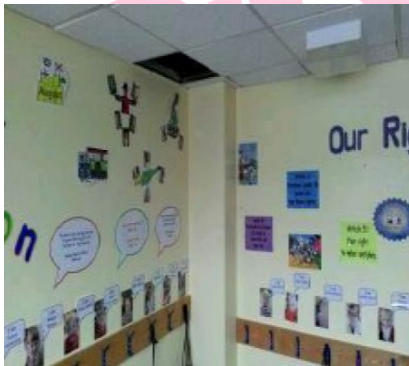
The wood boxing to cloak room area (Room 25) was accessed and no suspected materials were found.

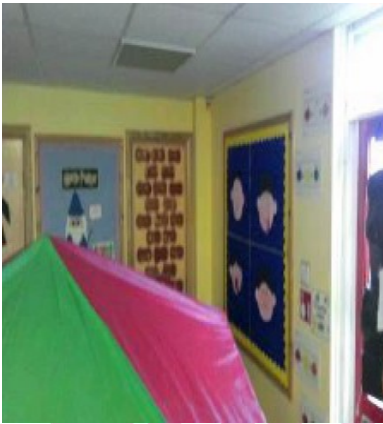
The wood boxing to Classroom 2 (Room 26) was accessed and no suspected materials were found.

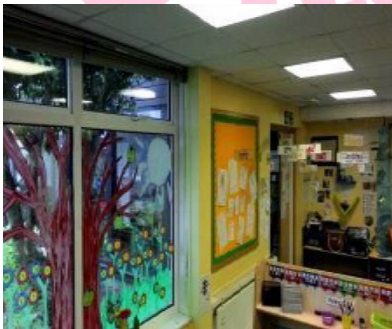
The wood boxing to Classroom 2 (Room 26) was accessed and no suspected materials were found.

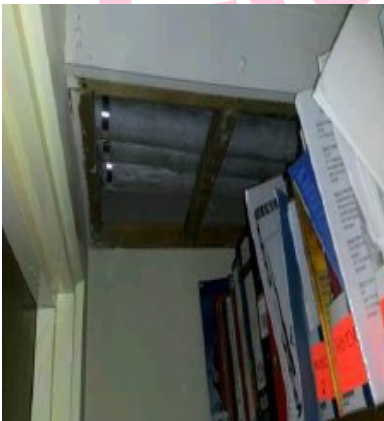
The wood boxing to the store (Room 28) was accessed and no suspected materials were found.

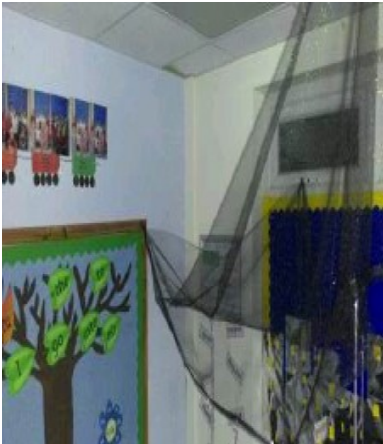
The wood boxing to classroom 4 (Room 29) was accessed and no suspected materials were found.

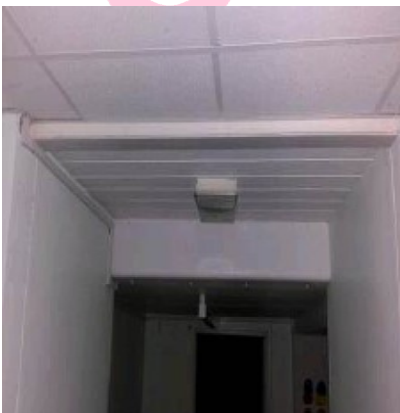
The wood boxing to the cloak room (Room 30) was accessed and no suspected materials were found.

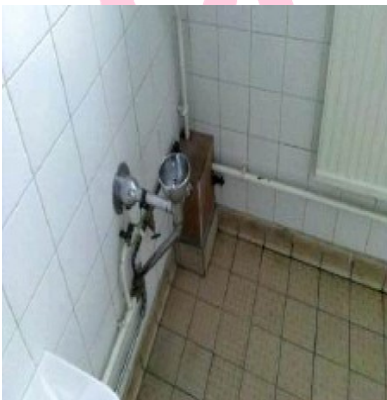
The wood boxing to the Boys WC (Room 33) was accessed and no suspected materials were found.

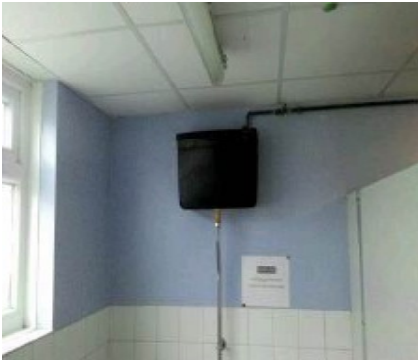
The cistern to Boys WC (Room 33) was accessed and no suspected materials were found.

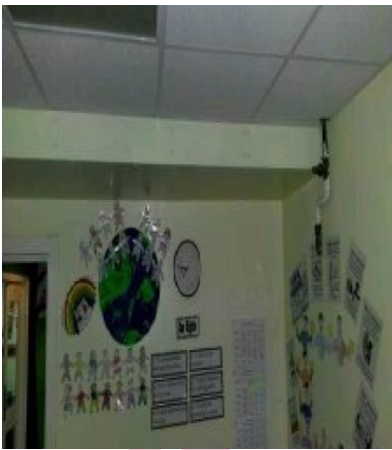
The wood boxing to Classroom 5 (Room 34) was accessed and no suspected materials were found.

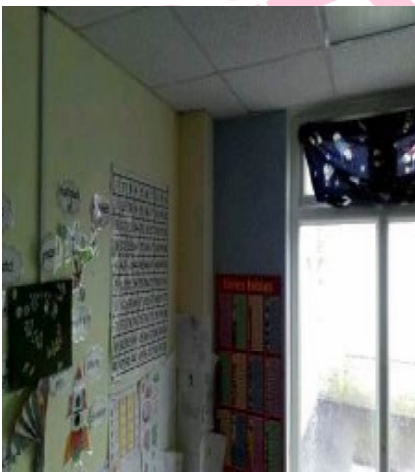
The wood boxing to Classroom 5 (Room 34) was accessed and no suspected materials were found.

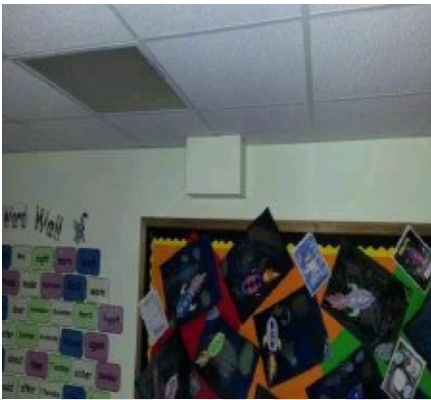
The wood boxing to Classroom 5 (Room 34) was accessed and no suspected materials were found.

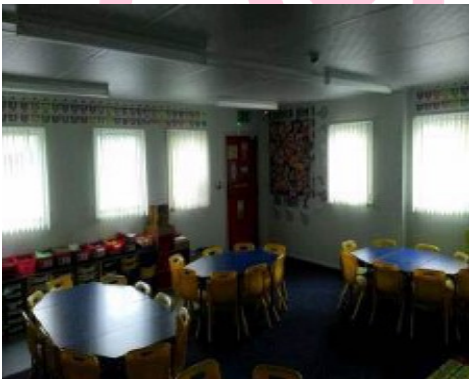
The wood boxing to Classroom A and Cloaks) (Room 35) was accessed and no suspected materials were found.

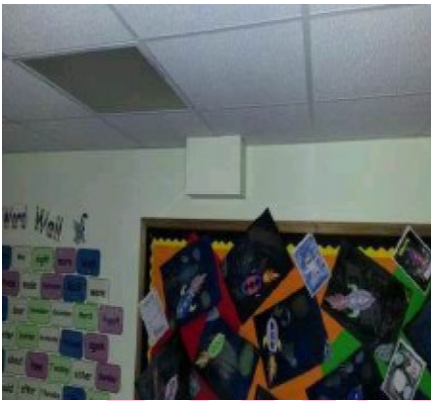
The wood boxing to Classroom 5 (Room 34) was accessed and no suspected materials were found.

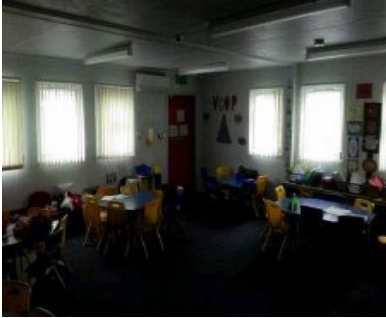
The wood boxing to the Classroom B and the cloaks areas (Room 36) was accessed and no suspected materials were found.

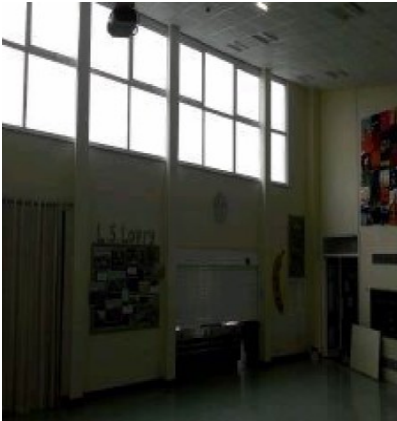
The wood boxing (x 5) to the Assembly Hall (Room 37) was accessed and no suspected materials were found.

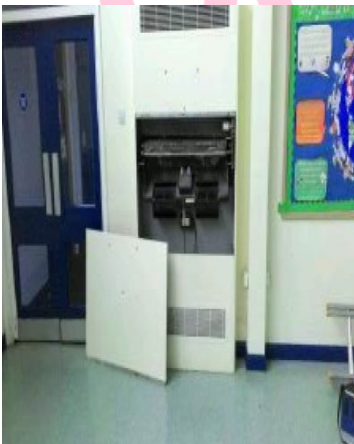
The wall heaters in the assembly hall (Room 37) were accessed and no suspected materials were found.

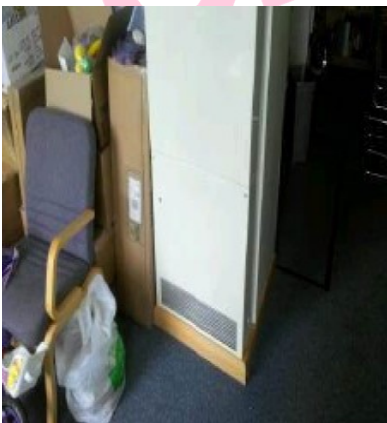
The wall heaters in the staff room (Room 41) were accessed and no suspected materials were found.

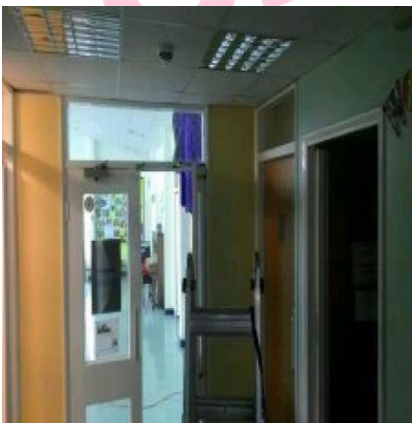
The corridor (Room 45) was accessed and no suspected materials were found.

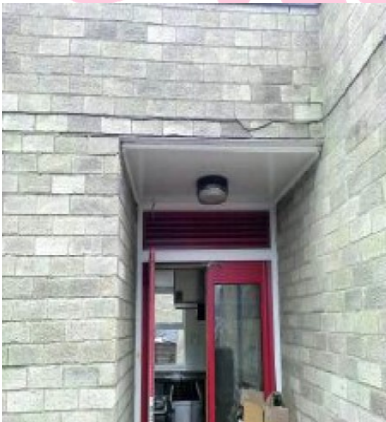
The external canopy above the kitchen door was accessed and no suspected materials were found.
