ASBESTOS SURVEY REPORT FOR BIDDICK PRIMARY SCHOOL, KIRKHAM BIDDICK VILLAGE, WASHINGTON

Asbestos Register for Biddick Primary School

UPRN: - 208189

Premises Manager / Samo: - Tenant Date: 08 August 2025

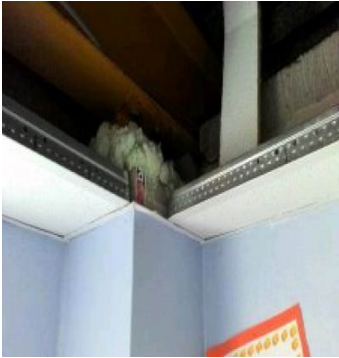
Item 7 As EB002449

The insulating board cladding to the metal columns within the cloak room (Room 5) contain asbestos.

Any change in its appearance should be noted and reported to Property Services.

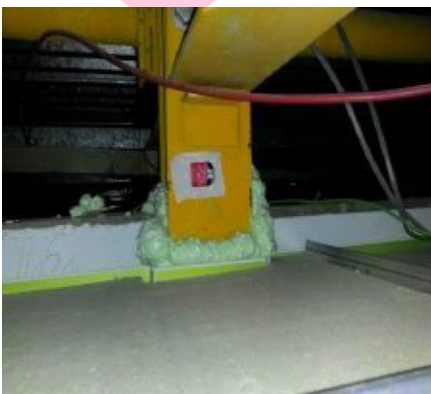
Item 21 As: EB002449

The insulating board cladding to the metal columns within Classroom 8 (Room 16) contains asbestos.

Any change in its appearance should be noted and reported to Property Services.

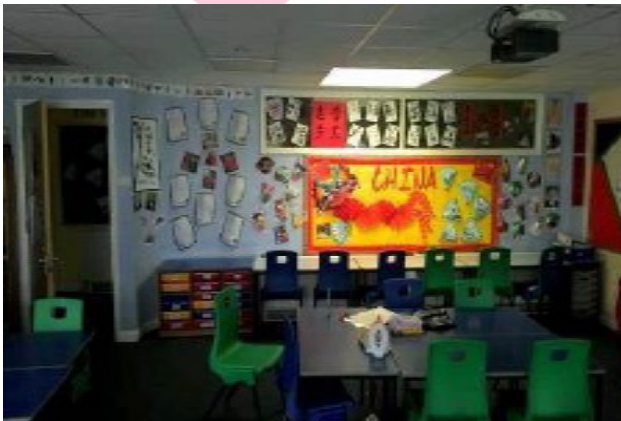
Item 30 As: EB002452

The insulating board panels to the partition wall in Classroom 7 (Room 18) do not contain asbestos.

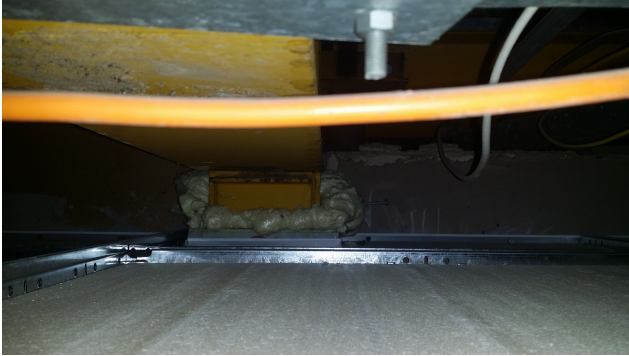
Item 58 Ref: As 316836-1

The lining to columns in the void above the girls toilet (Room 012) does contain asbestos.

Do not inspect. However any change in appearance should be reported to Property Services.

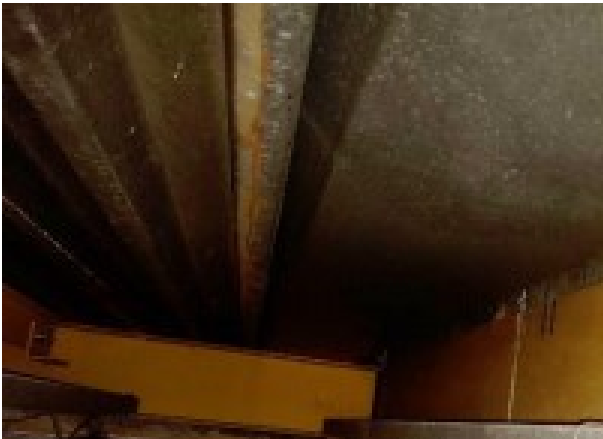
Item 64 Ref: Presumed

The lining to columns in the void above the Ladies toilets (Area 1) is presumed to contain asbestos.

Do not inspect. However any change in appearance should be reported to Property Services.

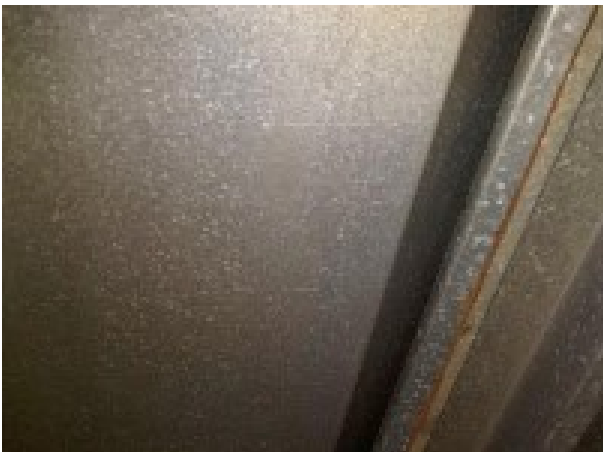
Item 65 Ref: 21-31381-2

The mastic to the metal deck on the ceiling void above the ladies toilet (Area 1) does not contain asbestos.

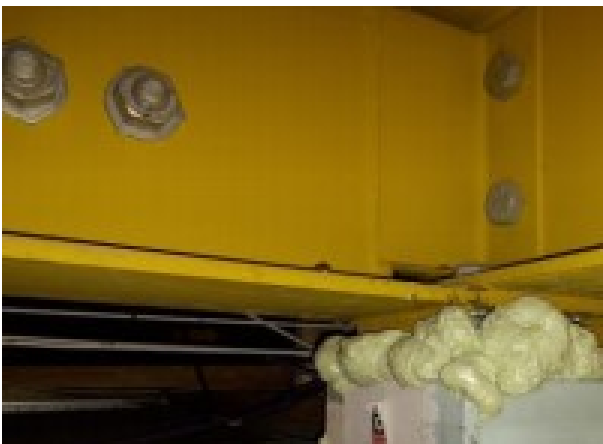
Item 66 Ref: Presumed

The lining to columns in the void above the Ladies toilets (Area 1) is presumed to contain asbestos.

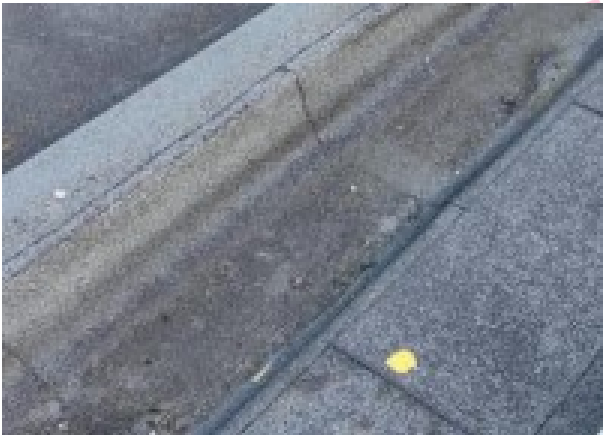
Item 68 Ref: 21-31381-6

The bitumen on the roof areas of extraction installation locations above ladies toilets (Area 4) does not contain asbestos.

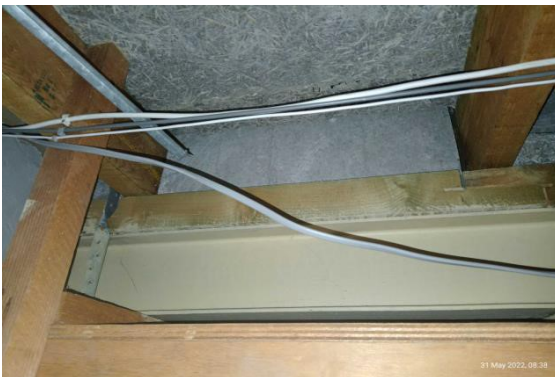
Item 73 Ref: 22-47235-2

The firebreaks (Corridor G0/20 False ceiling void/Area 1) do not contain asbestos.

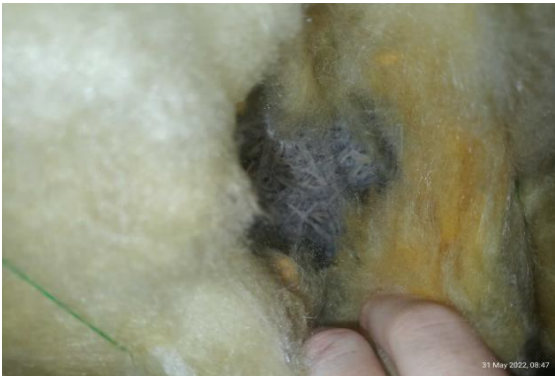
Item 74 Ref: 22-47235-1

The ceiling (Strawboard) (Lobby G0/27 False ceiling void/Area 2) does not contain asbestos.

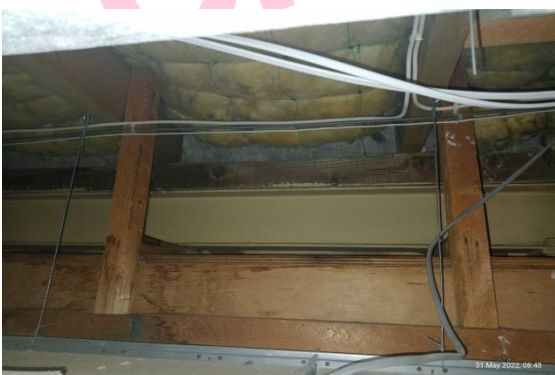
Item 75 Ref: 22-47235-2

The firebreaks (Lobby G0/27 False ceiling void/Area 2) do not contain asbestos.

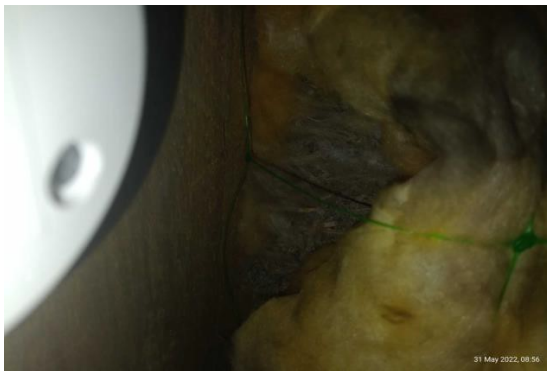
Item 76 Ref: 22-47235-1

The ceiling (Strawboard)
(Classroom 2 G0/26 False
ceiling void/Area 3) does not
contain asbestos.

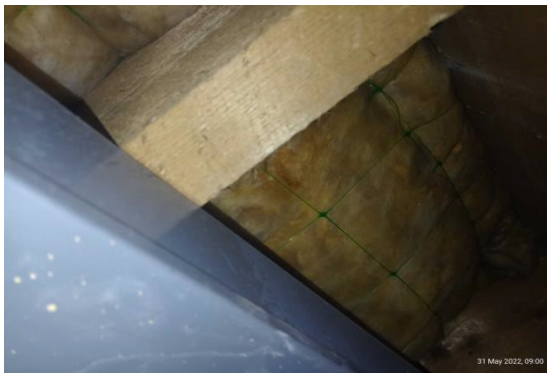
Item 77 Ref: 22-47235-1

The ceiling (Strawboard)
(Classroom 3 G0/23 False
ceiling void/Area 4) does not
contain asbestos.

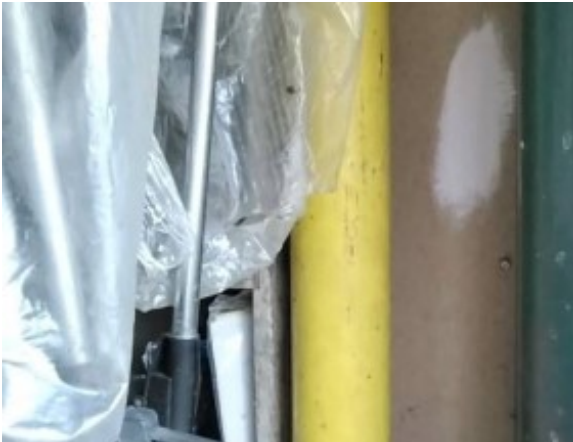
Item 88 Ref: AW005502

The pipework insulation in the Store Room (G/002) does not contain asbestos.

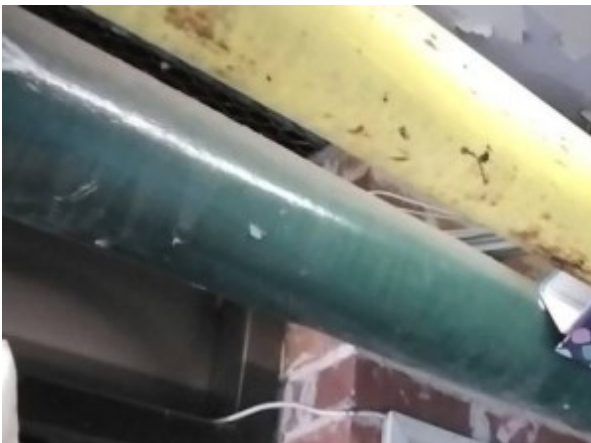
Item 89 Ref: AW005503

The pipework insulation in the Store Room (G/002) does not contain asbestos.

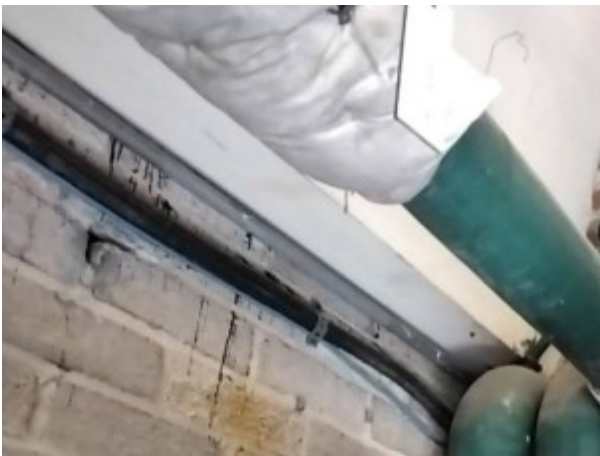
Item 90 Ref: AW005504

The pipework insulation in the Store Room (G/002) does not contain asbestos.

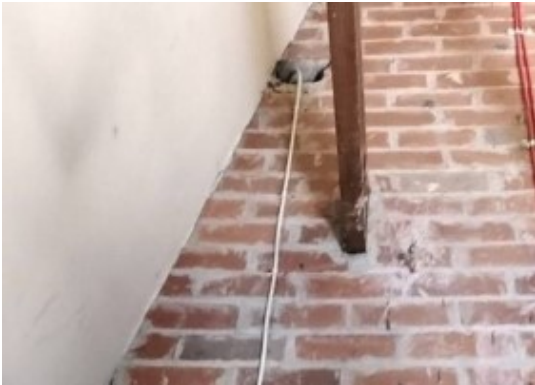
Item 91 Ref: AW005505

The wall debris in the Store Room (G/002) does not contain asbestos.

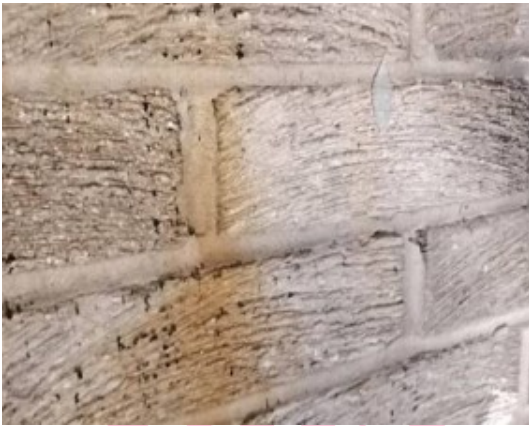
Item 92 Ref: AW005506

The wall debris in the Store Room (G/002) does not contain asbestos.

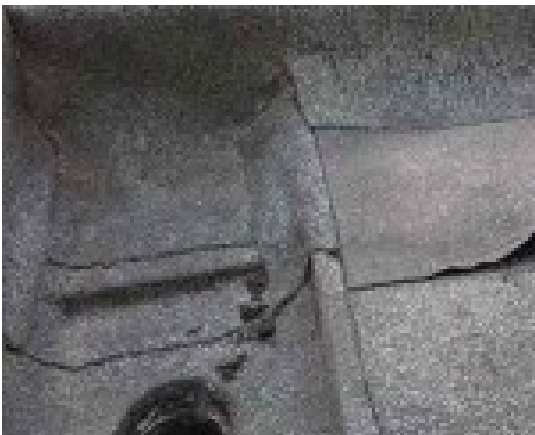
Item 93 Ref: OQ000544

The roof insulation to the felt flat roof (External E/001) does not contain asbestos.

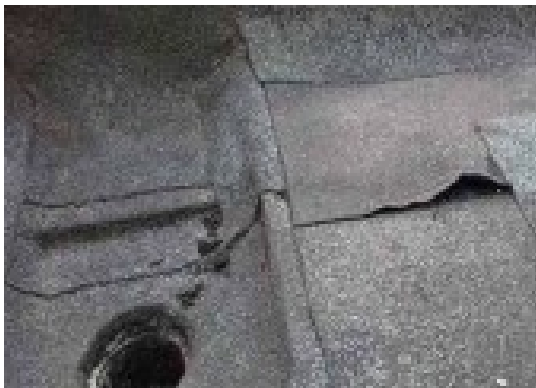
Item 94 Ref: OQ000543

The roof felt top layer to the felt flat roof (External E/001) does not contain asbestos.

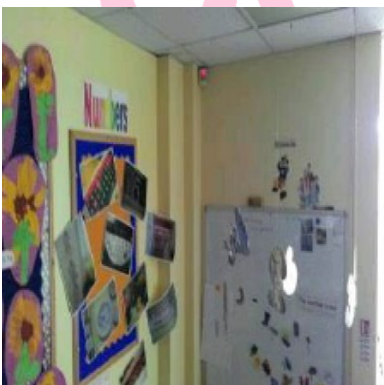
The wood boxing to the Classroom 1 and Lobby (Room 21) was accessed and no suspected materials were found.

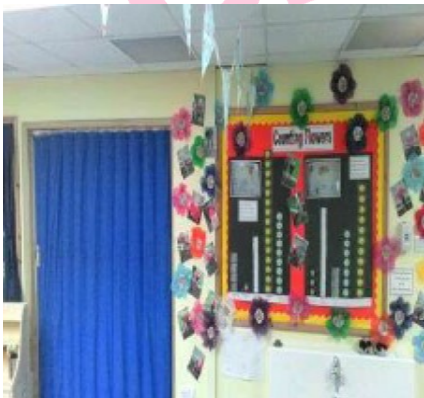
The wood boxing to classroom 3 (Room 23) was accessed and no suspected materials were found.

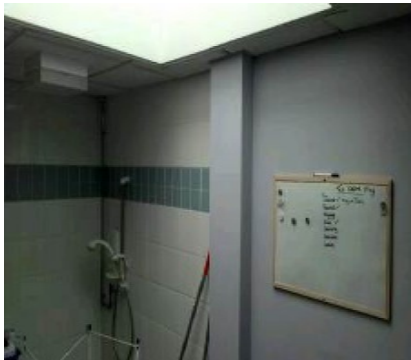
The wood boxing to the staff room (Room 24) was accessed and no suspected materials were found.

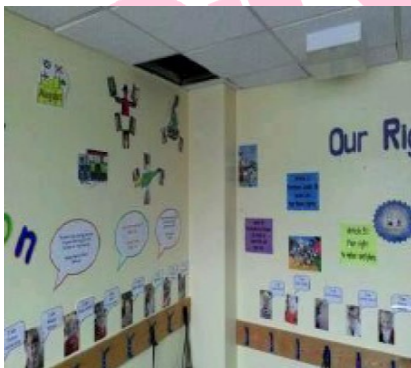
The wood boxing to cloak room area (Room 25) was accessed and no suspected materials were found.

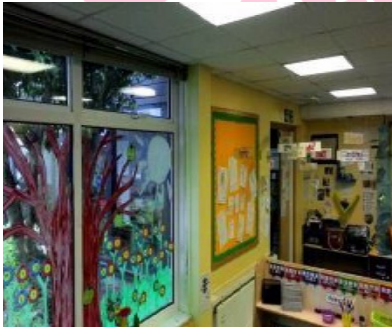
The wood boxing to Classroom 2 (Room 26) was accessed and no suspected materials were found.

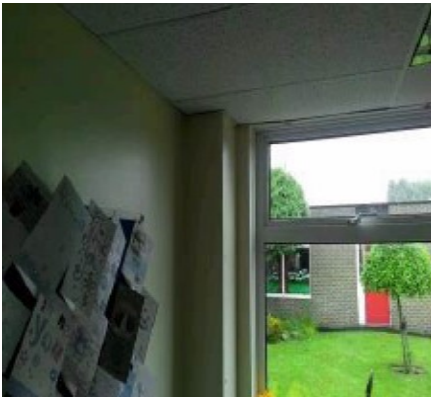
The wood boxing to the Staff Room (Room 41) was accessed and no suspected materials were found.

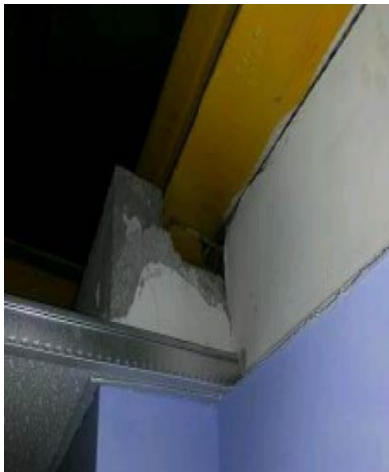
The ceiling void in the Staff Room (Room 41) was accessed and no suspected materials were found.

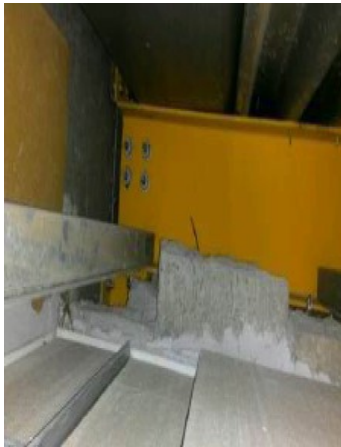
The unclad inspection point in the ceiling void to the Ladies WC (Room 44) was accessed and no suspected materials were found.

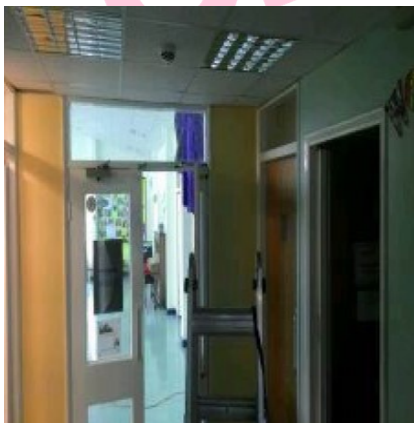
The corridor (Room 45) was accessed and no suspected materials were found.

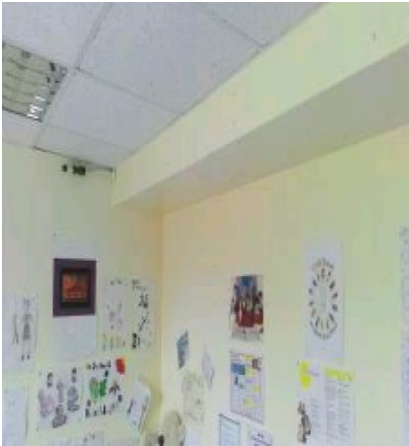
The wood boxing to the Head Teachers Office (Room 49) was accessed and no suspected materials were found.

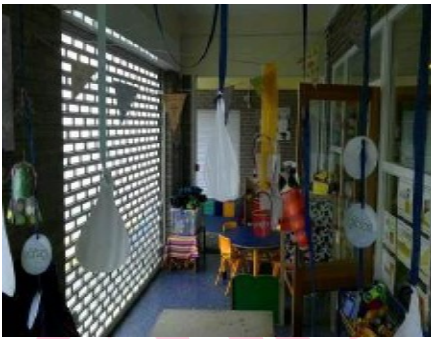
The external play area (Area 50) was accessed and no suspected materials were found.

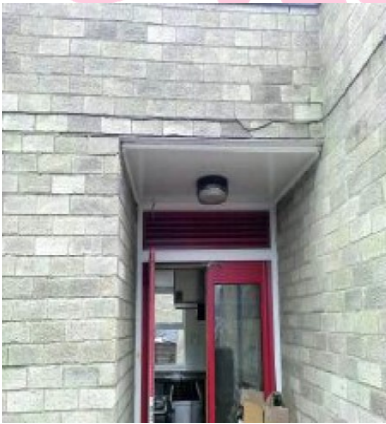
The external canopy above the kitchen door was accessed and no suspected materials were found.
