### **ASBESTOS SURVEY REPORT FOR SPRINGWELL DENE SCHOOL, SUNDERLAND**

## **Asbestos Register for SPRINGWELL DENE SCHOOL, SUNDERLAND**

**Date: 13 August 2025**

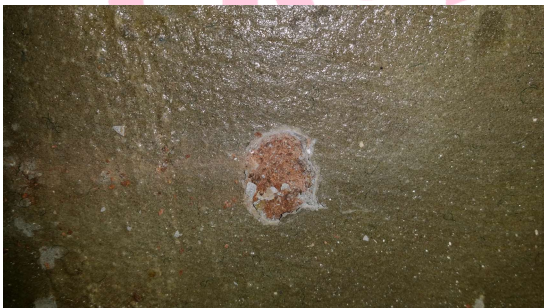
### **Item 3 Ref: As 291230-1**

Subfloor in 006/office does not contain asbestos.

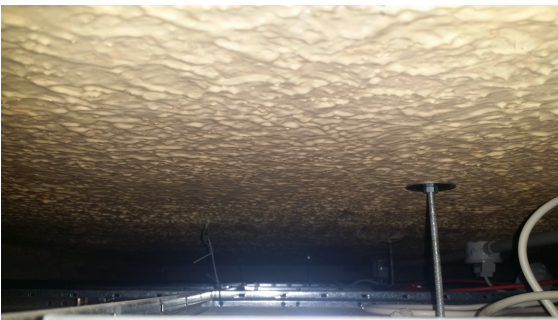
### **Item 5 Ref: 291230-2**

Textured coating to ceiling & wall tops in 008/lobby-void above does not contain

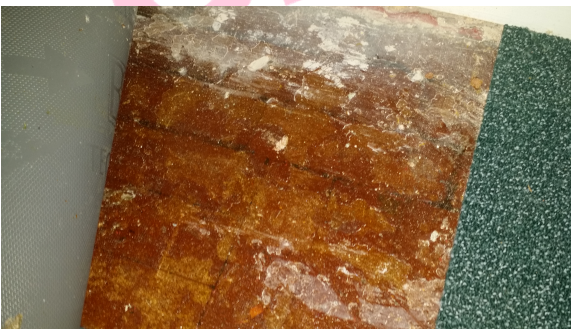
### **Item 6 Ref: As 291230-1**

Subfloor in 009/corridor does not contain asbestos.

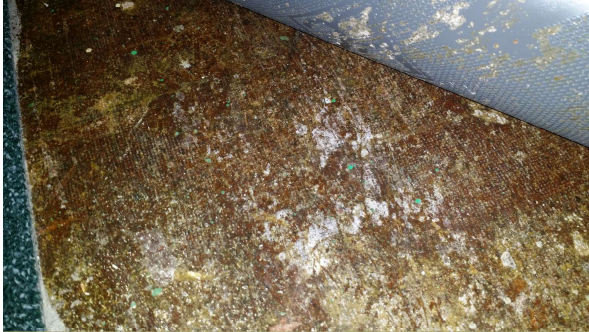
### **Item 7 Ref: As 291230-1**

Subfloor in 011/reception store does not contain asbestos.

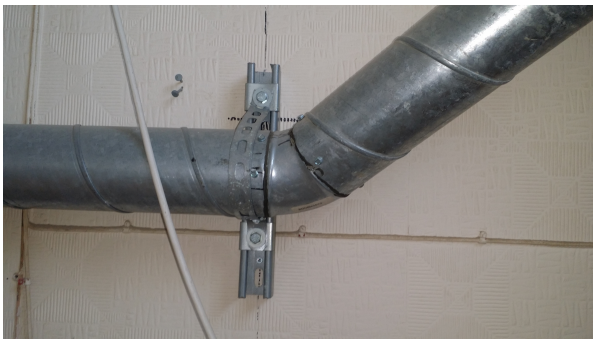
### **Item 8 Ref: 291230-5**

Sealant to ductwork in 012/parent room-void above does not contain asbestos.

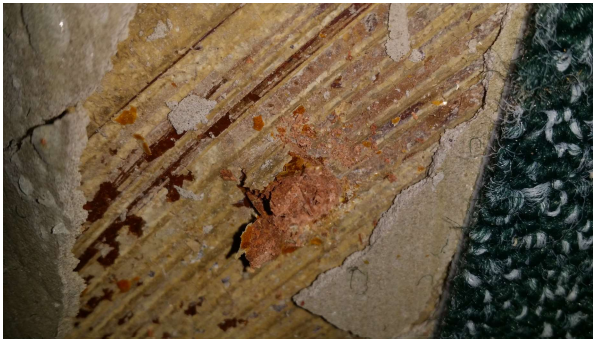
### **Item 9 Ref: 291230-3**

Subfloor in 013/quiet room does not contain asbestos.

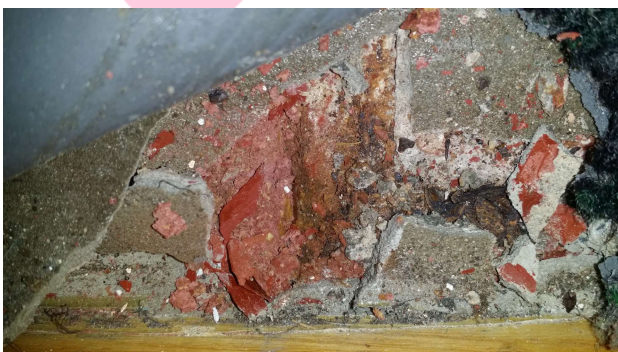
**Item 15 Ref: 291230-6**

Subfloor in 015/foyer does not  
contain asbestos.

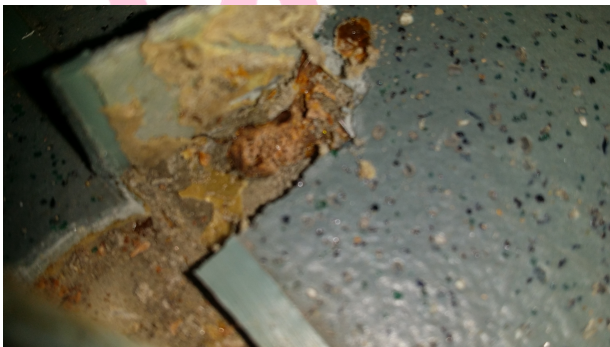
#### **Item 27 Ref: As 291230-7**

Subfloor in 019/kitchen office does not contain asbestos.

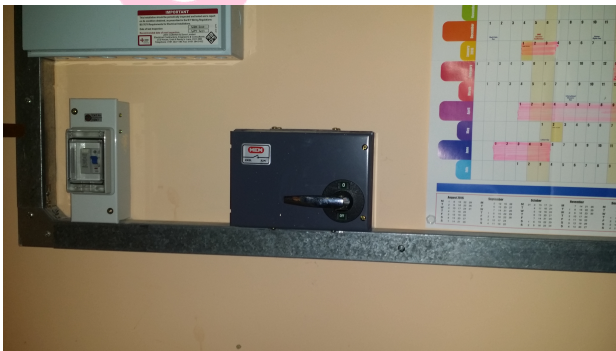
### **Item 45 Ref: Presumed**

Electrics MEM box in 023/store is presumed to contain asbestos.

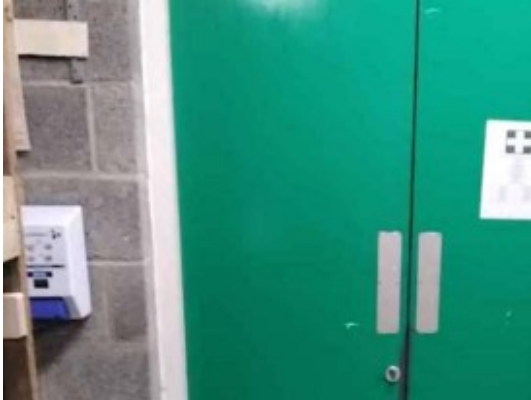
### **Item 103 - Ref: AW005906**

The door frame sealant (composite mastic) (External E/003 Workshop) does not contain asbestos.

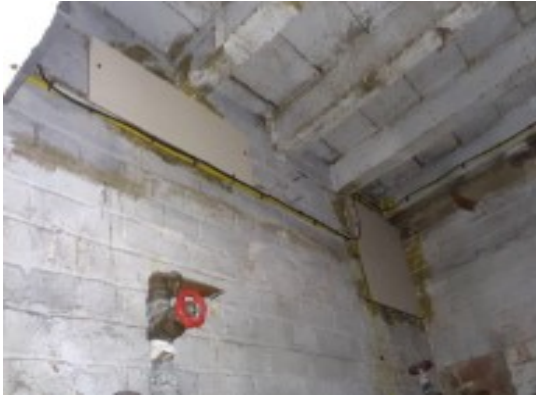
#### **Item 109 - Ref: PK002142**

The cement panels to wall penetrations in the Plant Room (Z1/01) do not contain asbestos.

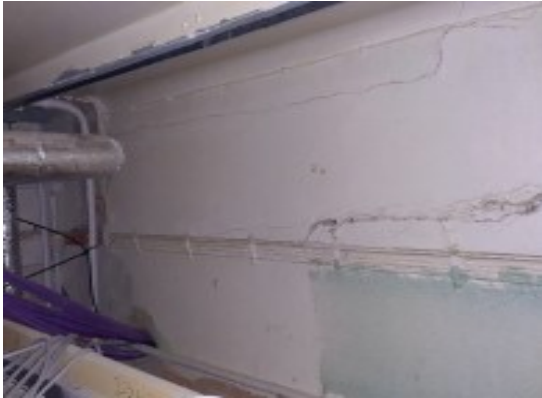
#### **Item 110 - Ref: PK002132**

The spray coating remnants to the wall in the Entrance Foyer (G/01) does not contain asbestos.

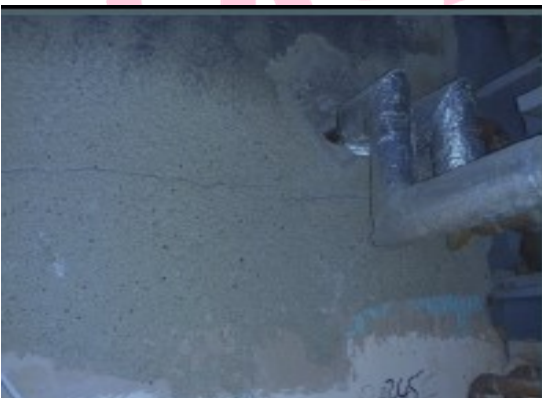
#### **Item 111 - Ref: As PK002134**

The spray coating remnants to the brick wall in the Corridor 8 Art (G/10) does not contain asbestos.

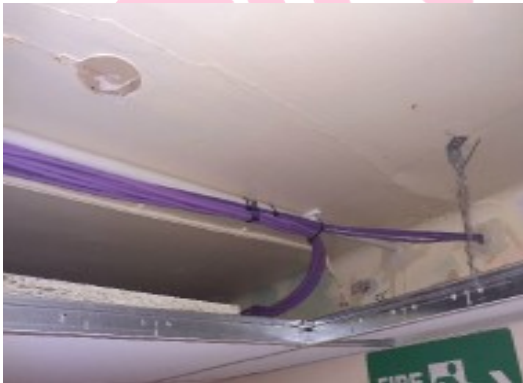
#### **Item 114 - Ref: As PK002132**

The spray coating remnants to the wall in the Corridor 3 (G/14) does not contain asbestos.

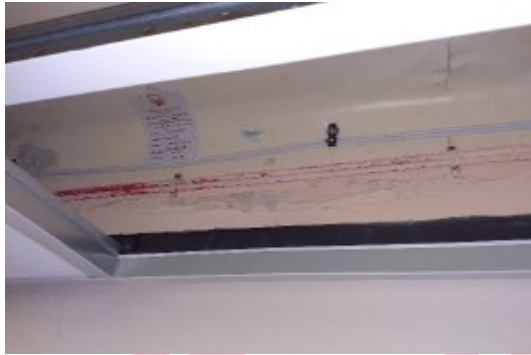
#### **Item 116 - Ref: PK002137**

The spray coating remnants to the wall in the Corridor 2 (G/17) does not contain asbestos.

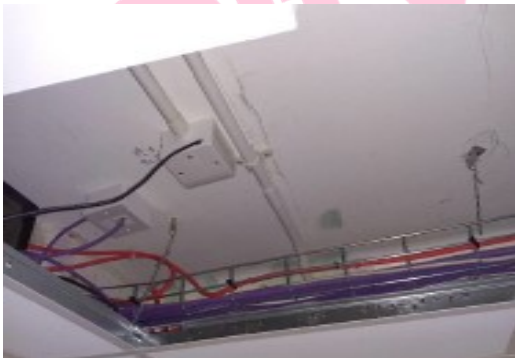
#### **Item 117 - Ref: As PK002132**

The spray coating remnants to the wall in the Corridor 10 (G/19) does not contain asbestos.

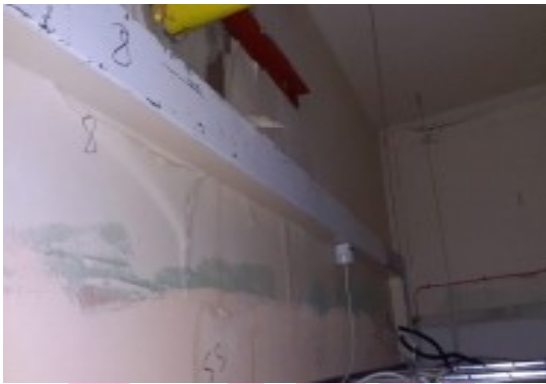
### **Item 119 - Ref: As PK002132**

The spray coating remnants to the wall in the Corridor to Hall Store 2 (G/20) does not contain asbestos.

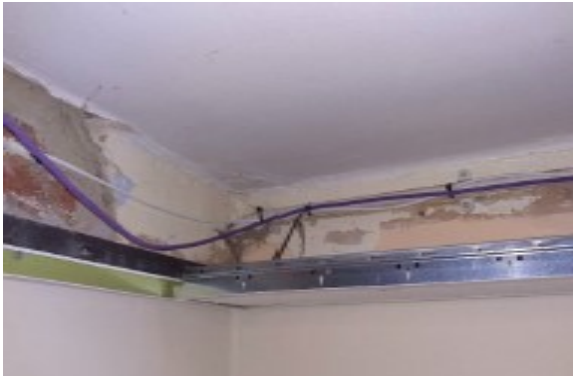
#### **Item 124 - Ref: PK002133**

The spray coating remnants to the walls in Lobby 3 (G/06) does not contain asbestos.

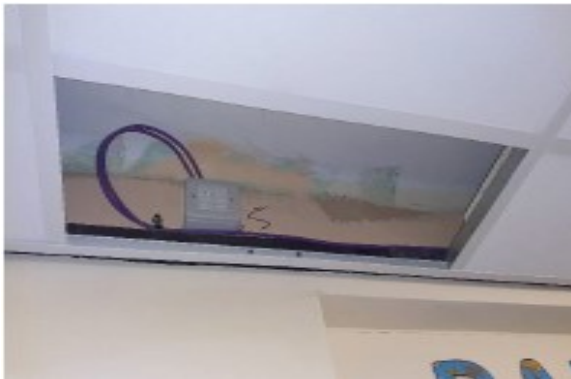
#### **Item 125 - Ref: As PK002132**

The spray coating remnants to the walls in Corridor 7 (G/07) does not contain asbestos.

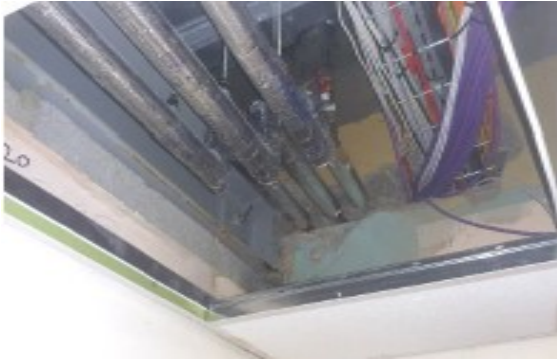
**Item 127 - Ref: PK002135**

The bitumen drip metal roof structure in Corridor 8 (G/08) does not contain asbestos.
