ASBESTOS SURVEY REPORT FOR EAST HERRINGTON ACADEMY, SUNDERLAND

EAST HERRINGTON ACADEMY, SUNDERLAND

Date: 09 September 2024

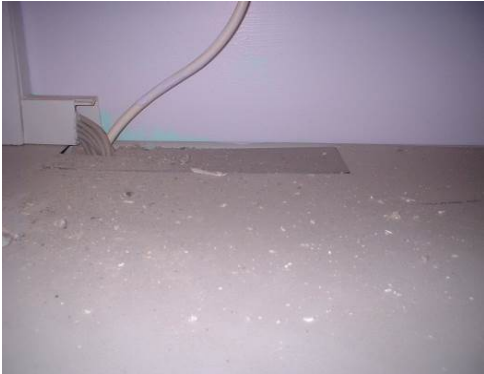
Item 1 Ref: Sample 01

The debris on the computer terminal in the library (Room 0/03) does not contain asbestos.

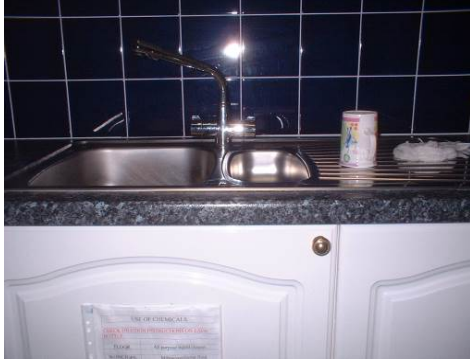
Item 4 - Ref: Sample 03

The sink pad in the after school kitchen (Room 0/06) does not contain asbestos.

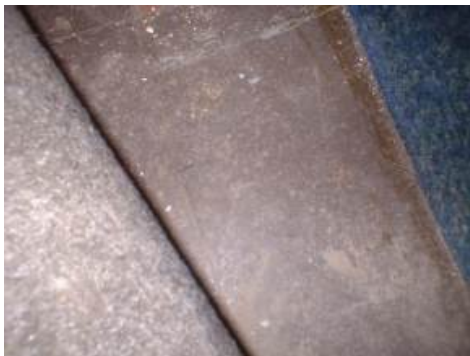
As Sample 02

The floor covering to the electrical intake cupboard (Room 0/07) contained asbestos.

Removed in October 2006

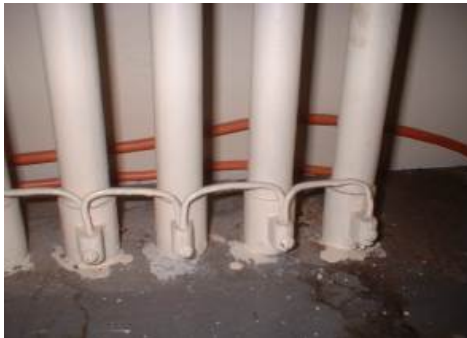
Sample 06

The debris to the electrical intake cupboard (Room 0/07) did not contain asbestos.

Removed in October 2006

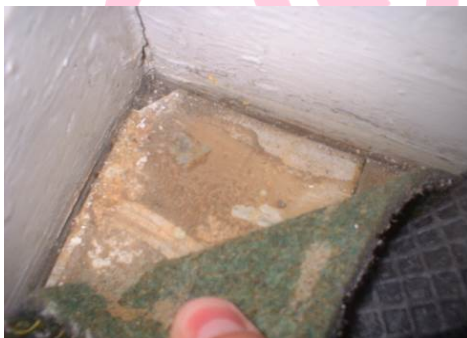
Item 5 - Ref: Sample 07

The vinyl flooring to the conservatory (Room 0/13) does not contain asbestos.

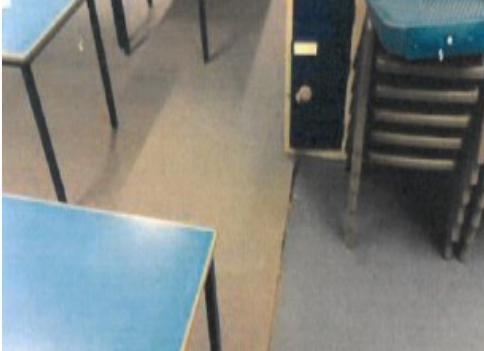
Item 6 - Ref: Sample 08 & AQ000123

The floor covering (vinyl tiles & adhesive below lino & carpet) (Room 0/11 Y2 classroom) contains asbestos.

Any change in its appearance should be recorded and passed to Property Services.

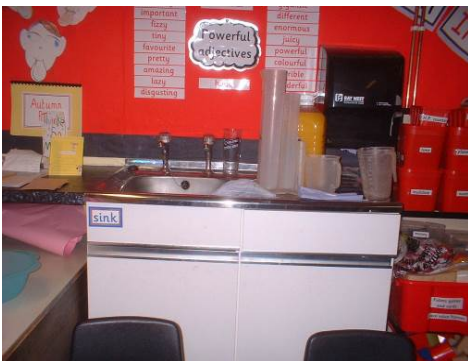
Item 8 - Ref: Sample 09

The sink pad in the infant school classroom (Room 0/14) does not contain asbestos.

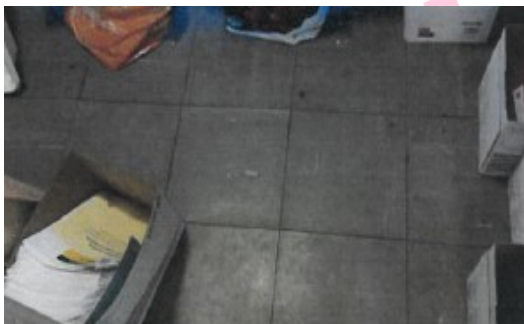
Item 10 – As Sample 10 & As AQ000124

The floor covering (vinyl tiles & adhesive) (Room 0/13 Y2 classroom stationary cupboard) contains asbestos.

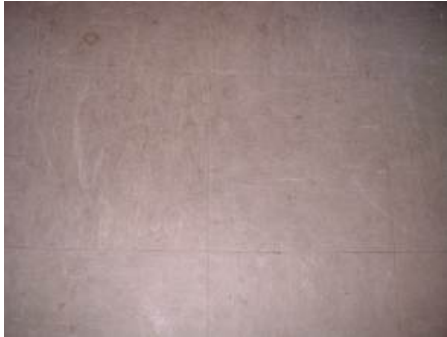
Item 21 - As Sample 18

The vinyl flooring in the infant classroom store (Room 0/32) does not contain asbestos.

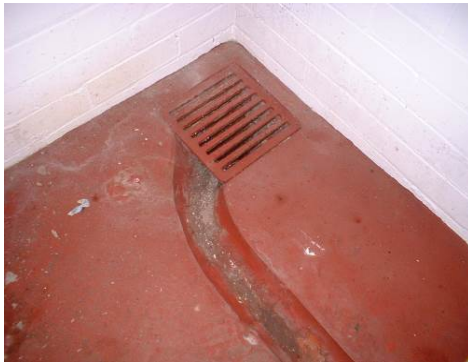
Item 22 - Ref: Sample 21

The debris to the floor in the infant school boiler house (Room 0/33) does not contain asbestos.

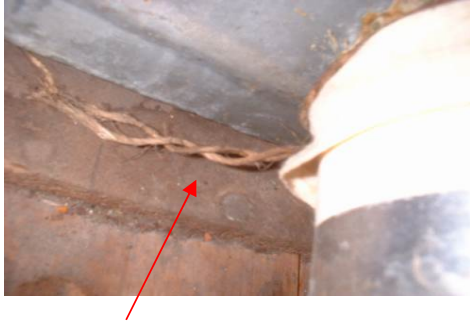
Item 27 - Ref: Sample 26

The redundant rope in the main hall ceiling void (Room 1/01) does not contain asbestos.

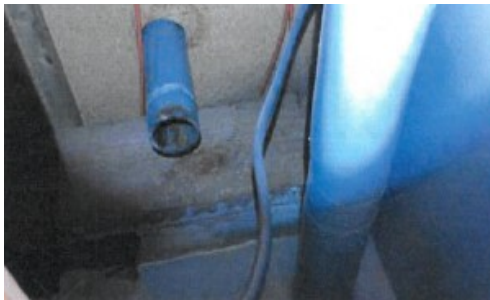
Item 28 - Ref: AQ000120

The disabled toilet ceiling void redundant flue (Room 0/06 cleaners cupboard & toilets) contains asbestos.

Any change in its appearance should be recorded and passed to Property Services.

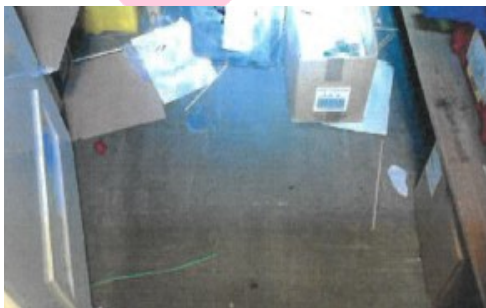
Item 29 - Ref: AQ000121

The floor covering (vinyl tiles & adhesive) (Room 0/07 store rooms) contains asbestos.

Any change in its appearance should be recorded and passed to Property Services.

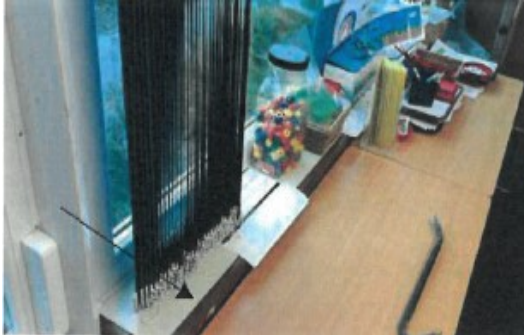
Item 30 - Ref: AQ000115

The window sill covering (composite material) (Room 0/01 Reception classroom) does not contain asbestos.

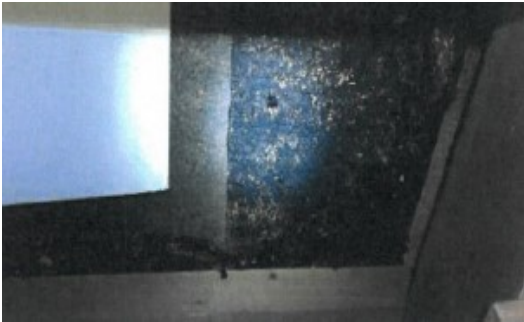
Item 31 - Ref: AQ000116

The ceiling void flat roof felt-bitumen (Room 0/02 Reception toilets & cloakroom) does not contain asbestos.

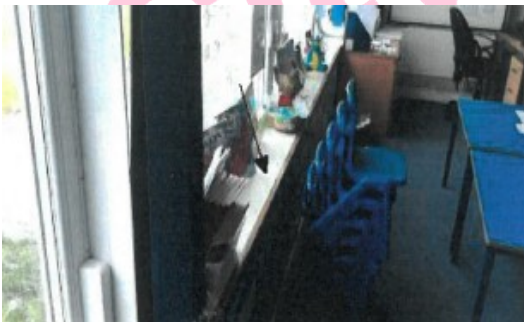
Item 32 - Ref: As AQ000115

The window sill covering (composite material) (Room 0/03 classroom) does not contain asbestos.

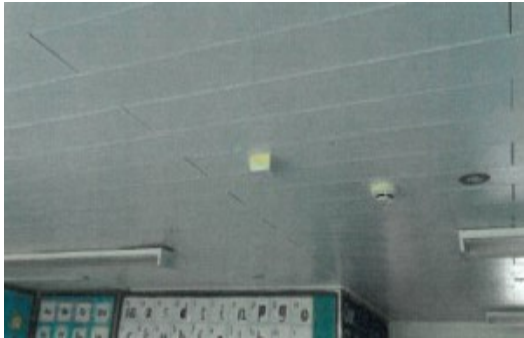
Item 33 - Ref: AQ000117

The Suspended ceiling tiles (Room 0/03 classroom) does not contain asbestos.

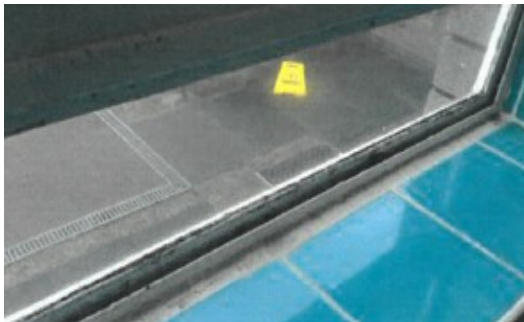
Item 34 - Ref: AQ000118

The Window putty (Room 0/04 Toilets & Cloakroom) does not contain asbestos.

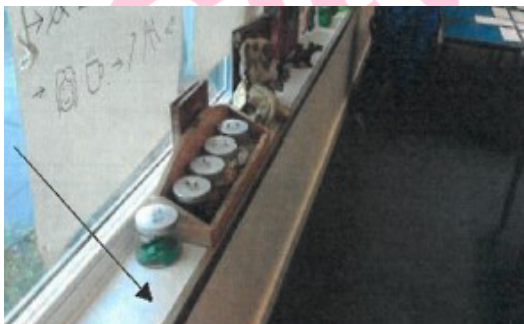
Item 35 - Ref: As AQ000115

The Window sill covering (composite material) (Room 0/05 classroom) does not contain asbestos.

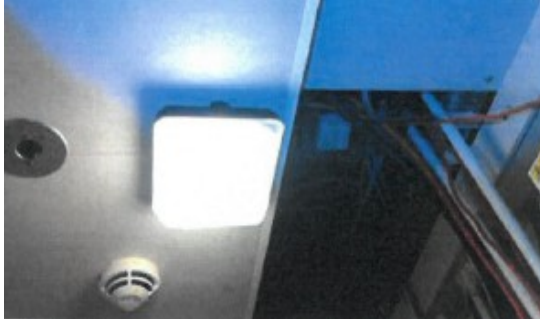
Item 36 - Ref: AQ000122

The Suspended Ceiling – Supalux (Room 0/09 electric cupboard) does not contain asbestos.

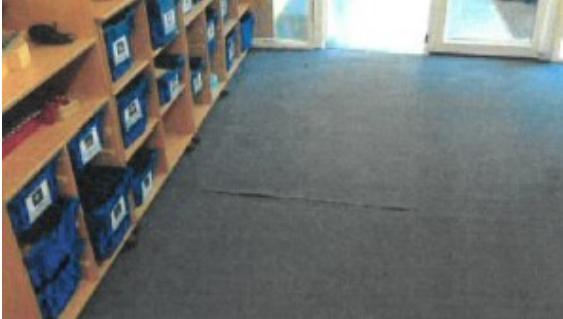
Item 39 - Ref: AQ000125

The Vinyl tile below carpet (Room 0/15 music room lobby) does not contain asbestos.

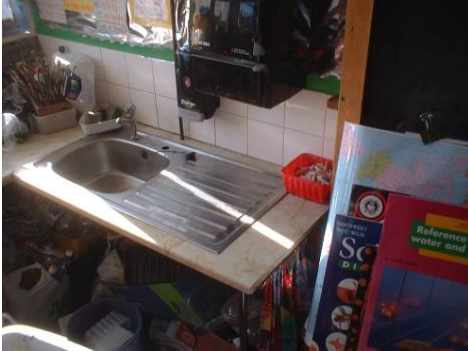
Item 1 - Ref: Sample 27

The sink pad in this primary school classroom (Room 0/34) does not contain asbestos.

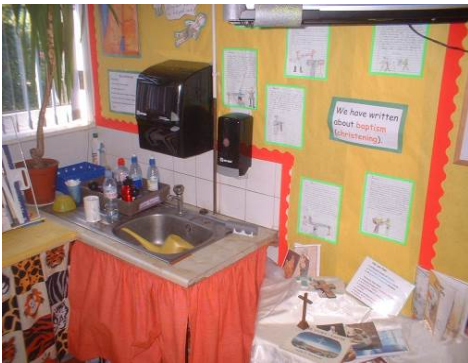
Item 2 – Ref: Sample 28

The sink pad in this primary school classroom (Room 0/35) does not contain asbestos.

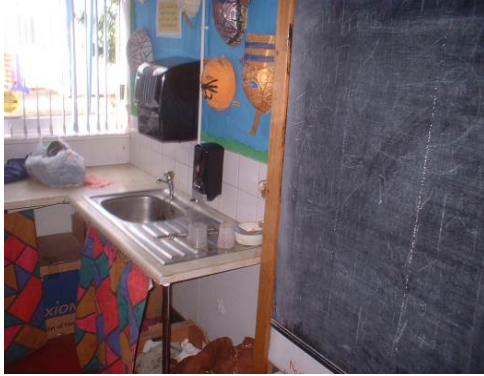
Item 4 - Ref: Sample 30

The sink pad in this primary school classroom (Room 0/36) does not contain asbestos.

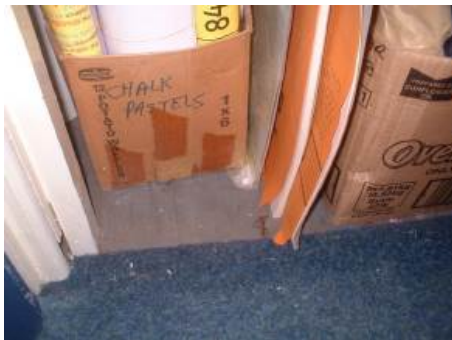
Item 5 - As Sample 29

The vinyl floor tiles in the primary school classroom store (Room 0/36) do not contain asbestos.

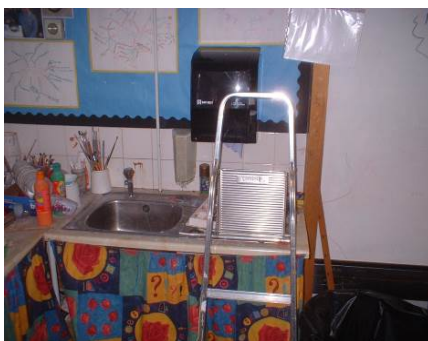
Item 6 - Ref: Sample 31

The sink pad in this primary school classroom (Room 0/37) does not contain asbestos.

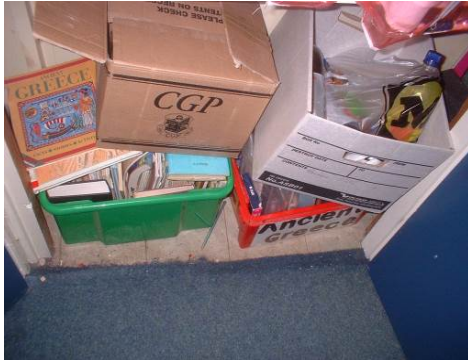
Item 7 - Ref: Sample 32

The vinyl flooring in this primary school classroom (Room 0/37) does not contain asbestos.

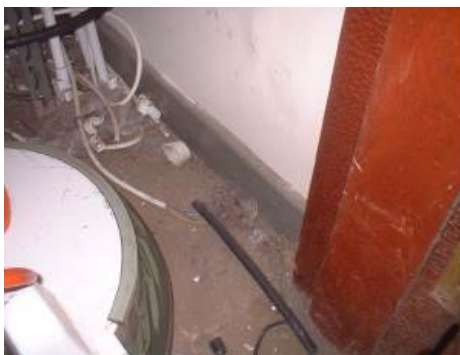
Ref: Sample 37

The debris to the floor in the electrical cupboard (Room 0/43) did not contain asbestos.

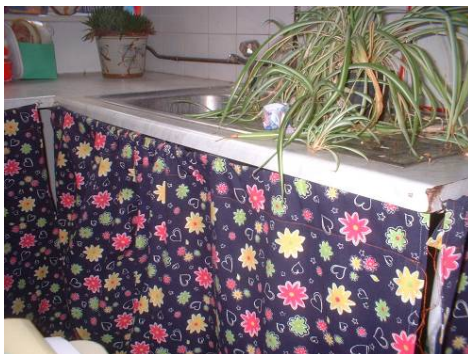
Item 16 - Ref: Sample 43

The sink pad in classroom 5 (Room 0/59) does not contain asbestos.

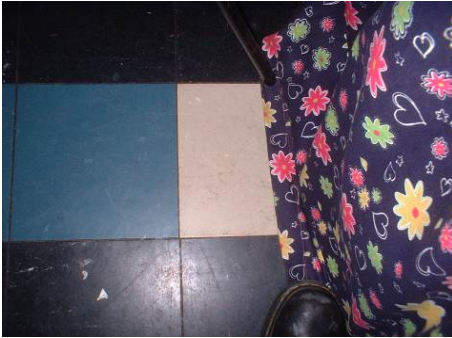
Item 17 - Ref: Sample 44

The vinyl flooring to classroom 5 (Room 0/59) does not contain asbestos.

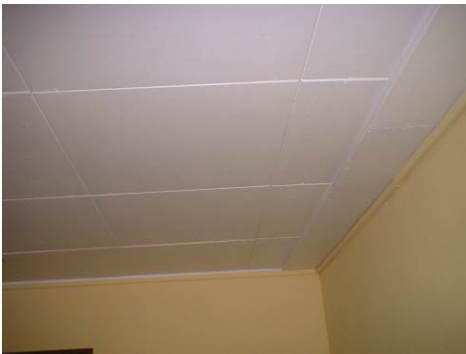
Item 18 - Ref: Sample 45

The ceiling in the staff room (Room 0/51) does not contain asbestos.

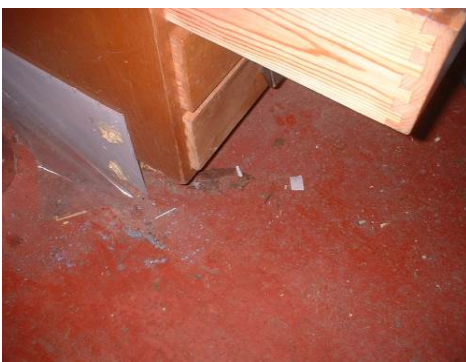
Item 19 - Ref: Sample 46

The debris to the floor in the primary school boiler room (Room 0/68) does not contain asbestos.

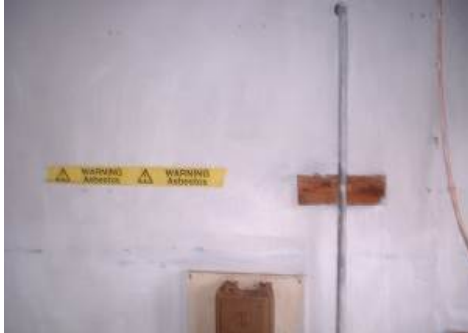
Ref: Sample 47

The wall lining boards to the boiler room in the annexe (Room 0/69) contained asbestos.

These have been removed.

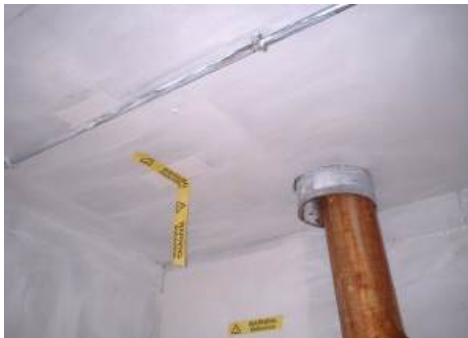
Ref: Sample 48

The ceiling boards to the boiler room in the annexe (Room 0/69) contained asbestos.

These have been removed.

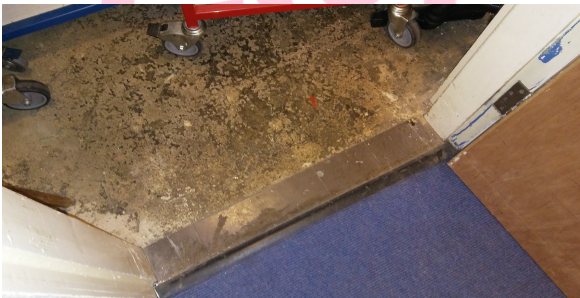
Item 32 - Ref: 182913-8

The bitumen adhesive to the floor in the electric cupboard (Rm 0/18) contains asbestos.

Any change in its appearance should be recorded and passed to Property Services.

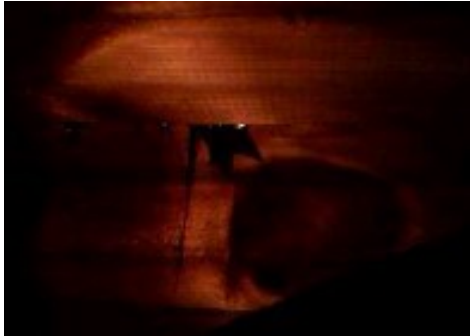
Item 36 Ref: CB000088

The bitumen from between wood roof in Store bottom of kitchen hatch does not contain asbestos.

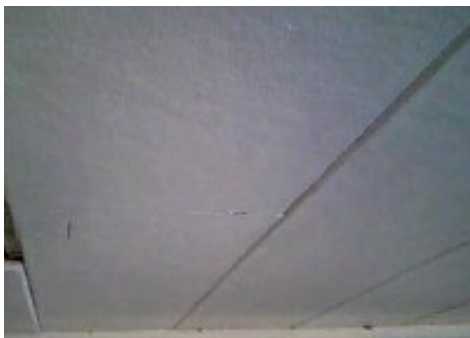
Item 38 Ref: As BB000951

The fibreglass ceiling in Practical Area does not contain asbestos.

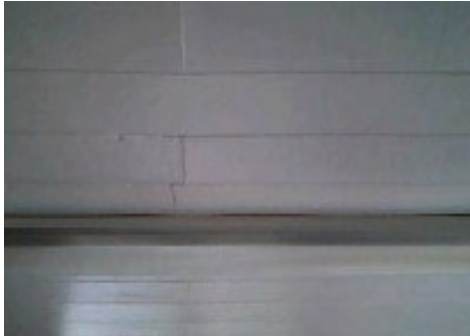
Item 39 Ref: As BB000951

The fibreboard ceiling in Reception Classroom does not contain asbestos.

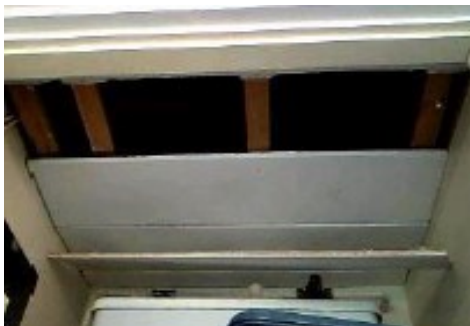
Item 40 Ref: As BB000951

The fibreboard ceiling in Reception Tank Cupboard does not contain asbestos.

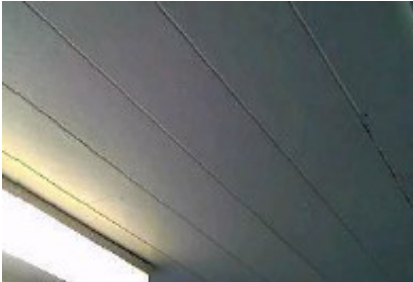
Item 43 Ref: As BB000951

The fibreboard ceiling in Year 1 Classroom Cupboard does not contain asbestos.

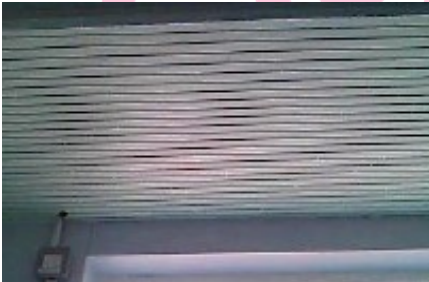
Item 44 Ref: As BB000951

The fibreboard ceiling in Boys Toilet does not contain asbestos.

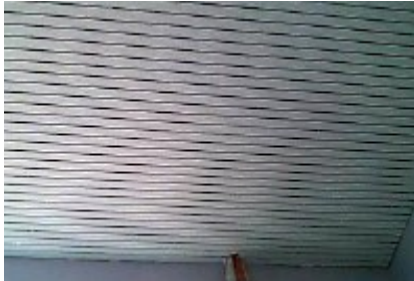
Item 45 Ref: As BB000951

The fibreglass ceiling in Girls Toilet does not contain asbestos.

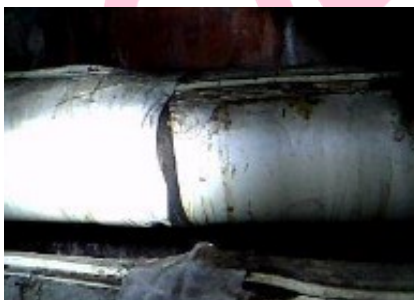
Item 47 Ref: BB000953

The black foam lagging to pipes in Water tank void does not contain asbestos.

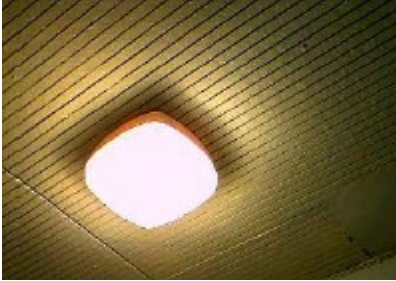
Item 48 Ref: As BB000951

The fibreglass ceiling in Corridor does not contain asbestos.

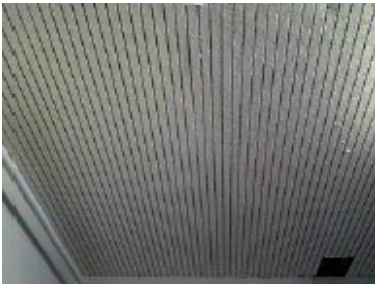
Item 49 Ref: As BB000951

The fibreglass ceiling in IT Suite does not contain asbestos.

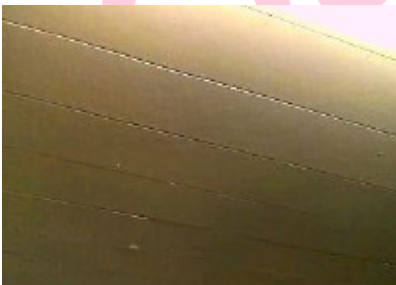
Item 50 Ref: As BB000951

The fibreglass ceiling in Year 2 Classroom does not contain asbestos.

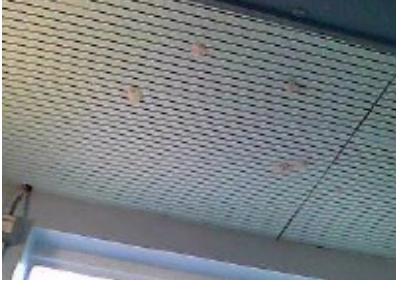
Item 51 Ref: As BB000951

The fibreboard ceiling in Toilet does not contain asbestos.

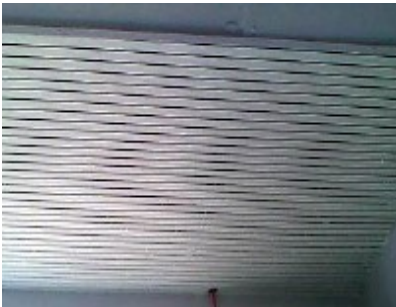
Item 52 Ref: As BB000951

The fibreboard ceiling in Toilet does not contain asbestos.

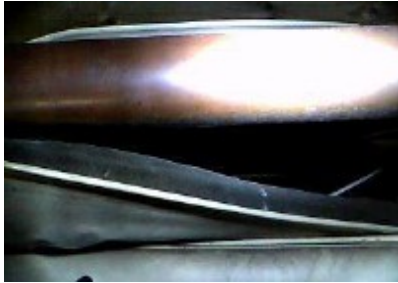
Item 54 Ref: As BB000953

The black foam lagging to pipes in Water Tank void 2 does not contain asbestos.

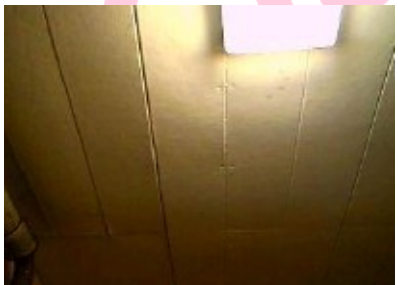
Item 56 Ref: As BB000951

The fibreboard ceiling in Year 2 Classroom 2 Store does not contain asbestos.

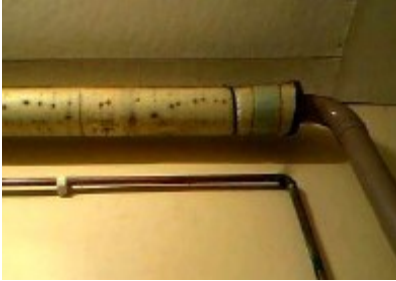
Item 57 Ref: As BB000953

The pipe lagging in Year 2 Classroom 2 Store does not contain asbestos.

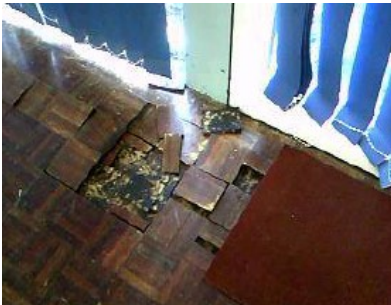
Item 58 Ref: AC001852

The parquet flooring and bitumen below in Key Stage 1 Hall does not contain asbestos.

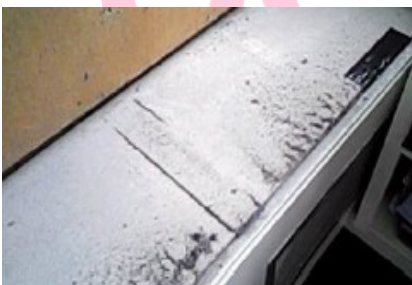
Item 59 Ref: EB000075

The insulation board to lining panels underside of heater cover in Print Room does not contain asbestos.

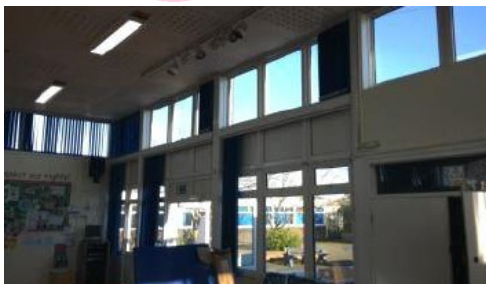
Item 62 Ref: AD000724

The column and beam cladding behind modern cappings in Main Hall contain asbestos.

Any change in its appearance should be recorded and passed to Property Services.

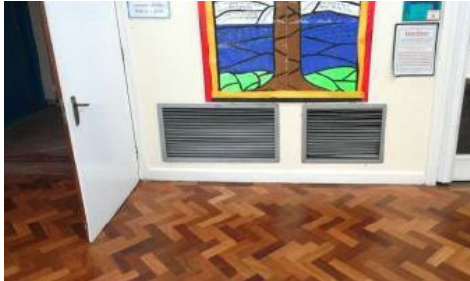
Item 63 Ref: AD000720

The wall heater internal ceiling soffit panels in Main Hall does not contain asbestos.

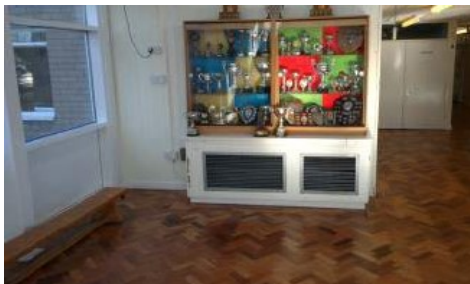
Item 64 Ref: As AD000720

The wall heater internal ceiling soffit panels in Main Hall beneath trophy display does not contain asbestos.

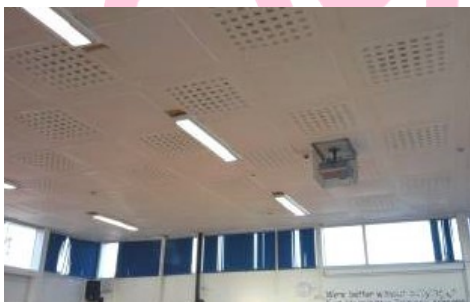
Item 65 Ref: AD000722

The ceiling tiles in Main Hall does not contain asbestos.

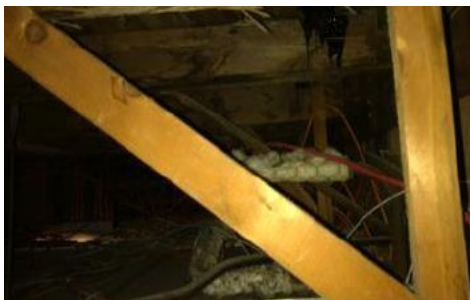
Item 67 Ref: AD000725

The ceiling void pipework insulation in PE Cupboard does not contain asbestos.

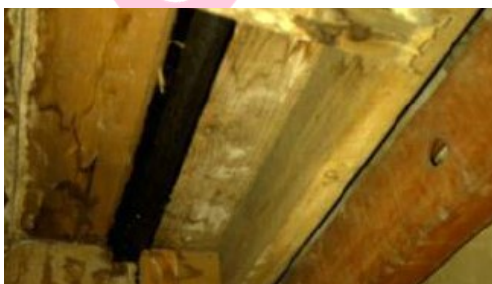
Item 68 Ref: AD000726

The ceiling void soffit felt wrap in PE Cupboard does not contain asbestos.

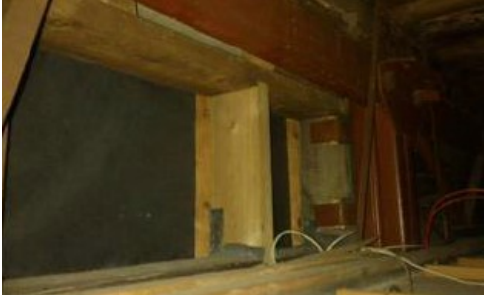
Item 69 Ref: AD000727

The wall covering behind cladding in PE Cupboard does not contain asbestos.

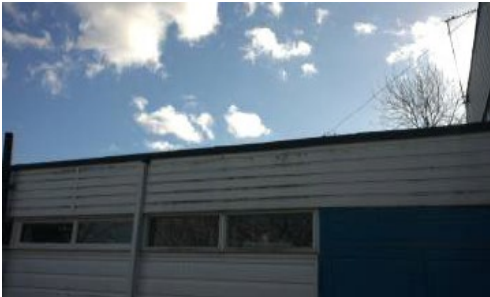
Item 70 Ref: AD000728

The flat roof coverings (External) does not contain asbestos.

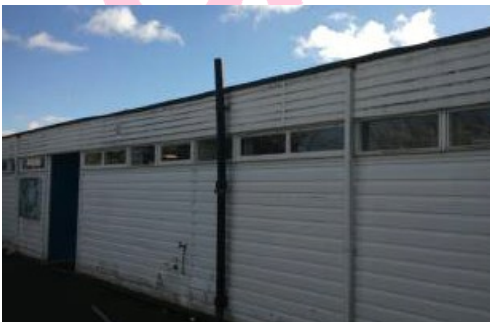
Item 71 Ref: AD000729

The window putty (External) does not contain asbestos.

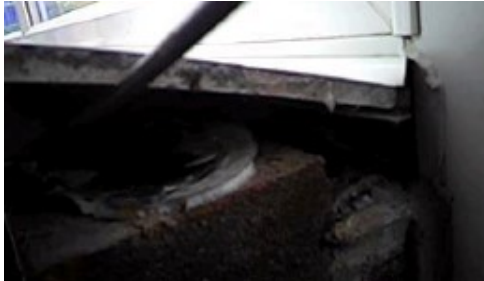
Item 72 Ref: EA000243

The low level conservatory wall cavity Insulation in Reception conservatory area does not contain asbestos.

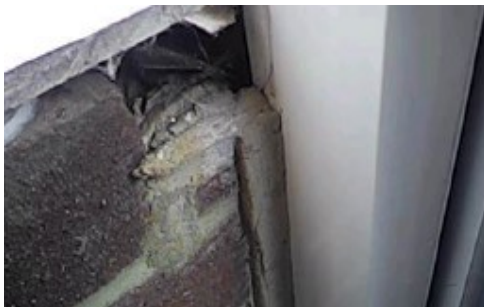
Item 73 Ref: EA000244

The damp proof course beneath window sills in Reception conservatory area does not contain asbestos.

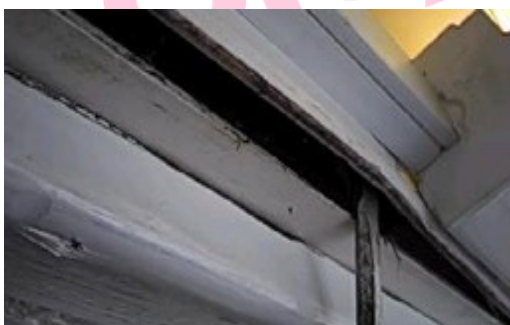
Item 74 Ref: EA000244

The damp proof course between class and conservatory wall in Reception conservatory area does not contain asbestos.

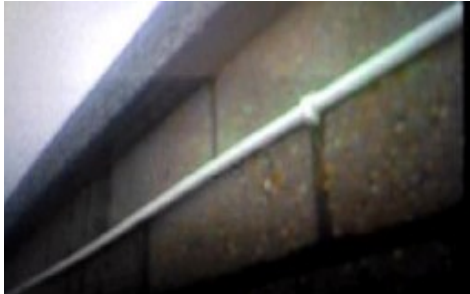
Item 75 Ref: EA000246

The bitumen felt to flat roof in Reception conservatory area does not contain asbestos.

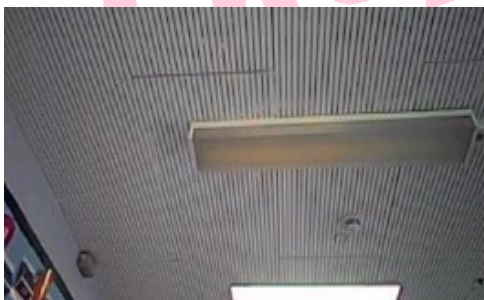
Item 77 Ref: EA000248

The suspended ceiling tiles in Year 1 Cloakroom does not contain asbestos.

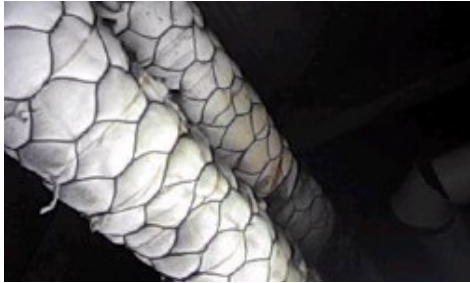
Item 81 Ref: EA000253

The lagging to pipework within ceiling void in Corridor adj Kitchen does not contain asbestos.

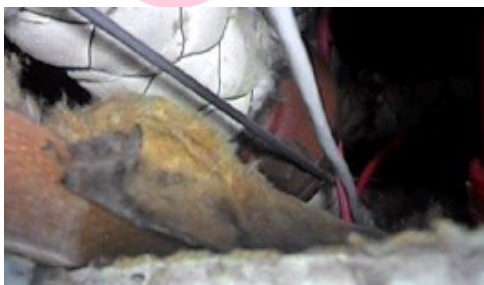
Item 83 Ref: EA000254

The tar paper to mmmf firebreak blankets in Corridor adj Kitchen does not contain asbestos.

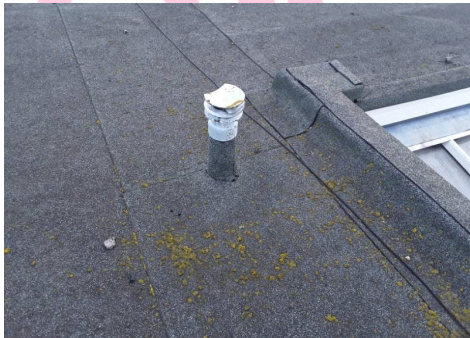
Item 98 Ref: PE001548

The cement flue (External/Roof 7) contains asbestos.

Removed April 2022 – waiting WCN

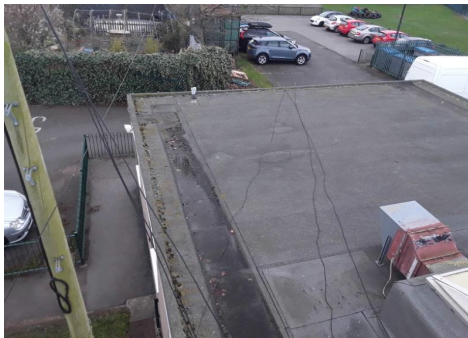
Item 103 Ref: As PE001548

The cement flue (External/Roof 5) contains asbestos.

Removed April 2022 – waiting WCN

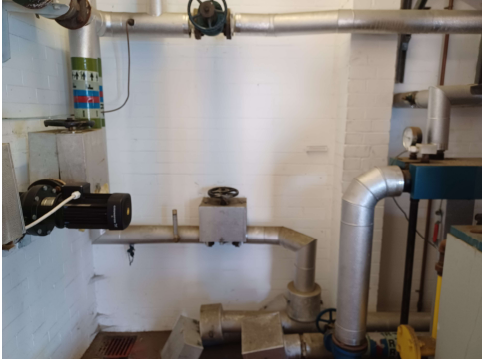
Item 108 Ref: 581161-1

The debris to walls behind boilers (Rm 0/26 KS1 Boiler Room) contains asbestos.

Removed January 2024.

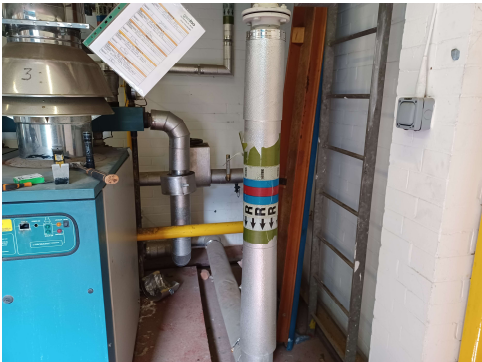
Item 109 Ref: 581161-2

The debris to wall RHS of boilers (Rm 0/26 KS1 Boiler Room) contains asbestos.

Removed January 2024.

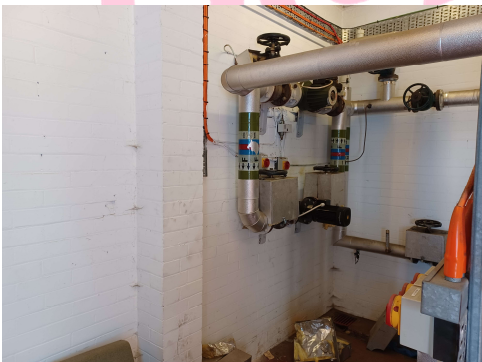
Item 110 Ref: 581161-3

The debris to wall LHS of boilers (Rm 0/26 KS1 Boiler Room) contains asbestos.

Removed January 2024.

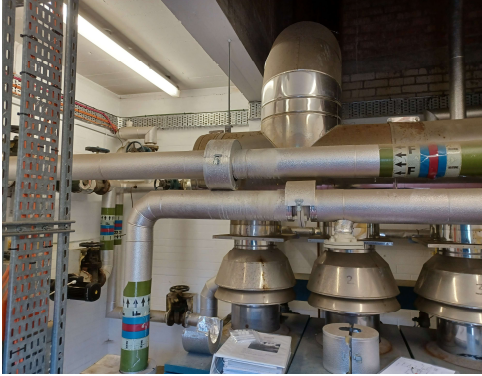
Item 111 Ref: Presumed

The debris to pipework below armer cladding (Rm 0/26 KS1 Boiler Room) is presumed to contain asbestos.

Removed January 2024.

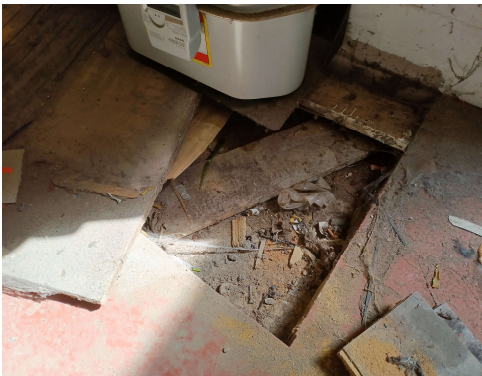
Item 112 Ref: 581161-6

The debris within gas box sump (Rm 0/26 KS1 Boiler Room) does not contain asbestos.

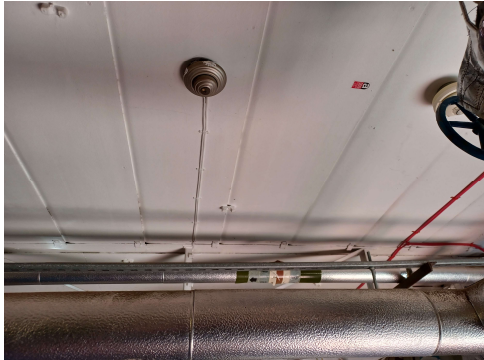
Item 114 Ref: 581161-10

The underside of roof (Rm 0/27 Boiler Room adj Kitchen) contains asbestos.

Removed October 2023.

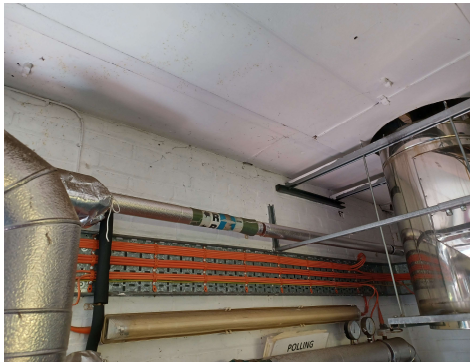
Item 115 Ref: 581161-11

The flat ceiling panels (Rm 0/27 Boiler Room adj Kitchen) contains asbestos.

Removed October 2023.

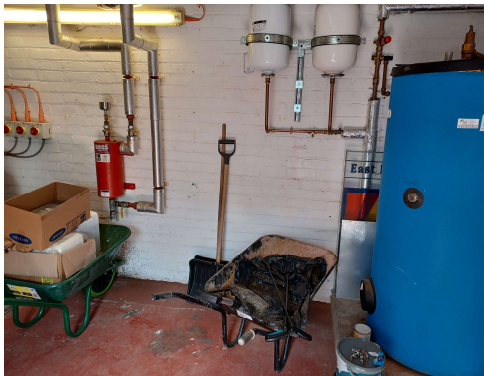
Item 118 Ref: 581161-13

The debris to wall opposite entrance wall (Rm 0/27 Boiler Room adj Kitchen) contains asbestos.

Removed October 2023.

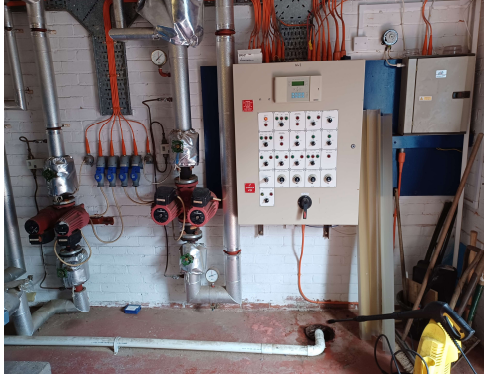
Item 120 Ref: 581161-15

The debris to electric wall (Rm 0/27 Boiler Room adj Kitchen) contains asbestos.

Removed October 2023.

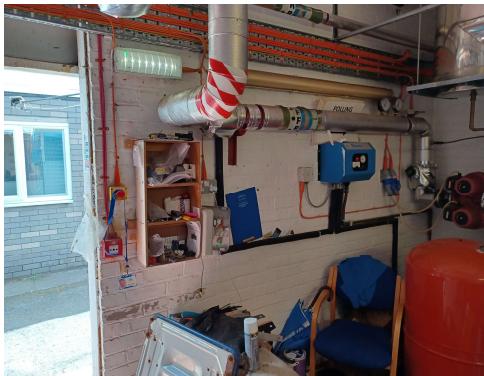
Item 121 Ref: 581161-16

The debris to entrance wall (Rm 0/27 Boiler Room adj Kitchen) contains asbestos.

Removed October 2023.

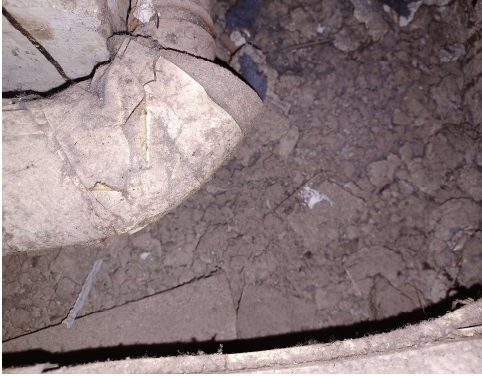
Item 126 Ref: 581161-8

The debris to floor (Rm 0/29 Assembly Hall – pipework trench below) contains asbestos.

Any change in its appearance should be recorded and passed to Property Services.

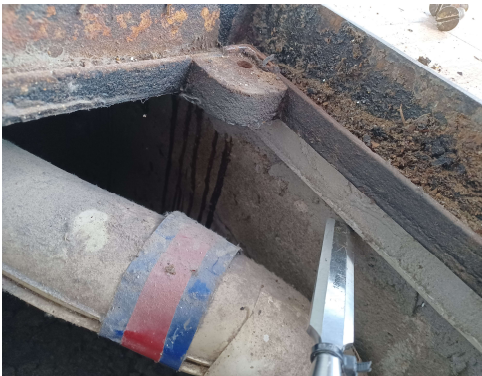
Item 127 Ref: 581161-9

The shuttering to floor slabs running below heaters (Rm 0/29 Assembly Hall – pipework trench below) contains asbestos.

Any change in its appearance should be recorded and passed to Property Services.

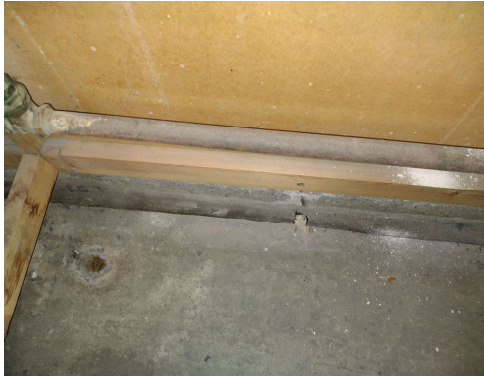
Item 132 Ref: 581161-19

The damp proof course (Rm 0/36 Classroom) contains asbestos.

Any change in its appearance should be recorded and passed to Property Services.

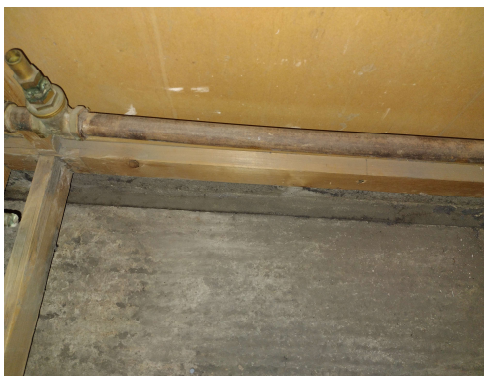
Item 134 Ref: As 581161-19

The damp proof course (Rm 0/37 Classroom) contains asbestos.

Any change in its appearance should be recorded and passed to Property Services.

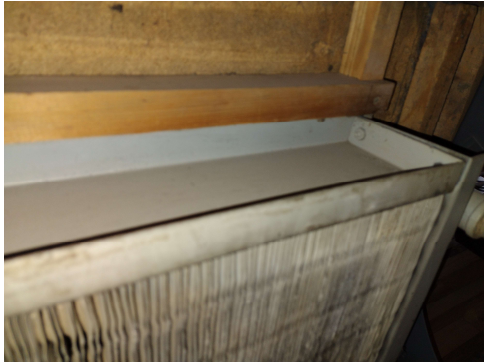
Item 135 Ref: As 581161-20

The sealant surrounding convector (Rm 0/37 Classroom) contains asbestos.

Any change in its appearance should be recorded and passed to Property Services.

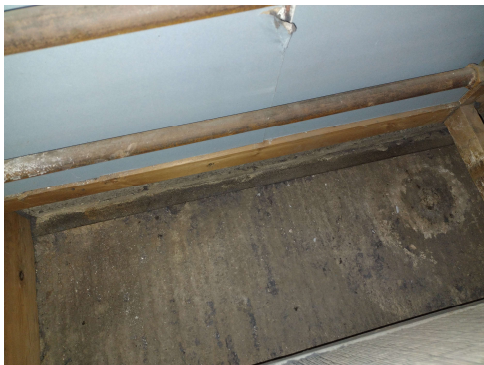
Item 136 Ref: As 581161-19

The damp proof course (Rm 0/38 Classroom) contains asbestos.

Any change in its appearance should be recorded and passed to Property Services.

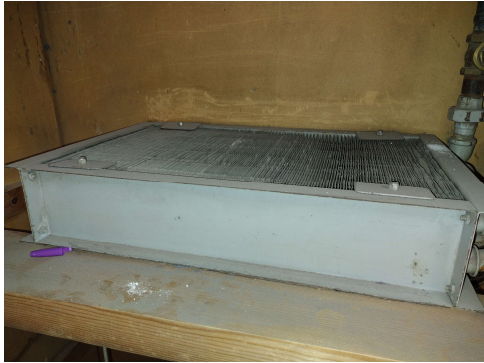
Item 138 Ref: As 581161-20

The sealant surrounding convector (Rm 0/39 Corridor) contains asbestos.

Any change in its appearance should be recorded and passed to Property Services.

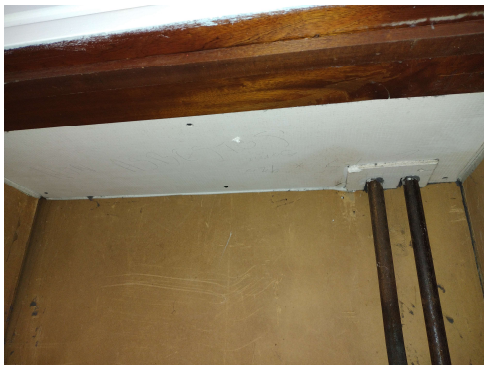
Item 139 Ref: 581161-21

The ceiling & service penetration infill (Rm 0/39 Corridor) does not contain asbestos.

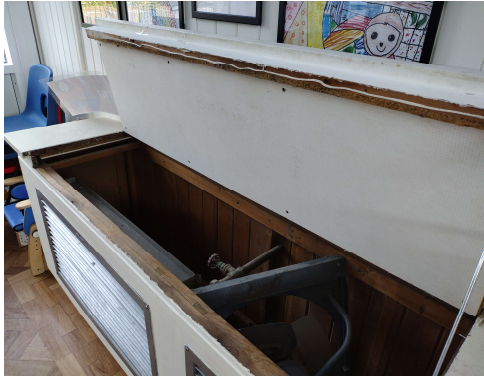
Item 141 Ref: As 581161-21

The cabinet soffit lining (Rm 0/40 Dining Hall) does not contain asbestos.

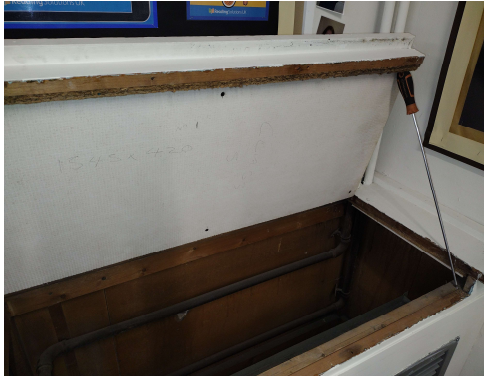
Item 144 Ref: As 581161-21

The cabinet soffit lining (Rm 0/42 Classroom) does not contain asbestos.

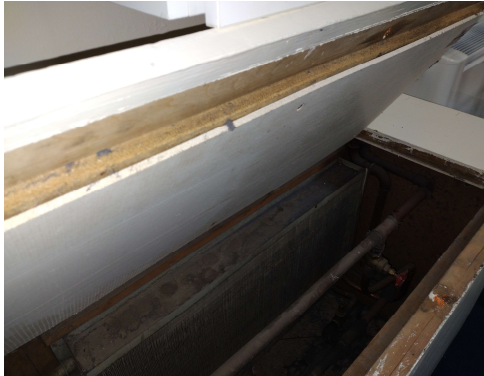
Item 147 Ref: As 581161-21

The cabinet soffit lining (Rm 0/43 Classroom) does not contain asbestos.
