ASBESTOS SURVEY REPORT FOR FULWEL JUNIOR SCHOOL, SEA ROAD, SUNDERLAND, SR6 9EE.

Asbestos Register for

Fulwell Junior School, Sea Road, Sunderland, SR6 9EE

Date: 30 May 2025

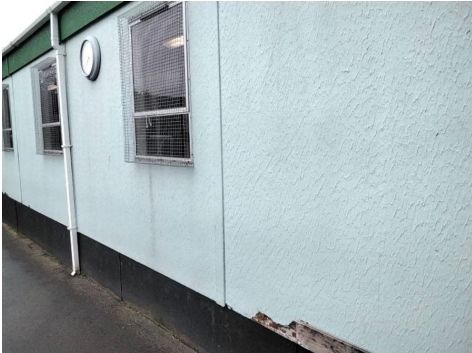
Item 58 Ref: CF006519

The wall coating
(External/E001) does not
contain asbestos.

Demolished in refurb 2024

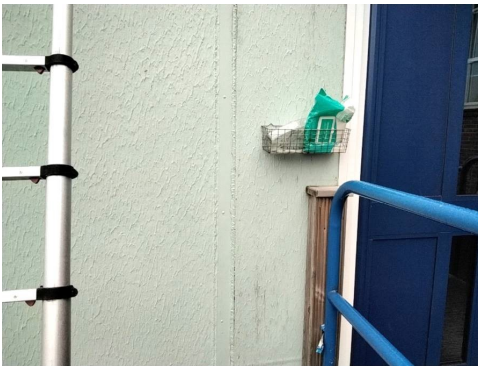
Item 59 Ref: CF006520

The wall panel
(External/E001) does not
contain asbestos.

Demolished in refurb 2024

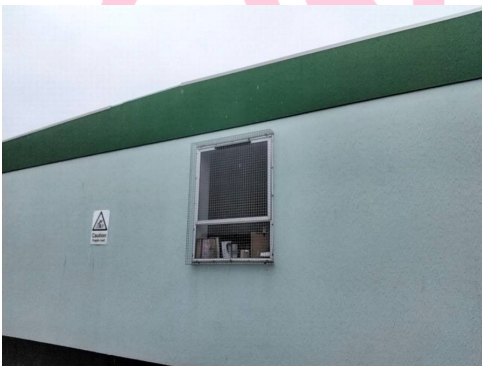
Item 60 Ref: CF006526

The window putty
(External/E001) does not
contain asbestos.

Demolished in refurb 2024

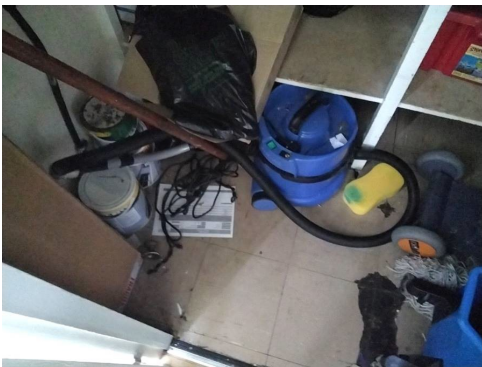
Item 62 Ref: CF006521

The floor tiles (Electrical Cupboard/G009) do not contain asbestos.

Demolished in refurb 2024

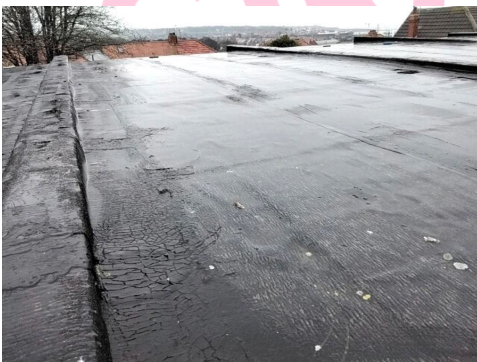
Item 63 Ref: CF006525

The roof felt below modern plastic covering (External/E002) does not contain asbestos.

Demolished in refurb 2024

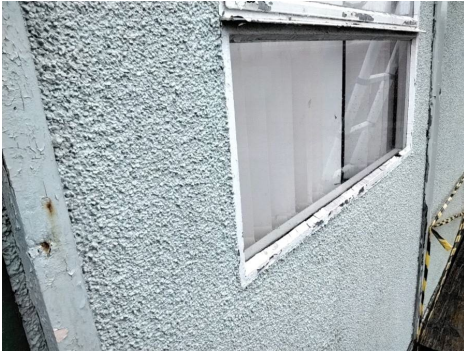
Item 67 Ref: CF006526

The window putty
(External/E002) does not
contain asbestos.

Demolished in refurb 2024

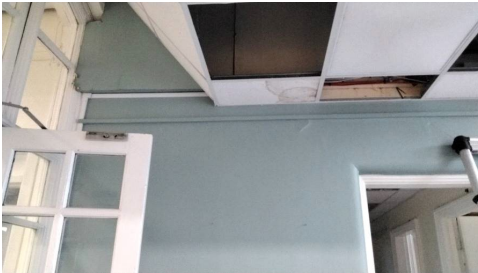
Item 68 Ref: NO000600

The Wall coating fire flex paint
(Reception/Entrance Hall
G/001) does not contain
asbestos.

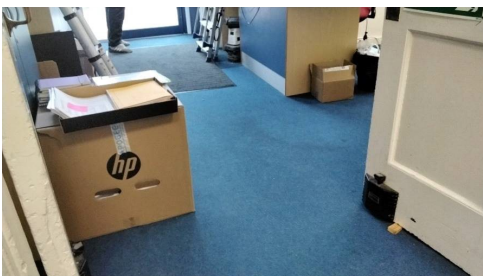
Item 69 Ref: NO000601

The Floor (Reception/
Entrance Hall G/001) does not
contain asbestos.

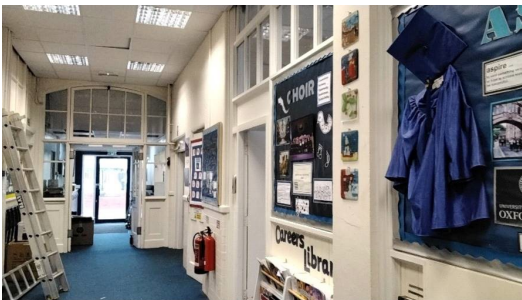
Item 71 Ref: As NO000600

The Wall coating fire flex paint (Corridor G/003) does not contain asbestos.

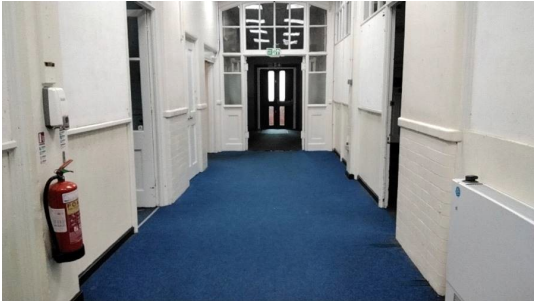
Item 73 Ref: As NO000600

The Wall coating fire flex paint (Corridor G/010) does not contain asbestos.

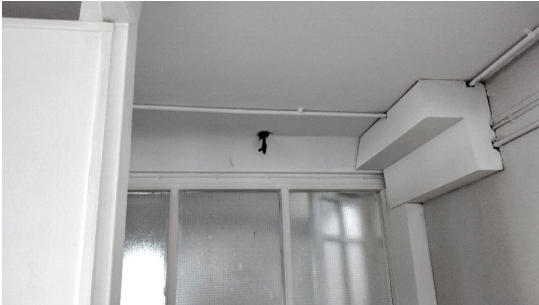
Item 76 Ref: NO000605

The Debris/Residue in pipe penetration (Female Toilets G/020) does not contain asbestos.

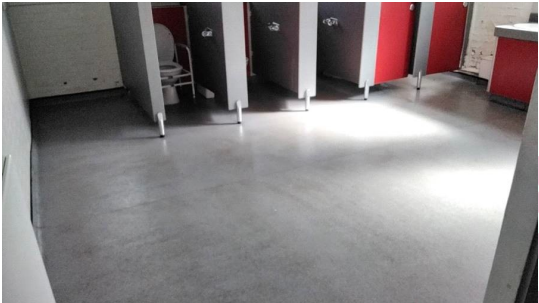
Item 77 Ref: As NO000601

The Floor adhesive remnants (Female Toilets G/020) do not contain asbestos.

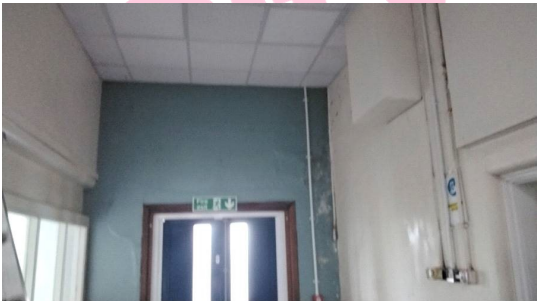
Item 78 Ref: As NO000600

The Wall coating fire flex paint (Entrance Hall/Foyer/Lobby G/021) does not contain asbestos.

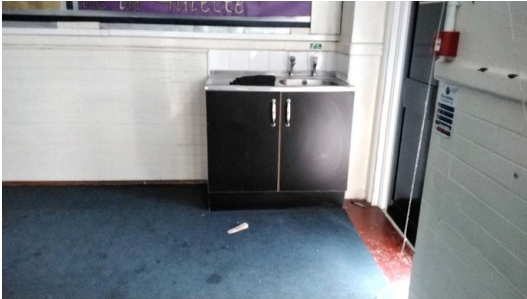
Item 82 Ref: NO000597

The Pipework to sink waste pipe (Classroom G/026) does not contain asbestos.

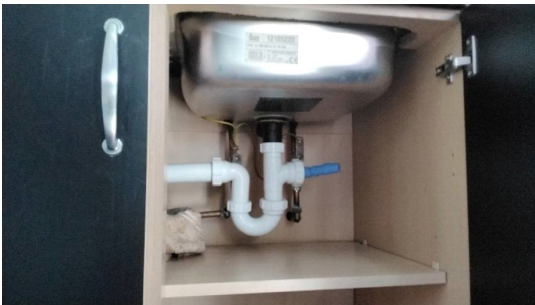
Item 83 Ref: NO000598

The Under sink mat (Classroom G/026) does not contain asbestos.

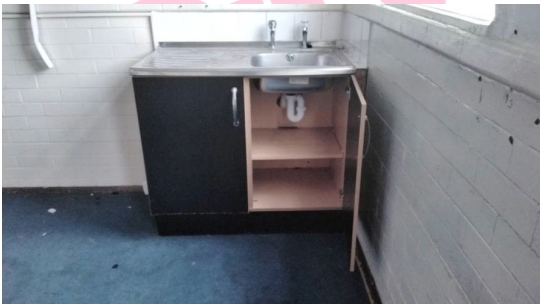
Item 84 Ref: As NO000597

The Pipework to sink waste pipe (Classroom G/027) does not contain asbestos.

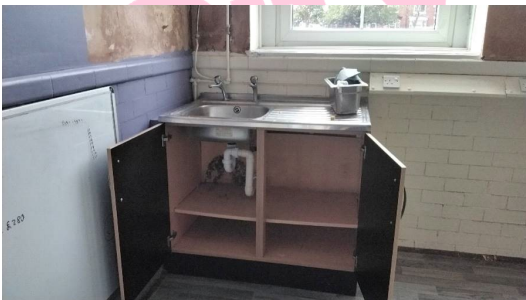
Item 87 Ref: As NO000598

The Under sink mat
(Classroom G/028) does not
contain asbestos.

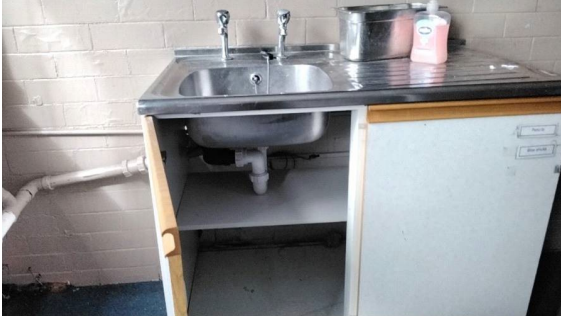
Item 88 Ref: As NO000598

The Under sink mat
(Classroom G/029) does not
contain asbestos.

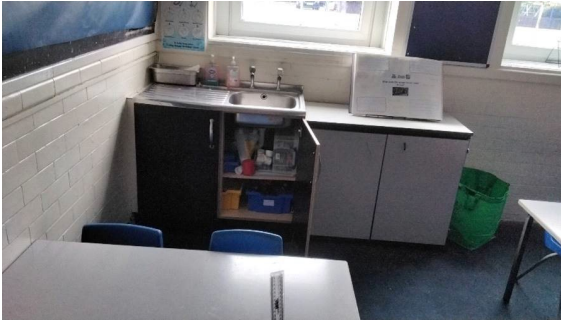
Item 89 Ref: As NO000597

The Pipework to sink waste
pipe (Classroom G/030) does
not contain asbestos.

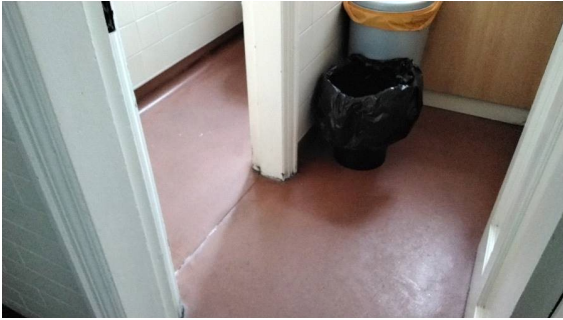
Item 91 Ref: As NO000601

The Floor beneath lino (Toilets G/033) does not contain asbestos.

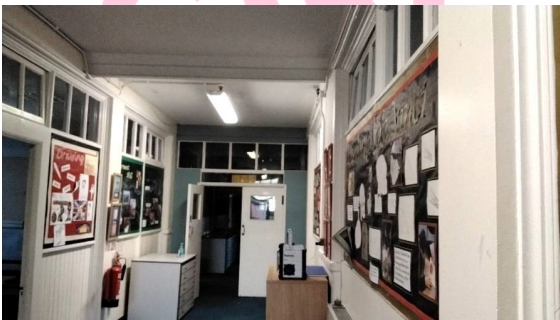
Item 96 Ref: As NO000596

The Wall coating (Corridor 1/002) does not contain asbestos.

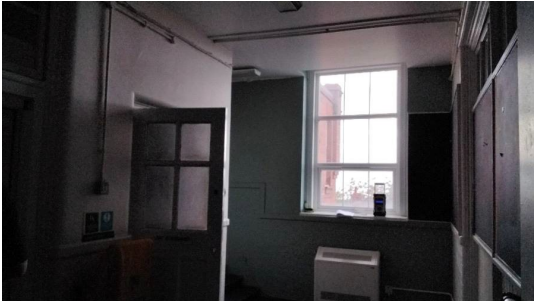
Item 97 Ref: As NO000596

The Wall coating (Corridor 1/007) does not contain asbestos.

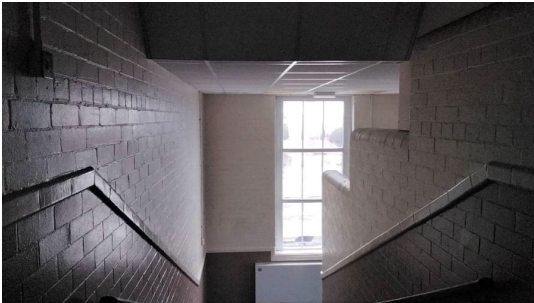
Item 98 Ref: As NO000596

The Wall coating (Landing 1/009) does not contain asbestos.

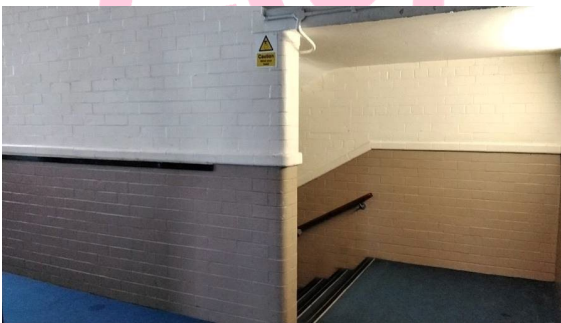
Item 108 Ref: As NO000600

The Wall coating fire flex paint (Landing MZ/001) does not contain asbestos.

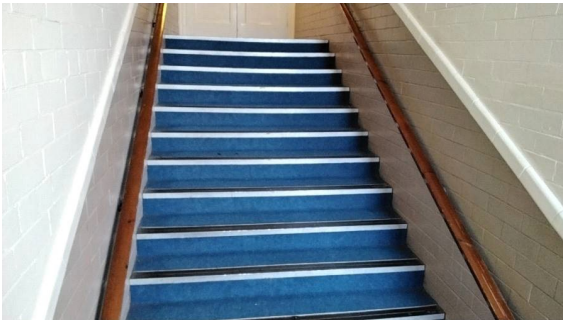
Item 110 Ref: As NO000603

The Floor nosing to stairs (Landing MZ/001) does not contain asbestos.

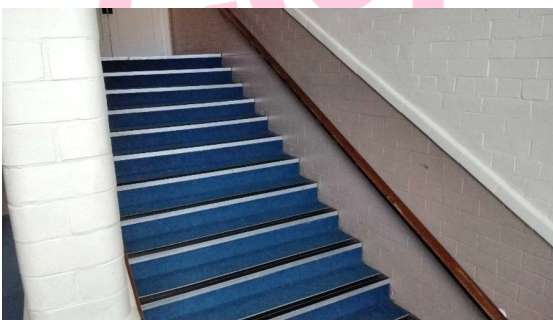
Item 114 Ref: As NO000603

The Floor nosing to stairs (Landing MZ/003) does not contain asbestos.

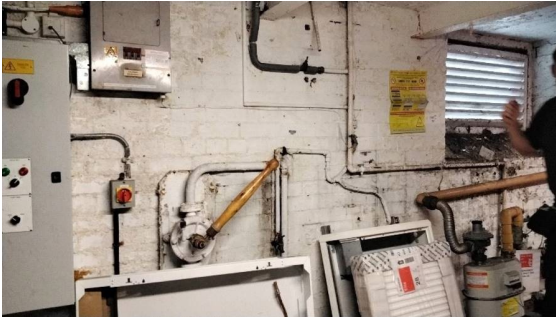
Item 115 Ref: NO000592

The Debris/Residue to wall at pipe penetration area (Boiler Room Z1/001) does not contain asbestos.

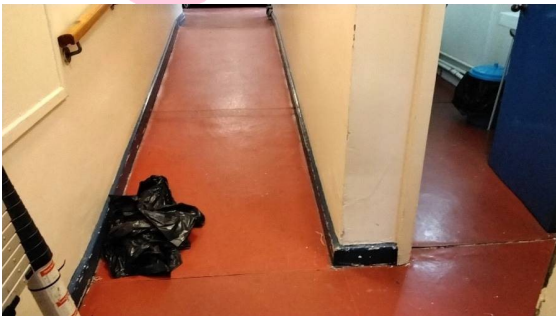
Item 117 Ref: NO000582

The Floor covering adhesive residue (Entrance Hall/Foyer/Lobby G/001) contains asbestos.

Any change in its appearance should be recorded and passed to Property Services.

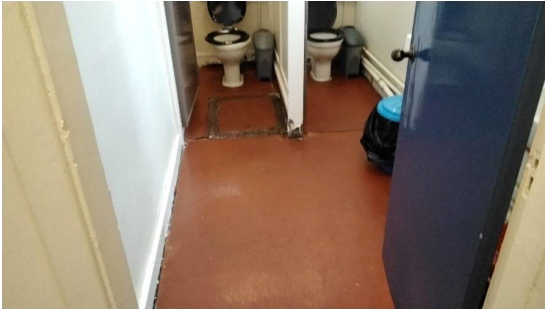
Item 118 Ref: As NO000582

The Floor covering adhesive residue (Toilets G/002) contains asbestos.

Any change in its appearance should be recorded and passed to Property Services.

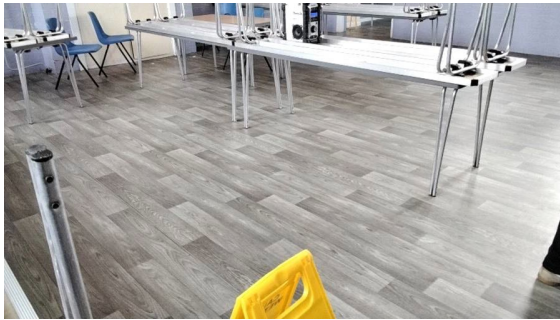
Item 130 Ref: NO000586

The Floor adhesive parquet blocks (Dining hall/area G/009) does not contain asbestos.

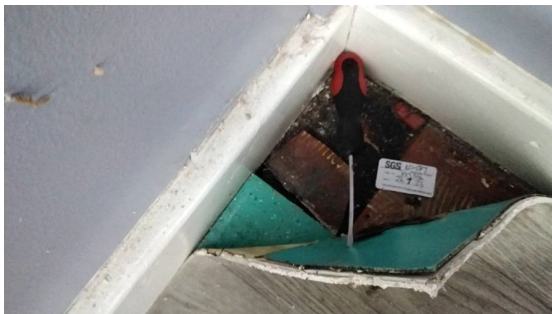
Item 131 Ref: NO000587

The Floor tile red thicker/older type (Corridor G/010) contains asbestos.

Any change in its appearance should be recorded and passed to Property Services.

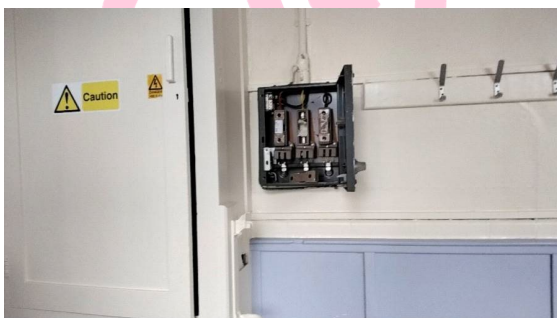
Item 132 Ref: NO000588

The Electrical Services Fuses/Flashguards (Corridor G/010) contains asbestos.

Any change in its appearance should be recorded and passed to Property Services.

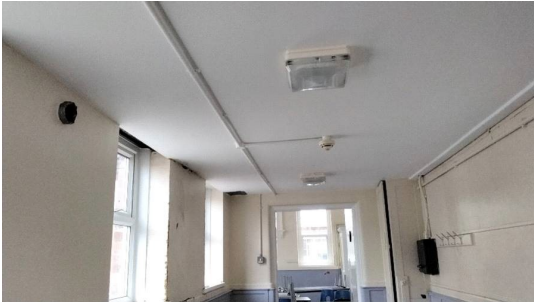
Item 133 Ref: NO000589

The Ceiling inspected within (Corridor G/010) does not contain asbestos.

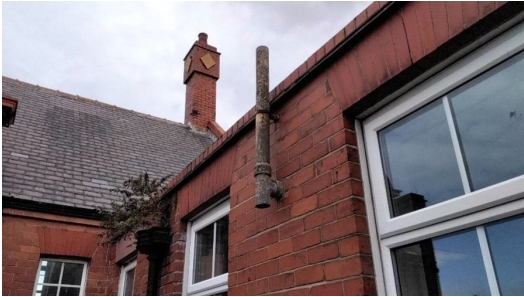
Item 136 Ref: As NO000590

The Flue Pipe (External E/001) contains asbestos.

Any change in its appearance should be recorded and passed to Property Services.
