ASBESTOS SURVEY REPORT FOR FULWEL JUNIOR SCHOOL, SEA ROAD, SUNDERLAND, SR6 9EE.

Asbestos Register for

Fulwell Junior School, Sea Road, Sunderland, SR6 9EE

Date: 31 July 2025

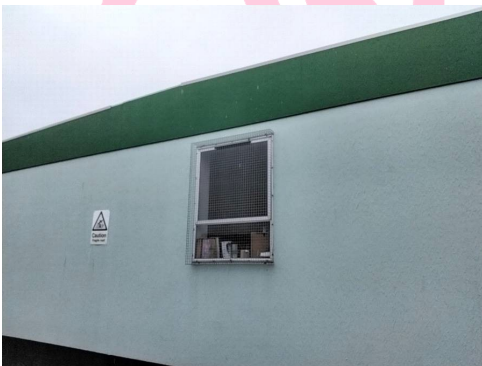
Item 60 Ref: CF006526

The window putty
(External/E001) does not
contain asbestos.

Demolished in refurb 2024

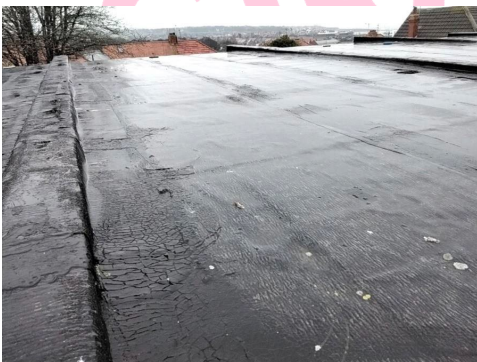
Item 63 Ref: CF006525

The roof felt below modern plastic covering (External/E002) does not contain asbestos.

Demolished in refurb 2024

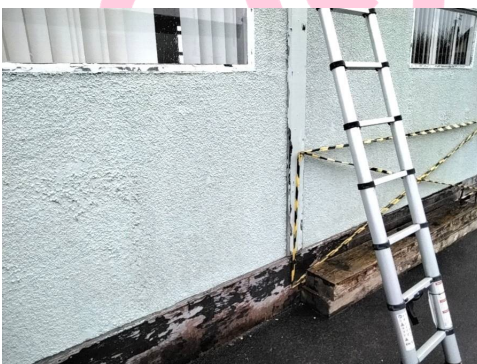
Item 66 Ref: CF006524

The wall panel (External/E002) does not contain asbestos.

Demolished in refurb 2024

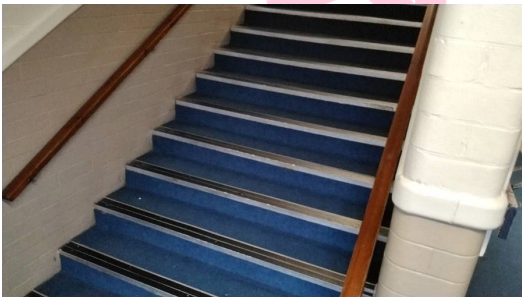
Item 72 Ref: NO000603

The Floor nosing to stairs (Corridor including stairs to Mezzanine G/004) does not contain asbestos.

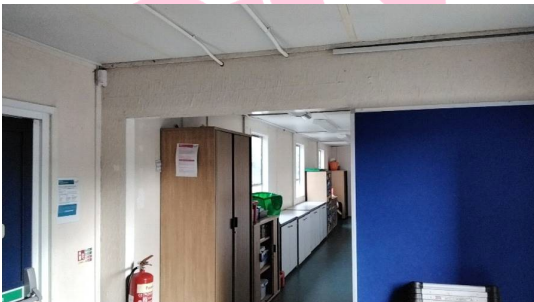
Item 75 Ref: NO000604

The Wall coating (Entrance Hall G/014) does not contain asbestos.

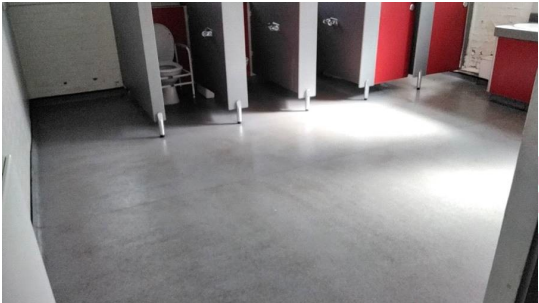
Item 77 Ref: As NO000601

The Floor adhesive remnants (Female Toilets G/020) do not contain asbestos.

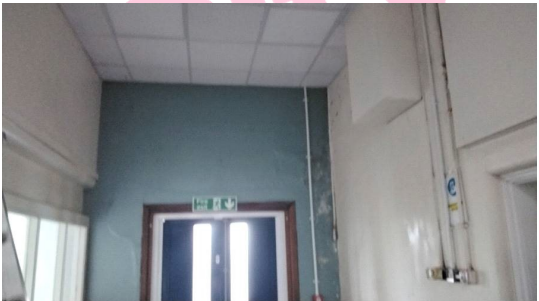
Item 78 Ref: As NO000600

The Wall coating fire flex paint (Entrance Hall/Foyer/Lobby G/021) does not contain asbestos.

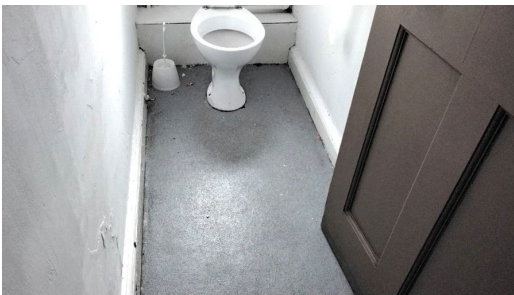
Item 80 Ref: As NO000601

The Floor beneath lino (Toilets G/024) does not contain asbestos.

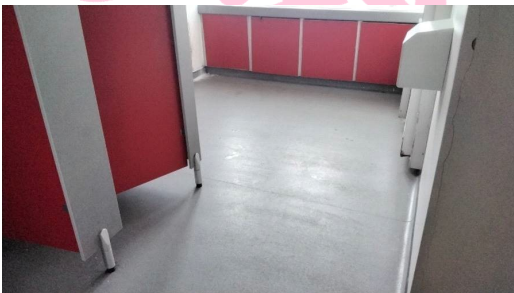
Item 81 Ref: As NO000601

The Floor beneath lino (Toilets G/025) does not contain asbestos.

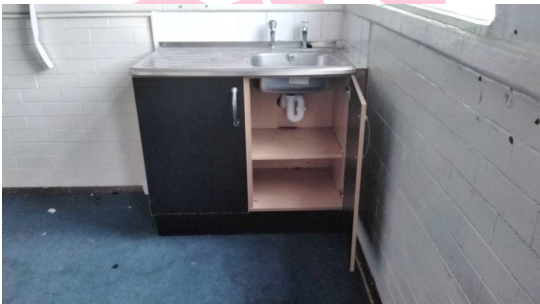
Item 84 Ref: As NO000597

The Pipework to sink waste pipe (Classroom G/027) does not contain asbestos.

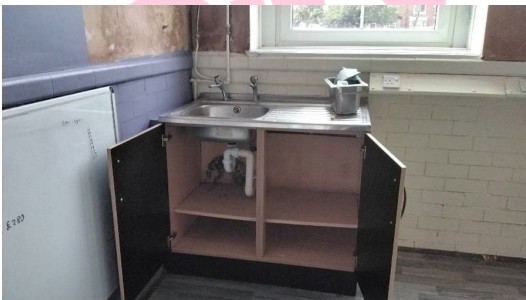
Item 87 Ref: As NO000598

The Under sink mat
(Classroom G/028) does not
contain asbestos.

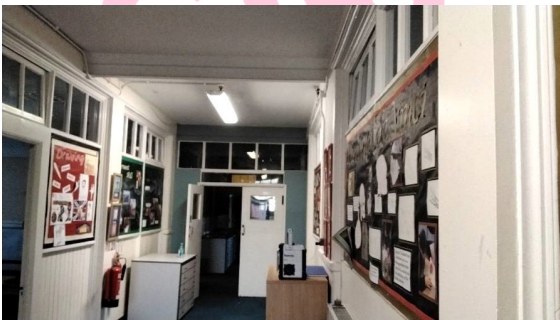
Item 96 Ref: As NO000596

The Wall coating (Corridor 1/002) does not contain asbestos.

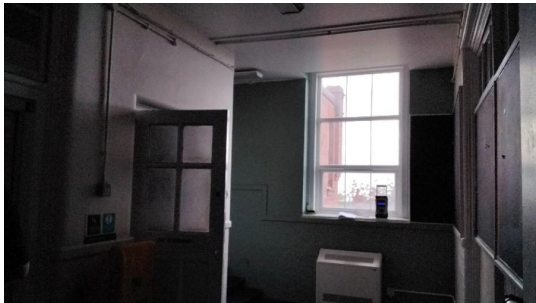
Item 97 Ref: As NO000596

The Wall coating (Corridor 1/007) does not contain asbestos.

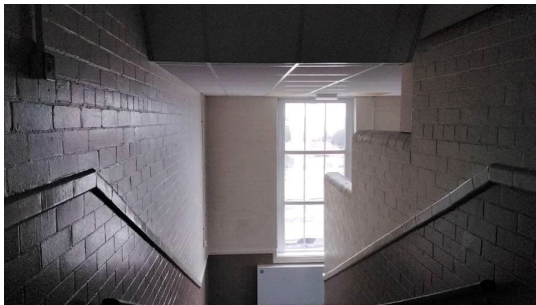
Item 98 Ref: As NO000596

The Wall coating (Landing 1/009) does not contain asbestos.

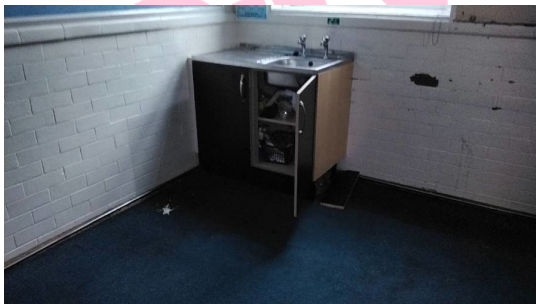
Item 99 Ref: NO000597

The Pipework to sink water pipe (Classroom 1/013) does not contain asbestos.

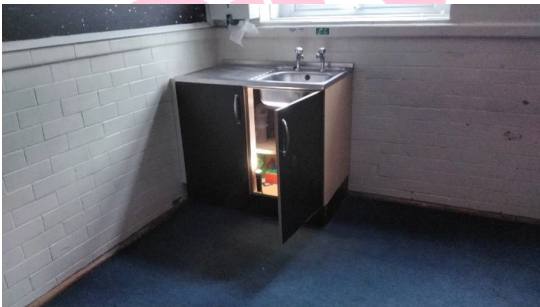
Item 102 Ref: As NO000598

The Under sink mat
(Classroom 1/015) does not
contain asbestos.

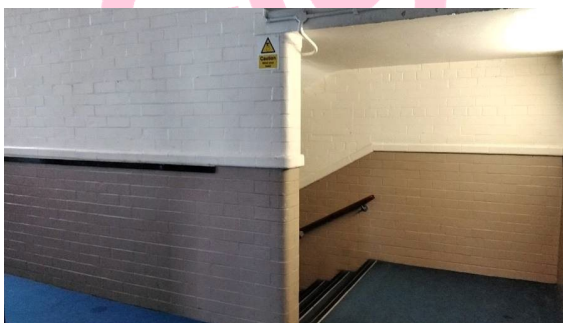
Item 108 Ref: As NO000600

The Wall coating fire flex paint (Landing MZ/001) does not contain asbestos.

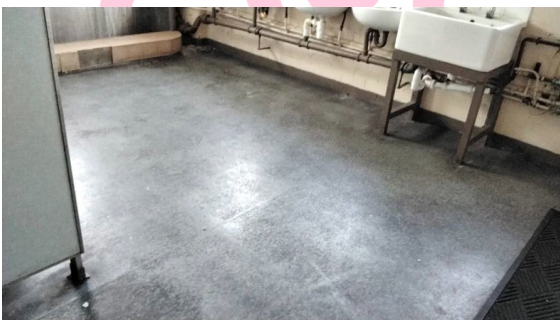
Item 111 Ref: As NO000601

The Floor (Male Toilets MZ/002) does not contain asbestos.

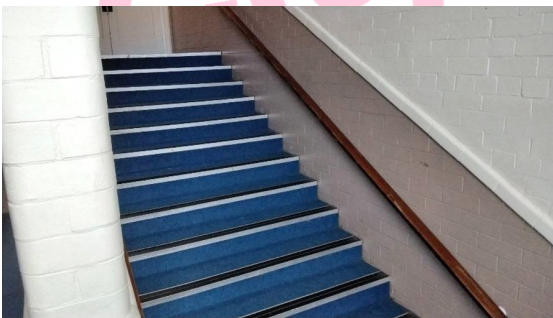
Item 114 Ref: As NO000603

The Floor nosing to stairs (Landing MZ/003) does not contain asbestos.

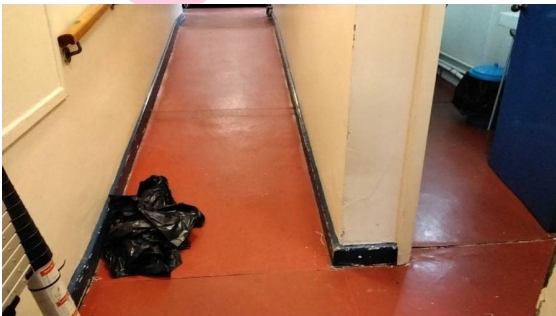
Item 117 Ref: NO000582

The Floor covering adhesive residue (Entrance Hall/Foyer/Lobby G/001) contains asbestos.

Any change in its appearance should be recorded and passed to Property Services.

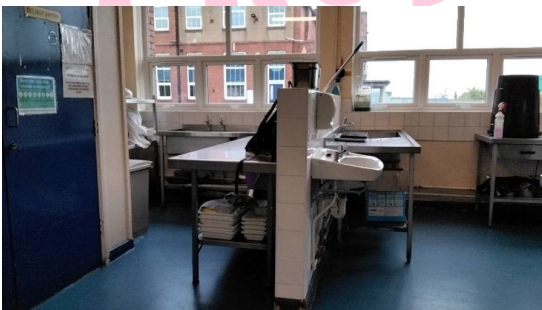
Item 123 Ref: NO000583

The Under sink mat (Kitchen G/006) does not contain asbestos.

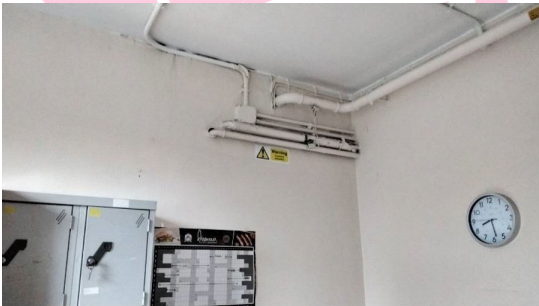
Item 126 Ref: Presumed

The Pipework insulation (Office G/007) Is presumed to contain asbestos.

Any change in its appearance should be recorded and passed to Property Services.

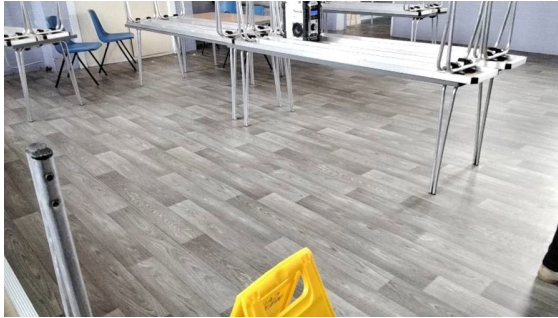
Item 130 Ref: NO000586

The Floor adhesive parquet blocks (Dining hall/area G/009) does not contain asbestos.

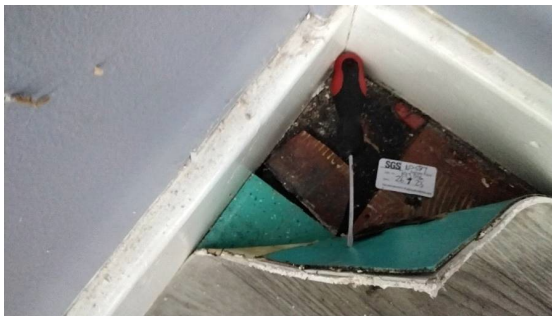
Item 131 Ref: NO000587

The Floor tile red thicker/older type (Corridor G/010) contains asbestos.

Any change in its appearance should be recorded and passed to Property Services.

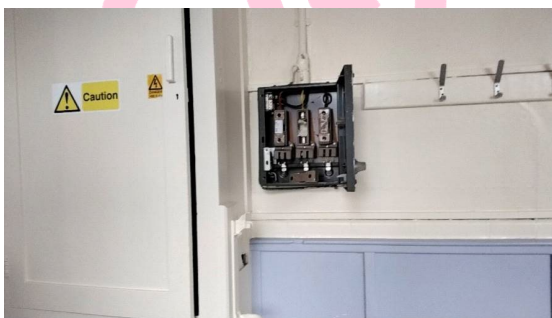
Item 132 Ref: NO000588

The Electrical Services Fuses/Flashguards (Corridor G/010) contains asbestos.

Any change in its appearance should be recorded and passed to Property Services.

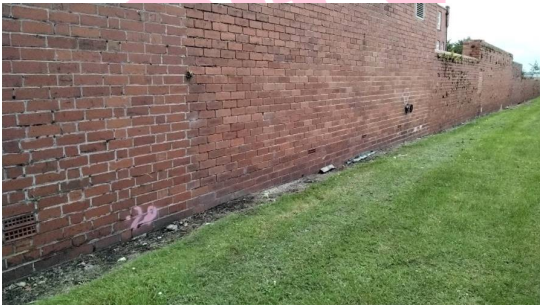
Item 135 Ref: NO000591

The Damp proof course (External E/001) does not contain asbestos.
