ASBESTOS SURVEY REPORT FOR HILL VIEW INFANT SCHOOL, SUNDERLAND

HILL VIEW INFANT SCHOOL, SUNDERLAND

Date: 25 November 2024

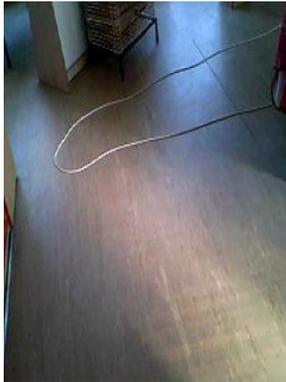
Item 4 - Ref: BB000804

The floor tiles to room 17 do not contain asbestos.

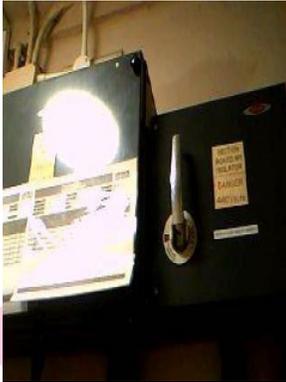
Item 5 – Presumed

The flash guards to the fuse box in the corridor (Rm 0/24) were strongly presumed to contain asbestos.

These were removed 8th July 2013.

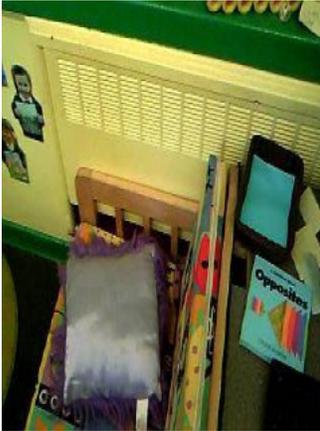
Item 7 – As BB000791

The insulation board between the old heater and the brick work to the wall in Room 0/29 does not contain asbestos.

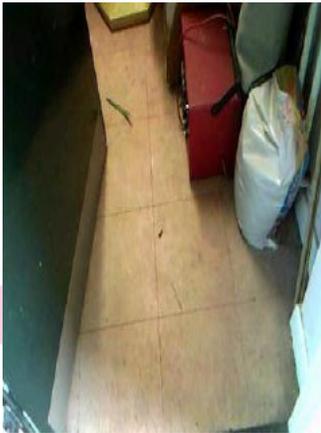
Item 8 – As BB000802

The floor tiles to room 0/30 do not contain asbestos.

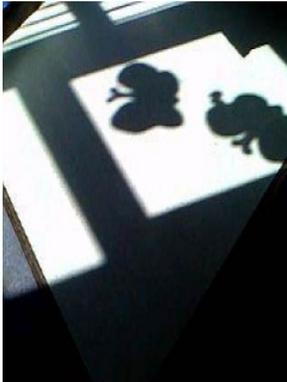
Item 10 – As BB000801

The lino to room 0/34 does not contain asbestos.

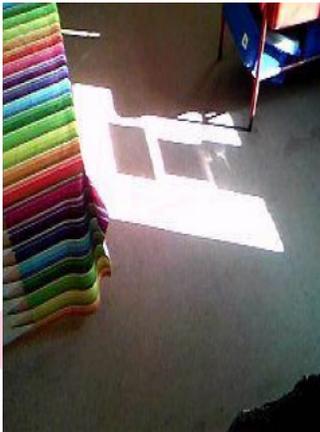
Item 11 – Ref: BB000801

The lino to room 0/35 does not contain asbestos.

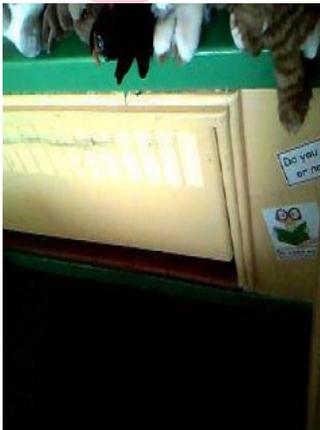
Item 12 – As BB000791

The insulation panel between the heater and the brickwork to the wall in room 0/39 does not contain asbestos.

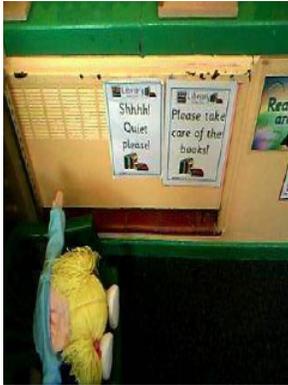
Item 13 – As BB000791

The insulation panel between the heater and the brickwork to the wall in room 0/42 does not contain asbestos.

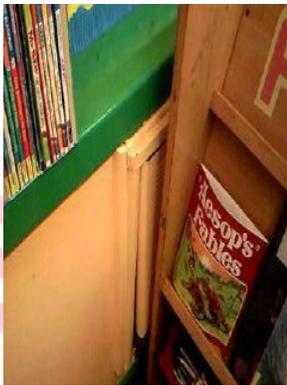
Item 14 – As BB000791

The insulation panel between the heater and the brickwork to the wall in room 0/45 does not contain asbestos.

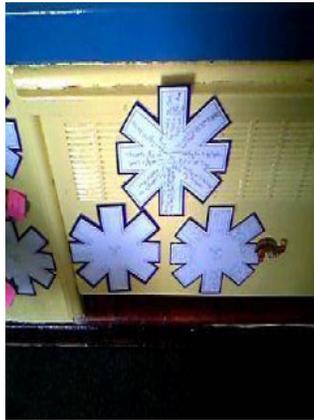
Item 16 – As BB000791

The insulation panel between the heater and the brickwork to the wall in room 0/51 does not contain asbestos.

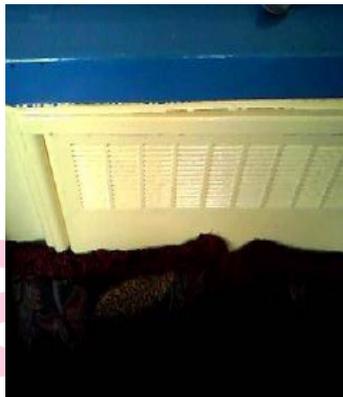
Item 17 – As BB000791

The insulation panel between the heater and the brickwork to the wall in room 0/53 does not contain asbestos.

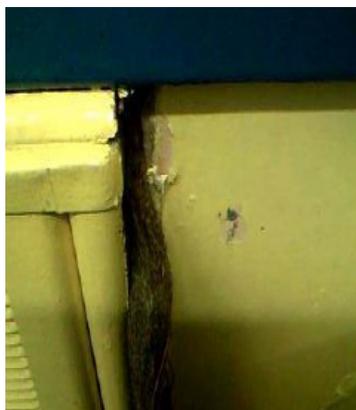
Item 18 – Ref: BB000791

The insulation panel between the heater and the brickwork to the wall in room 0/55 does not contain asbestos.

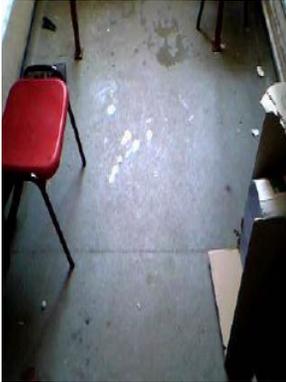
Item 19 – As BB000801

The lino to room 0/75 does not contain asbestos.

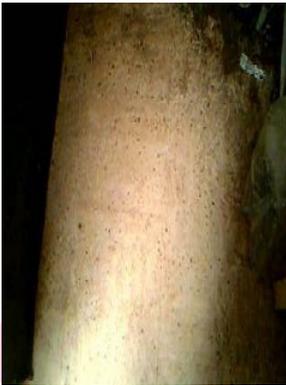
Item 20 – Ref: BB000802

The floor tiles to room 0/76 do not contain asbestos.

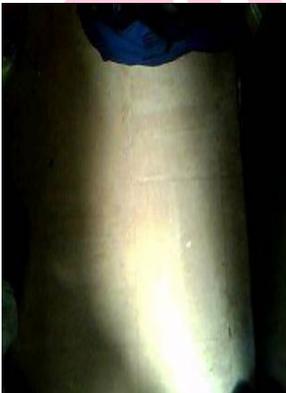
Item 21 – As: BB000802

The floor tiles to room 0/78 do not contain asbestos.

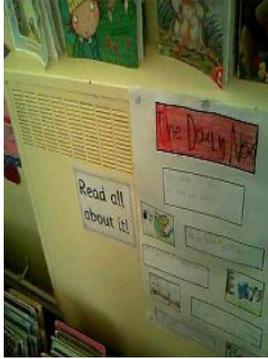
Item 22 – As: BB000791

The insulation panel between the heater and the brickwork to the wall in room 0/83 does not contain asbestos.

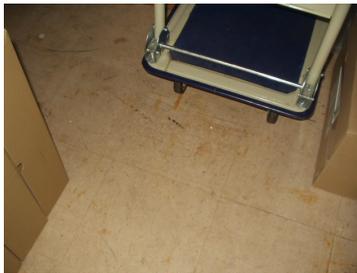
Item 23 - Ref: AW0838/08

The beige floor tiles to the store room (Rm 0/84) do not contain asbestos.

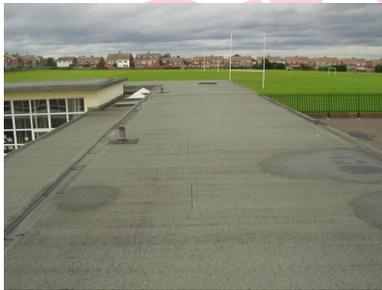
Item 24 - Ref: AW0840/08

The roof felt to the external of the building does not contain asbestos.

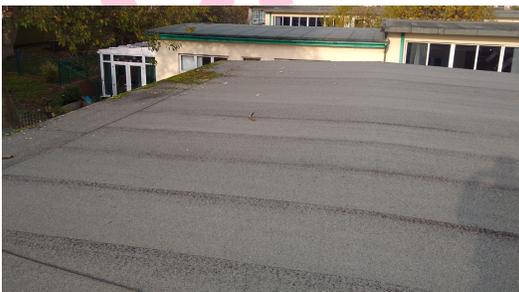
Item 45 Ref: 437902-5

The flat roof (External Roof 1) does not contain asbestos.

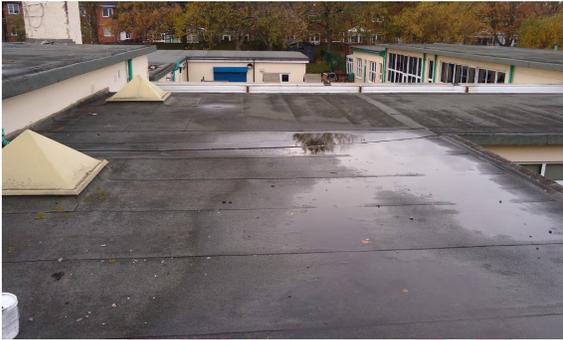
Item 50 Ref: 437902-10

The flat roof (External Roof 4) does not contain asbestos.

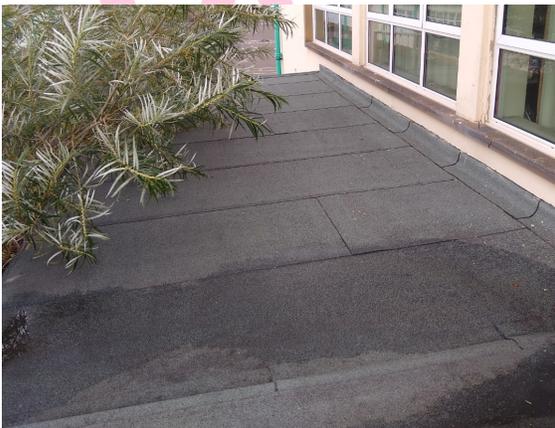
Item 51 Ref: 437902-11

The flat roof (External Roof 5) does not contain asbestos.

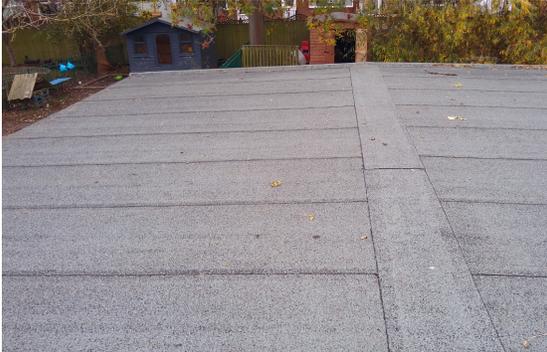
Item 52 Ref: 437902-12

The flat roof (External Roof 6) does not contain asbestos.

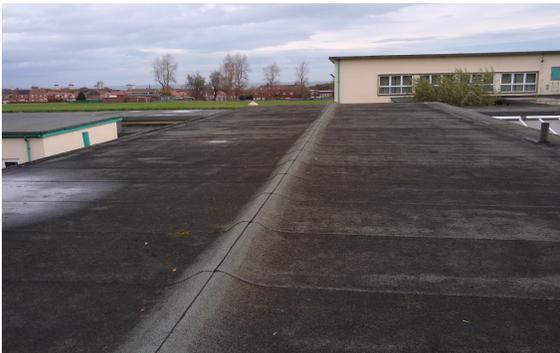
Item 53 Ref: 437902-13

The flat roof (External Roof 7) does not contain asbestos.

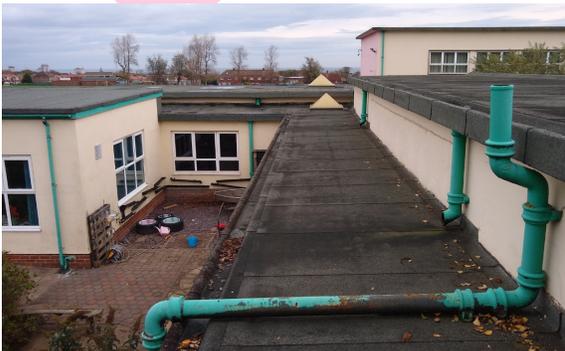
Item 54 Ref: 437902-14

The flat roof (External Roof 8) does not contain asbestos.

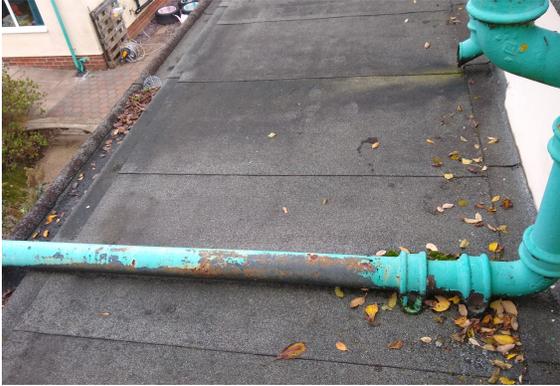
Item 55 Ref: 437902-15

The mastic to downpipe joints (External Roof 8) does not contain asbestos.

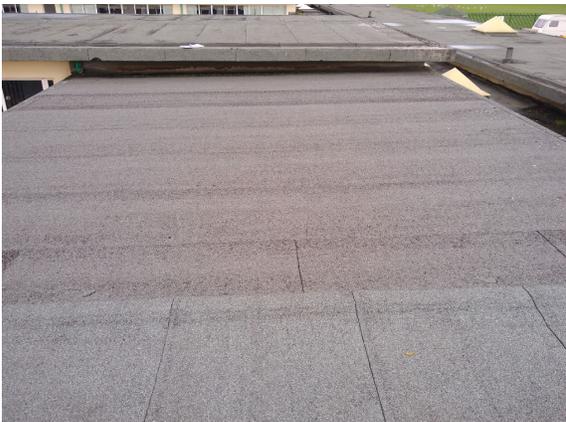
Item 56 Ref: 437902-16

The flat roof (External Roof 9) does not contain asbestos.

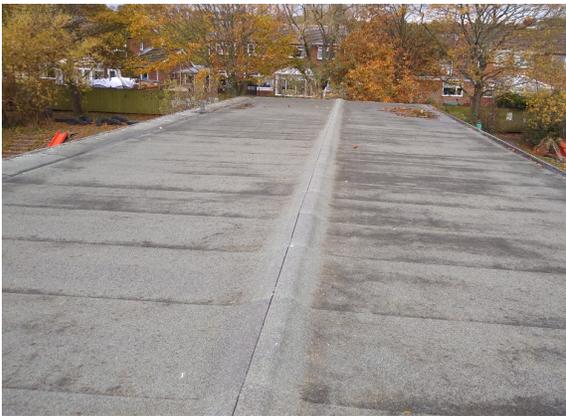
Item 57 Ref: 437902-17

The flat roof (External Roof 10) does not contain asbestos.

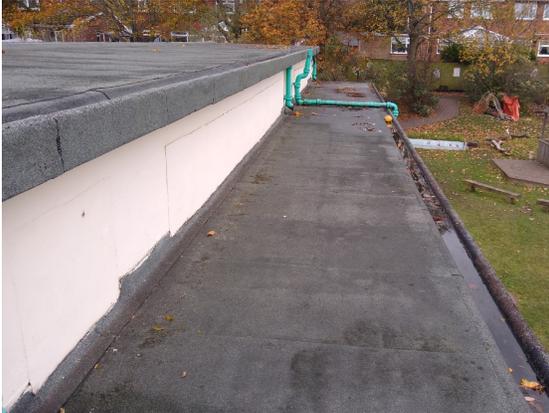
Item 58 Ref: 437902-18

The flat roof (External Roof 11) does not contain asbestos.

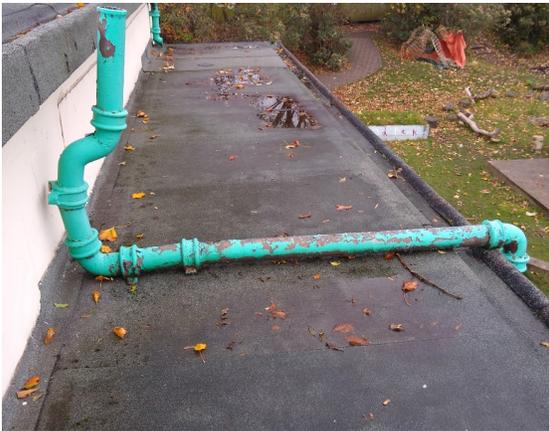
Item 59 Ref: As 437902-15

The mastic to downpipe joints (External Roof 11) does not contain asbestos.

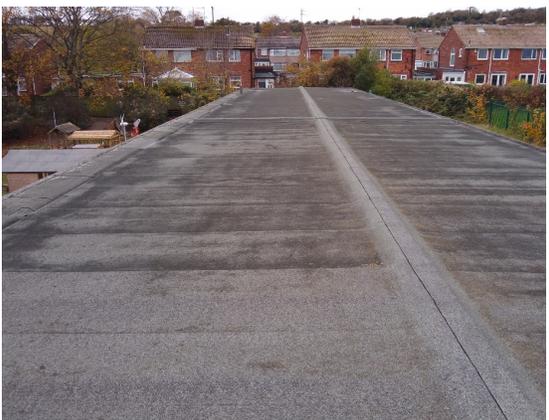
Item 60 Ref: 437902-19

The flat roof (External Roof 12) does not contain asbestos.

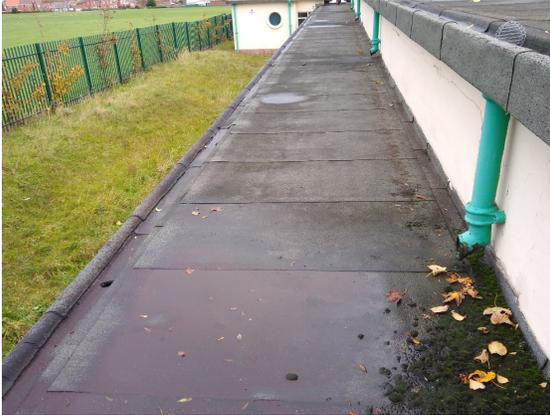
Item 61 Ref: 437902-20

The flat roof (External Roof 13) does not contain asbestos.

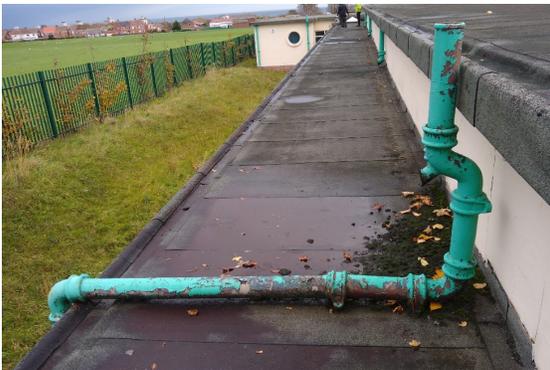
Item 62 Ref: As 437902-15

The mastic to downpipe joints (External Roof 13) does not contain asbestos.

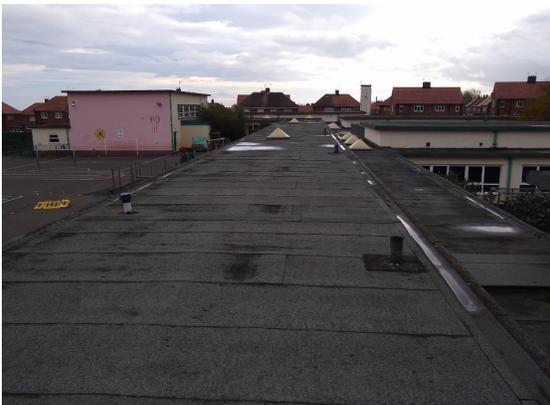
Item 63 Ref: 437902-21

The flat roof (External Roof 14) does not contain asbestos.

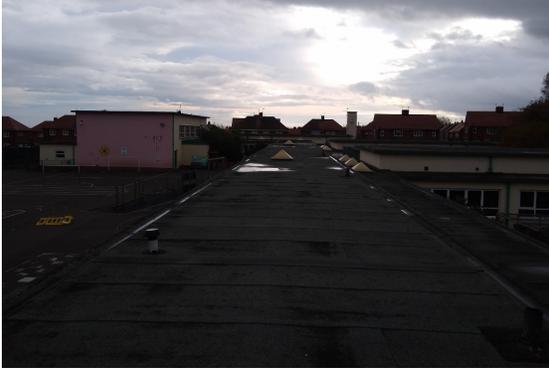
Item 64 Ref: 437902-22

The flat roof (External Roof 14) does not contain asbestos.

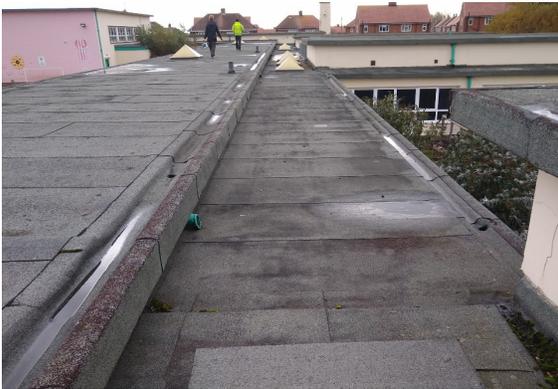
Item 65 Ref: 437902-23

The flat roof (External Roof 15) does not contain asbestos.

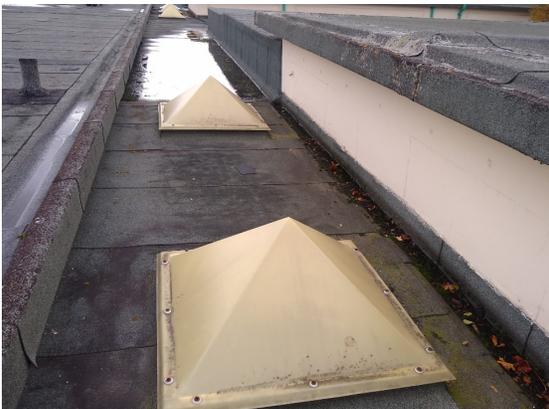
Item 66 Ref: 437902-24

The flat roof (External Roof 15) does not contain asbestos.

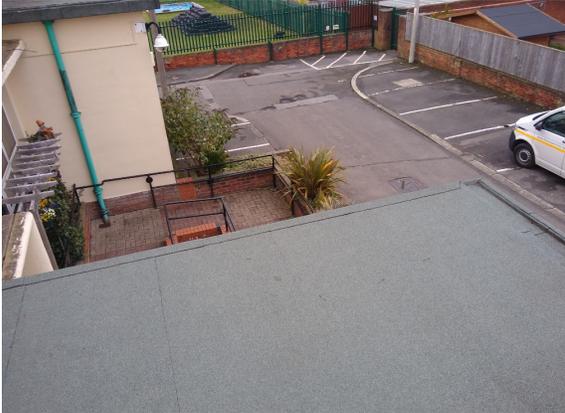
Item 67 Ref: 437902-25

The flat roof (External Roof 16) does not contain asbestos.

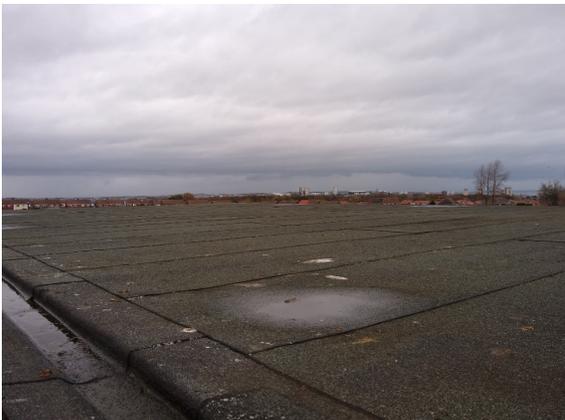
Item 68 Ref: 437902-26

The flat roof (External Roof 17) does not contain asbestos.

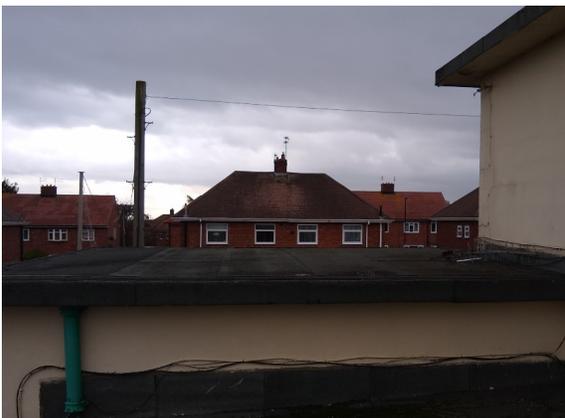
Item 69 Ref: 437902-27

The flat roof (External Roof 18) does not contain asbestos.

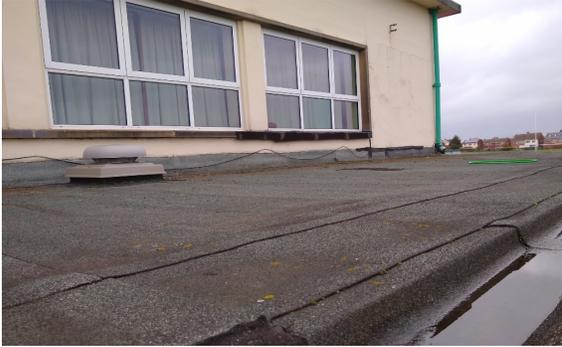
Item 70 Ref: 437902-28

The flat roof (External Roof 19) does not contain asbestos.

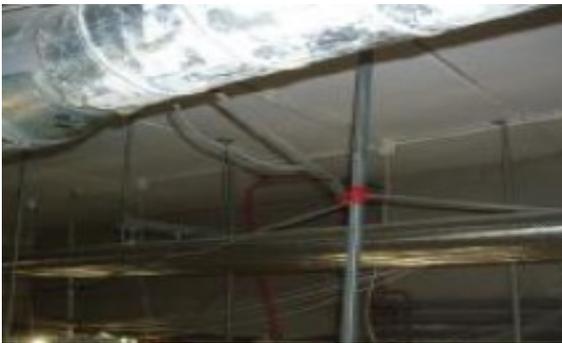
Item 71 Ref: SC17529

The ceiling board above ceiling tiles (Nursery WC ceiling void/Rm 013) does not contain asbestos.

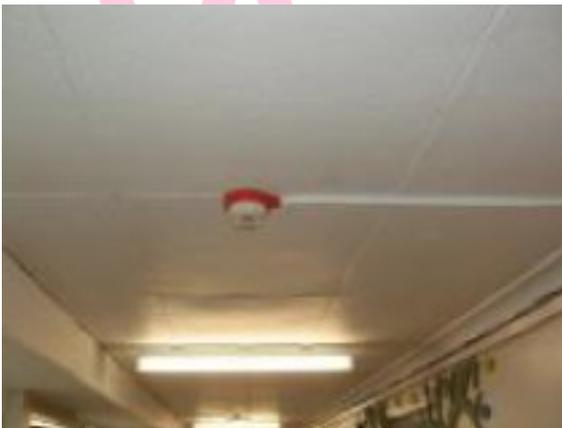
Item 72 Ref: SC17530

The ceiling board (Corridor 2/022) does not contain asbestos.

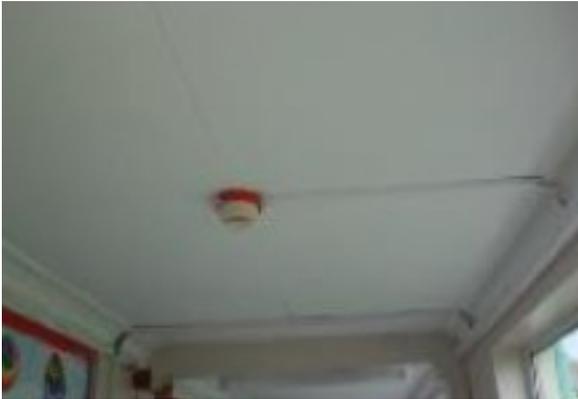
Item 73 Ref: SC17531

The ceiling board (Corridor 3/048) does not contain asbestos.

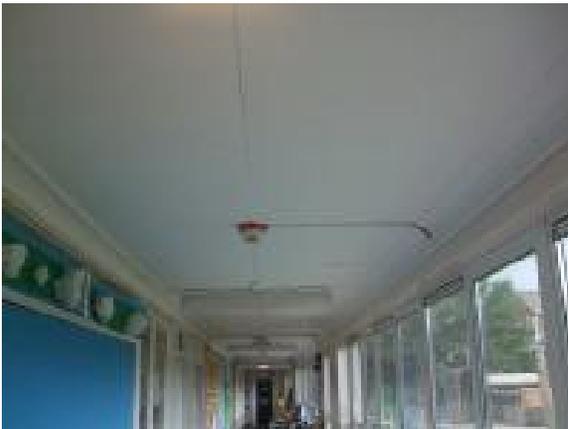
Item 74 Ref: SC17532

The ceiling board (Corridor 4/060) does not contain asbestos.

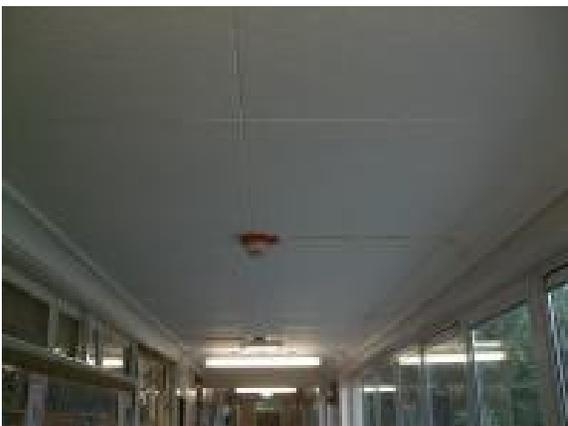
Item 75 Ref: SC17533

The ceiling board (Corridor 5/075) does not contain asbestos.

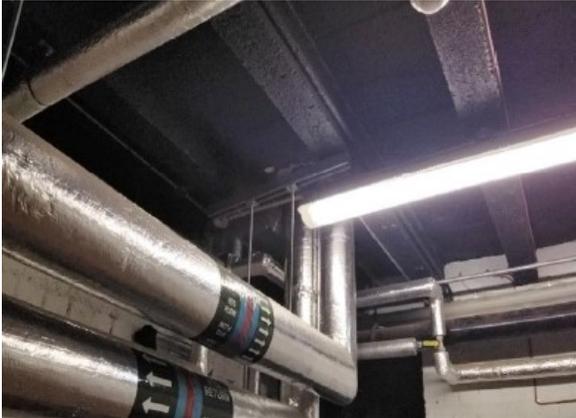
Item 76 Ref: NO000535

The debris/residue to the ceiling in the Boiler Room Z/001 does not contain asbestos.

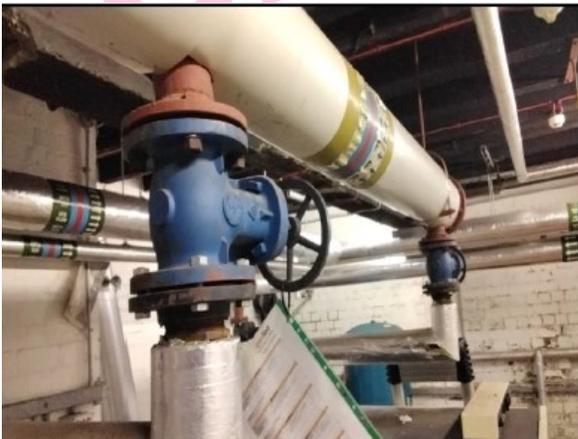
Item 81 Ref: NO000540

The pipework gaskets valve over boiler in the Boiler Room Z/001 does not contain asbestos.

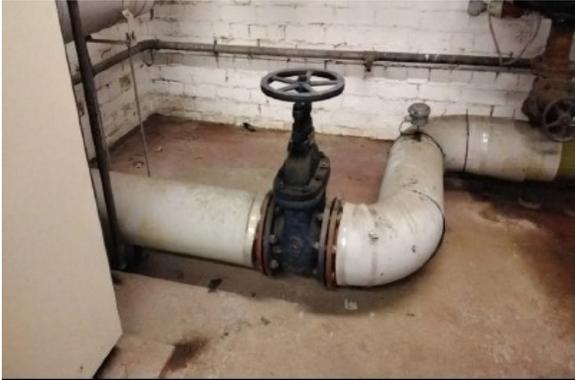
Item 82 Ref: NO00541

The pipework gaskets return flow valve and end stop in the Boiler Room Z/001 does not contain asbestos.

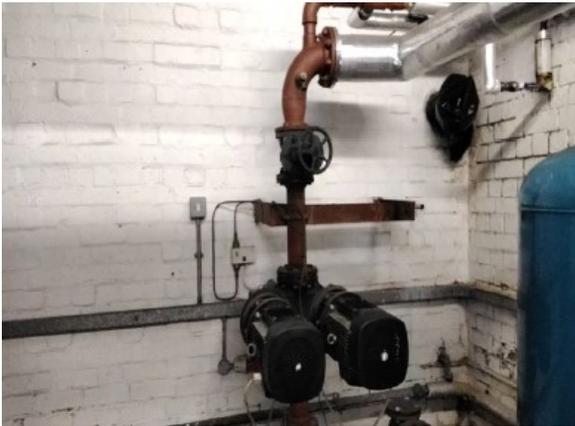
Item 83 Ref: NO00542

The pipework gaskets grunfos pumps in the Boiler Room Z/001 does not contain asbestos.

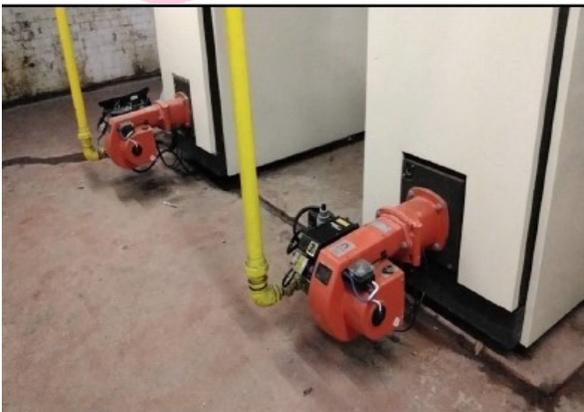
Item 84 Ref: NO000543

The pipework gasket on front of boiler in Boiler Room Z/001 does not contain asbestos.

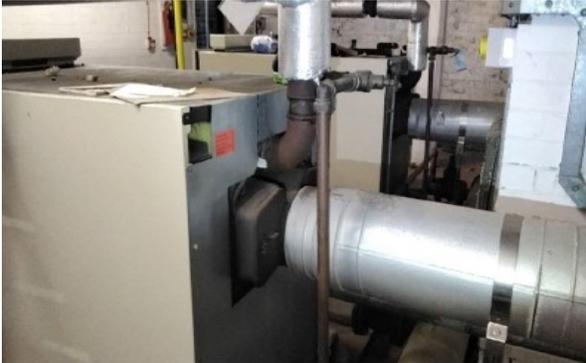
Item 85 Ref: NO000544

The boiler sealant at boiler HW outlet in the Boiler Room Z/001 does not contain asbestos.
