ASBESTOS SURVEY REPORT FOR HILL VIEW INFANT SCHOOL, SUNDERLAND

Asbestos Register for

HILL VIEW INFANT SCHOOL, SUNDERLAND

Date: 04 July 2025

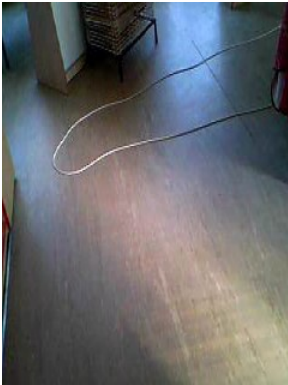
Item 4 - Ref: BB000804

The floor tiles to room 17 do not contain asbestos.

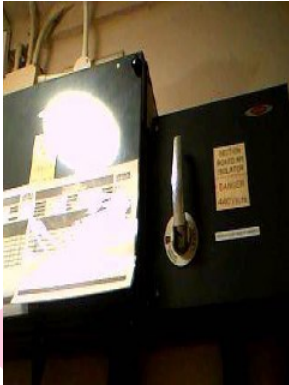
Item 5 – Presumed

The flash guards to the fuse box in the corridor (Rm 0/24) were strongly presumed to contain asbestos.

These were removed 8th July 2013.

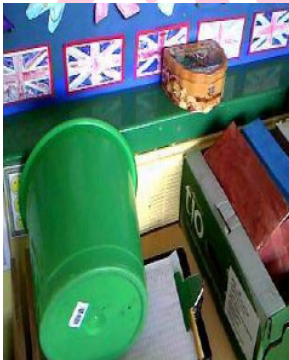
Item 6 – As BB000791

The insulation board between the old heater and the brick work to the wall in Room 0/26 does not contain asbestos.

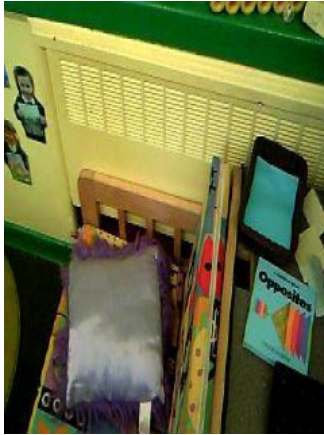
Item 7 – As BB000791

The insulation board between the old heater and the brick work to the wall in Room 0/29 does not contain asbestos.

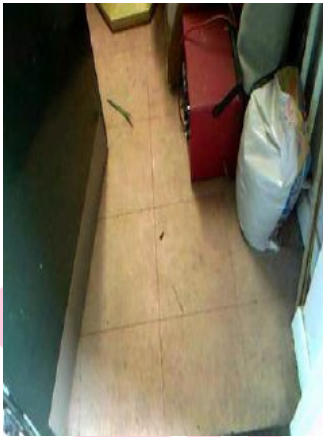
Item 8 – As BB000802

The floor tiles to room 0/30 do not contain asbestos.

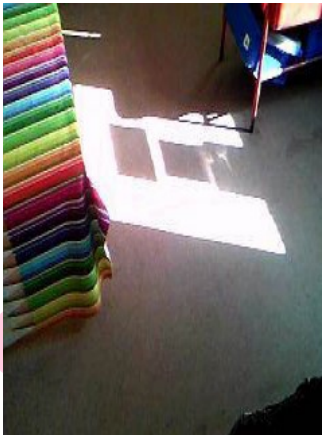
Item 11 – Ref: BB000801

The lino to room 0/35 does not contain asbestos.

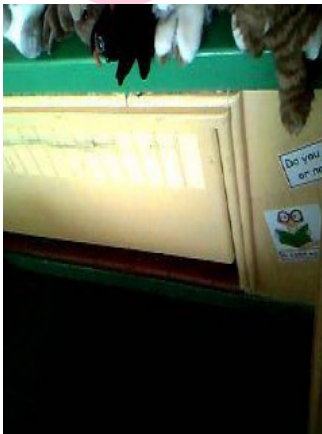
Item 12 – As BB000791

The insulation panel between the heater and the brickwork to the wall in room 0/39 does not contain asbestos.

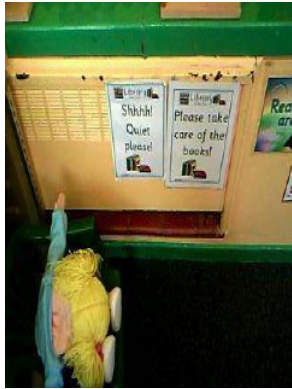
Item 13 – As BB000791

The insulation panel between the heater and the brickwork to the wall in room 0/42 does not contain asbestos.

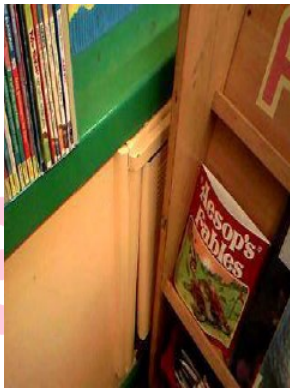
Item 14 – As BB000791

The insulation panel between the heater and the brickwork to the wall in room 0/45 does not contain asbestos.

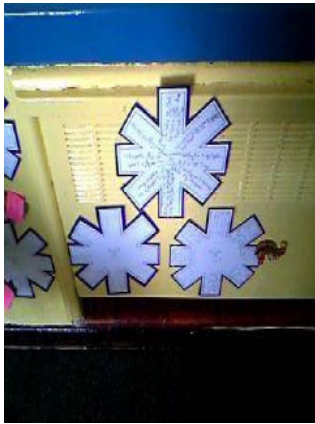
Item 16 – As BB000791

The insulation panel between the heater and the brickwork to the wall in room 0/51 does not contain asbestos.

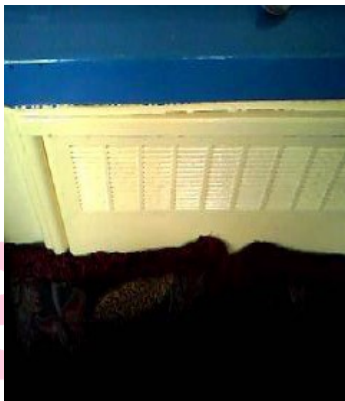
Item 17 – As BB000791

The insulation panel between the heater and the brickwork to the wall in room 0/53 does not contain asbestos.

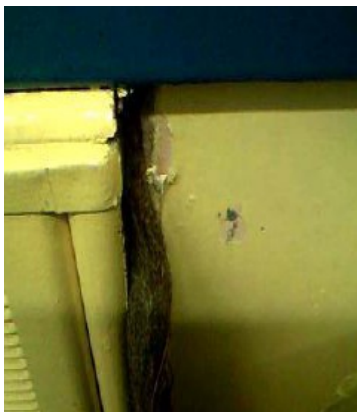
Item 18 – Ref: BB000791

The insulation panel between the heater and the brickwork to the wall in room 0/55 does not contain asbestos.

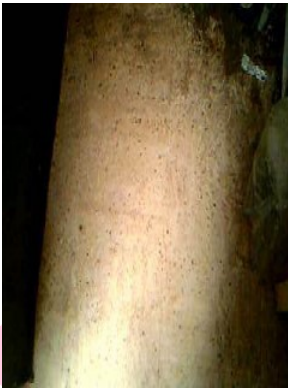
Item 20 – Ref: BB000802

The floor tiles to room 0/76 do not contain asbestos.

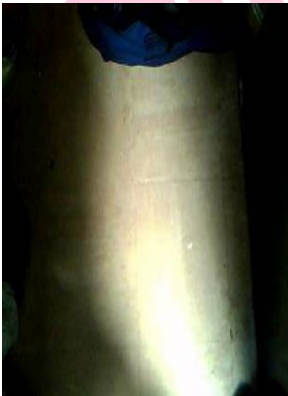
Item 21 – As: BB000802

The floor tiles to room 0/78 do not contain asbestos.

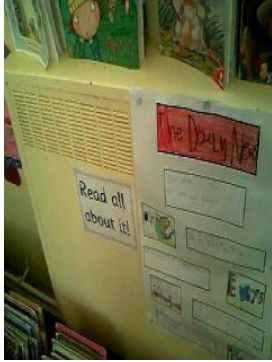
Item 22 – As: BB000791

The insulation panel between the heater and the brickwork to the wall in room 0/83 does not contain asbestos.

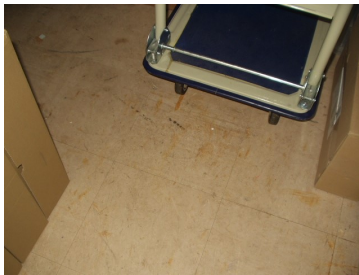
Item 23 - Ref: AW0838/08

The beige floor tiles to the store room (Rm 0/84) do not contain asbestos.

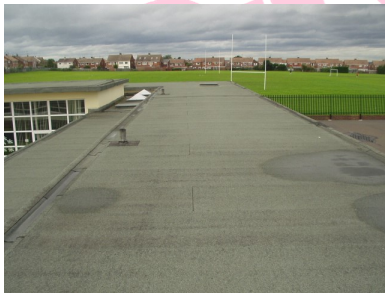
Item 24 - Ref: AW0840/08

The roof felt to the external of the building does not contain asbestos.

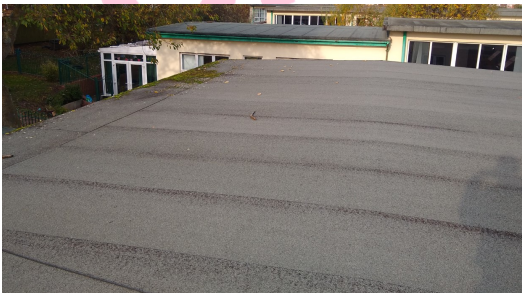
Item 45 Ref: 437902-5

The flat roof (External Roof 1) does not contain asbestos.
