ASBESTOS SURVEY REPORT FOR HUDSON ROAD PRIMARY SCHOOL –VILLIERS STREET SOUTH, SUNDERLAND

Asbestos Register for Hudson Road Primary School

Date: 01 August 2025

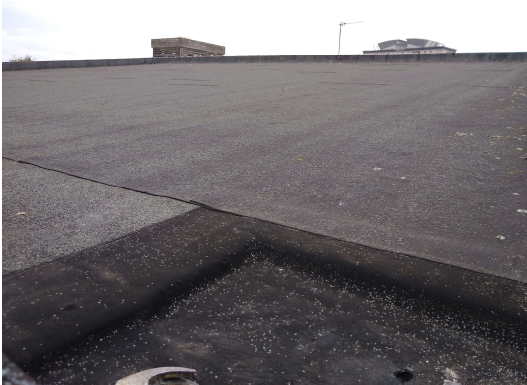
Item 7 Ref: 332593-5

The roof felt to Roof 4 (Nursery) does not contain asbestos.

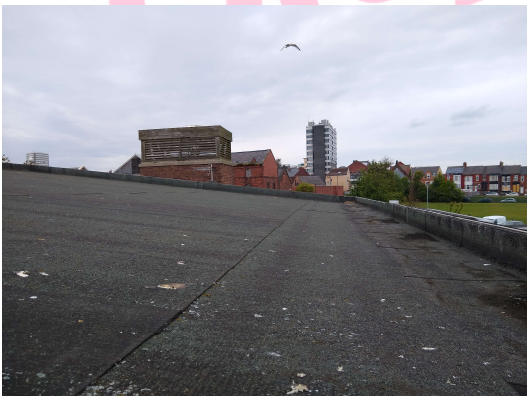
Item 8 Ref: 332593-6

The insulation below felt to Roof 4 (Nursery) does not contain asbestos.

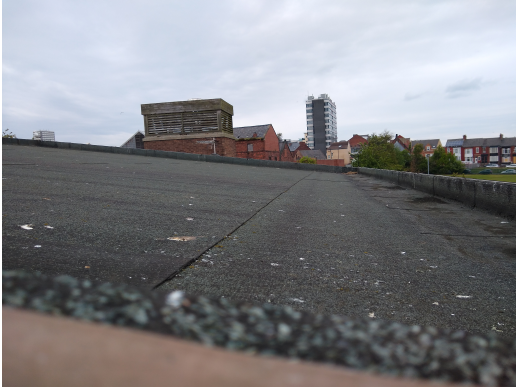
Item 9 Ref: 332593-15

The roof felt to Roof 5 (Nursery) does not contain asbestos.

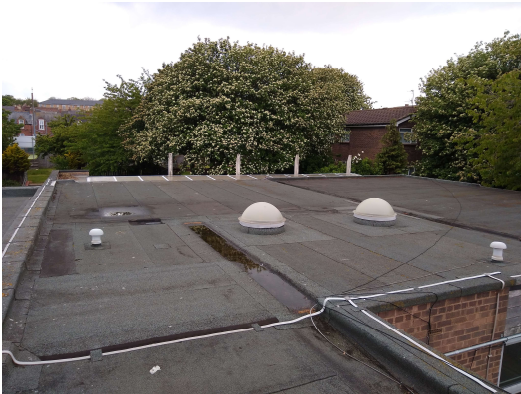
Item 10 Ref: As 332593-6

The insulation below felt to Roof 5 (Nursery) does not contain asbestos.

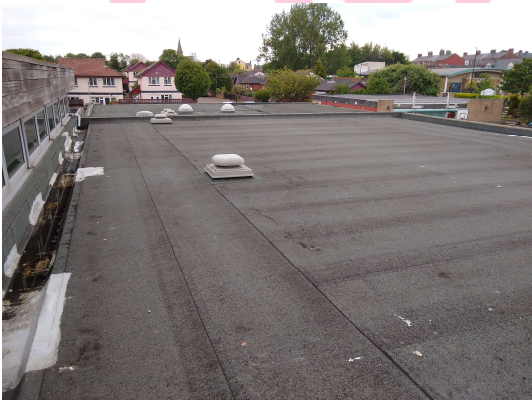
Item 11 Ref: 332593-8

The roof felt to Roof 6 (Nursery) does not contain asbestos.
