### ASBESTOS SURVEY REPORT FOR HUDSON ROAD PRIMARY SCHOOL –VILLIERS STREET SOUTH, SUNDERLAND

## **Asbestos Register for Hudson Road Primary School**

**Date: 06 July 2026**

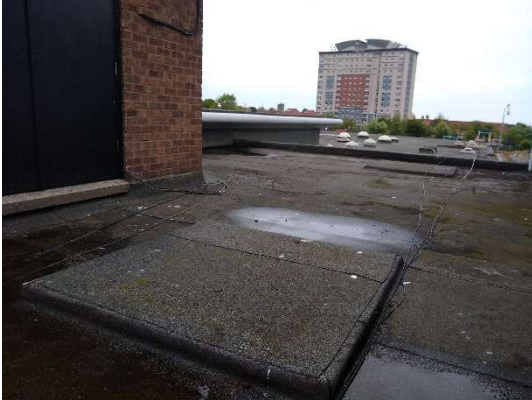
**Item 4 Ref: 332593-3**

The roof felt to Roof 3 (Nursery) does not contain asbestos.

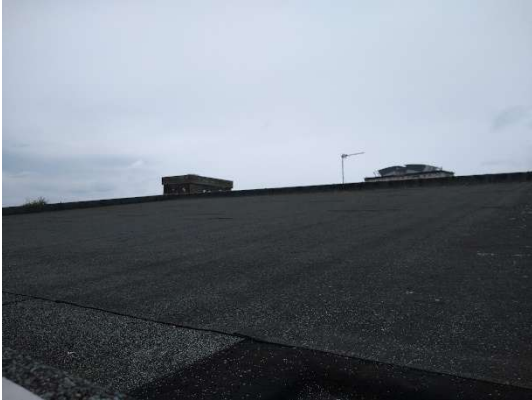
### **Item 7 Ref: 332593-5**

The roof felt to Roof 4 (Nursery) does not contain asbestos.

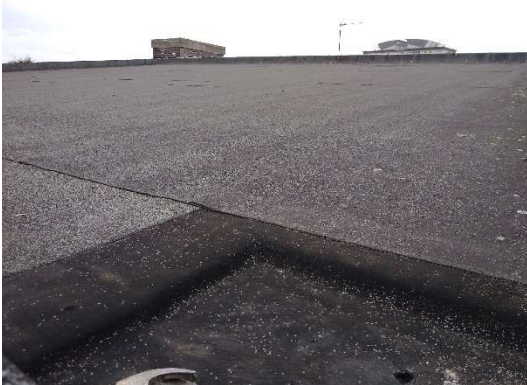
### **Item 8 Ref: 332593-6**

The insulation below felt to Roof 4 (Nursery) does not contain asbestos.

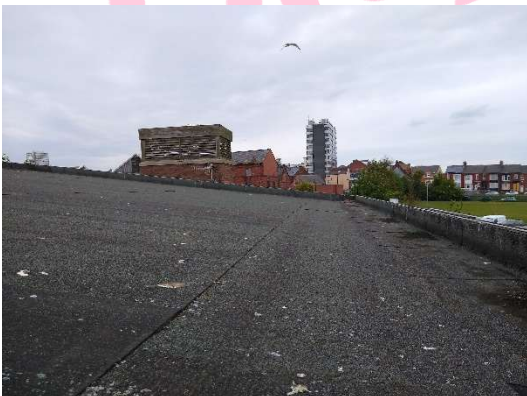
### **Item 9 Ref: 332593-15**

The roof felt to Roof 5 (Nursery) does not contain asbestos.

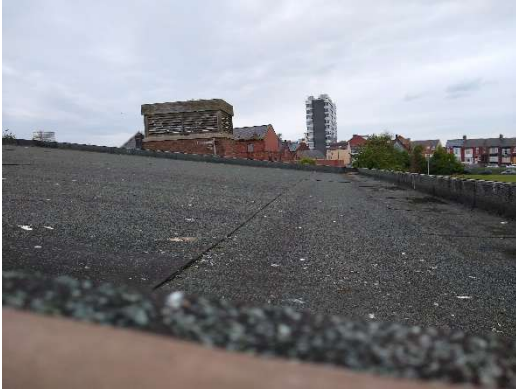
### **Item 10 Ref: As 332593-6**

The insulation below felt to Roof 5 (Nursery) does not contain asbestos.

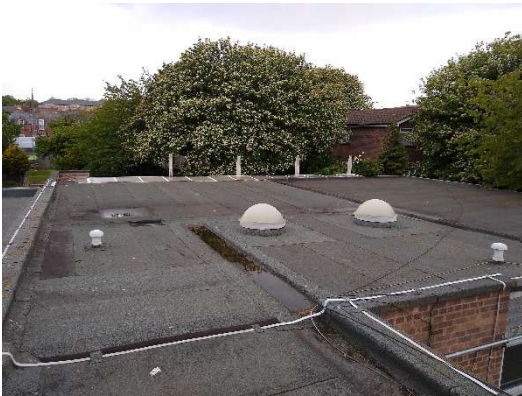
### **Item 11 Ref: 332593-8**

The roof felt to Roof 6 (Nursery) does not contain asbestos.

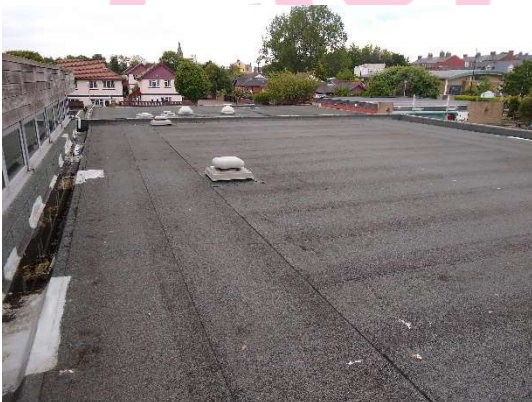
### **Item 12 Ref: 332593-9**

The roof felt to Roof 7 (Nursery) does not contain asbestos.

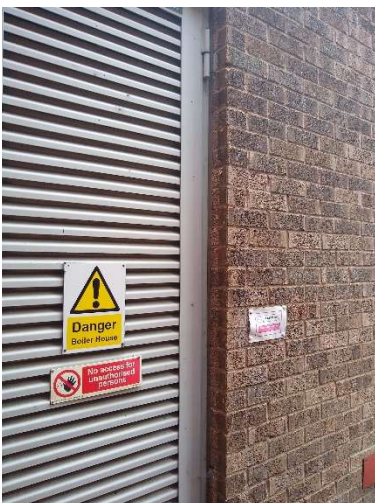
### **Item 57 Ref: 343523-22**

The Old mastic to boiler room door (externals) does contain asbestos.
