ASBESTOS SURVEY REPORT FOR HUDSON ROAD PRIMARY SCHOOL –VILLIERS STREET SOUTH, SUNDERLAND

Asbestos Register for Hudson Road Primary School

Date: 10 September 2024

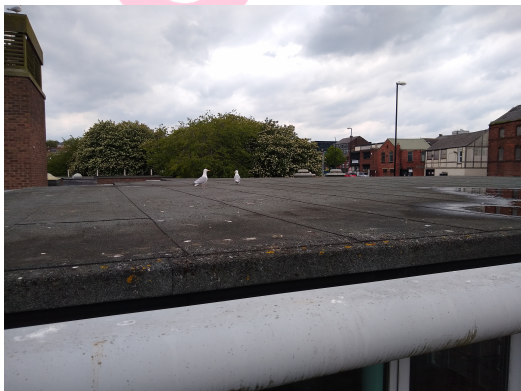
Item 6 Ref: 332593-7

The roof felt to Roof 3 (Nursery) does not contain asbestos.

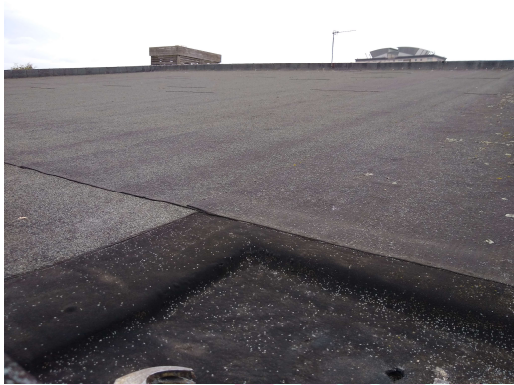
Item 8 Ref: 332593-6

The insulation below felt to Roof 4 (Nursery) does not contain asbestos.

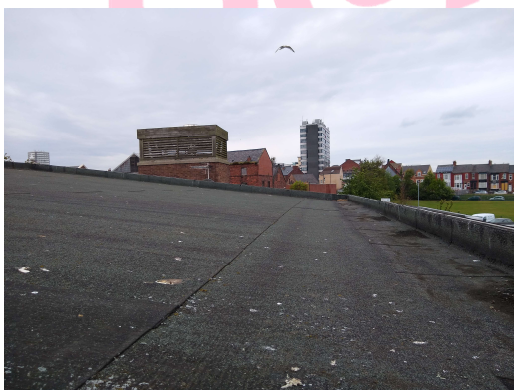
Item 9 Ref: 332593-15

The roof felt to Roof 5 (Nursery) does not contain asbestos.

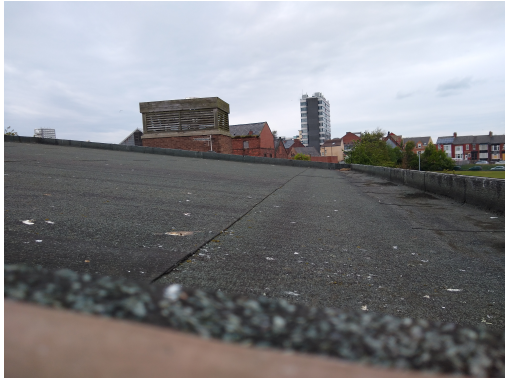
Item 10 Ref: As 332593-6

The insulation below felt to Roof 5 (Nursery) does not contain asbestos.

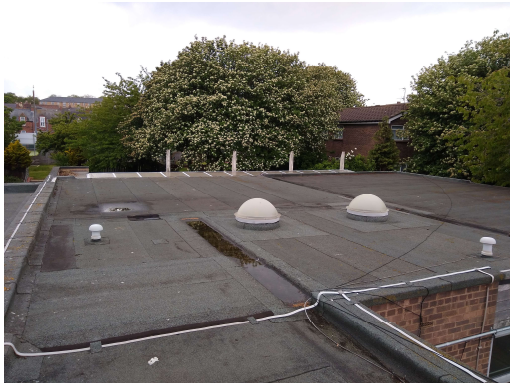
Item 11 Ref: 332593-8

The roof felt to Roof 6 (Nursery) does not contain asbestos.

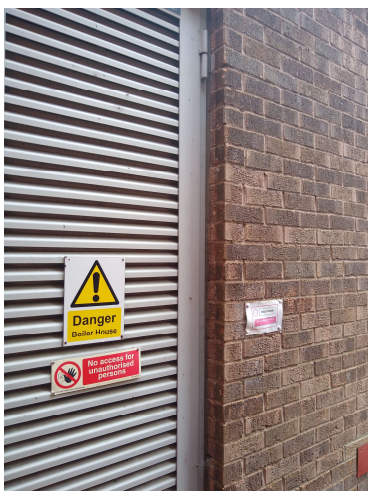
Item 57 Ref: 343523-22

The Old mastic to boiler room door (externals) does contain asbestos.
