### ASBESTOS SURVEY REPORT FOR JOHN F KENNEDY PRIMARY SCHOOL, WASHINGTON

*Control of Asbestos  
Regulations 2012*

### JOHN F KENNEDY PRIMARY SCHOOL, WASHINGTON

**Date: 04 June 2026**

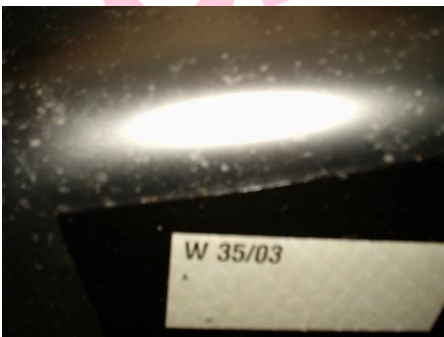
### **Item 3 - Ref: JP0651/07**

The sink pad to the classroom (Room 0/17) does not contain asbestos.

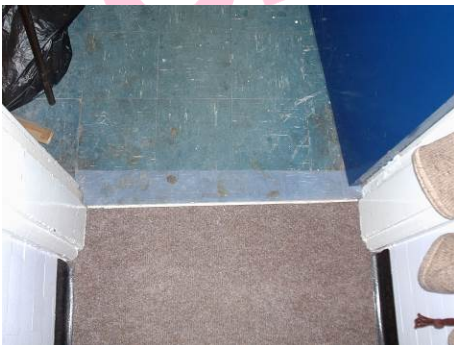
**Item 18 - Ref:JP0666/07**

The blue floor tiles to the caretakers office (Room 0/74) does not contain asbestos

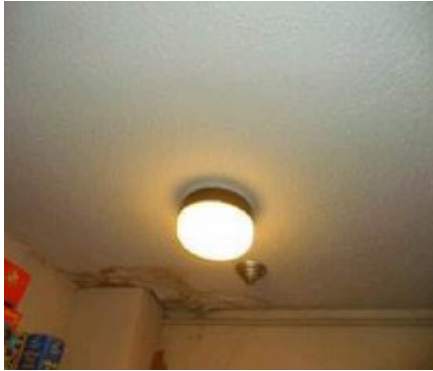
**Item 25 - As:VP003646**

*The textured coating to the ceiling within the Domestic Service Room contains asbestos.*

*Removed July 2024*

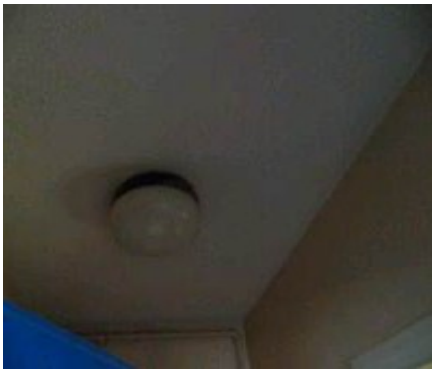
**Item 26 - As:VP003646**

*The textured coating to the ceiling within the toilets contains asbestos.*

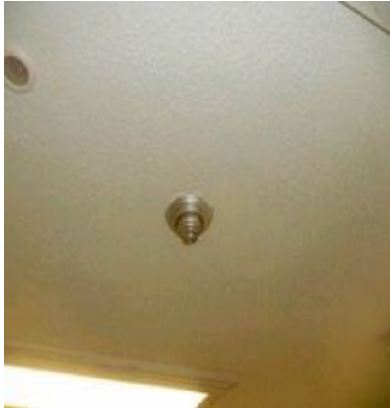
**Item 28 - As:VP003646**

*The textured coating to the ceiling within the entrance lobby contains asbestos.*

*Removed July 2024*

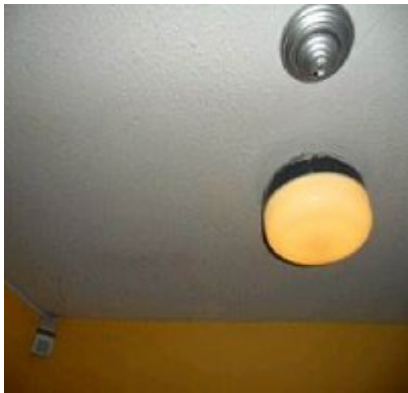
**Item 29 - As:VP003646**

*The textured coating to the ceiling within the store room contains asbestos.*

*Removed July 2024*

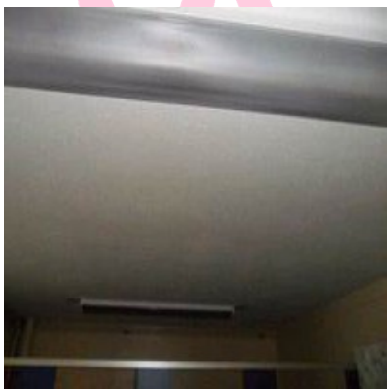
**Item 30: As VP003646**

*The textured coating to the ceiling within the toilets contains asbestos.*

*Removed July 2024*

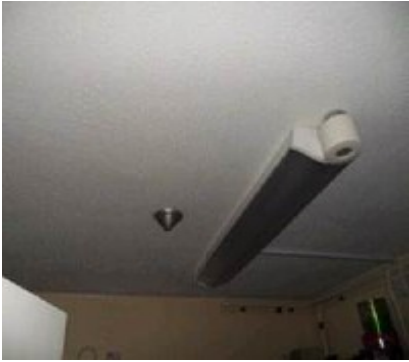
**Item 31 - As:VP003646**

*The textured coating to the ceiling within the utility contains asbestos.*

*Removed July 2024*

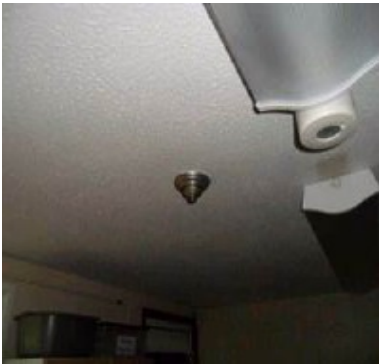
**Item 32 - As:VP003646**

*The textured coating to the ceiling within the kitchen contains asbestos.*

*Removed July 2024*

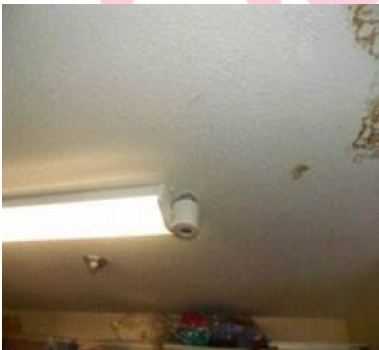
**Item 33: As VP003646**

*The textured coating to the ceiling within the store contains asbestos.*

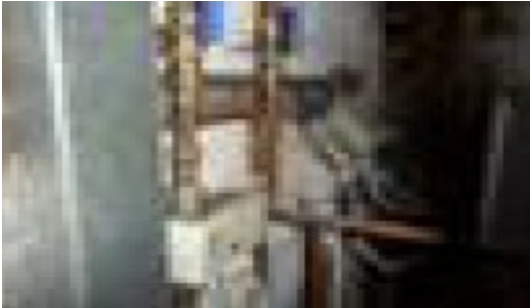
**Item 49 Ref: BS004215**

The Residue to wall (Boiler Room 1) does not contain asbestos.

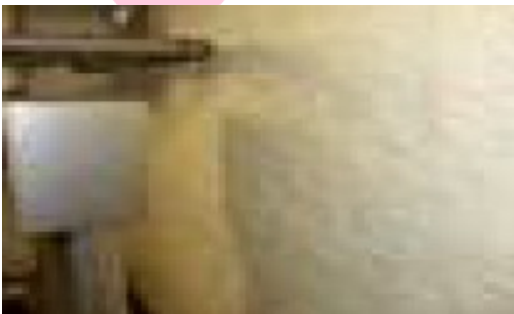
**Item 51 Ref: BS004217**

The Residue to wall (Boiler Room 1) does not contain asbestos.

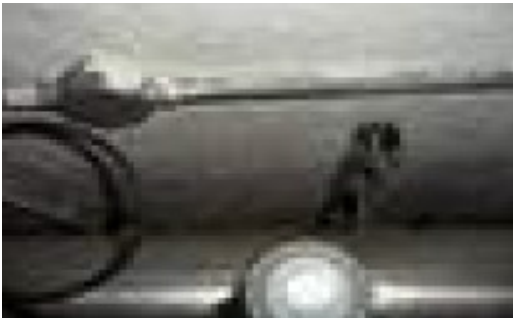
**Item 53 Ref: BS004219**

The Residue to Ceiling (Boiler Room 1) does not contain asbestos.

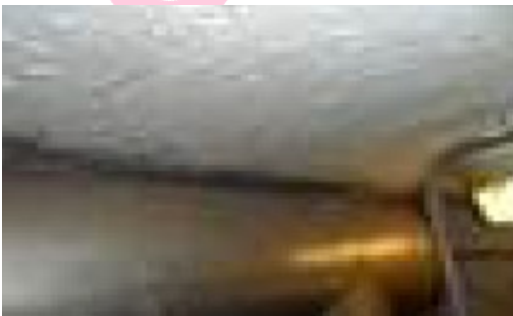
**Item 54 Ref: BS004220**

The Residue to Ceiling (Boiler Room 1) does not contain asbestos.

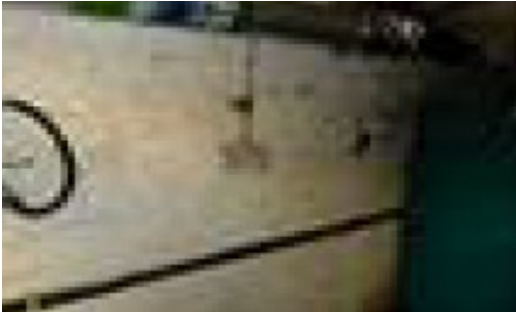
**Item 58 Ref: BS004224**

The Residue to wall (Boiler Room 2) does not contain asbestos.

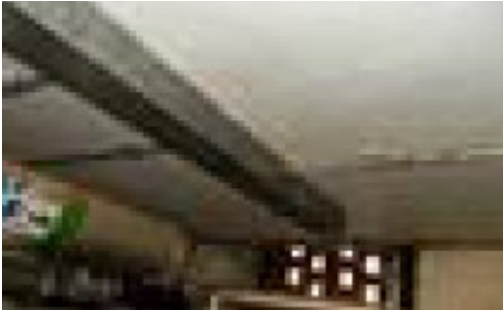
**Item 61 Ref: BS004227**

The Residue to ceiling (Boiler Room 2) does not contain asbestos.

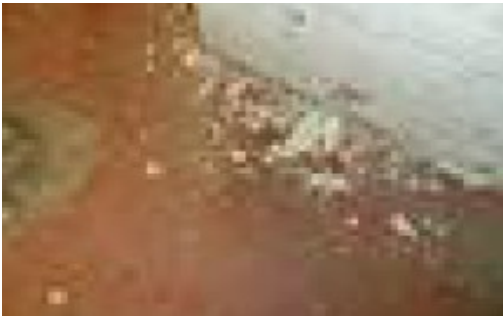
**Item 62 Ref: BS004228**

The Debris to floor (Boiler Room 2) does not contain asbestos.

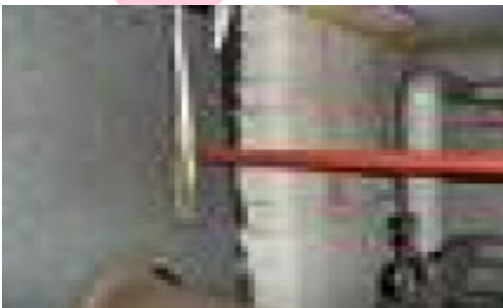
**Item 63 Ref: BS004229**

The Residue to wall (Boiler Room 3) does not contain asbestos.

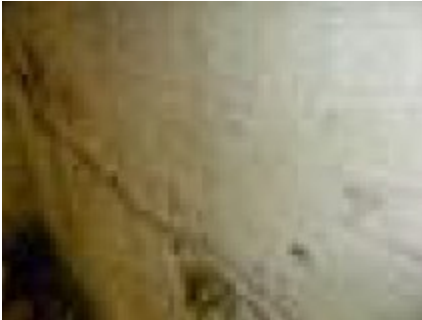
**Item 64 Ref: BS004230**

The Residue to wall (Boiler Room 3) does not contain asbestos.

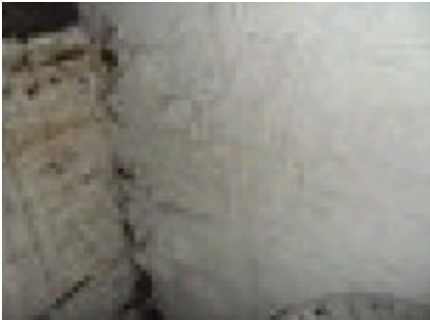
**Item 65 Ref: BS004231**

The Residue to wall (Boiler Room 3) contains asbestos.

Any change in its appearance should be recorded and passed to Property Services.

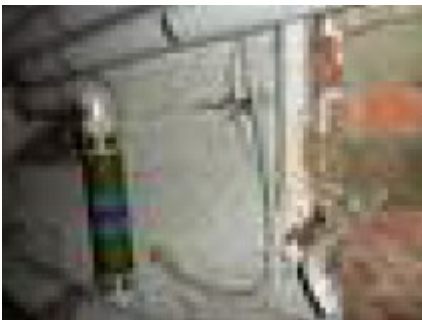
**Item 66 Ref: BS004232**

The Residue to wall (Boiler Room 3) does not contain asbestos.

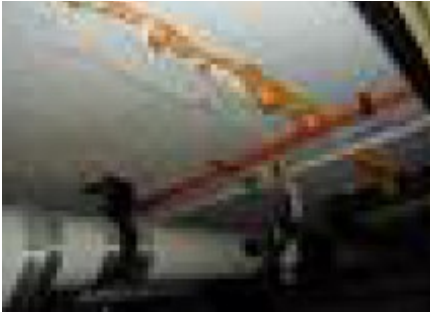
**Item 67 Ref: BS004234**

The Residue to ceiling (Boiler Room 3) contains asbestos.

Any change in its appearance should be recorded and passed to Property Services.

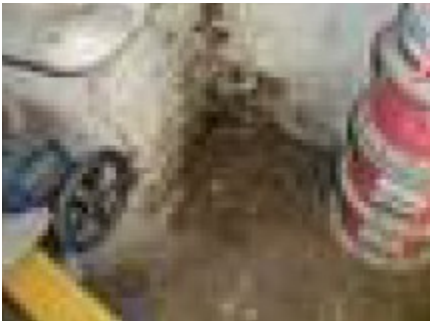
**Item 68 Ref: BS004235**

The Debris to floor (Boiler Room 3) does not contain asbestos.

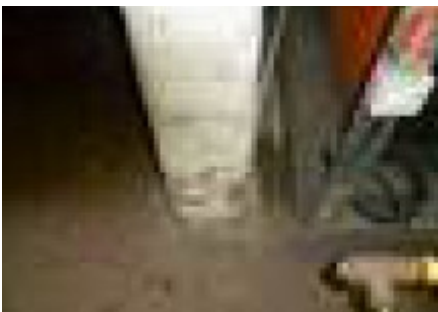
**Item 69 Ref: BS004236**

The Debris to floor (Boiler Room 3) does not contain asbestos.

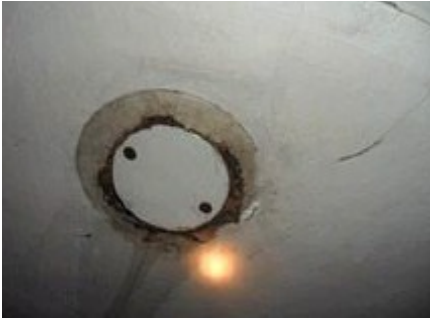
**Item 70 Ref: VP003636**

The Ceiling panels above s-ceiling (Corridor) do not contain asbestos.

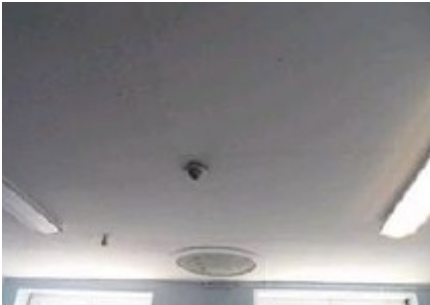
**Item 71 Ref: As VP003636**

The Fibreboard ceiling panel (Boys Toilet) does not contain asbestos.

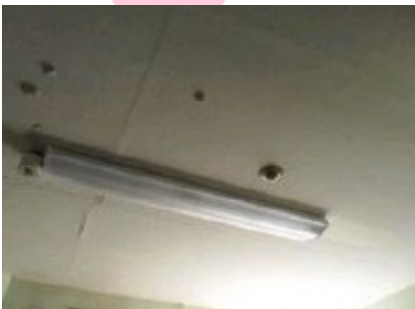
**Item 72 Ref: As VP003636**

The Fibreboard ceiling panel (Girls Toilet) does not contain asbestos.

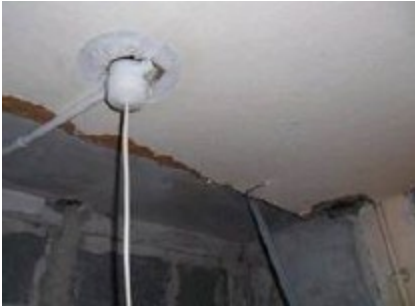
### **Item 73 Ref: As VP003636**

The Fibreboard ceiling panel (Staff Toilet) does not contain asbestos.

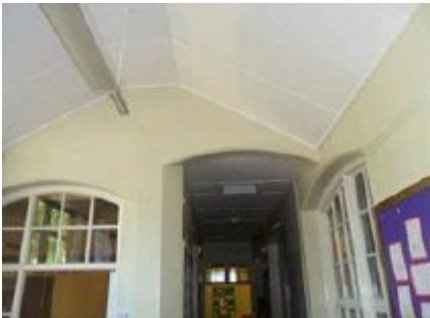
### **Item 74 Ref: As VP003636**

The Fibreboard ceiling panel (Year 2 Corridor) does not contain asbestos.

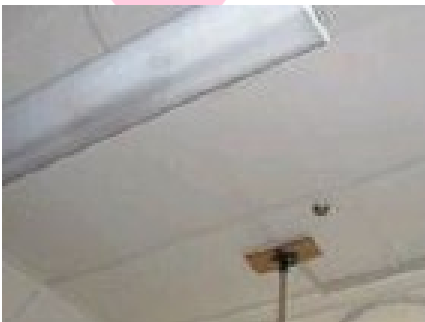
### **Item 75 Ref: As VP003636**

The Fibreboard ceiling panel (Teaching Area 2B) does not contain asbestos.

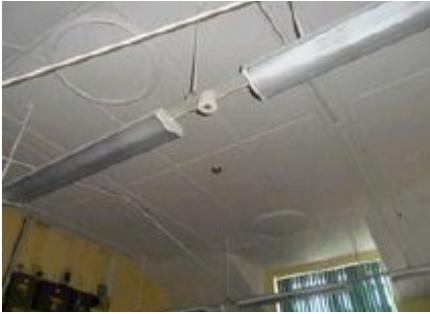
**Item 76 Ref: As VP003636**

The Fibreboard ceiling panel (Teaching Area 2A) does not contain asbestos.

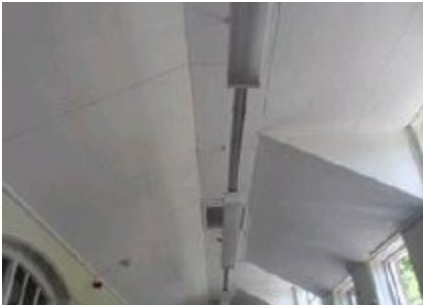
**Item 77 Ref: As VP003636**

The Fibreboard ceiling panel (Year 1 Corridor) does not contain asbestos.

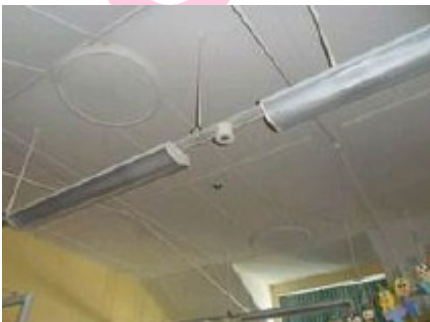
**Item 78 Ref: As VP003636**

The Fibreboard ceiling panel (Teaching Area 1B) does not contain asbestos.

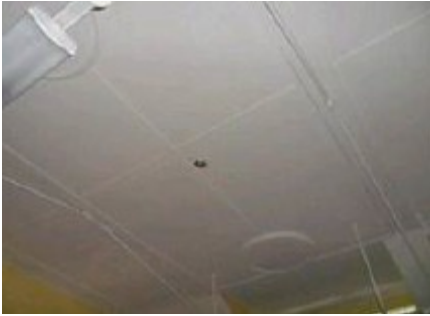
**Item 79 Ref: As VP003636**

The Fibreboard ceiling panel (Teaching Area 1A) does not contain asbestos.

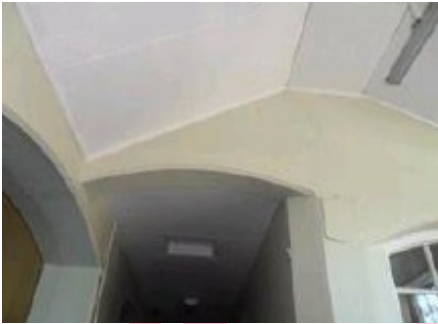
**Item 80 Ref: As VP003636**

The Fibreboard ceiling panel (Reception Corridor) does not contain asbestos.

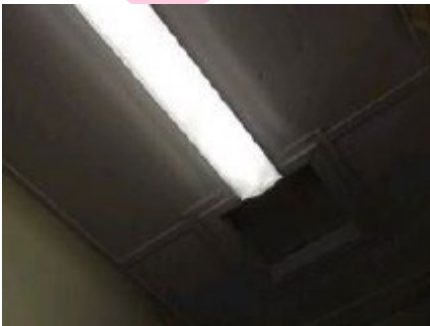
**Item 81 Ref: As VP003636**

The Fibreboard ceiling panel (Lobby) does not contain asbestos.

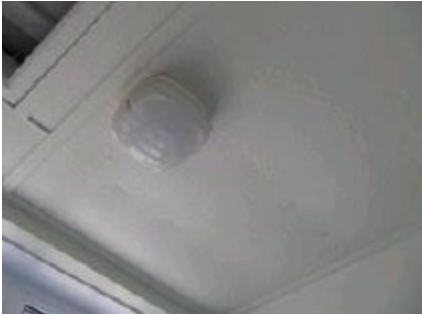
**Item 82 Ref: As VP003636**

The Fibreboard ceiling panel (Staff Toilet) does not contain asbestos.

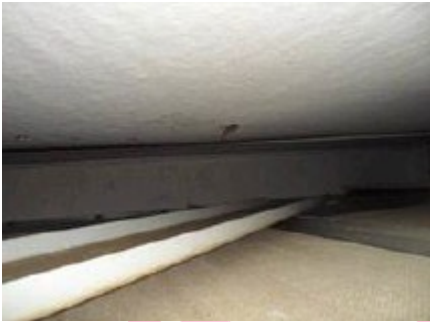
**Item 83 Ref: As VP003636**

The Fibreboard ceiling panel (Caretakes Room) does not contain asbestos.

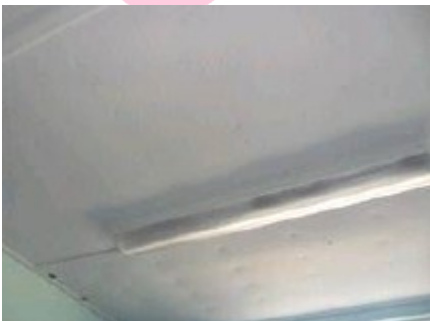
**Item 84 Ref: As VP003636**

The Fibreboard ceiling panel (Girls Toilet) does not contain asbestos.

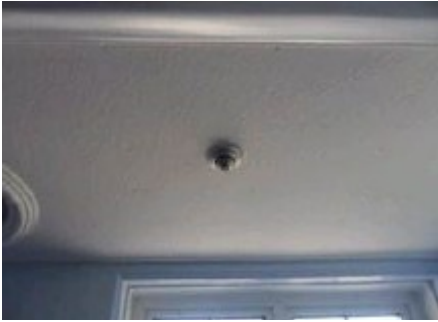
**Item 85 Ref: As VP003636**

The Fibreboard ceiling panel (Boys Toilet) does not contain asbestos.

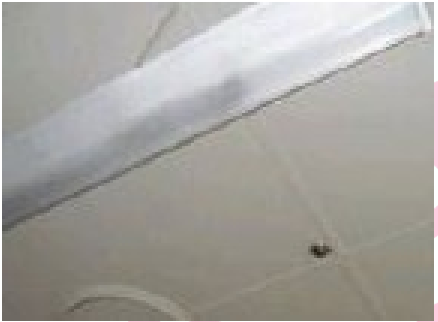
**Item 86 Ref: As VP003636**

The Fibreboard ceiling panel (Reception Class R3) does not contain asbestos.

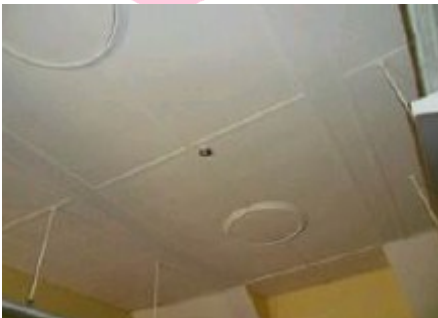
**Item 87 Ref: As VP003636**

The Fibreboard ceiling panel (Library L1) does not contain asbestos.

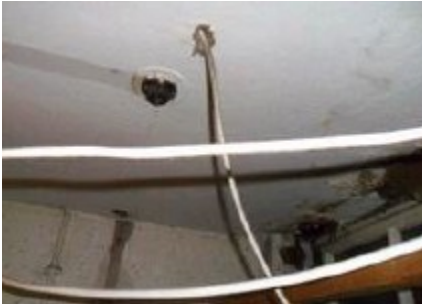
**Item 88 Ref: As VP003636**

The Fibreboard ceiling panel (Circulation) does not contain asbestos.

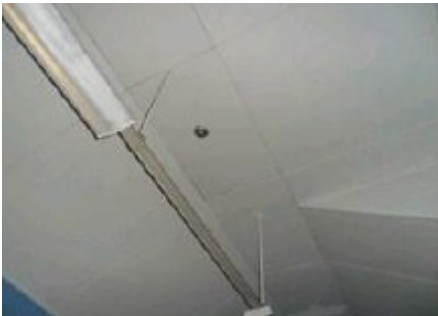
**Item 89 Ref: VP003637**

The Fibreboard Ceiling Panels (Year 3 Corridor) does not contain asbestos.

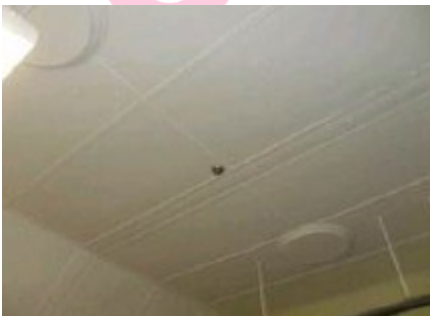
**Item 90 Ref: As VP003637**

The Fibreboard Ceiling Panels (Library L1) does not contain asbestos.

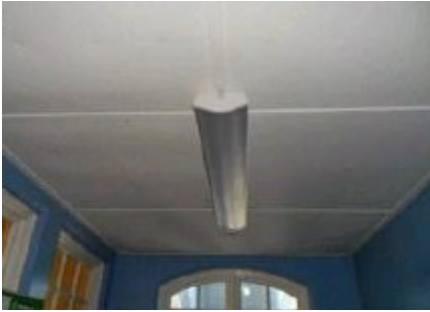
**Item 91 Ref: As VP003637**

The Fibreboard Ceiling Panels (Circulation) does not contain asbestos.

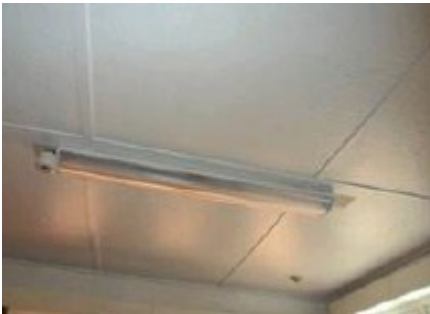
**Item 92 Ref: As VP003637**

The Fibreboard Ceiling Panels (Store) does not contain asbestos.

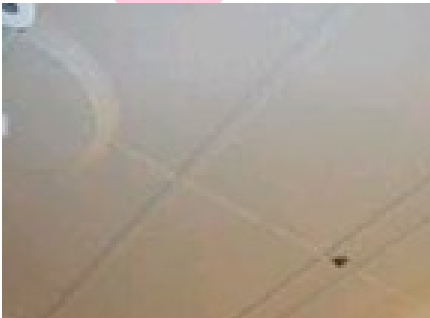
**Item 93 Ref: As VP003637**

The Fibreboard Ceiling Panels (Teaching Area 3) does not contain asbestos.

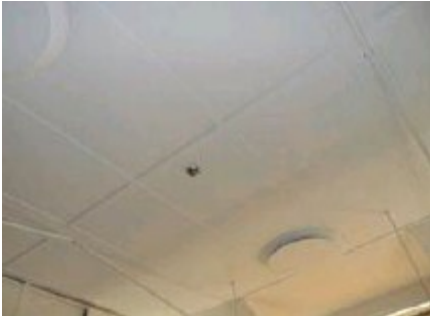
**Item 94 Ref: As VP003637**

The Fibreboard Ceiling Panels (Teaching Area 3B) does not contain asbestos.

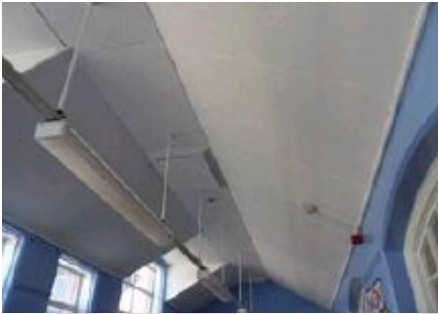
**Item 95 Ref: As VP003637**

The Fibreboard Ceiling Panels (Year 4 Corridor) does not contain asbestos.

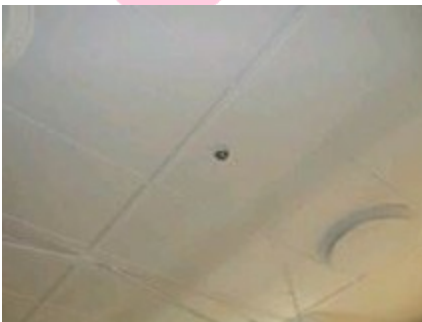
**Item 96 Ref: As VP003637**

The Fibreboard Ceiling Panels (Teaching Area 4A) does not contain asbestos.

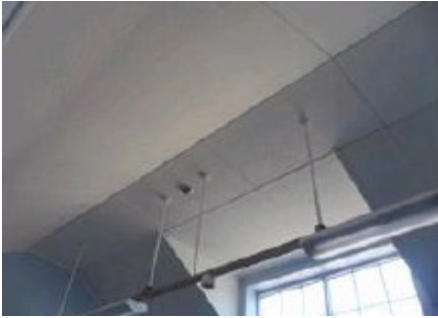
**Item 97 Ref: As VP003637**

The Fibreboard Ceiling Panels (Art Corridor) does not contain asbestos.

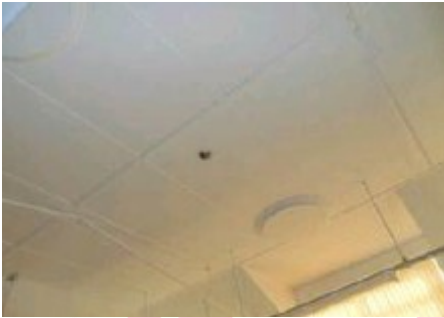
**Item 98 Ref: As VP003637**

The Fibreboard Ceiling Panels (Art Studio) does not contain asbestos.

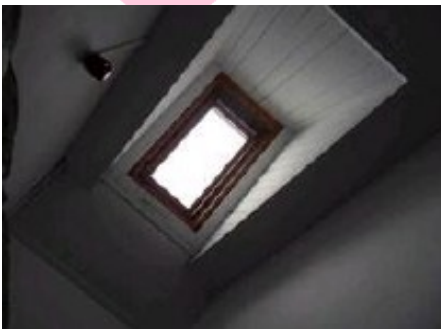
**Item 99 Ref: As VP003637**

The Fibreboard Ceiling Panels (Year 5 Corridor) does not contain asbestos.

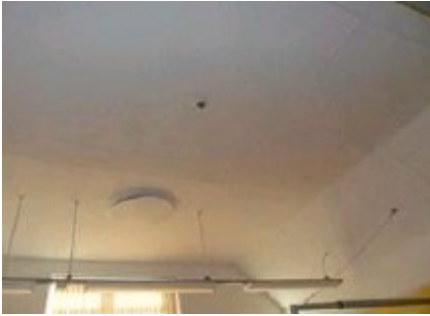
**Item 100 Ref: As VP003637**

The Fibreboard Ceiling Panels (Teaching Area 5A) does not contain asbestos.

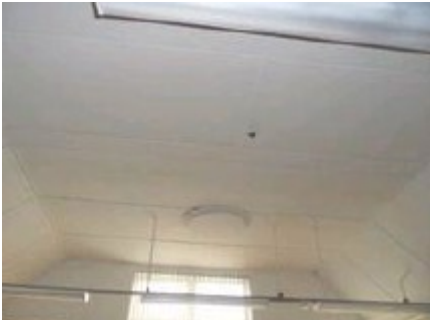
**Item 101 Ref: As VP003637**

The Fibreboard Ceiling Panels (Teaching Area 5B) does not contain asbestos.

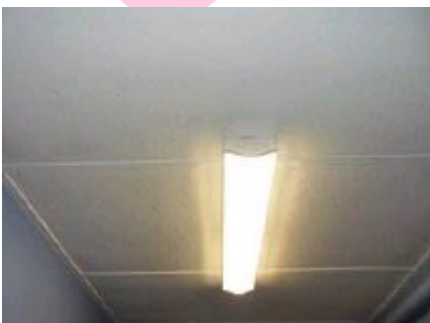
**Item 102 Ref: As VP003637**

The Fibreboard Ceiling Panels (Circulation) does not contain asbestos.

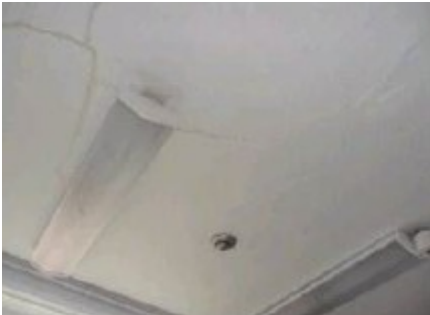
**Item 104 Ref: As VP003644**

The Textured coating to ceiling (Girls Toilet) does not contain asbestos.

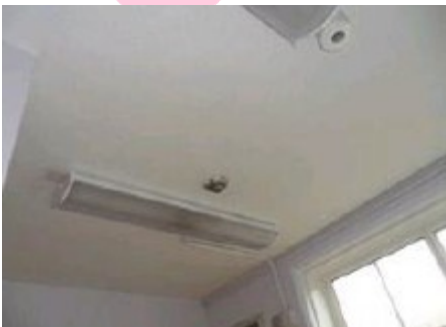
**Item 105 Ref: As VP003644**

The Textured coating to ceiling (Boys Toilet) does not contain asbestos.

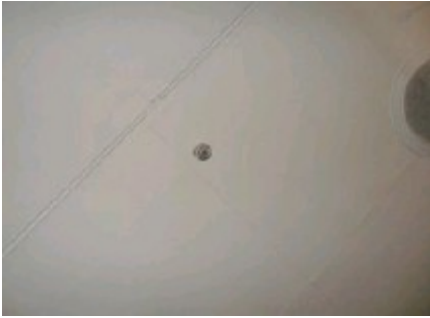
**Item 106 Ref: VP003645**

The Fibreboard ceiling panels (Teaching Area 6C) does not contain asbestos.

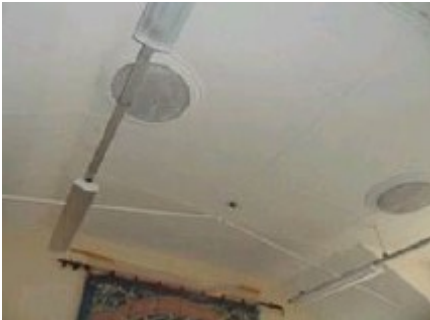
**Item 107 Ref: As VP003645**

The Fibreboard ceiling panels (Parents Room) does not contain asbestos.

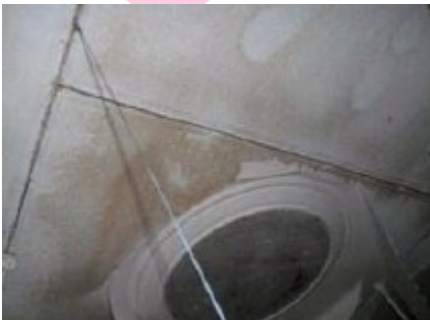
**Item 108 Ref: As VP003645**

The Fibreboard ceiling panels (Teaching Area 6A) does not contain asbestos.

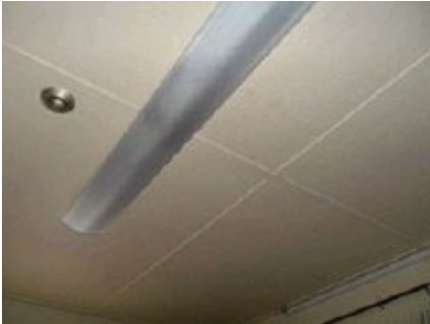
**Item 109 Ref: As VP003645**

The Fibreboard ceiling panels (Store) does not contain asbestos.

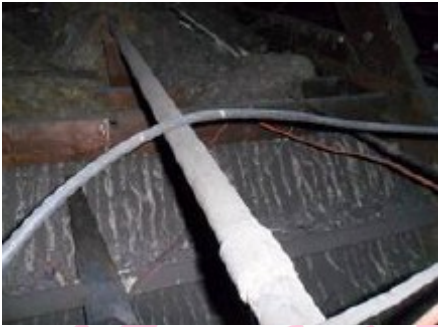
**Item 110 Ref: VP003657**

The Residue to pipework (Loft 1) does not contain asbestos.

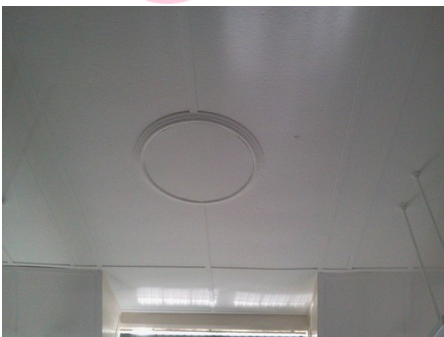
**Item 111 Ref: 47656-15**

The Ceiling (Classroom/003) does not contain asbestos.

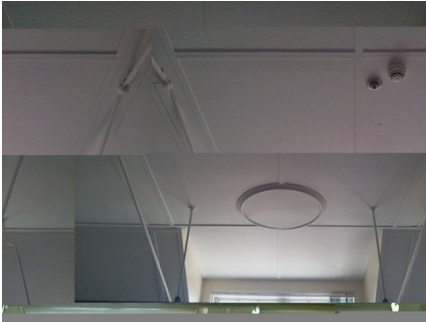
**Item 112 Ref: 47656-16**

The Ceiling (Classroom/005)  
does not contain asbestos.

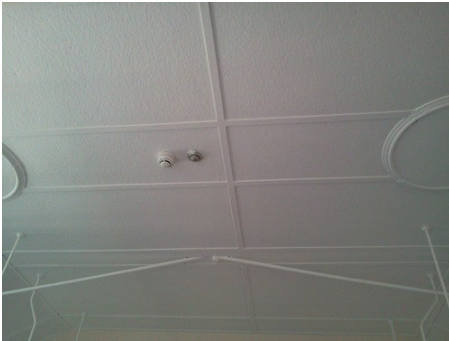
**Item 113 Ref: As 47656-16**

The Ceiling (Classroom/006)  
does not contain asbestos.

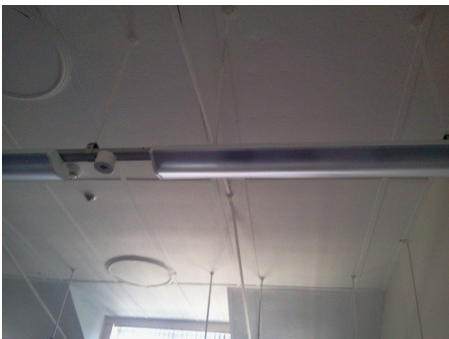
**Item 114 Ref: 47656-15**

The Ceiling (Classroom/007)  
does not contain asbestos.

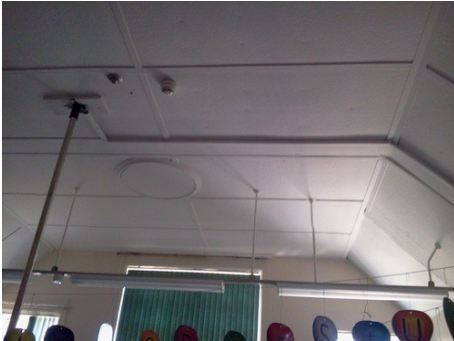
**Item 115 Ref: 47656-17**

The Ceiling (Classroom/008) does not contain asbestos.

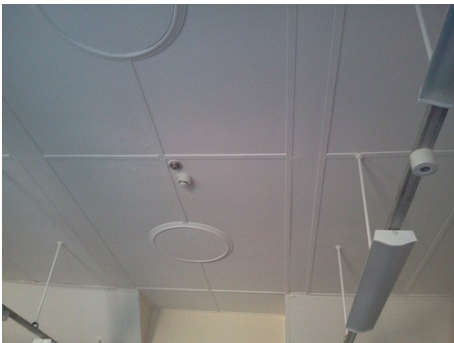
**Item 116 Ref: As 47656-17**

The Ceiling (Classroom/009) does not contain asbestos.

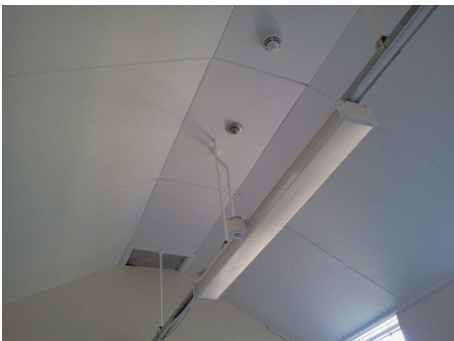
**Item 117 Ref: 47656-18**

The Pitched ceiling (Corridor/011) does not contain asbestos.

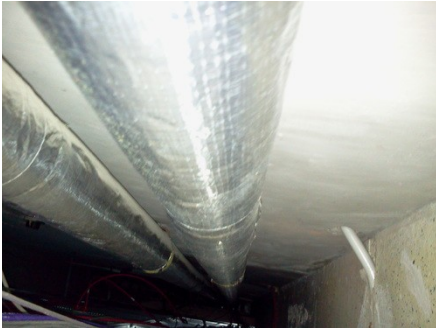
**Item 118 Ref: As 47656-13**

The Fixed ceiling (Corridor void above/012) does not contain asbestos.

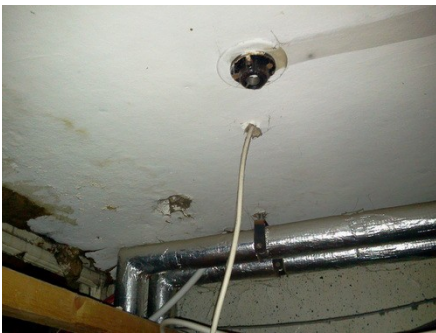
**Item 119 Ref: 47656-13**

The Fixed ceiling (Corridor void above/013) does not contain asbestos.

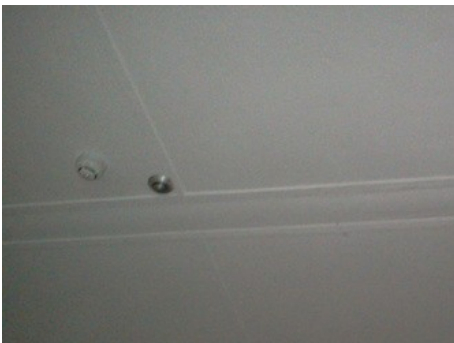
**Item 120 Ref: 47656-19**

The Ceiling (Classroom/019) does not contain asbestos.

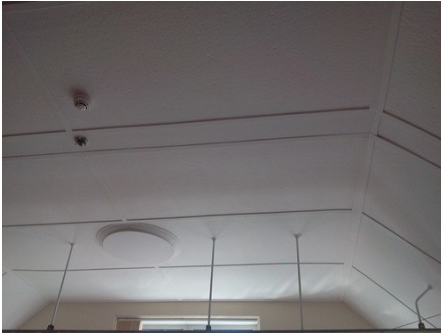
**Item 121 Ref: As 47656-19**

The Ceiling (Classroom/021)  
does not contain asbestos.

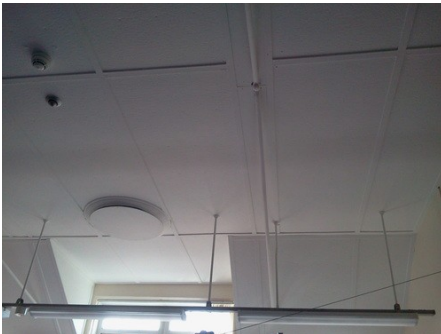
**Item 122 Ref: As 47656-19**

The Ceiling (Classroom/022)  
does not contain asbestos.

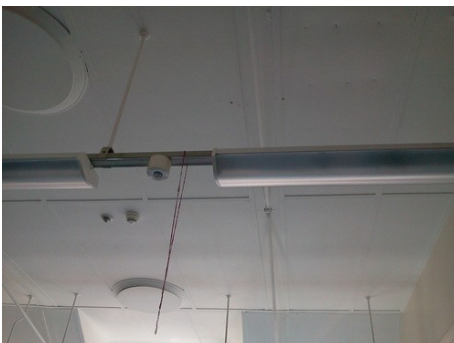
**Item 123 Ref: 47656-20**

The Ceiling (Classroom/023)  
does not contain asbestos.

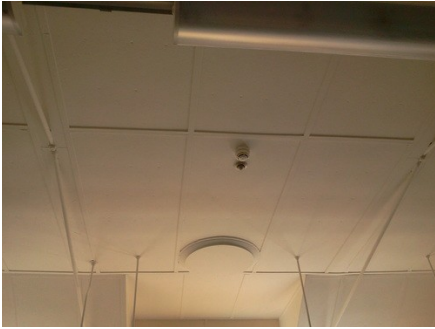
**Item 124 Ref: As 47656-20**

The Ceiling (Classroom/025)  
does not contain asbestos.

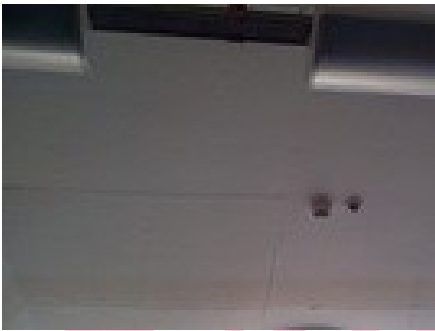
**Item 125 Ref: 47656-21**

The Ceiling (Classroom/026)  
does not contain asbestos.

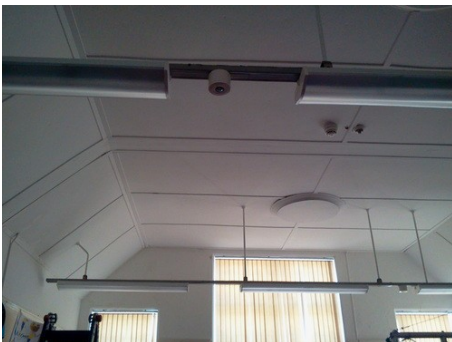
**Item 126 Ref: As 47656-20**

The Ceiling (Classroom/028)  
does not contain asbestos.

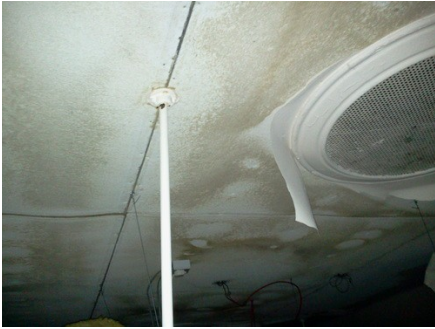
**Item 127 Ref: 47656-22**

The Ceiling (Classroom/032 void above) does not contain asbestos.

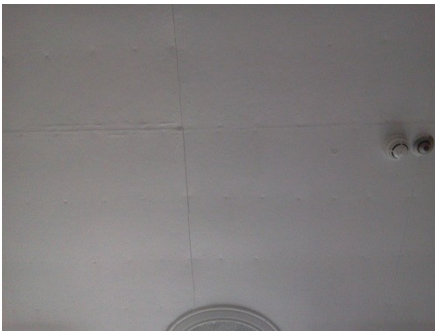
**Item 128 Ref: As 47656-9**

The Ceiling (Classroom/033) does not contain asbestos.

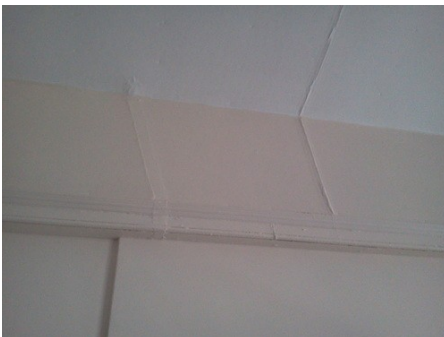
**Item 129 Ref: As 47656-9**

The High level panels (Classroom/033) does not contain asbestos.

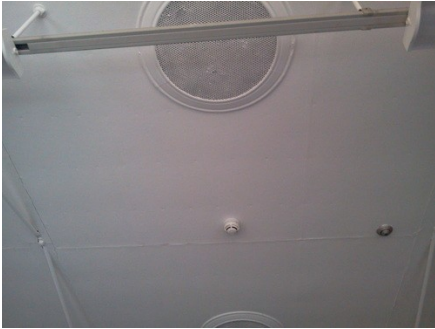
**Item 130 Ref: 47656-9**

The Ceiling (Community Room/034) does not contain asbestos.

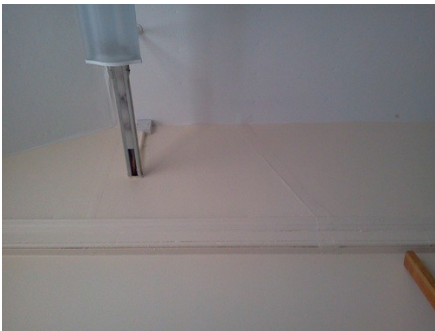
**Item 131 Ref: As 47656-9**

The High level panels (Community Room/034) does not contain asbestos.

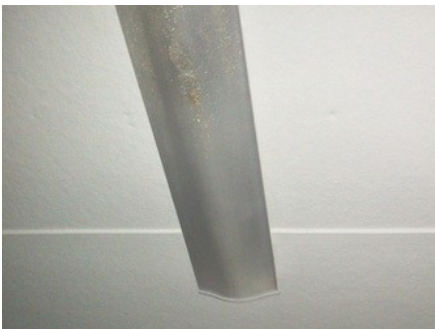
**Item 132 Ref: 47656-12**

The Ceiling (Corridor/036) does not contain asbestos.

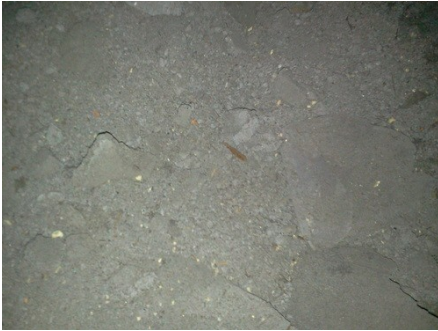
**Item 133 Ref: 47656-1**

The Debris to ceiling below reception (Loft Space/ 1/001) does not contain asbestos.

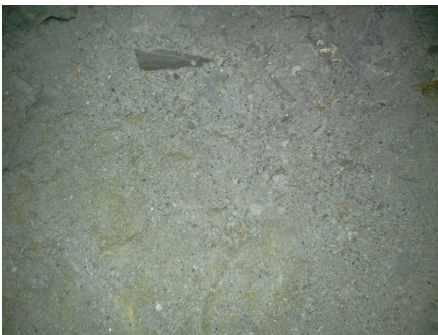
**Item 134 Ref: 47656-2**

The Debris to ceiling below year 1 (Loft Space/ 1/001) does not contain asbestos.

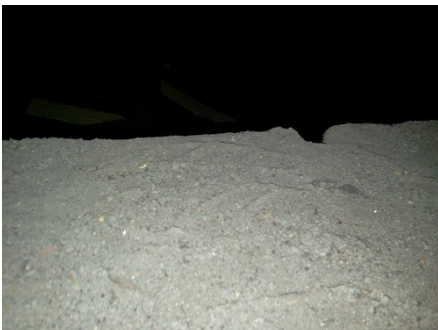
**Item 135 Ref: 47656-3**

The Debris to ceiling below year 2 (Loft Space/ 1/001) does not contain asbestos.

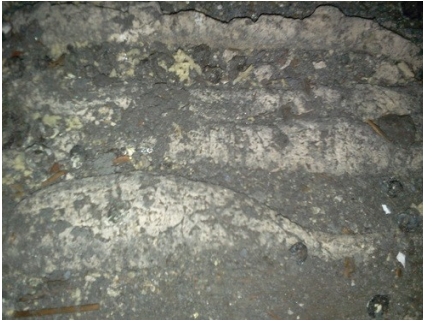
**Item 136 Ref: 47656-4**

The Debris to ceiling below year 5 (Loft Space/ 1/002) does not contain asbestos.

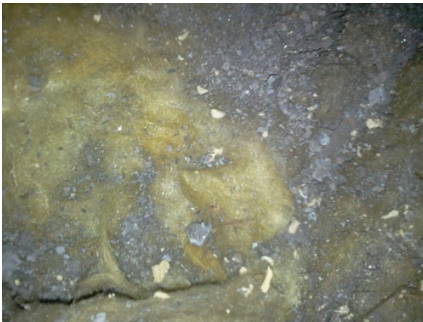
**Item 137 Ref: 47656-5**

The Debris to ceiling below year 4 (Loft Space/ 1/002) does not contain asbestos.

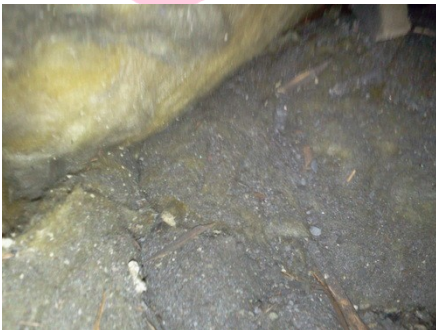
**Item 138 Ref: 47656-6**

The Debris to ceiling below year 3 (Loft Space/ 1/002) does not contain asbestos.

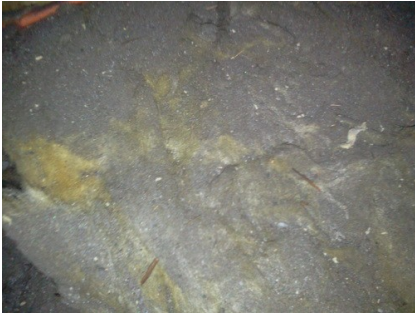
**Item 139 Ref: 47656-7**

The Debris to ceiling below equipment store (Loft Space/ 1/003) does not contain asbestos.

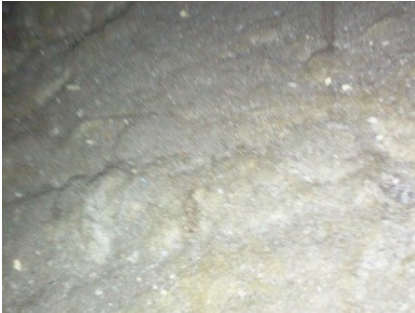
**Item 140 Ref: 47656-8**

The Debris to ceiling below community room (Loft Space/ 1/003) does not contain asbestos.

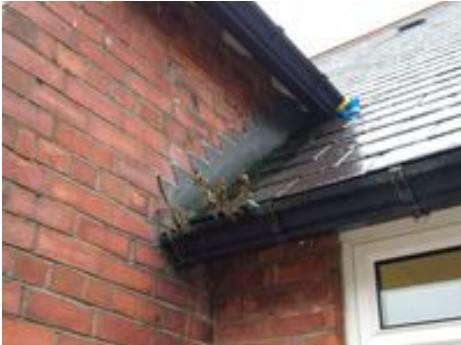
**Item 142 Ref: 451175-1**

The flashing to roof (External main building slated roofs) does not contain asbestos.

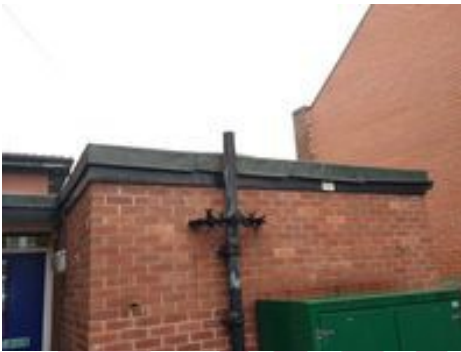
**Item 143 Ref: 451175-3**

The roof covering (External Roof 5) does not contain asbestos.
