ASBESTOS SURVEY REPORT FOR JOHN F KENNEDY PRIMARY SCHOOL, WASHINGTON

Asbestos Register for

JOHN F KENNEDY PRIMARY SCHOOL, WASHINGTON

Date: 26 September 2024

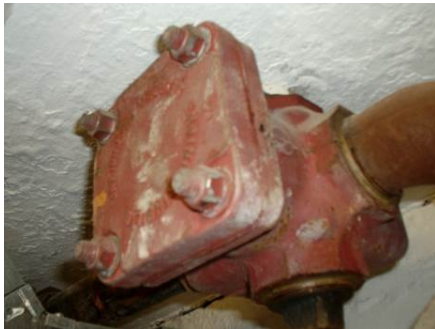
Item 1 Ref: JP0672/07

The gasket to the pipe joints in the boiler room (Room B1/1) does not contain asbestos.

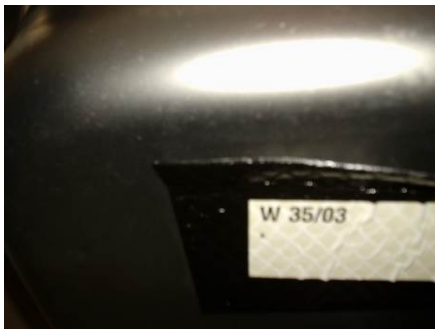
Item 2 - Ref: JP0650/07

The sink pad from the classroom (Room 0/16) does not contain asbestos.

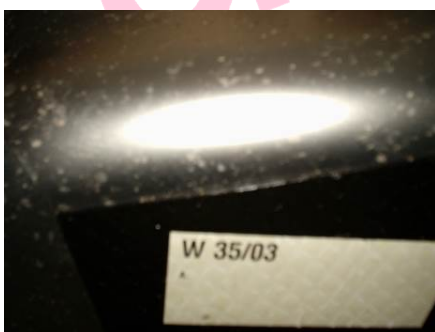
Item 3 - Ref: JP0651/07

The sink pad to the classroom (Room 0/17) does not contain asbestos.

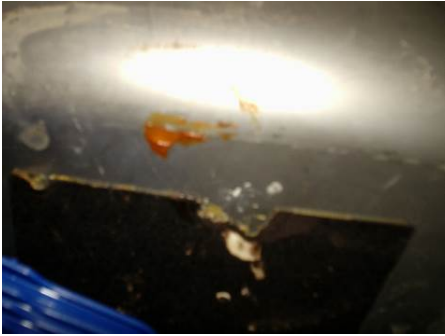
Item 10 - Ref: JP0658/07

The sink pad to the classroom (Room 0/54) does not contain asbestos.

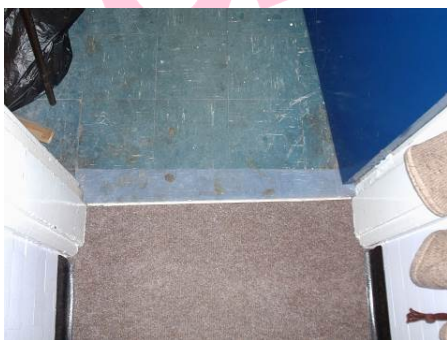
Item 18 - Ref:JP0666/07

The blue floor tiles to the caretakers office (Room 0/74) does not contain asbestos

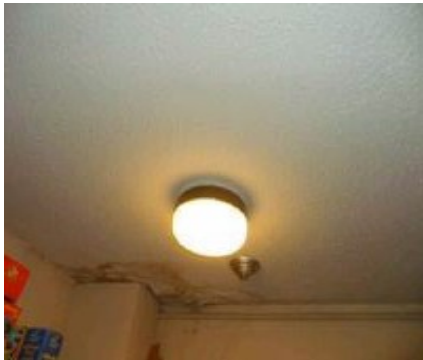
Item 25 - As:VP003646

The textured coating to the ceiling within the Domestic Service Room contains asbestos.

Removed July 2024

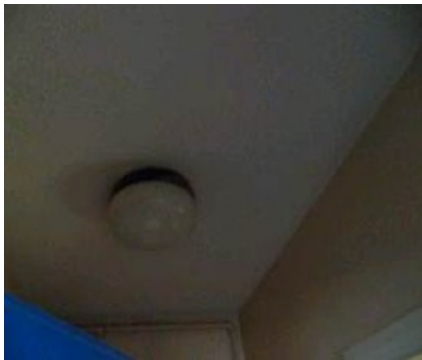
Item 26 - As:VP003646

The textured coating to the ceiling within the toilets contains asbestos.

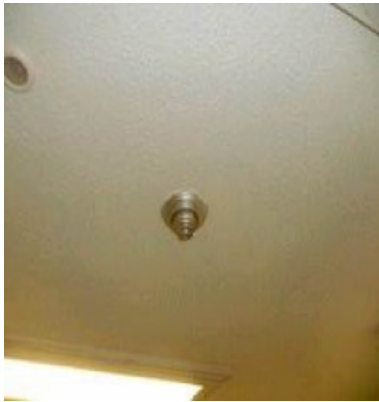
Item 28 - As:VP003646

The textured coating to the ceiling within the entrance lobby contains asbestos.

Removed July 2024

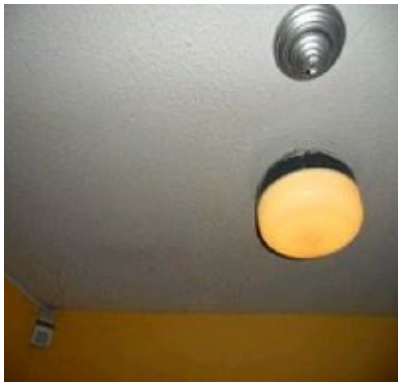
Item 29 - As:VP003646

The textured coating to the ceiling within the store room contains asbestos.

Removed July 2024

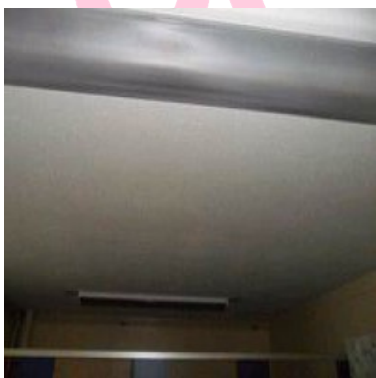
Item 30: As VP003646

The textured coating to the ceiling within the toilets contains asbestos.

Removed July 2024

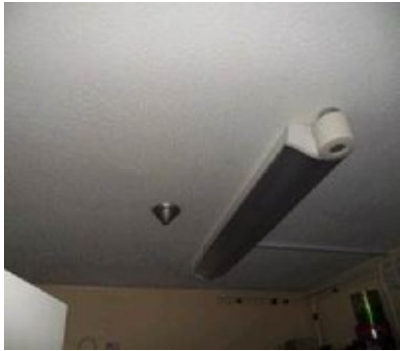
Item 31 - As:VP003646

The textured coating to the ceiling within the utility contains asbestos.

Removed July 2024

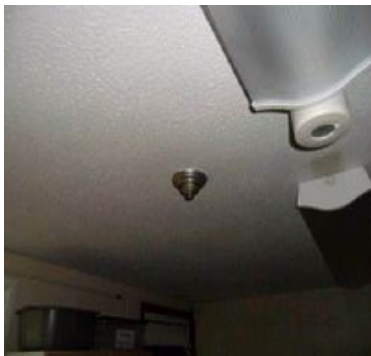
Item 32 - As:VP003646

The textured coating to the ceiling within the kitchen contains asbestos.

Removed July 2024

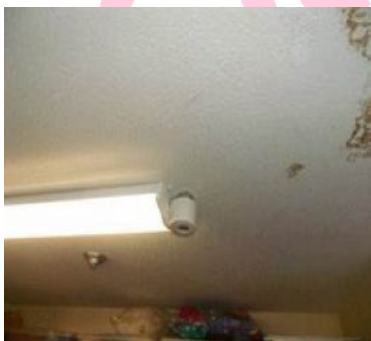
Item 33: As VP003646

The textured coating to the ceiling within the store contains asbestos.

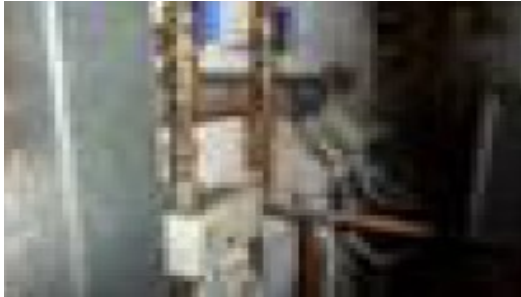
Item 49 Ref: BS004215

The Residue to wall (Boiler Room 1) does not contain asbestos.

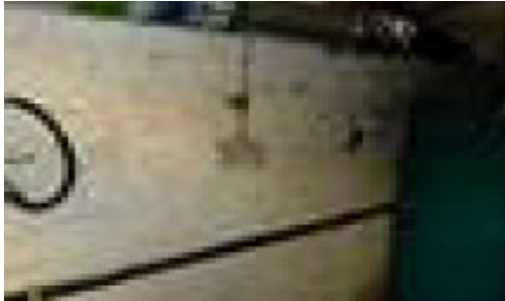
Item 58 Ref: BS004224

The Residue to wall (Boiler Room 2) does not contain asbestos.

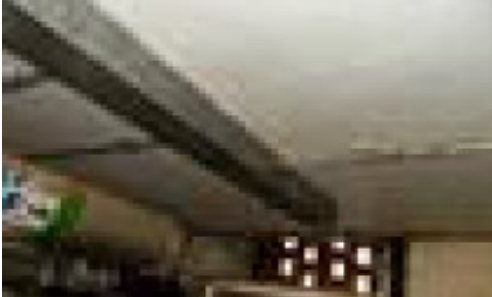
Item 61 Ref: BS004227

The Residue to ceiling (Boiler Room 2) does not contain asbestos.

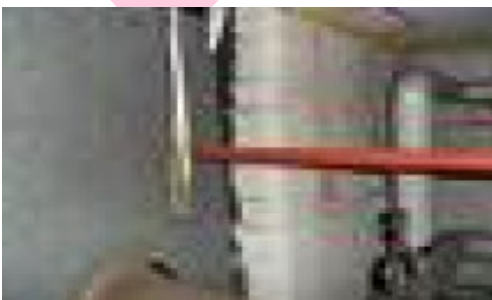
Item 63 Ref: BS004229

The Residue to wall (Boiler Room 3) does not contain asbestos.

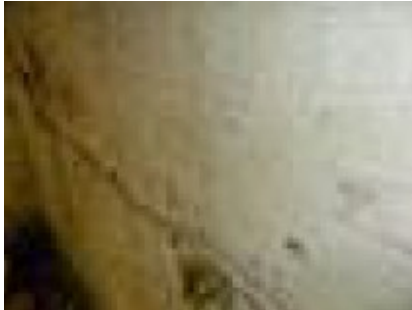
Item 64 Ref: BS004230

The Residue to wall (Boiler Room 3) does not contain asbestos.

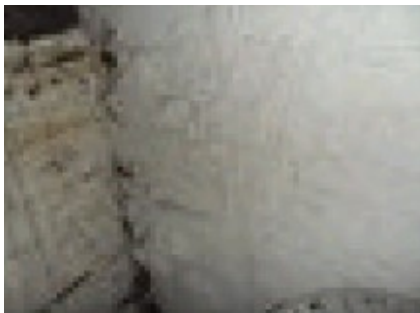
Item 65 Ref: BS004231

The Residue to wall (Boiler Room 3) contains asbestos.

Any change in its appearance should be recorded and passed to Property Services.

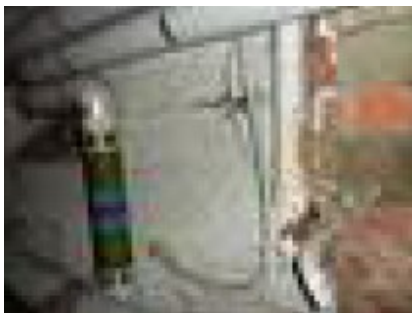
Item 66 Ref: BS004232

The Residue to wall (Boiler Room 3) does not contain asbestos.

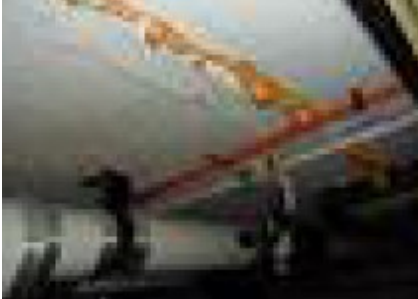
Item 67 Ref: BS004234

The Residue to ceiling (Boiler Room 3) contains asbestos.

Any change in its appearance should be recorded and passed to Property Services.

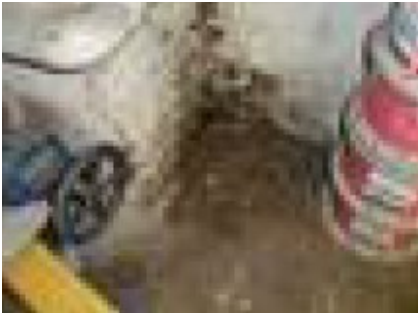
Item 68 Ref: BS004235

The Debris to floor (Boiler Room 3) does not contain asbestos.

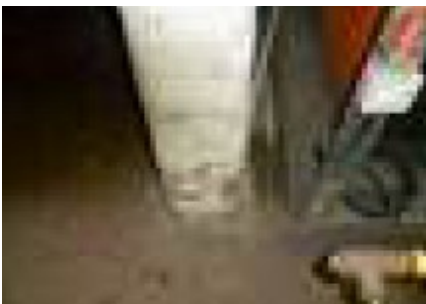
Item 69 Ref: BS004236

The Debris to floor (Boiler Room 3) does not contain asbestos.

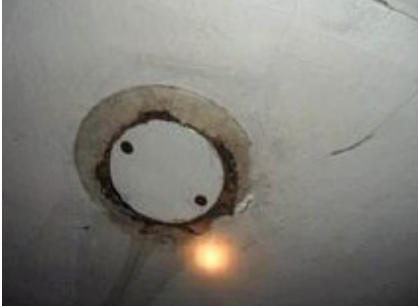
Item 70 Ref: VP003636

The Ceiling panels above s-ceiling (Corridor) do not contain asbestos.

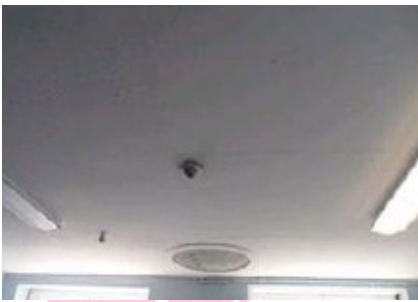
Item 71 Ref: As VP003636

The Fibreboard ceiling panel (Boys Toilet) does not contain asbestos.

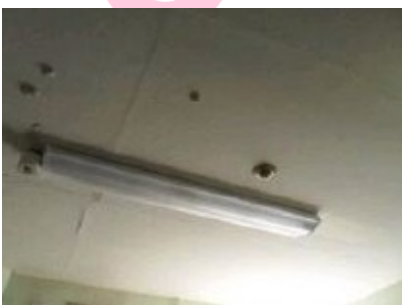
Item 72 Ref: As VP003636

The Fibreboard ceiling panel (Girls Toilet) does not contain asbestos.

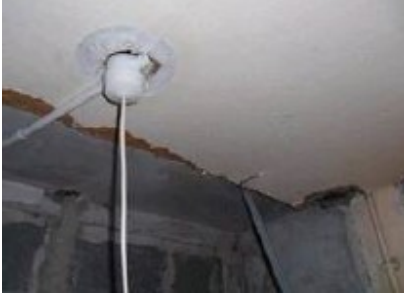
Item 73 Ref: As VP003636

The Fibreboard ceiling panel (Staff Toilet) does not contain asbestos.

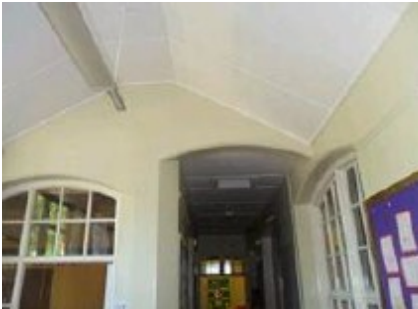
Item 74 Ref: As VP003636

The Fibreboard ceiling panel (Year 2 Corridor) does not contain asbestos.

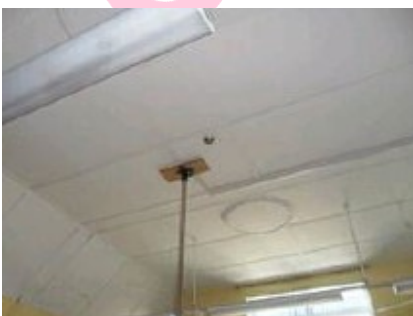
Item 75 Ref: As VP003636

The Fibreboard ceiling panel (Teaching Area 2B) does not contain asbestos.

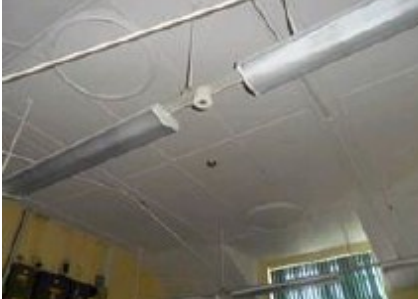
Item 76 Ref: As VP003636

The Fibreboard ceiling panel (Teaching Area 2A) does not contain asbestos.

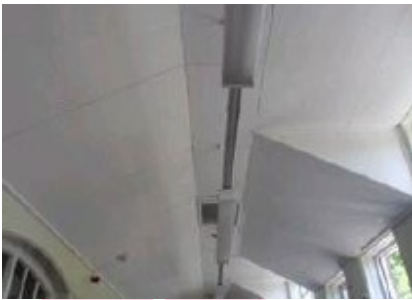
Item 77 Ref: As VP003636

The Fibreboard ceiling panel (Year 1 Corridor) does not contain asbestos.

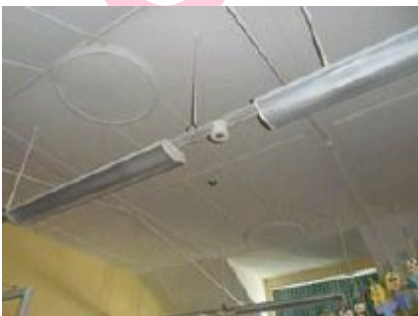
Item 78 Ref: As VP003636

The Fibreboard ceiling panel (Teaching Area 1B) does not contain asbestos.

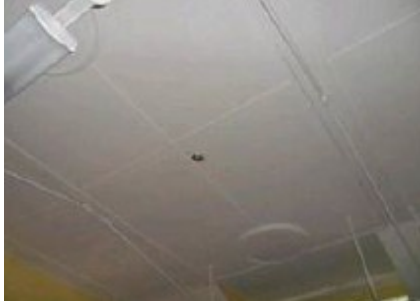
Item 79 Ref: As VP003636

The Fibreboard ceiling panel (Teaching Area 1A) does not contain asbestos.

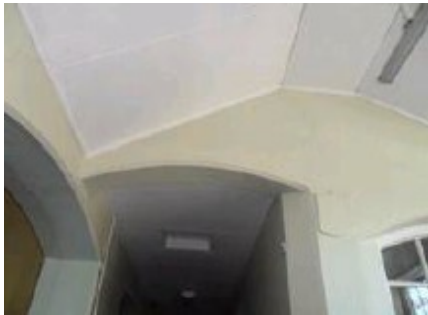
Item 80 Ref: As VP003636

The Fibreboard ceiling panel (Reception Corridor) does not contain asbestos.

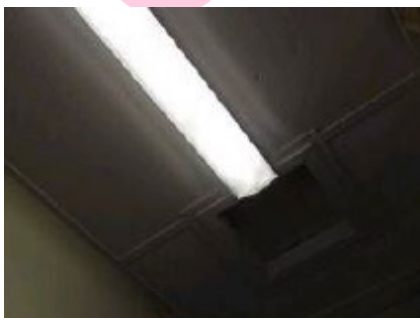
Item 81 Ref: As VP003636

The Fibreboard ceiling panel (Lobby) does not contain asbestos.

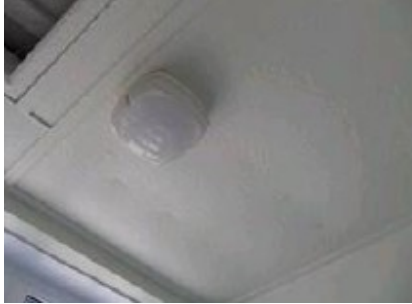
Item 82 Ref: As VP003636

The Fibreboard ceiling panel (Staff Toilet) does not contain asbestos.

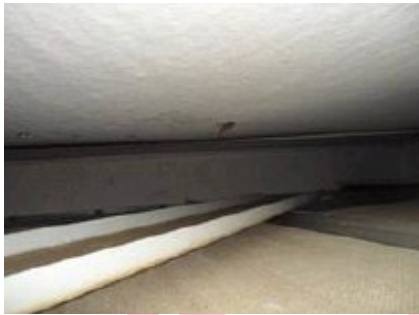
Item 83 Ref: As VP003636

The Fibreboard ceiling panel (Caretaker's Room) does not contain asbestos.

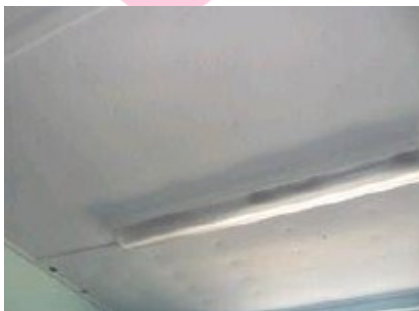
Item 84 Ref: As VP003636

The Fibreboard ceiling panel (Girls Toilet) does not contain asbestos.

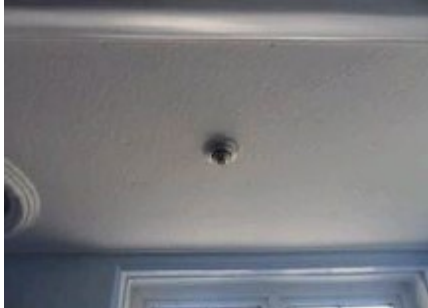
Item 85 Ref: As VP003636

The Fibreboard ceiling panel (Boys Toilet) does not contain asbestos.

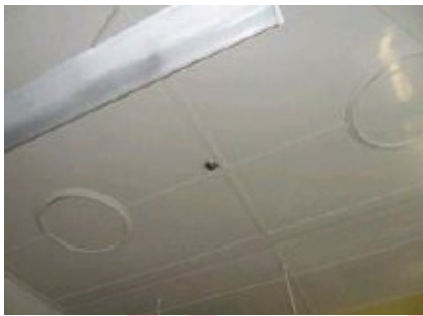
Item 86 Ref: As VP003636

The Fibreboard ceiling panel (Reception Class R3) does not contain asbestos.

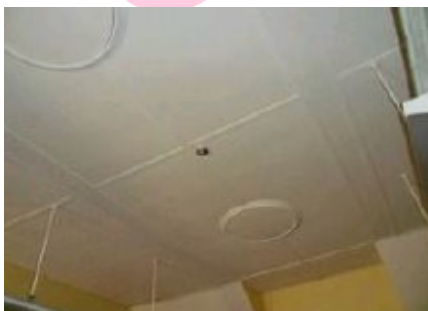
Item 87 Ref: As VP003636

The Fibreboard ceiling panel (Library L1) does not contain asbestos.

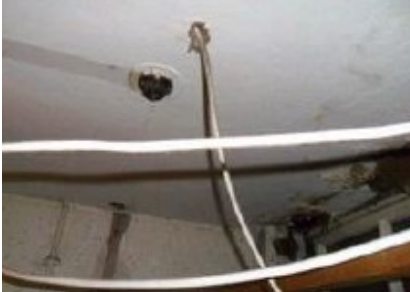
Item 88 Ref: As VP003636

The Fibreboard ceiling panel (Circulation) does not contain asbestos.

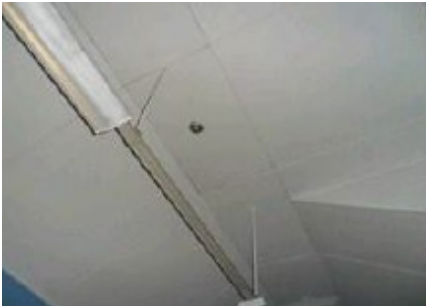
Item 89 Ref: VP003637

The Fibreboard Ceiling Panels (Year 3 Corridor) does not contain asbestos.

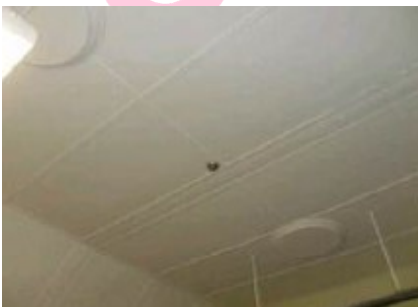
Item 90 Ref: As VP003637

The Fibreboard Ceiling Panels (Library L1) does not contain asbestos.

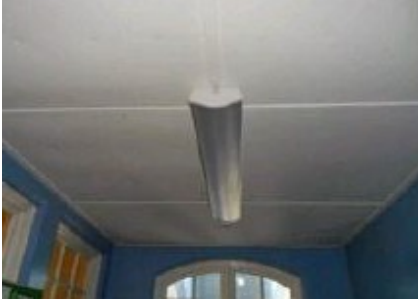
Item 91 Ref: As VP003637

The Fibreboard Ceiling Panels (Circulation) does not contain asbestos.

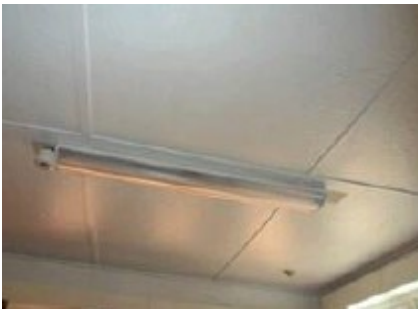
Item 92 Ref: As VP003637

The Fibreboard Ceiling Panels (Store) does not contain asbestos.

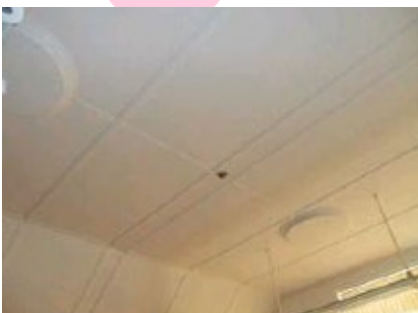
Item 93 Ref: As VP003637

The Fibreboard Ceiling Panels (Teaching Area 3) does not contain asbestos.

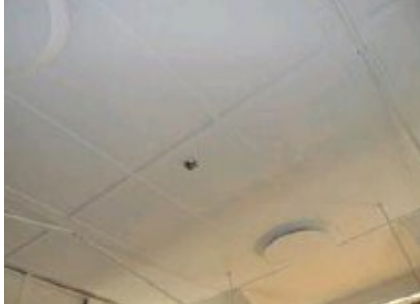
Item 94 Ref: As VP003637

The Fibreboard Ceiling Panels (Teaching Area 3B) does not contain asbestos.

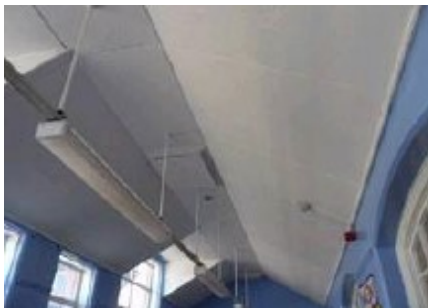
Item 95 Ref: As VP003637

The Fibreboard Ceiling Panels (Year 4 Corridor) does not contain asbestos.

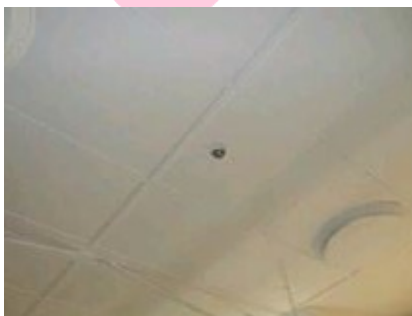
Item 96 Ref: As VP003637

The Fibreboard Ceiling Panels (Teaching Area 4A) does not contain asbestos.

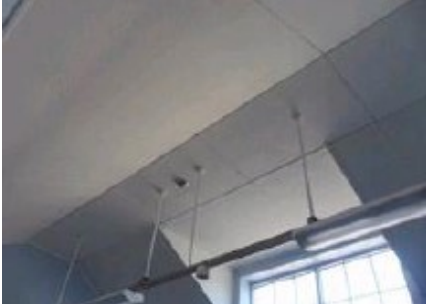
Item 97 Ref: As VP003637

The Fibreboard Ceiling Panels (Art Corridor) does not contain asbestos.

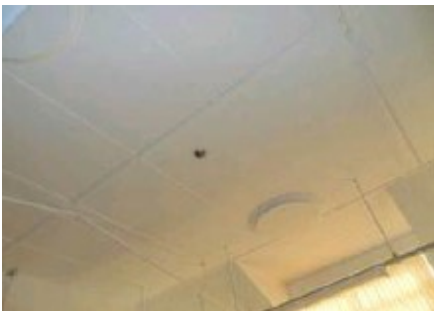
Item 98 Ref: As VP003637

The Fibreboard Ceiling Panels (Art Studio) does not contain asbestos.

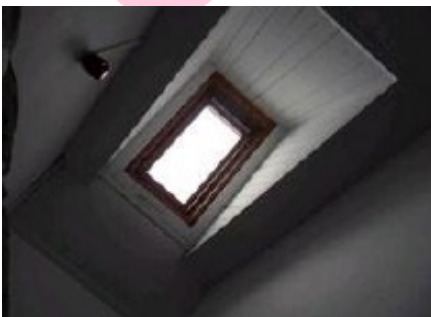
Item 99 Ref: As VP003637

The Fibreboard Ceiling Panels (Year 5 Corridor) does not contain asbestos.

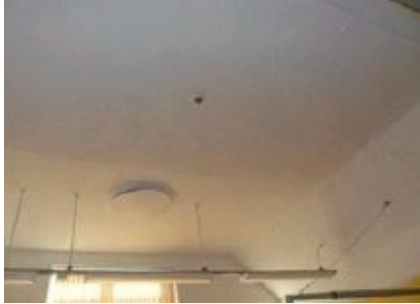
Item 100 Ref: As VP003637

The Fibreboard Ceiling Panels (Teaching Area 5A) does not contain asbestos.

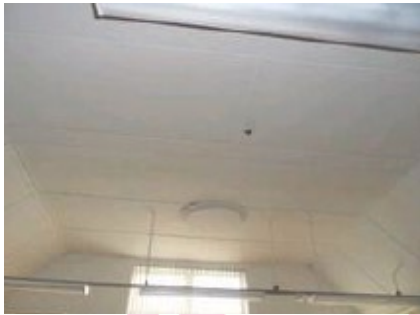
Item 101 Ref: As VP003637

The Fibreboard Ceiling Panels (Teaching Area 5B) does not contain asbestos.

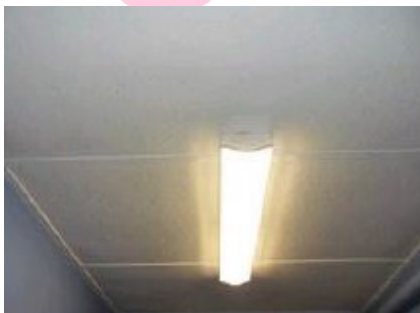
Item 102 Ref: As VP003637

The Fibreboard Ceiling Panels (Circulation) does not contain asbestos.

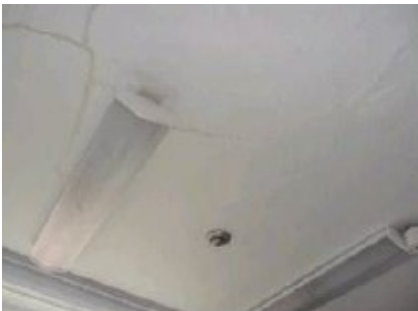
Item 104 Ref: As VP003644

The Textured coating to ceiling (Girls Toilet) does not contain asbestos.

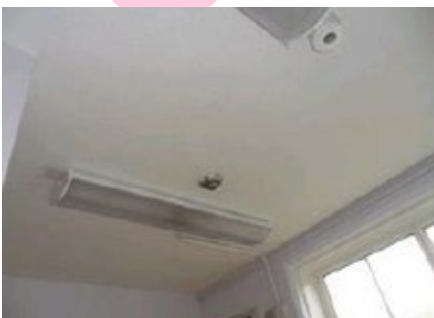
Item 105 Ref: As VP003644

The Textured coating to ceiling (Boys Toilet) does not contain asbestos.

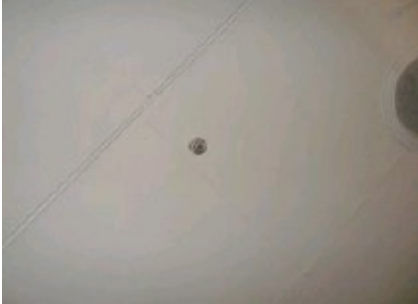
Item 106 Ref: VP003645

The Fibreboard ceiling panels (Teaching Area 6C) does not contain asbestos.

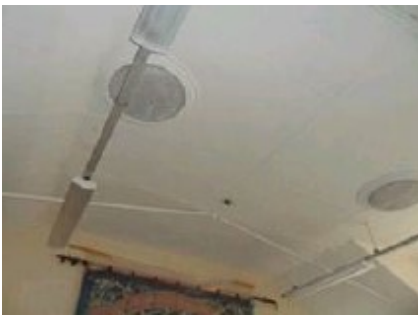
Item 107 Ref: As VP003645

The Fibreboard ceiling panels (Parents Room) does not contain asbestos.

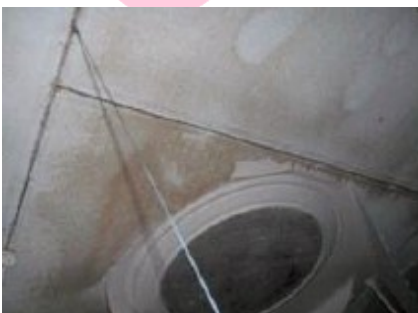
Item 108 Ref: As VP003645

The Fibreboard ceiling panels (Teaching Area 6A) does not contain asbestos.

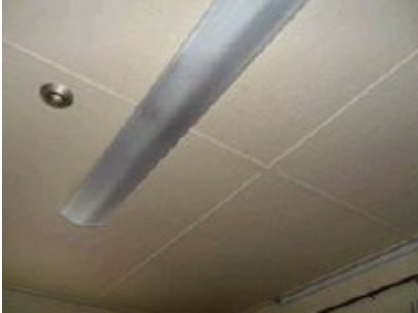
Item 109 Ref: As VP003645

The Fibreboard ceiling panels (Store) does not contain asbestos.

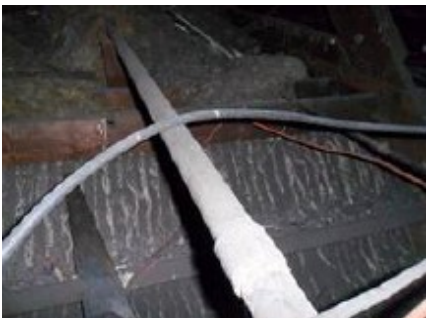
Item 110 Ref: VP003657

The Residue to pipework (Loft 1) does not contain asbestos.

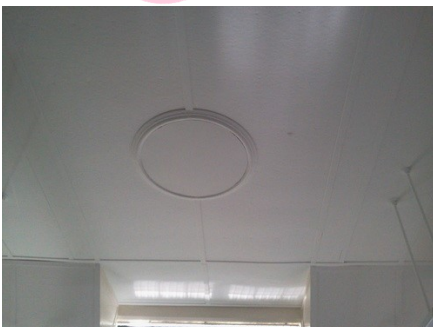
Item 111 Ref: 47656-15

The Ceiling (Classroom/003) does not contain asbestos.

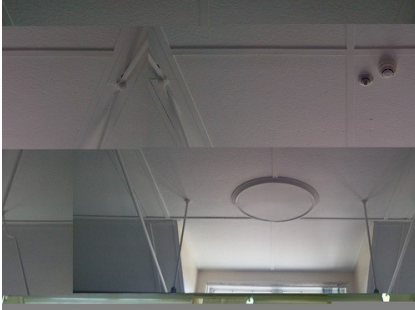
Item 112 Ref: 47656-16

The Ceiling (Classroom/005)
does not contain asbestos.

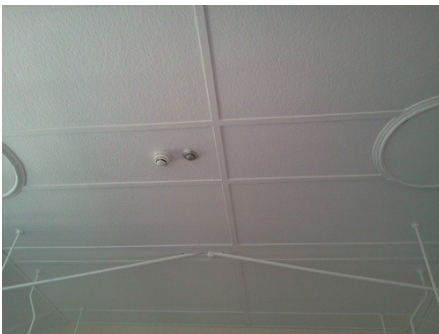
Item 113 Ref: As 47656-16

The Ceiling (Classroom/006)
does not contain asbestos.

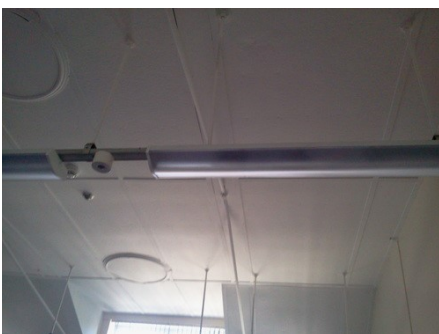
Item 114 Ref: 47656-15

The Ceiling (Classroom/007)
does not contain asbestos.

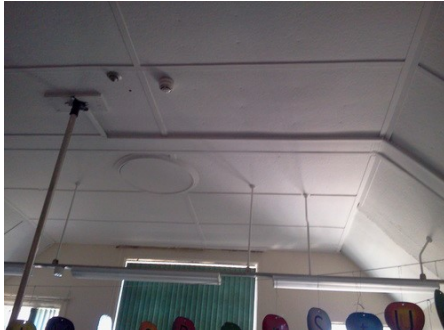
Item 115 Ref: 47656-17

The Ceiling (Classroom/008)
does not contain asbestos.

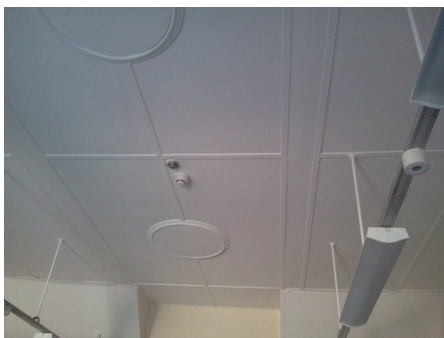
Item 116 Ref: As 47656-17

The Ceiling (Classroom/009)
does not contain asbestos.

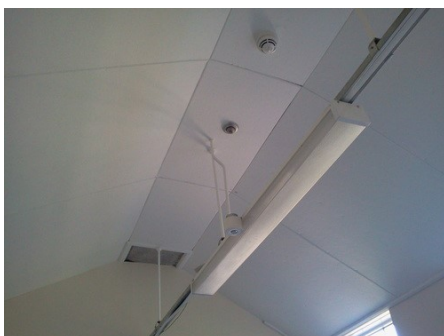
Item 117 Ref: 47656-18

The Pitched ceiling
(Corridor/011) does not
contain asbestos.

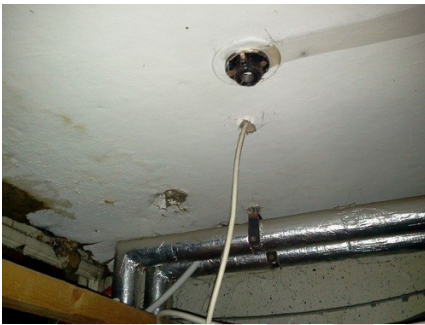
Item 119 Ref: 47656-13

The Fixed ceiling (Corridor void above/013) does not contain asbestos.

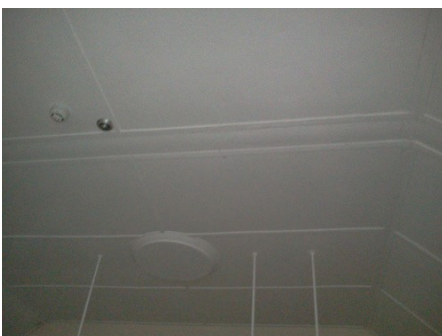
Item 120 Ref: 47656-19

The Ceiling (Classroom/019) does not contain asbestos.

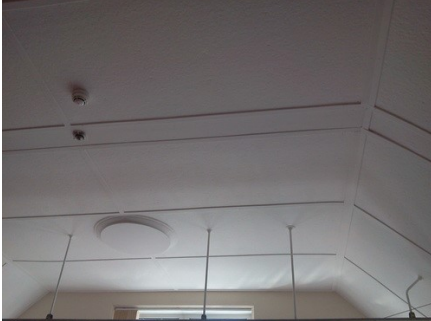
Item 121 Ref: As 47656-19

The Ceiling (Classroom/021)
does not contain asbestos.

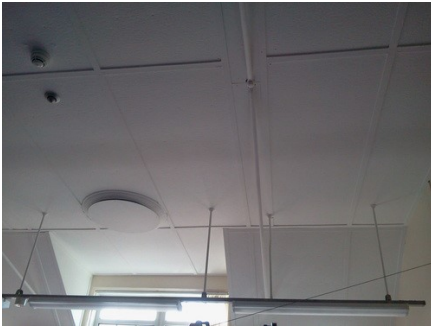
Item 122 Ref: As 47656-19

The Ceiling (Classroom/022)
does not contain asbestos.

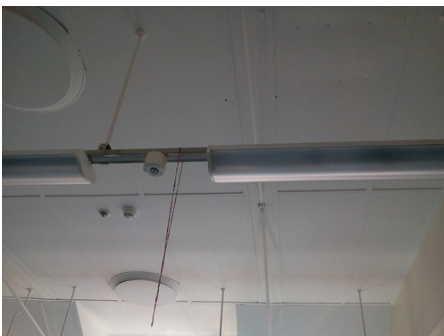
Item 123 Ref: 47656-20

The Ceiling (Classroom/023)
does not contain asbestos.

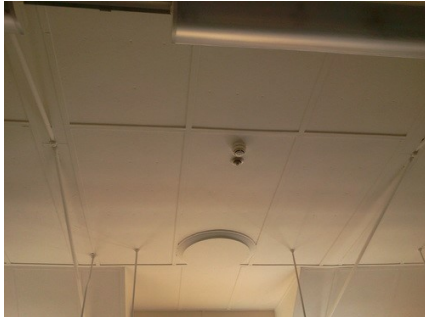
Item 124 Ref: As 47656-20

The Ceiling (Classroom/025)
does not contain asbestos.

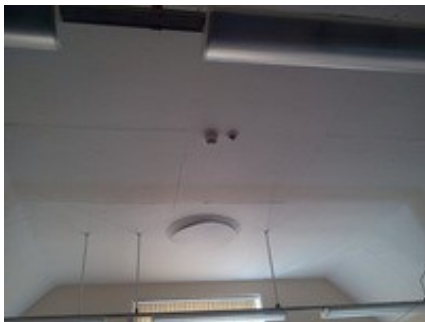
Item 125 Ref: 47656-21

The Ceiling (Classroom/026)
does not contain asbestos.

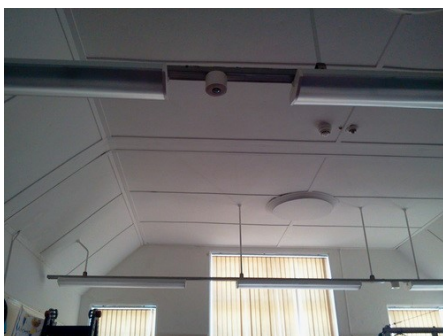
Item 126 Ref: As 47656-20

The Ceiling (Classroom/028)
does not contain asbestos.

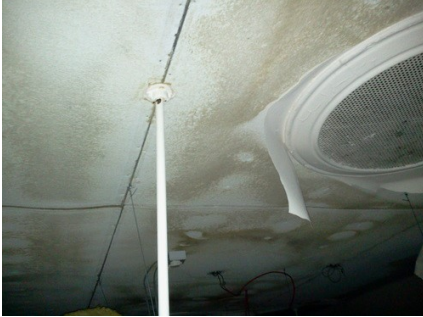
Item 127 Ref: 47656-22

The Ceiling (Classroom/032 void above) does not contain asbestos.

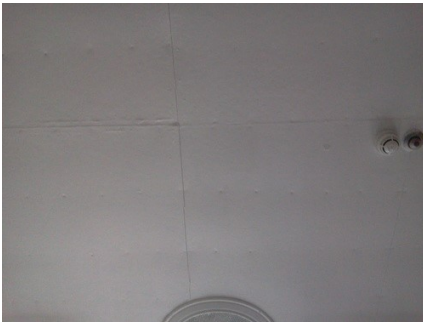
Item 128 Ref: As 47656-9

The Ceiling (Classroom/033) does not contain asbestos.

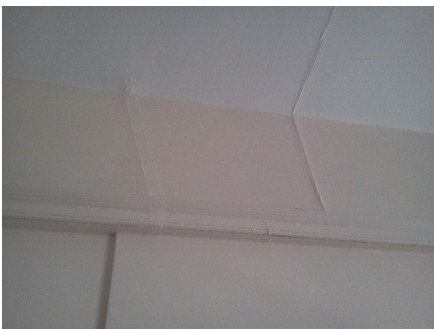
Item 129 Ref: As 47656-9

The High level panels (Classroom/033) does not contain asbestos.

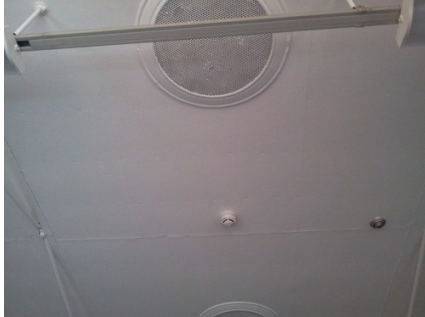
Item 130 Ref: 47656-9

The Ceiling (Community Room/034) does not contain asbestos.

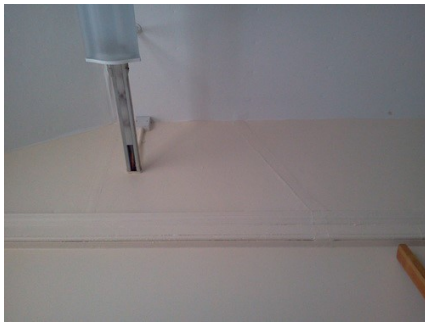
Item 131 Ref: As 47656-9

The High level panels (Community Room/034) does not contain asbestos.

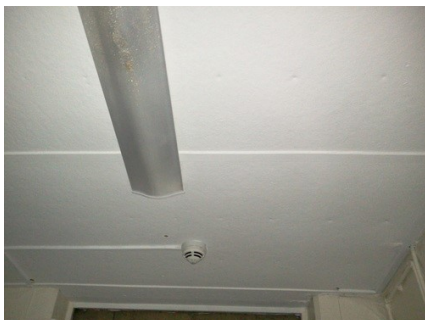
Item 132 Ref: 47656-12

The Ceiling (Corridor/036) does not contain asbestos.

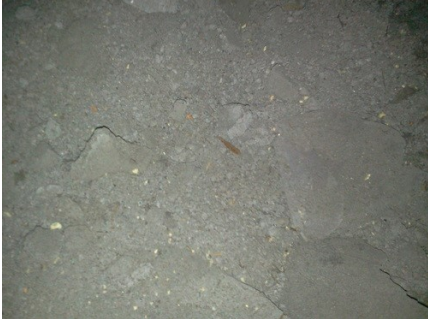
Item 133 Ref: 47656-1

The Debris to ceiling below reception (Loft Space/ 1/001) does not contain asbestos.

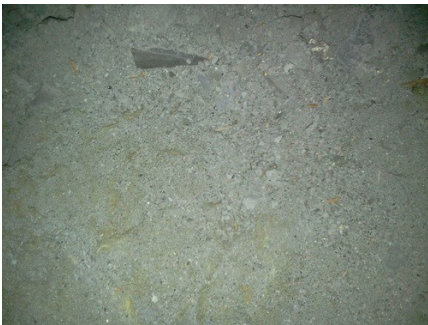
Item 134 Ref: 47656-2

The Debris to ceiling below year 1 (Loft Space/ 1/001) does not contain asbestos.

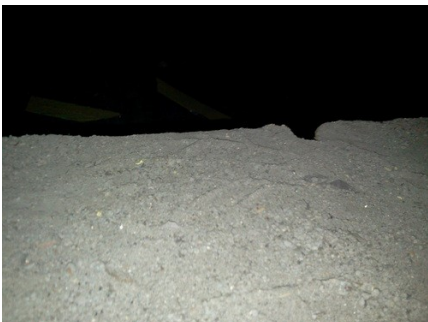
Item 135 Ref: 47656-3

The Debris to ceiling below year 2 (Loft Space/ 1/001) does not contain asbestos.

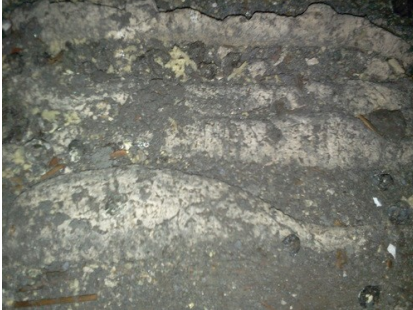
Item 136 Ref: 47656-4

The Debris to ceiling below year 5 (Loft Space/ 1/002) does not contain asbestos.

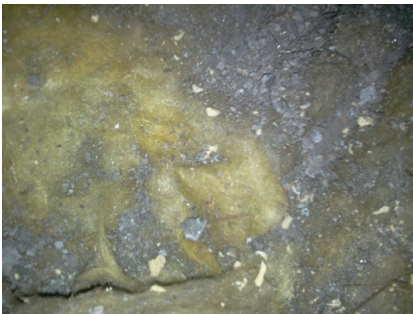
Item 137 Ref: 47656-5

The Debris to ceiling below year 4 (Loft Space/ 1/002) does not contain asbestos.

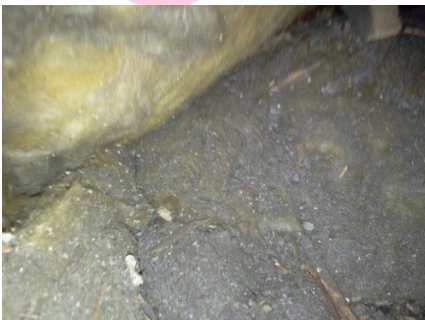
Item 138 Ref: 47656-6

The Debris to ceiling below year 3 (Loft Space/ 1/002) does not contain asbestos.

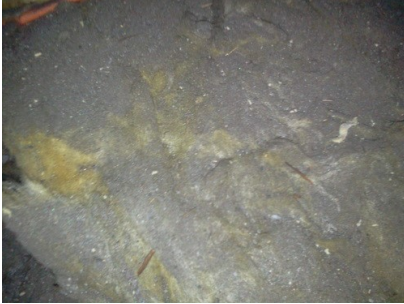
Item 139 Ref: 47656-7

The Debris to ceiling below equipment store (Loft Space/ 1/003) does not contain asbestos.

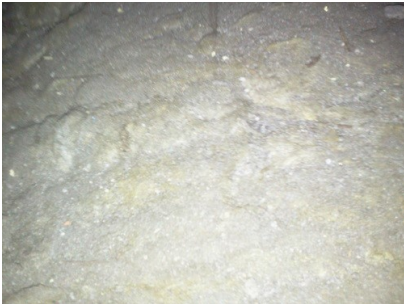
Item 140 Ref: 47656-8

The Debris to ceiling below community room (Loft Space/ 1/003) does not contain asbestos.

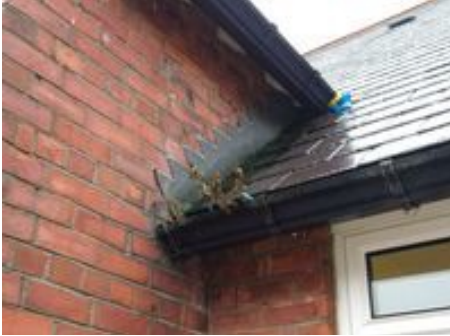
Item 142 Ref: 451175-1

The flashing to roof (External main building slated roofs) does not contain asbestos.

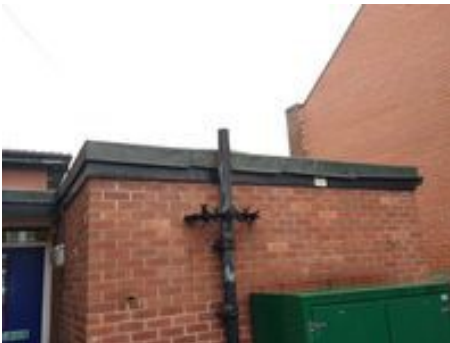
Item 143 Ref: 451175-3

The roof covering (External Roof 5) does not contain asbestos.
