ASBESTOS SURVEY REPORT FOR MILL HILL PRIMARY SCHOOL,
DOXFORD PARK, SUNDERLAND SR3 2PJ.

Asbestos Register for

Mill Hill Primary School, Doxford Park, SR3 2PJ

Date: 26 June 2026

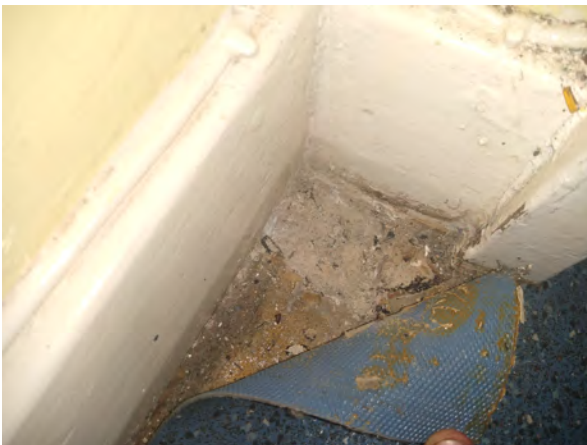
Item 32 Ref: 412662-8

The subfloor covering below modern lino in Rm 0/29d Medical Room contains asbestos.

Any change in its appearance should be recorded and passed to Property Services.

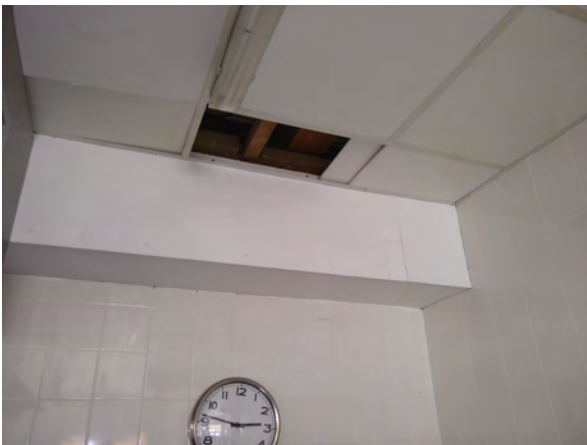
Item 35 Ref: 412662-26

The debris within high level horizontal boxing in Rm 0/30 Kitchen contains asbestos.

Removed July 2022

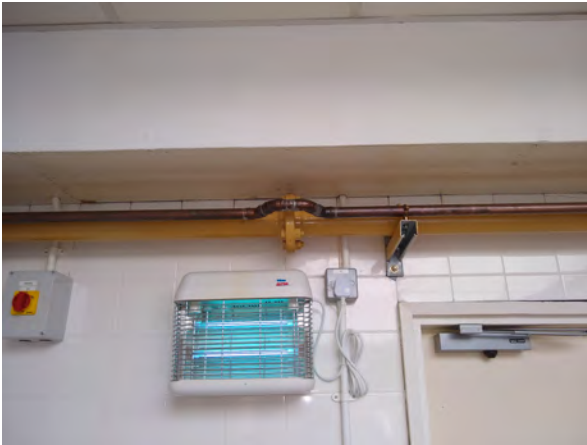
Item 37 Ref: 412662-27

The pipework flange gaskets in Rm 0/30 Kitchen do not contain asbestos.

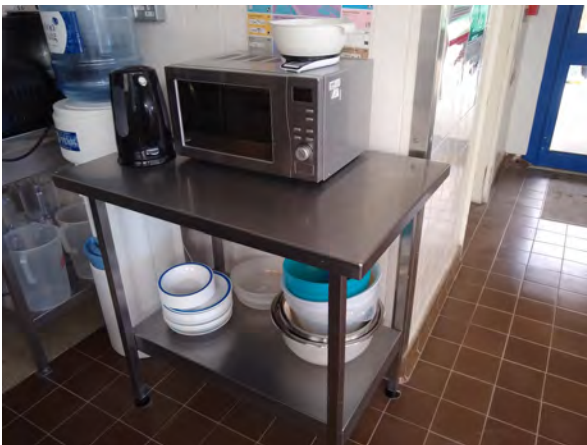
Item 38 Ref: 412662-28

The paint to underside of bench in Rm 0/30 Kitchen does not contain asbestos.

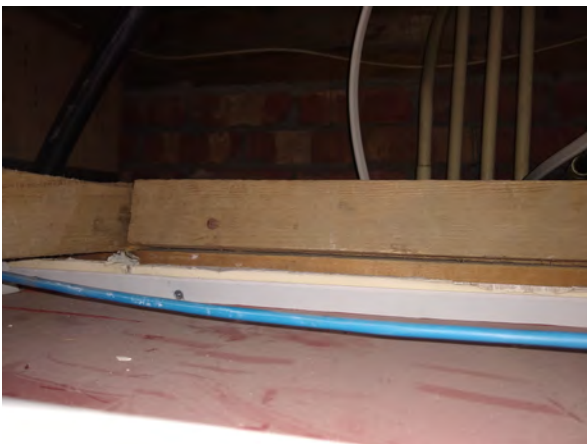
Item 39 Ref: 412662-21

The debris to boxing at former ceiling height in Rm 0/30 Kitchen void above contains asbestos.

Any change in its appearance should be recorded and passed to Property Services.

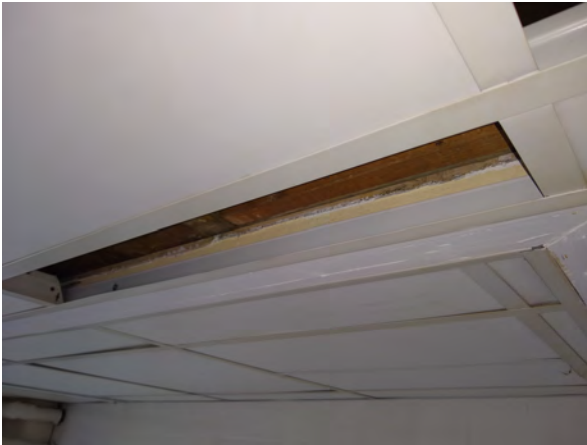
Item 40 Ref: 412662-22

The debris to former extractor hood framework at former ceiling height in Rm 0/30 Kitchen void above contains asbestos.

Any change in its appearance should be recorded and passed to Property Services.

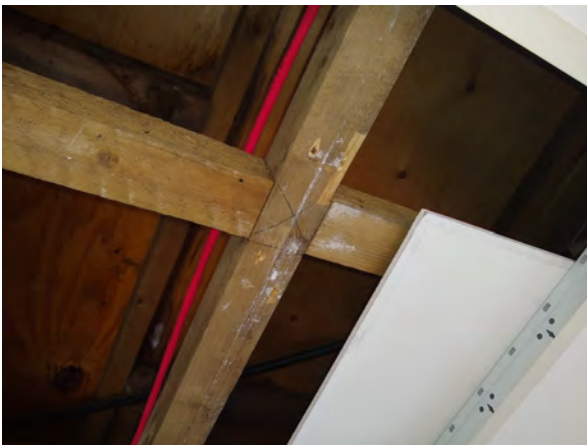
Item 41 Ref: 412662-23

The debris to former ceiling battens in Rm 0/30 Kitchen void above contains asbestos.

Any change in its appearance should be recorded and passed to Property Services.

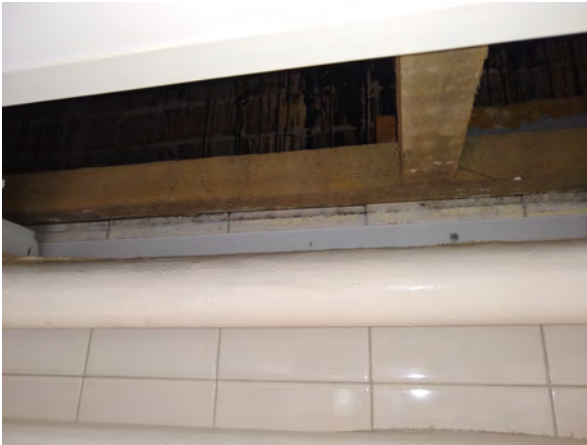
Item 43 Ref: 412662-25

The debris to perimeter walls at former ceiling height in Rm 0/30 Kitchen void above contains asbestos.

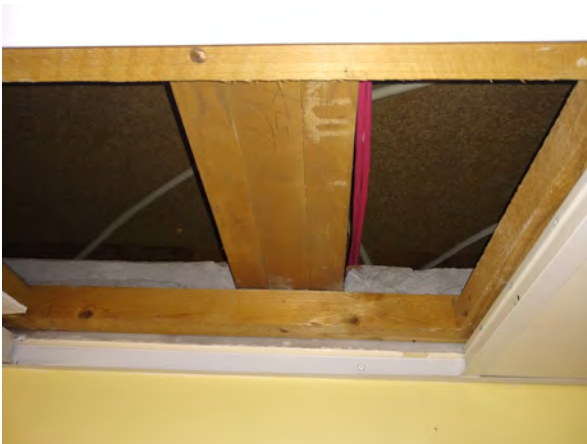
Item 45 Ref: 412662-31

The debris to remnant ceiling battens in Rm 0/31 Office void above contains asbestos.

Any change in its appearance should be recorded and passed to Property Services.

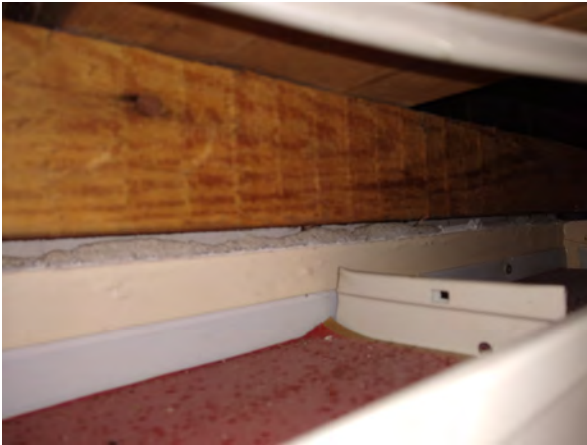
Item 46 Ref: 412662-32

The debris to walls at former ceiling height in Rm 0/32 WC void above contains asbestos.

Any change in its appearance should be recorded and passed to Property Services.

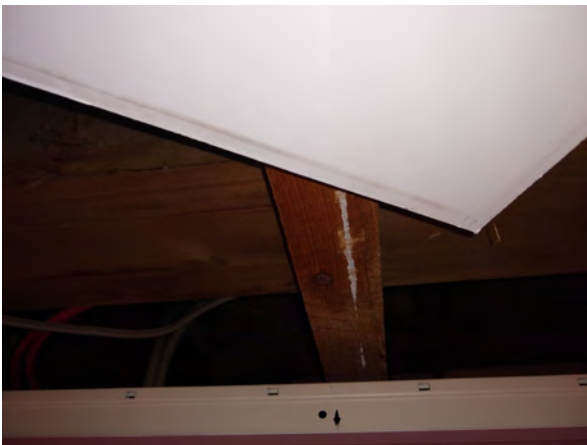
Item 47 Ref: 412662-33

The debris to remnant ceiling battens in Rm 0/32 WC void above contains asbestos.

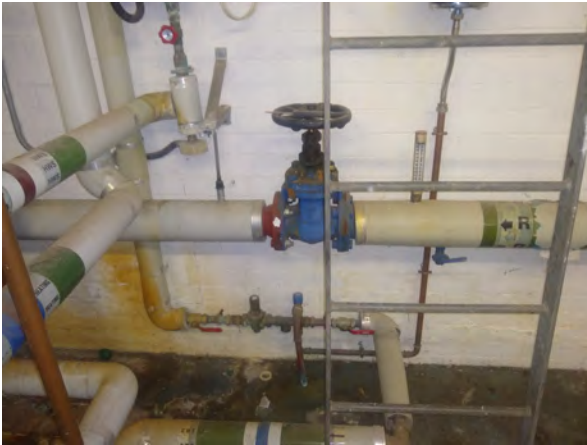
Item 49 Ref: 412662-34

The pipework flange gasket in Rm 0/33 Boiler Room contains asbestos.

Any change in its appearance should be recorded and passed to Property Services

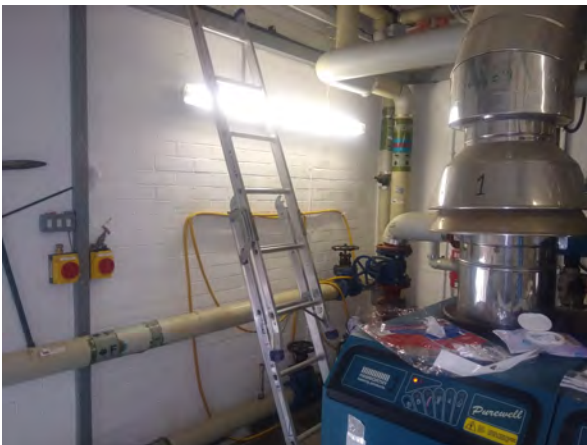
Item 50 Ref: 412662-35

The encapsulated insulation debris to wall (South) in Rm 0/33 Boiler Room contains asbestos.

Any change in its appearance should be recorded and passed to Property Services.

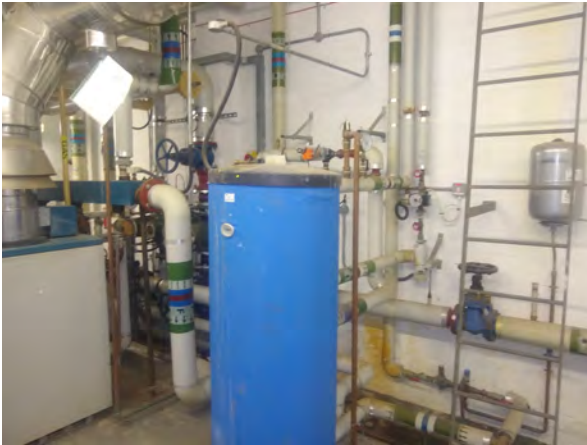
Item 52 Ref: 412662-37

The encapsulated insulation debris to wall (West) in Rm 0/33 Boiler Room contains asbestos.

Any change in its appearance should be recorded and passed to Property Services.

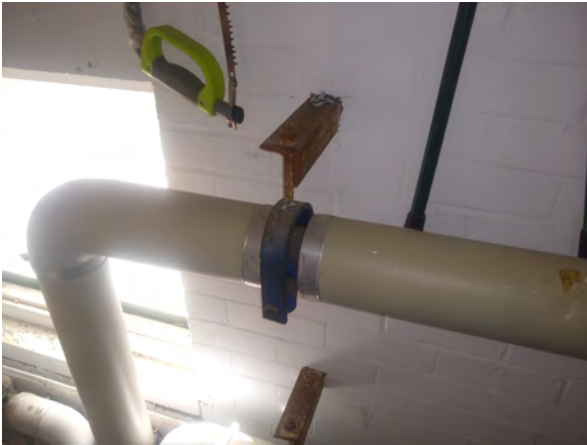
Item 55 Ref: 412662-40

The debris to original pipe hangers in Rm 0/33 Boiler Room contains asbestos.

Removed June 2020

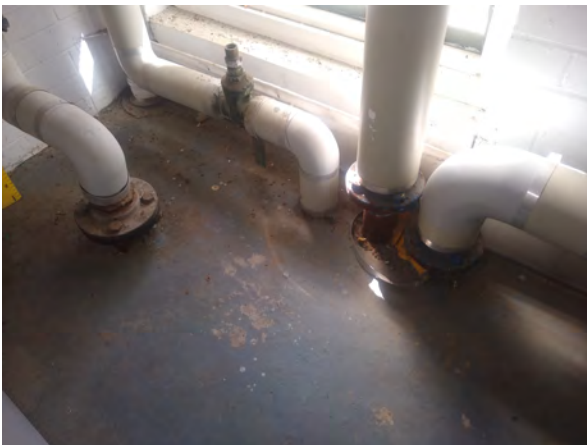
Item 56 Ref: 412662-41

The debris to original pipework flanges at low level in Rm 0/33 Boiler Room contains asbestos.

Removed June 2020

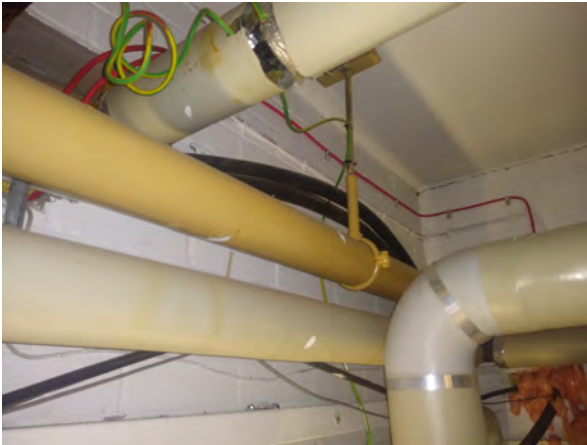
Item 58 Ref: 412662-43

The encapsulated debris to gas pipework adj walls in Rm 0/33 Boiler Room contains asbestos.

Any change in its appearance should be recorded and passed to Property Services.

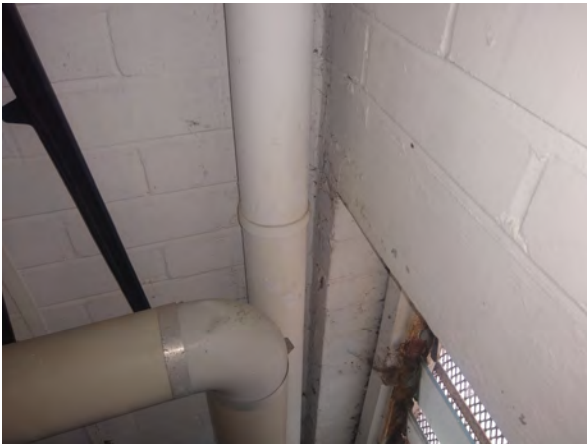
Item 59 Ref: 412662-44

The encapsulated debris to downpipes in Rm 0/33 Boiler Room contains asbestos.

Any change in its appearance should be recorded and passed to Property Services.

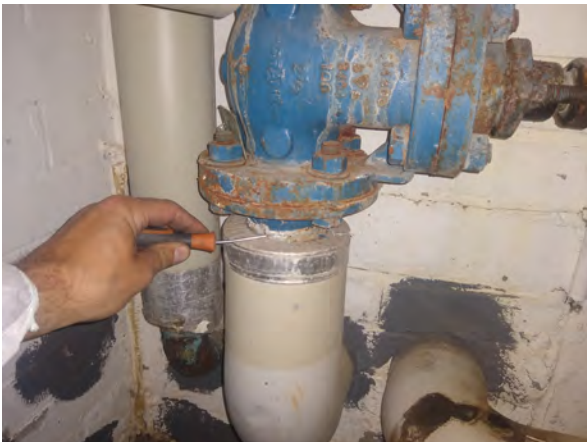
Item 60 Ref: 412662-45

The debris to original pipework in Rm 0/33 Boiler Room contains asbestos.

Removed June 2020

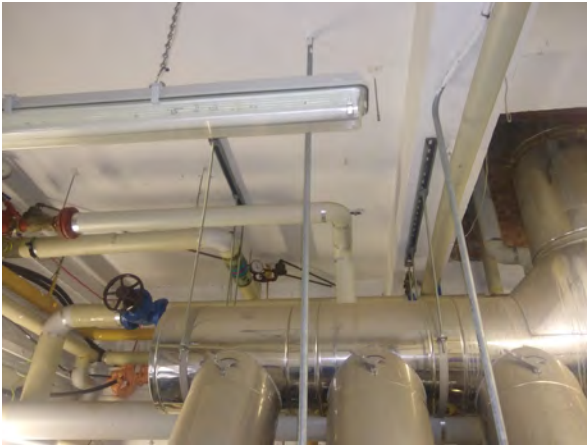
Item 61 Ref: 412662-46

The encapsulated debris to underside of roof in Rm 0/33 Boiler Room contains asbestos.

Any change in its appearance should be recorded and passed to Property Services.

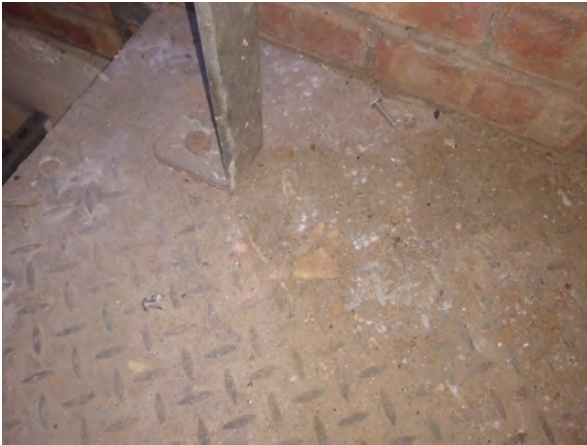
Item 64 Ref: 412662-49

The debris to floor in Rm 0/33 Boiler Room tank room above does not contain asbestos.

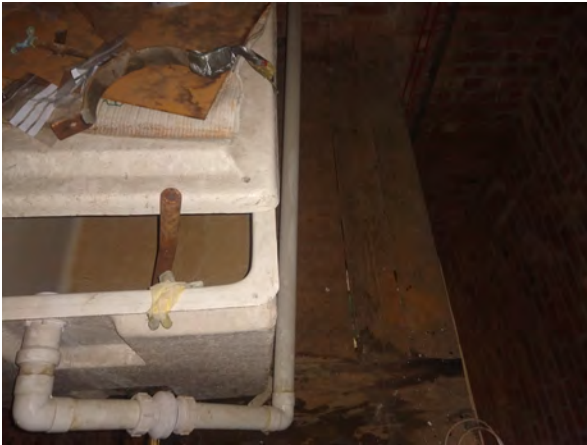
Item 67 Ref: 412662-54

The debris to tank plinth in Rm 0/33 Boiler Room tank room above contains asbestos.

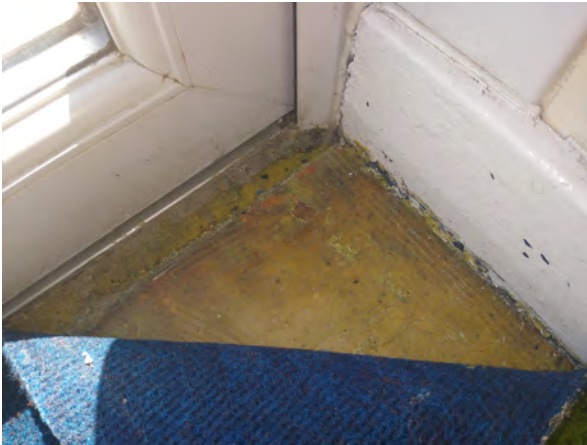
Item 70 Ref: As 412662-2

The sub floor covering below carpet in Rm 0/37 Classroom does not contain asbestos.

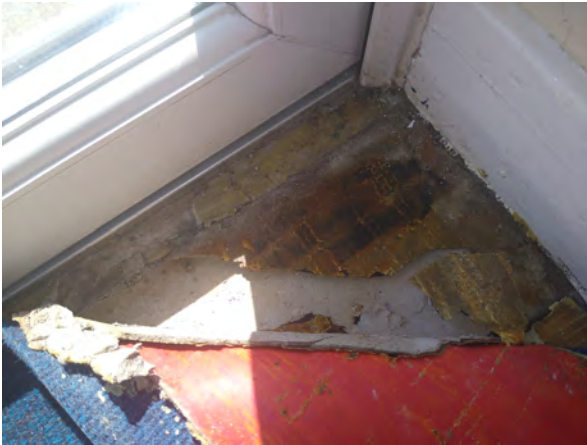
Item 73 Ref: As 412662-9

The remnant screed beneath lino in Rm 0/38 Classroom contains asbestos.

Any change in its appearance should be recorded and passed to Property Services.

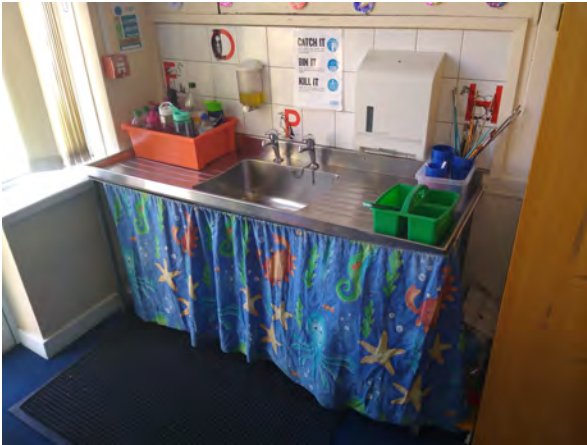
Item 76 Ref: As 412662-11

The sink pad in Rm 0/39 Classroom contains asbestos.

Any change in its appearance should be recorded and passed to Property Services.

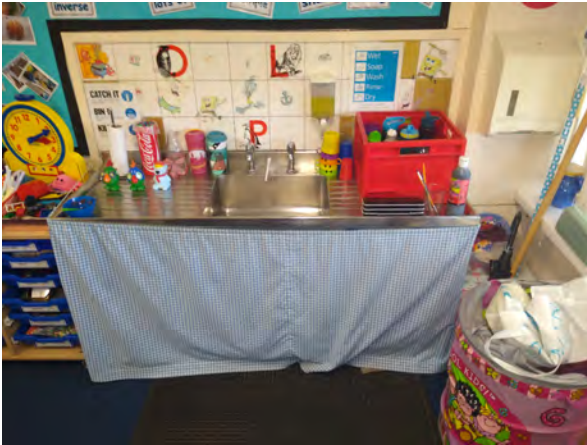
Item 79 Ref: 412662-11

The sink pad in Rm 0/40 Classroom contains asbestos.

Any change in its appearance should be recorded and passed to Property Services.

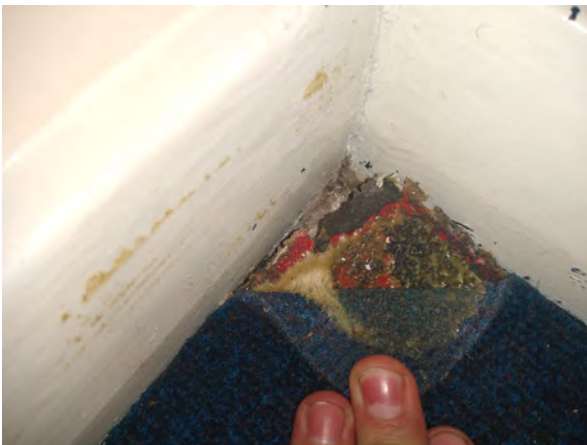
Item 80 Ref: As 412662-2

The sub floor covering below carpet in Rm 0/40 Classroom does not contain asbestos.

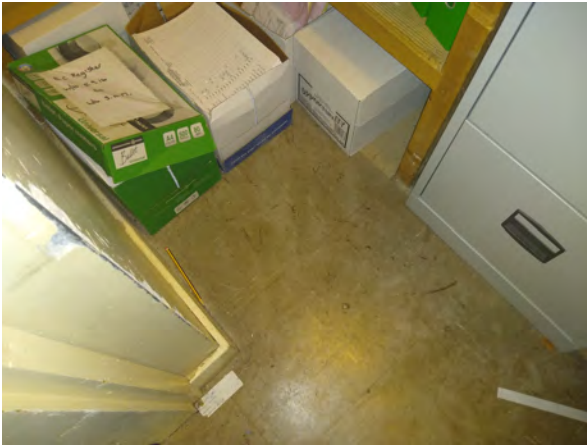
Item 82 Ref: 412662-12

The floor covering in Rm 0/41b Corridor Store contains asbestos.

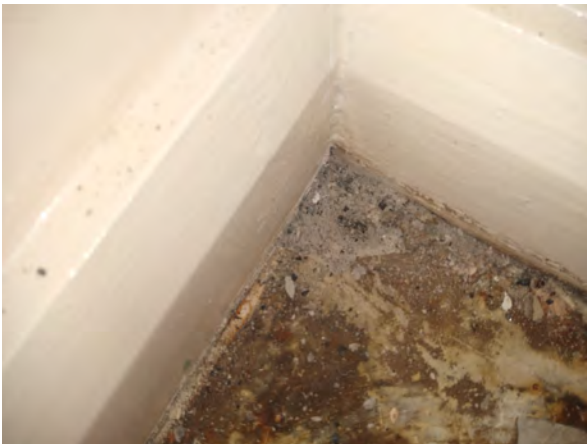
Item 84 Ref: As 412662-14

The screed to floor below modern lino and modern screed in Rm 0/42a Disabled WC does not contain asbestos.

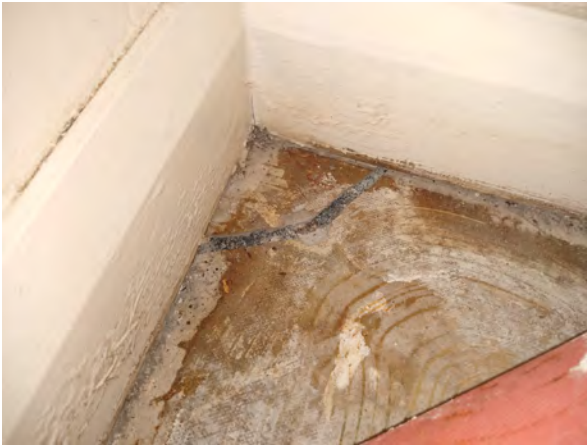
Item 85 Ref: As 412662-14

The screed to floor below modern lino and modern screed in Rm 0/42b Male Staff WC does not contain asbestos.

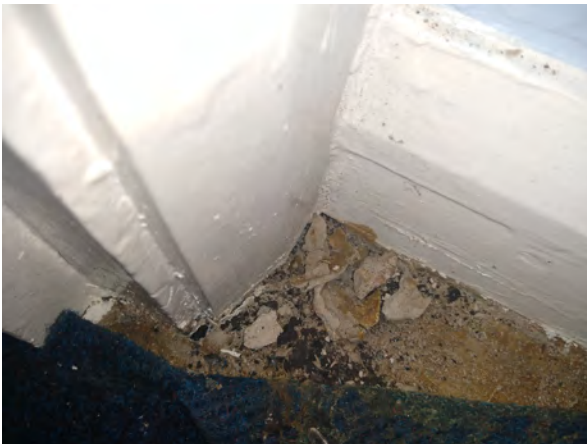
Item 87 Ref: 412662-14

The screed to floor below carpet in Rm 0/43 Corridor does not contain asbestos.

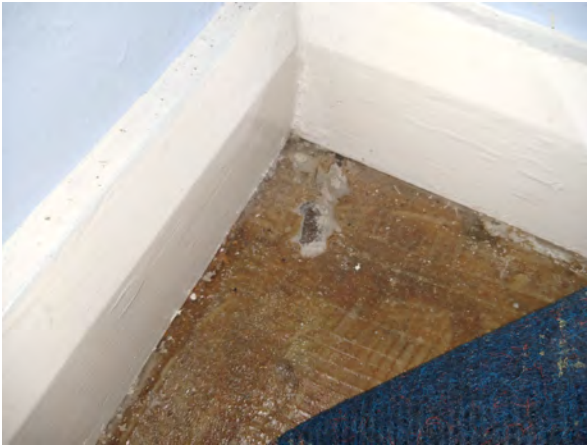
Item 88 Ref: As 412662-51

The screed to floor below carpet in Rm 0/44 Corridor does not contain asbestos.

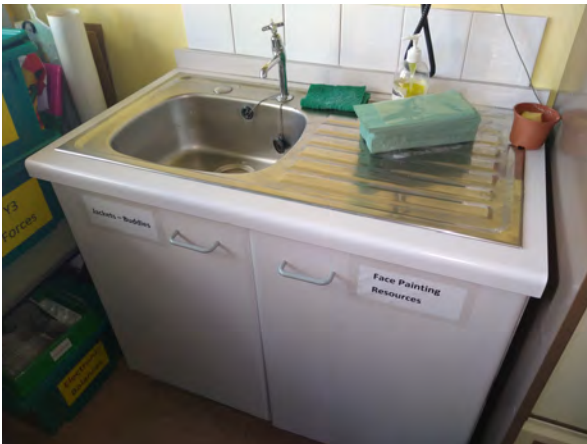
Item 90 Ref: 412662-52

The sink pad in Rm 0/46 PPA Room does not contain asbestos.

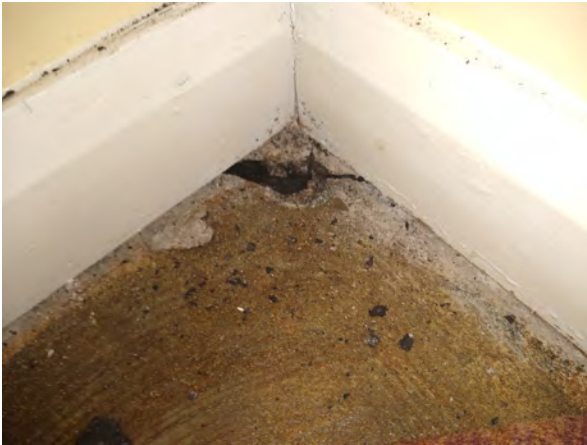
Item 91 Ref: 412662-51

The screed to floor below carpet in Rm 0/46 PPA Room does not contain asbestos.

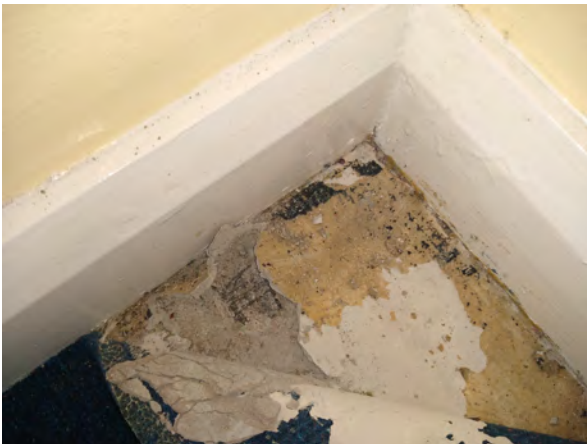
Item 93 Ref: As 412662-51

The screed to floor below carpet in Rm 0/47 Classroom does not contain asbestos.

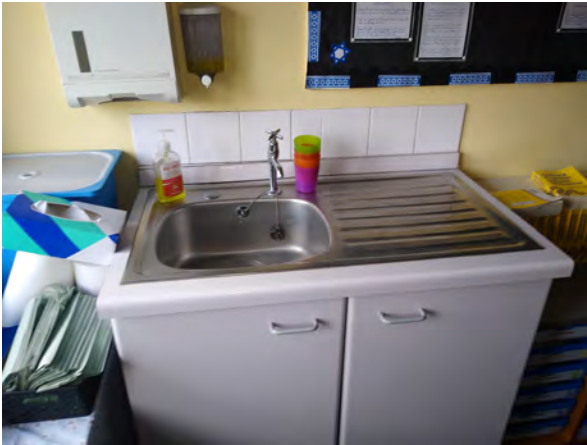
Item 94 Ref: As 412662-52

The sink pad in Rm 0/48 Classroom does not contain asbestos.

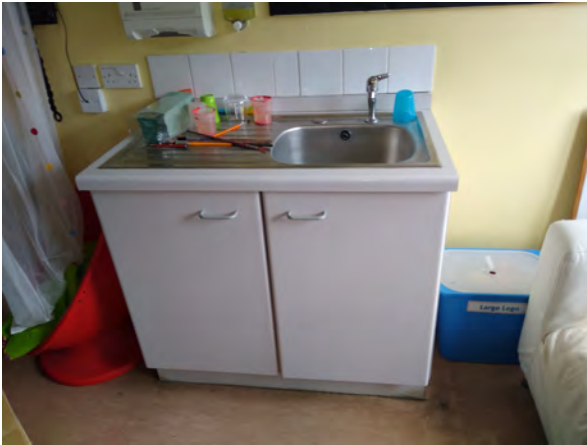
Item 97 Ref: As 412662-52

The sink pad in Rm 0/50 Classroom does not contain asbestos.

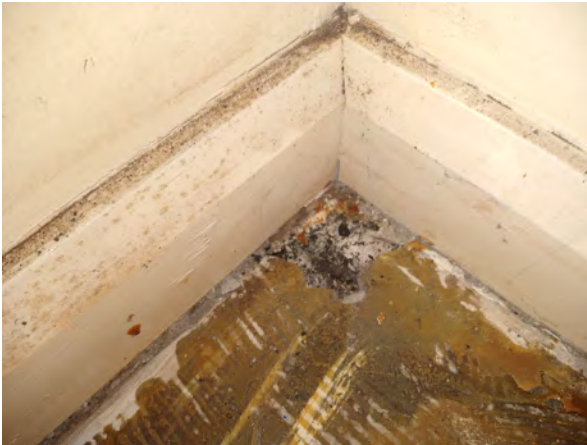
Item 103 Ref: As 412662-51

The screed to floor below modern lino in Rm 0/55 Stock Cupboard does not contain asbestos.

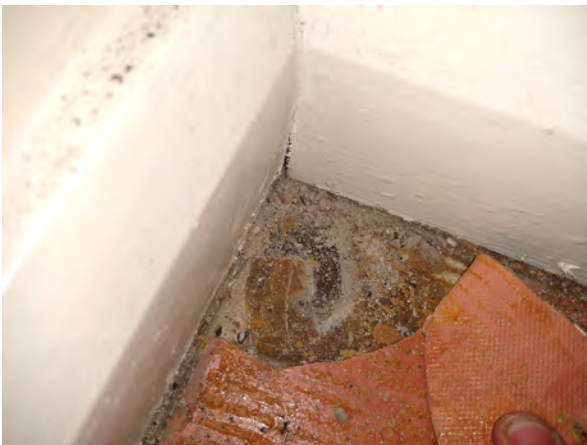
Item 104 Ref: As 412662-51

The screed to floor below modern lino in Rm 0/56 Deputy Head Office does not contain asbestos.

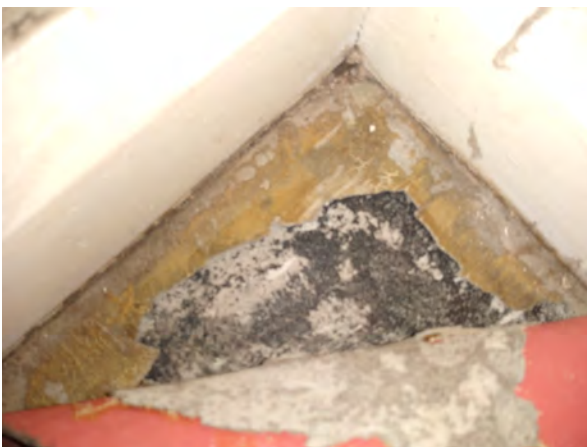
Item 105 Ref: As 412662-51

The screed to floor below modern lino in Rm 0/57 Stock Cupboard does not contain asbestos.

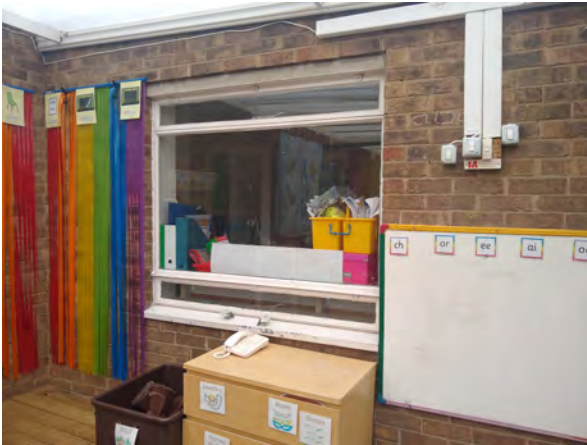
Item 109 Ref: 412662-58

The sealant to original window frame to 0/23 (External) contains asbestos.

Any change in its appearance should be recorded and passed to Property Services.

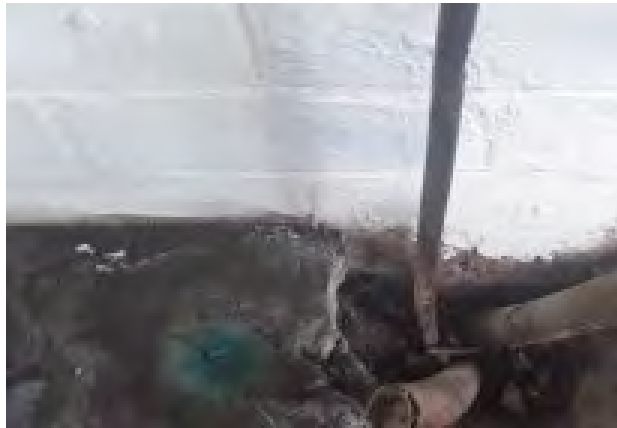
Item 110 Ref: 21-31964-1

The insulation on the floor within the hole in the Boiler room (0/33) contains asbestos.

Any change in its appearance should be recorded and passed to Property Services.

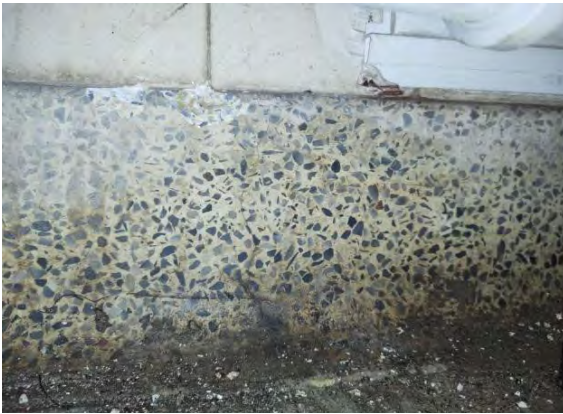
Item 115 Ref: 21-33323-7

The concrete composite floor (Area 7/Boys WC) does not contain asbestos.

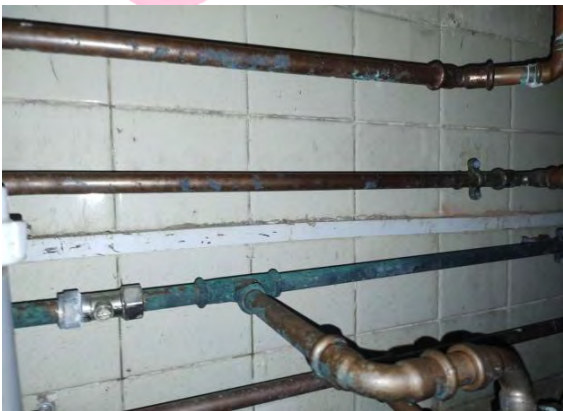
Item 117 Ref: 21-33323-6

The adhesive behind older ceramic tiles behind vanity unit (Area 8/Girls WC) does not contain asbestos.

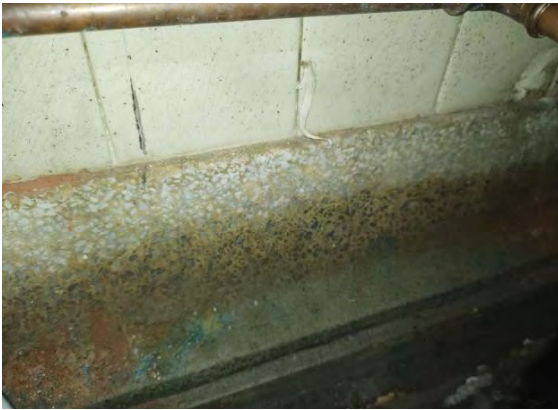
Item 118 Ref: 21-33323-7

The concrete composite floor (Area 8/Girls WC) does not contain asbestos.

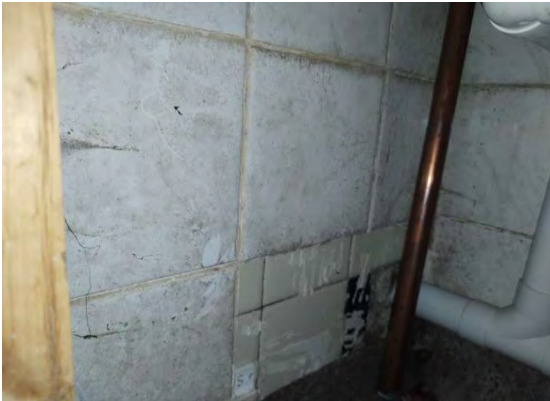
Item 119 Ref: 21-33323-5

The adhesive behind ceramic tiles (Area 14/WC) does not contain asbestos.

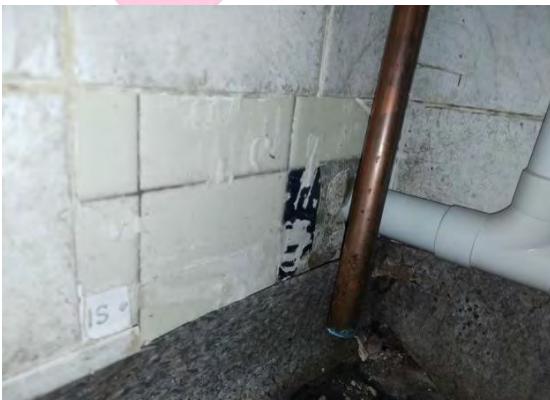
Item 120 Ref: 21-33323-6

The adhesive behind older ceramic tiles behind vanity unit (Area 14/WC) does not contain asbestos.

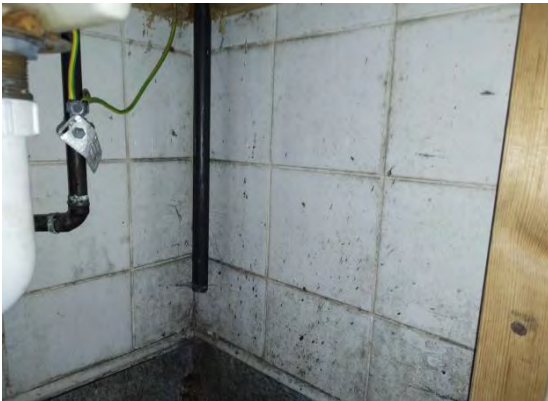
Item 121 Ref: 21-33323-5

The adhesive behind ceramic tiles (Area 16/WC) does not contain asbestos.

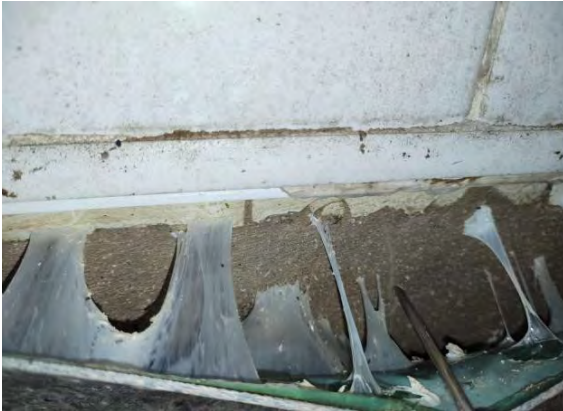
Item 122 Ref: 21-33323-6

The adhesive behind older ceramic tiles behind newer tiles (Area 16/WC) does not contain asbestos.

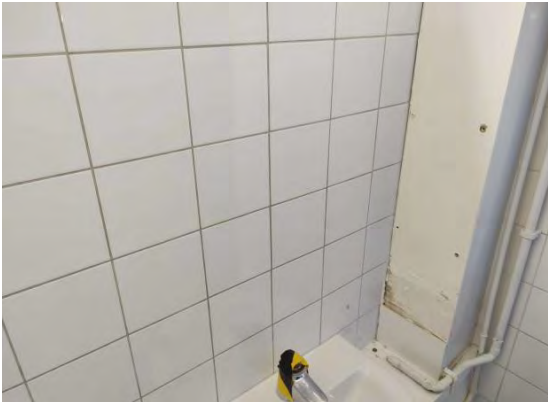
Item 125 Ref: 21-33323-3

The adhesive behind ceramic tiles (Area 34/Boys WC) does not contain asbestos.

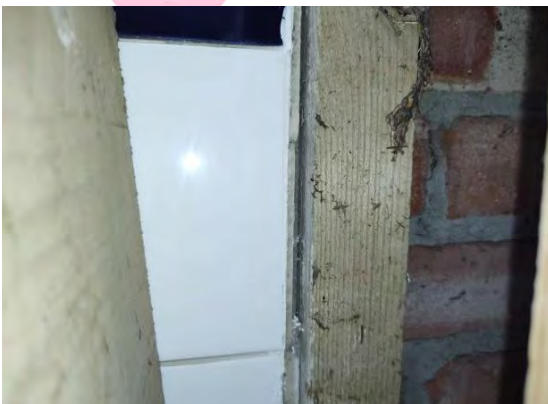
Item 126 Ref: 21-33323-4

The adhesive behind older ceramic tiles behind newer tiles (Area 34/Boys WC) does not contain asbestos.

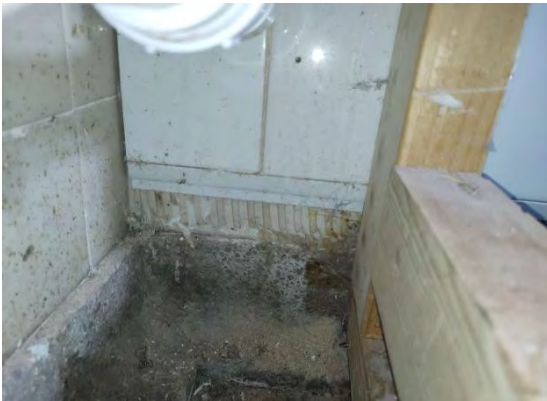
Item 127 Ref: 21-33323-3

The adhesive behind ceramic tiles (Area 35/Girls WC) does not contain asbestos.

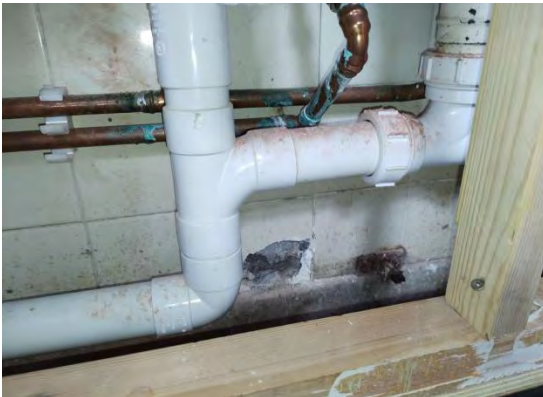
Item 128 Ref: 21-33323-4

The adhesive behind older ceramic tiles behind newer tiles (Area 35/Girls WC) does not contain asbestos.

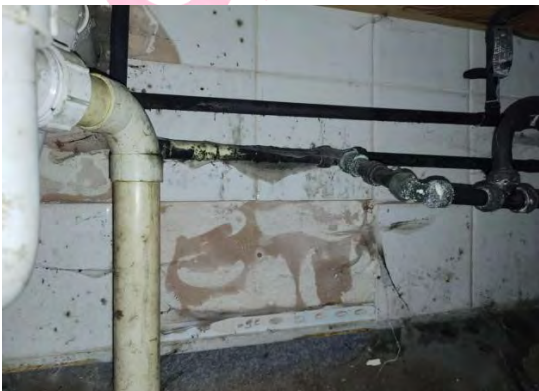
Item 129 Ref: 21-33323-8

The adhesive behind ceramic tiles (Area 24a/WC) does not contain asbestos.

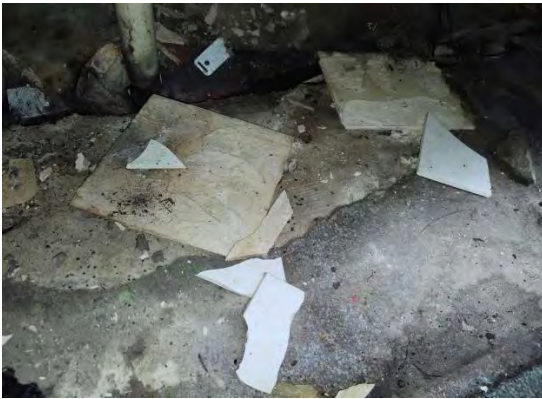
Item 130 Ref: 21-33323-8

The adhesive behind ceramic tile debris to floor behind vanity unit (Area 24a/WC) does not contain asbestos.

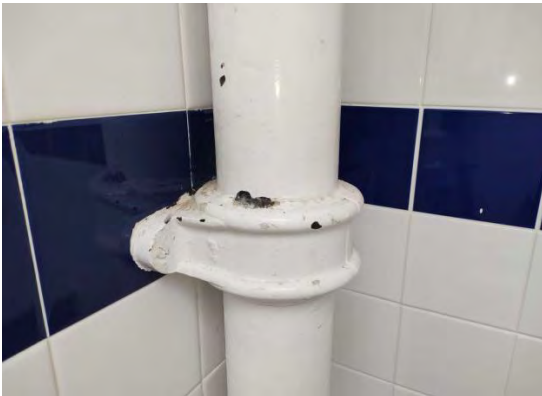
Item 131 Ref: 21-33323-9

The putty sealant in metal soil pipe joints (Area 24a/WC) does not contain asbestos.

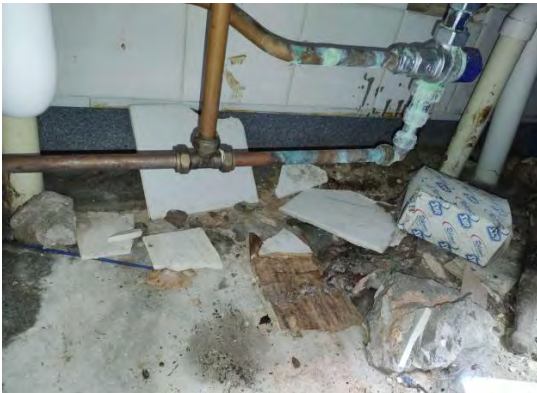
Item 133 Ref: 21-33323-8

The adhesive behind ceramic tile debris to floor behind vanity unit (Area 24b/WC) does not contain asbestos.

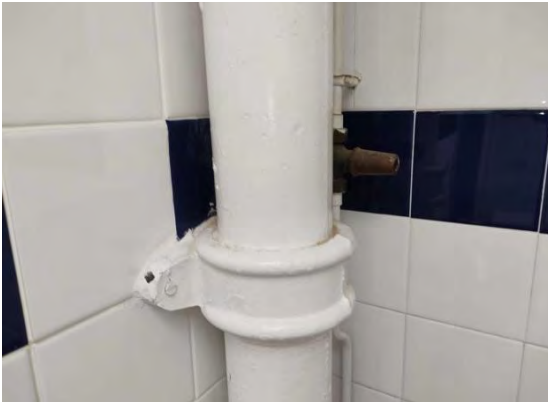
Item 134 Ref: 21-33323-9

The putty sealant in metal soil pipe joints (Area 24b/WC) does not contain asbestos.

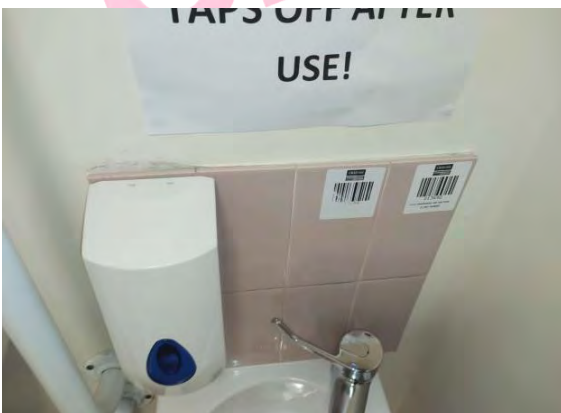
Item 135 Ref: 21-33323-2

The adhesive behind ceramic tiles (Area 42a/Disabled WC) does not contain asbestos.

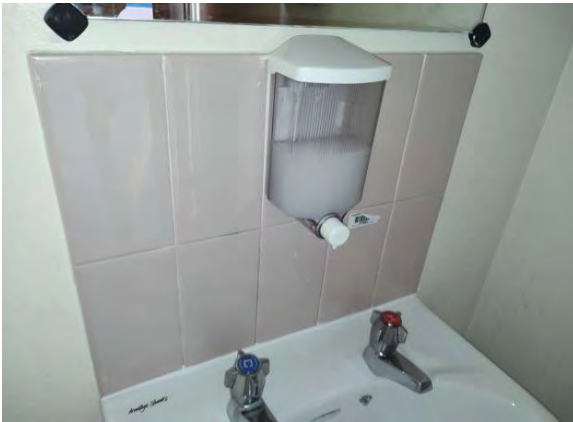
Item 136 Ref: 21-33323-2

The adhesive behind ceramic tiles (Area 42b/Male Staff WC) does not contain asbestos.

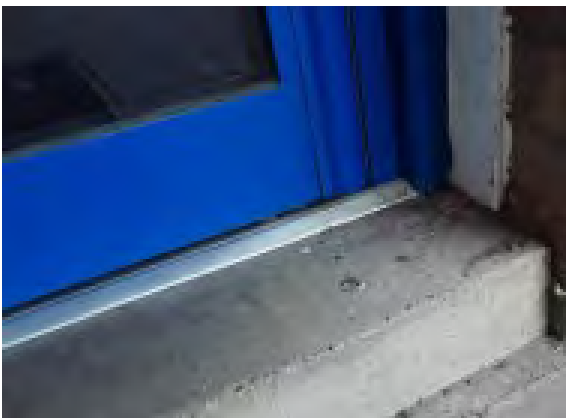
Item 137 Ref: 21-36673-1

The damp proof course in Area 1 (Low level overhanging roof to courtyard garden) does not contain asbestos.

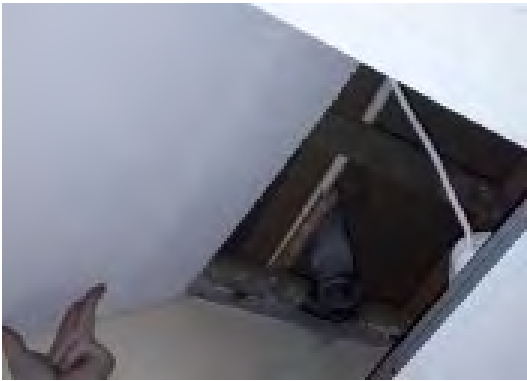
Item 139 Ref: 21-39847-1

The redundant flue inside the ceiling void above the ladies staff toilet (Area 37) does contain asbestos.

Any change in appearance should be reported to Property Services.

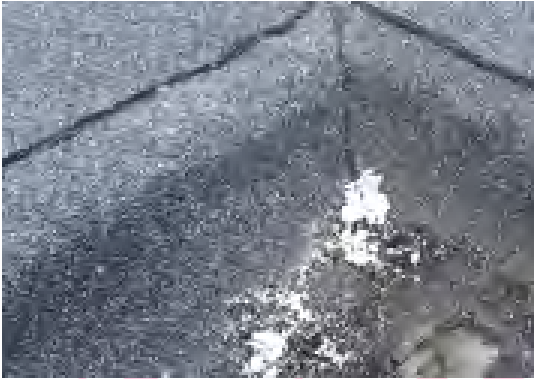
Item 140 Ref: 21-36673-1

The old roof felt beneath new roof felt (External) does not contain asbestos.

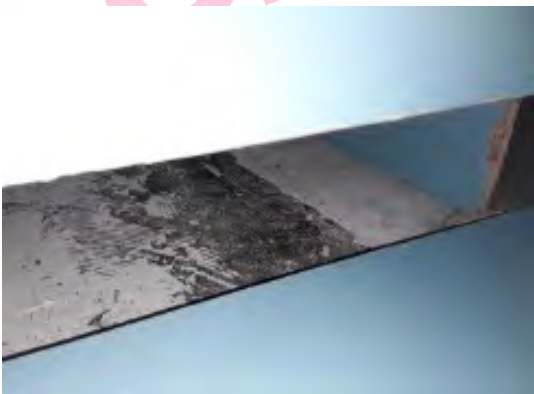
Item 141 Ref: 22-45452-1

The residual adhesive to floor below the screed in Area 1 Ladies Staff Toilets does not contain asbestos.

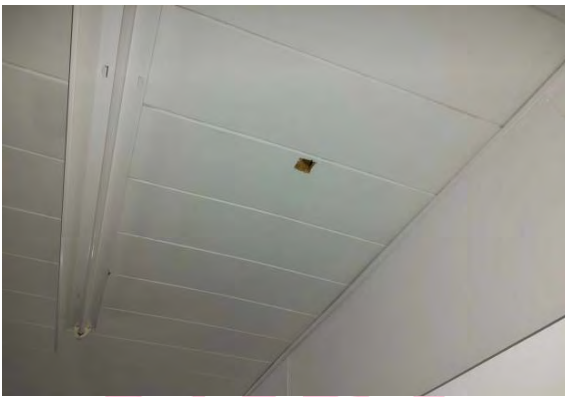
Item 143 Ref: 22-50672-1

The ceiling panels throughout (Area 1/Community Room) do not contain asbestos.

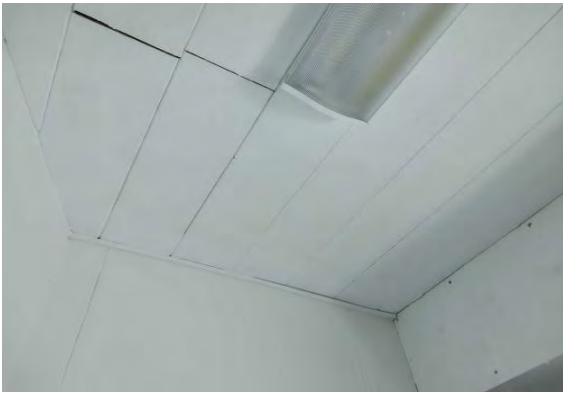
Item 145 Ref: 22-50672-1

The ceiling panels throughout (Area 2/Kitchen) do not contain asbestos.

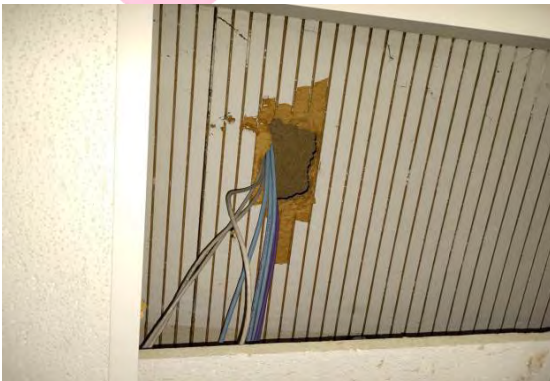
Item 147 Ref: 22-50672-3

The ceiling panels above false ceiling (Area 3/Lobby) do not contain asbestos.

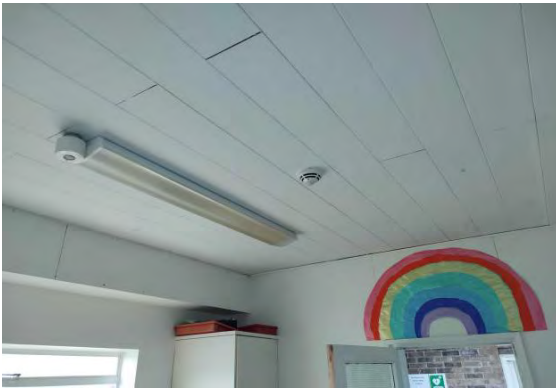
Item 148 Ref: 22-50672-2

The ceiling modern fibreboard wall panels (Area 4/Kitchen) do not contain asbestos.

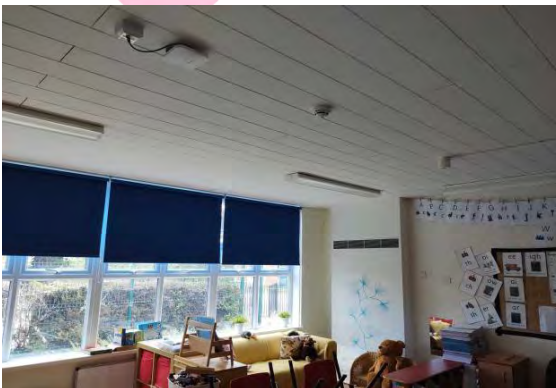
Item 150 Ref: 22-50672-1

The ceiling panels throughout (Area 5/Classroom) do not contain asbestos.

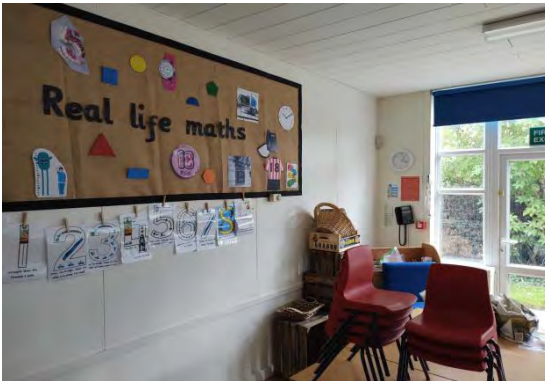
Item 151 Ref: 22-50672-2

The walls modern fibreboard wall panels (Area 5/ Classroom) do not contain asbestos.

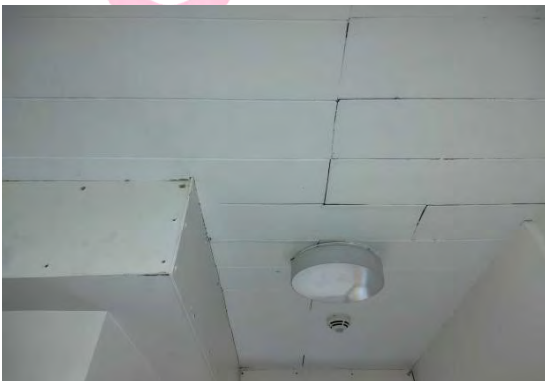
Item 153 Ref: 22-50672-1

The ceiling panels throughout (Area 8/Lobby) do not contain asbestos.

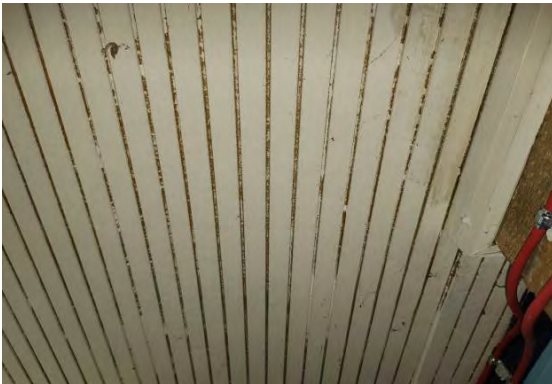
Item 154 Ref: 22-50672-3

The ceiling panels above false ceiling (Area 9/Cloakroom) do not contain asbestos.

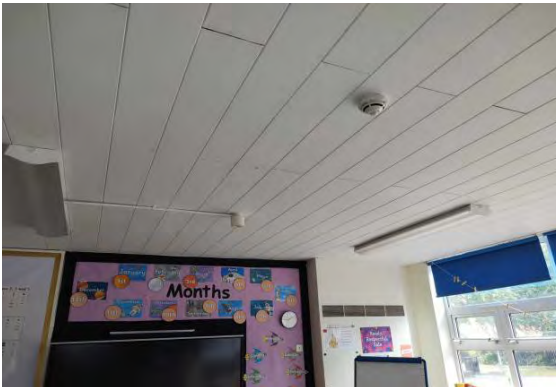
Item 155 Ref: 22-50672-1

The ceiling panels throughout (Area 10/Classroom) do not contain asbestos.

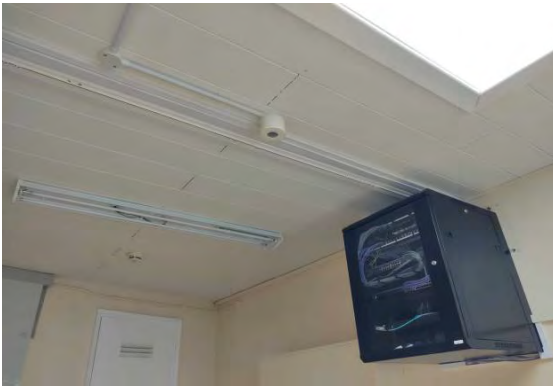
Item 157 Ref: 22-50672-1

The ceiling panels throughout (Area 11/Lobby) do not contain asbestos.

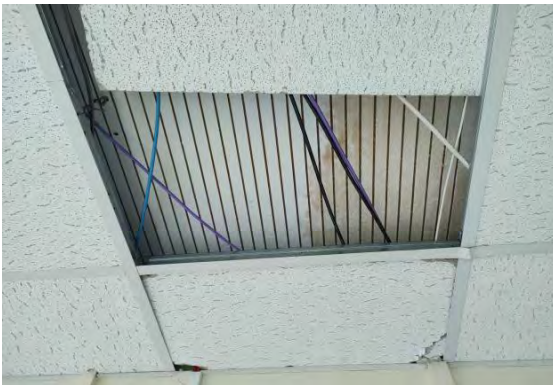
Item 158 Ref: 22-50672-3

The ceiling panels above low level false ceiling (Area 13/ Junior Hall) do not contain asbestos.

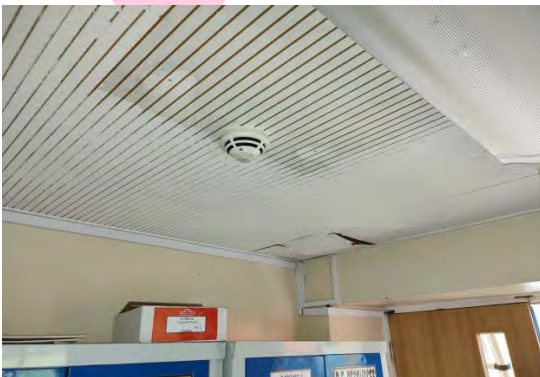
Item 159 Ref: 22-50672-4

The ceiling panels above false ceiling tiles (Area 14/Lobby) do not contain asbestos.

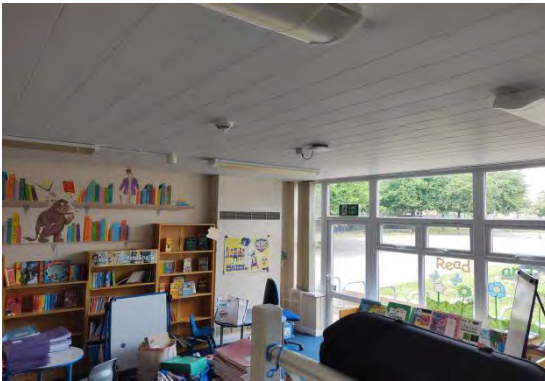
Item 160 Ref: 22-50672-5

The ceiling modern fibreboard ceiling panels (Area 15/ Library) does not contain asbestos.

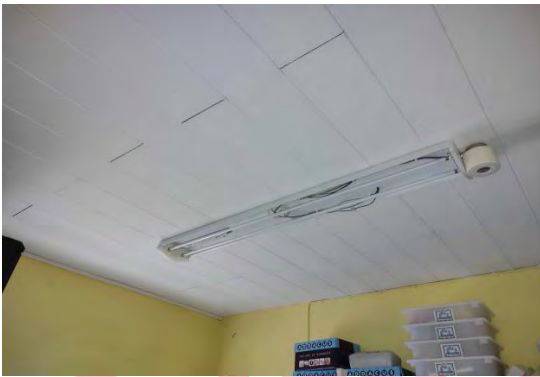
Item 161 Ref: 22-50672-5

The ceiling modern fibreboard ceiling panels (Area 16/Store) does not contain asbestos.

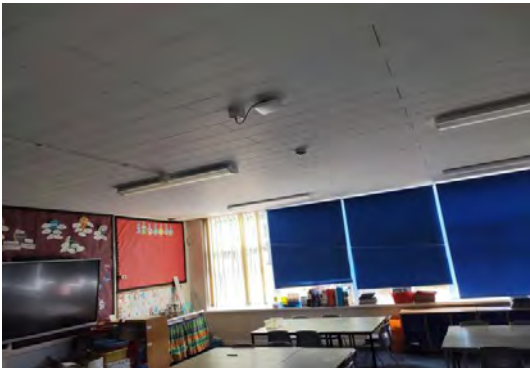
Item 164 Ref: 22-50672-5

The ceiling modern fibreboard ceiling panels (Area 19/ Classroom) does not contain asbestos.

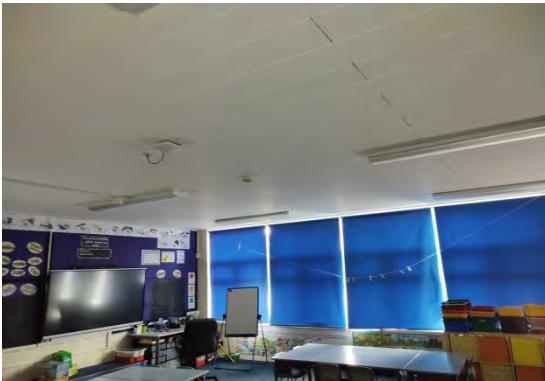
Item 166 Ref: 22-50672-5

The ceiling modern fibreboard ceiling panels (Area 21/ Classroom) does not contain asbestos.

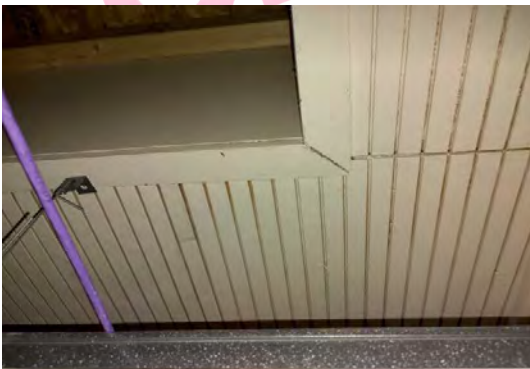
Item 168 Ref: 22-50672-4

The ceiling panels above false ceiling tiles (Area 24/Corridor) do not contain asbestos.

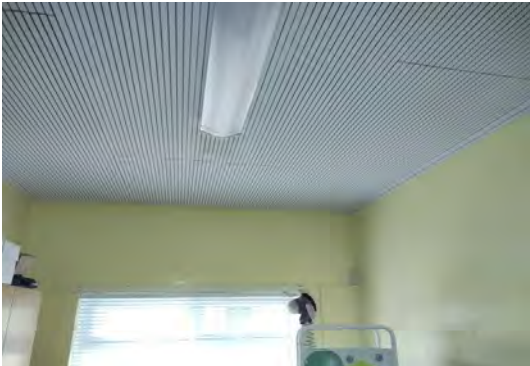
Item 170 Ref: 22-50672-4

The ceiling panels (Area 26/Medical Room) does not contain asbestos.

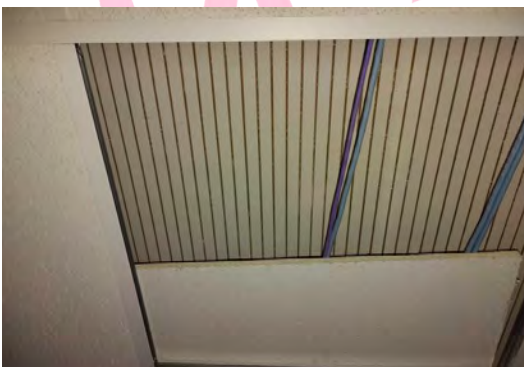
Item 171 Ref: 22-50672-4

The ceiling panels above false ceiling tiles (Area 27/ Cloakroom) do not contain asbestos.

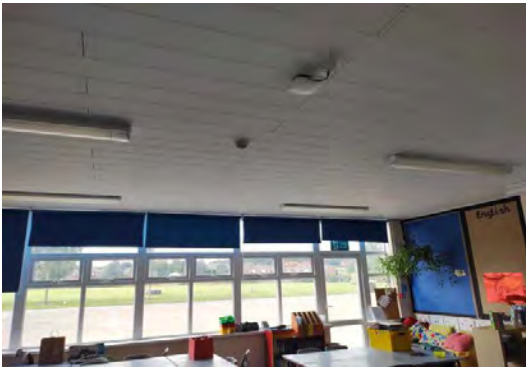
Item 172 Ref: 22-50672-5

The ceiling modern fibreboard ceiling panels (Area 28/ Classroom) does not contain asbestos.
