ASBESTOS SURVEY REPORT FOR MILL HILL PRIMARY SCHOOL,
DOXFORD PARK, SUNDERLAND SR3 2PJ.

Asbestos Register for

Mill Hill Primary School, Doxford Park, SR3 2PJ

Date: 26 June 2026

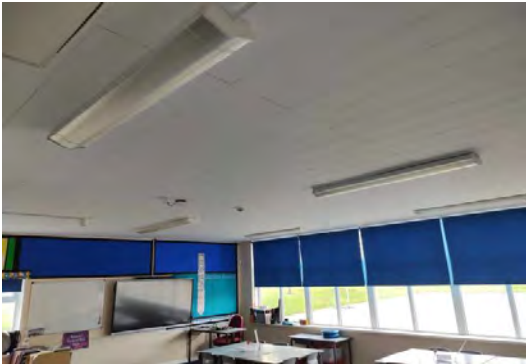
Item 173 Ref: 22-50672-5

The ceiling modern fibreboard ceiling panels (Area 29/ Classroom) does not contain asbestos.

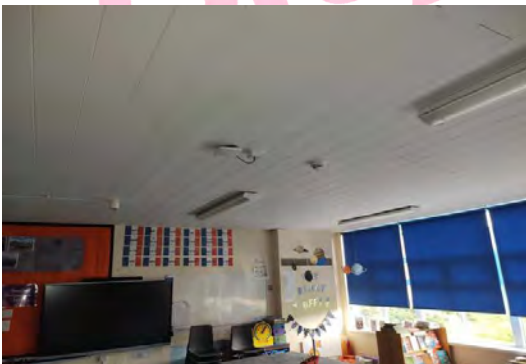
Item 174 Ref: 22-50672-5

The ceiling modern fibreboard ceiling panels (Area 30/ Classroom) does not contain asbestos.

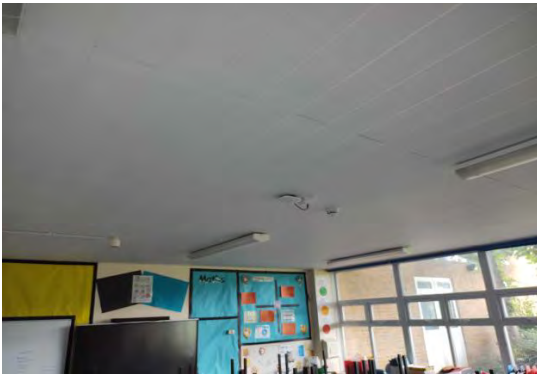
Item 175 Ref: 22-50672-5

The ceiling modern fibreboard ceiling panels (Area 31/ Classroom) does not contain asbestos.

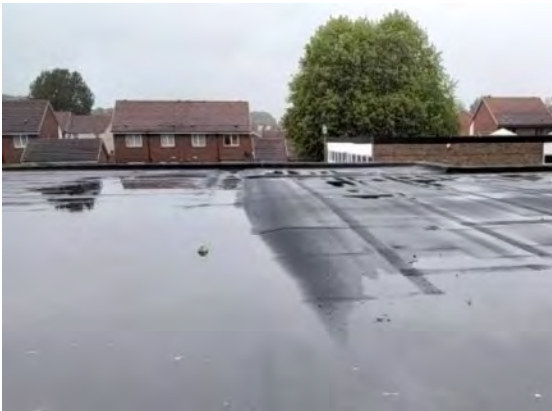
Item 176 Ref: SC004786

The roof felt (External/Main Roof) does not contain asbestos.

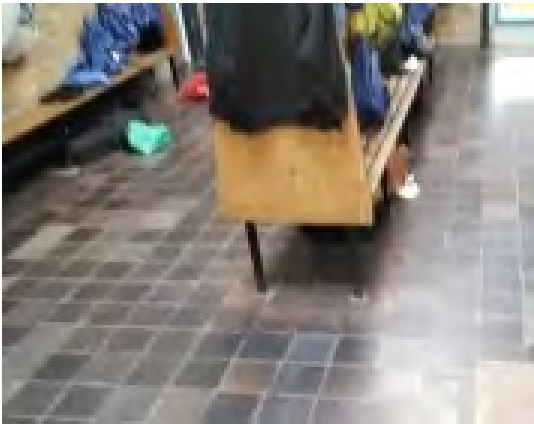
Item 178 Ref: KX001821

The floor tile including mortar and substrate in Cloak room Yr. 2/3 (Room G/002) does not contain asbestos.

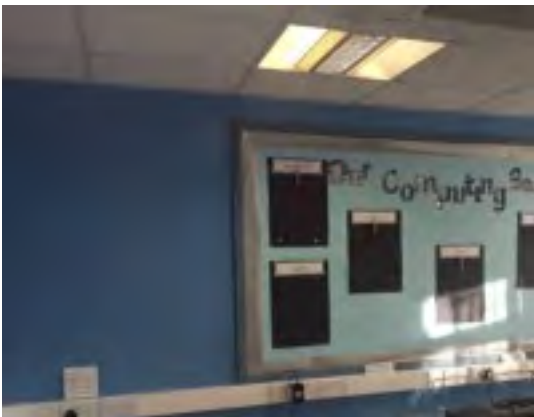
Item 179 Ref: NZ000986

The Wall to left hand side of room (Ground Floor G/001 Classroom) does not contain asbestos.

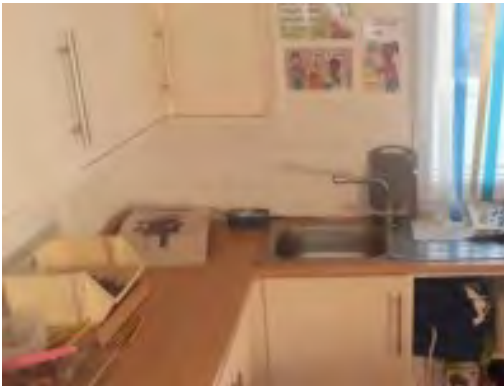
Item 181 Ref: NZ000988

The Under Sink Mat (Ground Floor G/002 Classroom) does not contain asbestos.

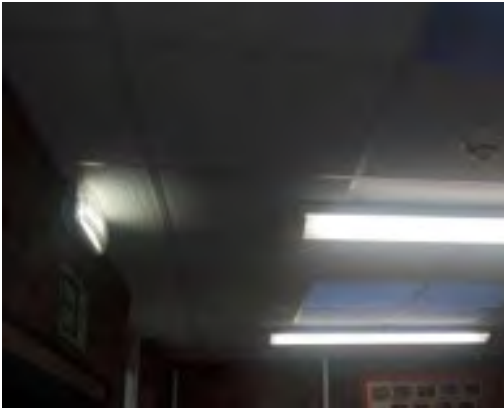
Item 182 Ref: As NZ000987

The Ceiling Void - Ceiling Above Also ceiling within toilets (Ground Floor G/003 Cloakroom) does not contain asbestos.

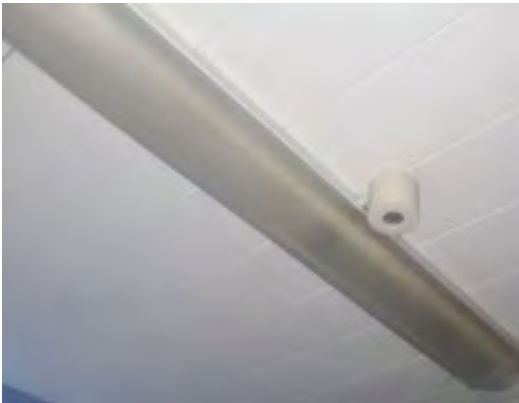
Item 185 Ref: NZ000991

The Ceiling (Ground Floor G/004 Hallway/passageway) does not contain asbestos.

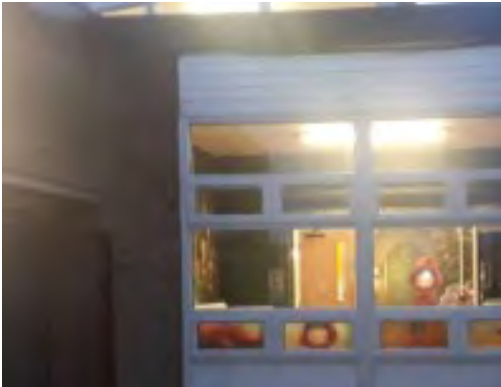
Item 188 Ref: NZ000993

The Window Putty/seal Mastic to frame wall to window (getting removed to hallway passage 0/04) (External E/001) does not contain asbestos.

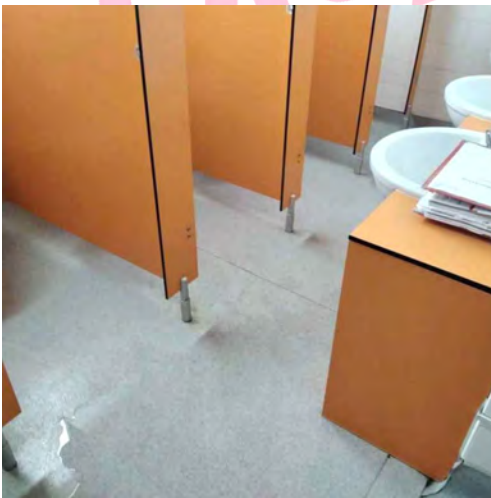
Item 189 Ref: CF010859

The terrazzo with bitumen floor covering (Ground Floor Rm 008 Female Toilets) does not contain asbestos.
