ASBESTOS SURVEY REPORT FOR ST ANNES RC PRIMARY, SUNDERLAND

Asbestos Register for ST ANNES RC PRIMARY, SUNDERLAND

Date: 22 July 2025

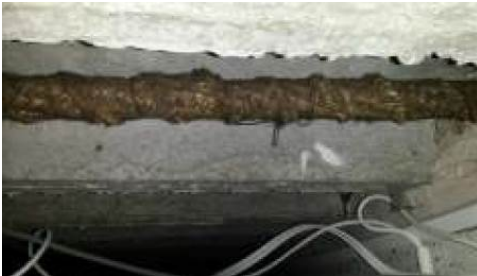
Item 7 Ref: 15-19198/8

The textile string to the pipe to the pipework to the void above the corridor (Room 21) does not contain asbestos.

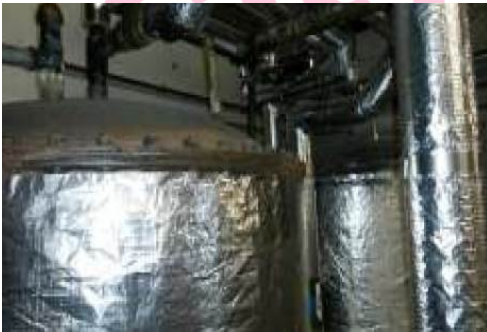
Item 9 Ref: 15-19198/5

The gaskets to the tanks in the boiler house (Room 23) do not contain asbestos.

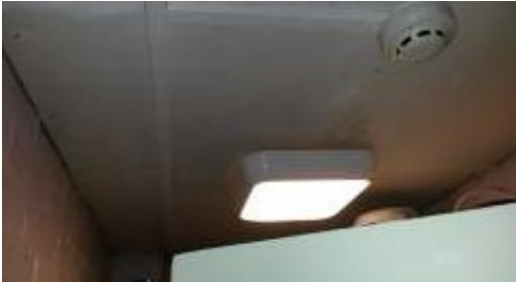
Item 19 Ref: 15-19198/15

The insulation board ceiling to the cleaners cupboard (Room 35) does not contain asbestos.

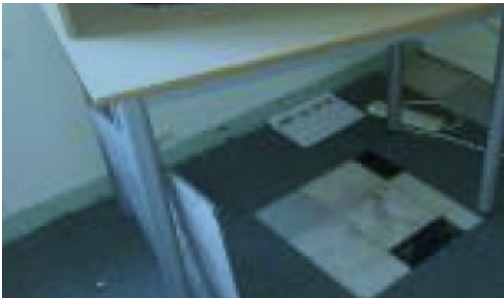
Item 20 Ref: 15-19198/16

The floor tiles and the adhesive to the Rainbow Room (Room 38) contain asbestos.

Any change in its appearance should be recorded and passed to Property Services.

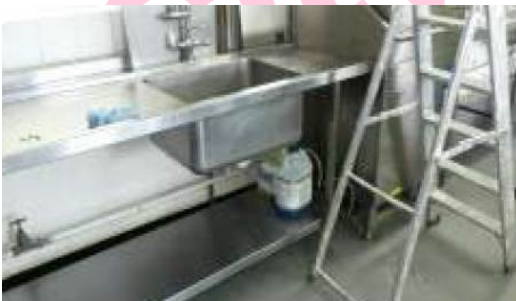
Item 21 Ref: 15-19198/17

The sink pad to the kitchen (Room 42) does not contain asbestos.

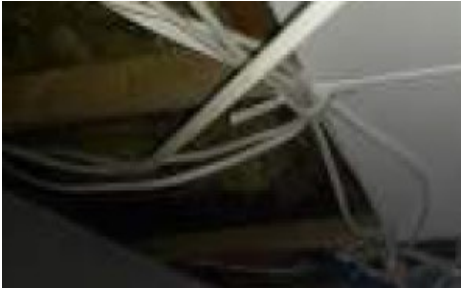
Item 22 Ref: 15-19198/18

The insulation board ceiling to the cleaners cupboard (Room 48) does not contain asbestos.

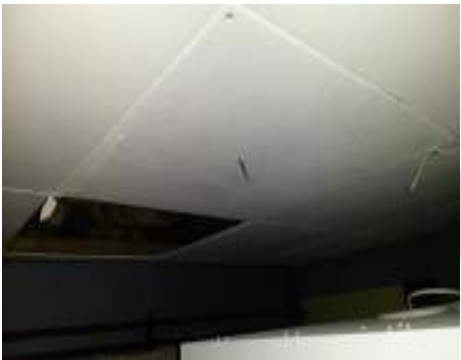
Item 23 Ref: 15-19198/19

The insulation board ceiling to the cleaners' cupboard (Room 48) does not contain asbestos.

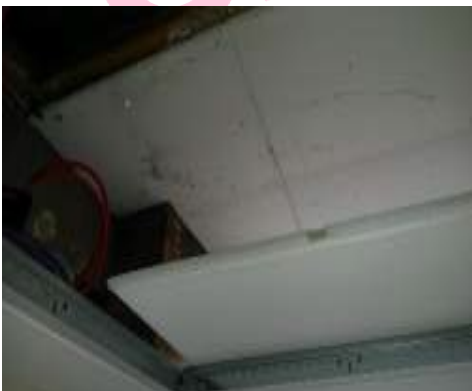
Item 24 Ref: 15-19198/20

The insulation board ceiling to the cleaners' cupboard (Room 51) does not contain asbestos.

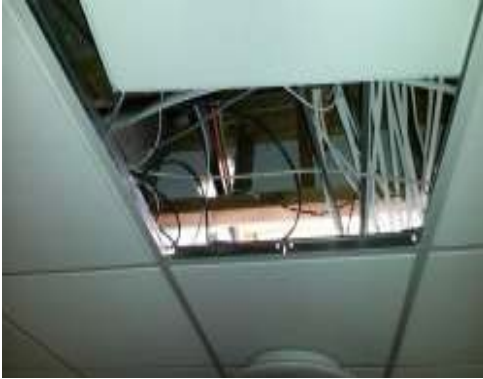
Item 25 Ref: 15-19198/20

The insulation board upstands to the redundant skylight in the void above Room 61 (Room 62) do not contain asbestos.

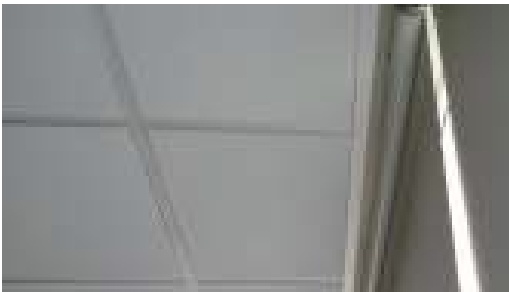
Item 26 Ref: 15-19198/22

The ceiling panels above the windows to the year 2 classroom (Room 73) do not contain asbestos.

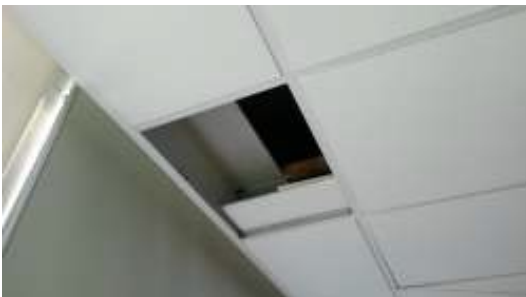
Item 27 Ref: 15-19198/23

The insulation board to the void above year 2 classroom (Room 74) does not contain asbestos.

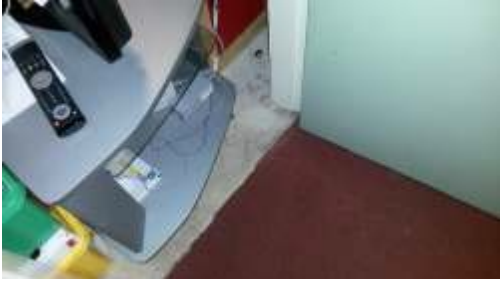
Item 28 Ref: 15-19198/24

The floor tiles and adhesive to the store (Room 82) contain asbestos.

Any change in its appearance should be noted and passed to Property Services.

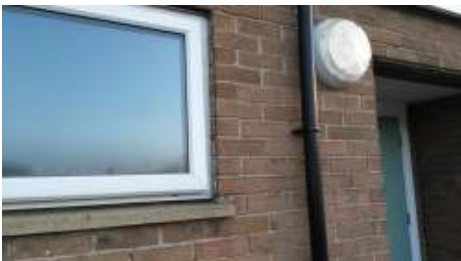
Item 32 Ref: 15-19198/31

The putty to the brickwork (External) does not contain asbestos.

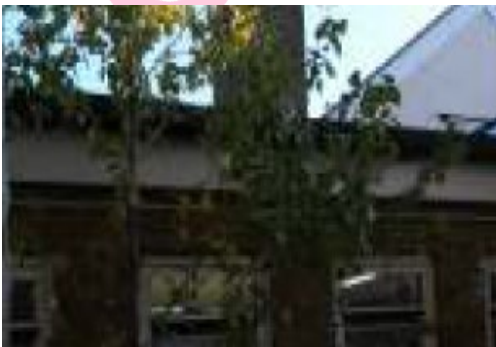
Item 33 Ref: 15-19198/28

The putty to the wood frame (External) does not contain asbestos.

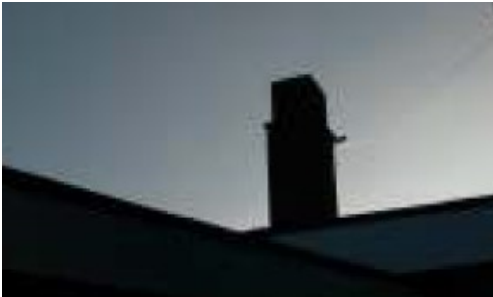
Item 34 Ref: 15-19198/27

The roof felt (external) does not contain asbestos.

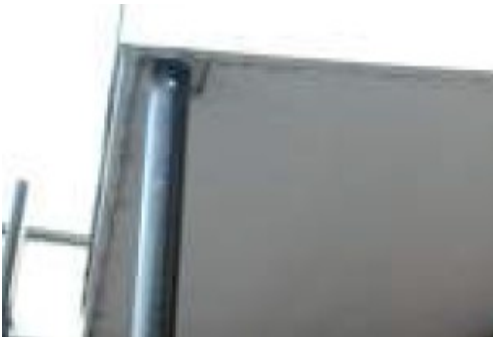
Item 35 Ref: 15-19198/25

The insulation board to the rear canopy outside the kitchen (external) does not contain asbestos.

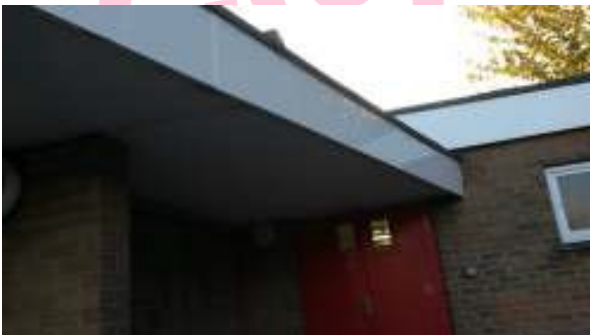
Item 36 Ref: 15-19198/26

The insulation board soffits to the rear canopy outside the kitchen (External) do not contain asbestos.

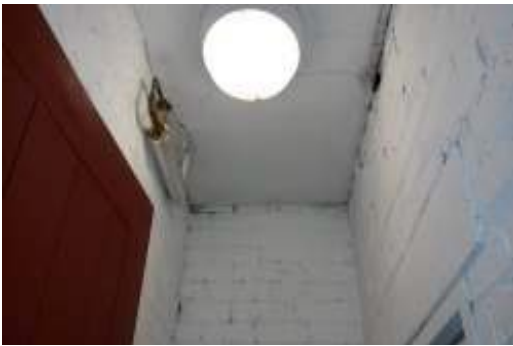
Item 37 Ref: 15-19198/33

The insulation board to the ceiling in the external wc does not contain asbestos.

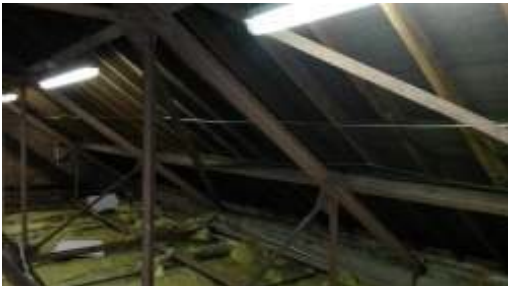
Item 38 Ref: 15-19198/34

The sarking felt to the roof tank room does not contain asbestos.

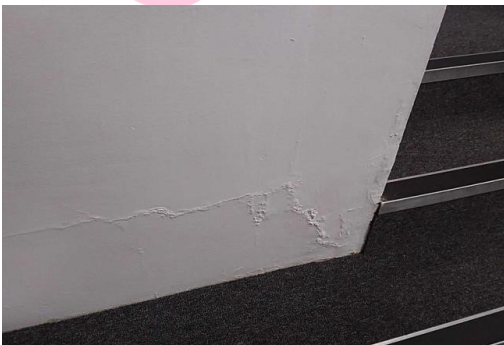
Item 53 Ref: 22-44268-2

The left side of walls (Corridor opposite main hall/Area 2) does not contain asbestos.

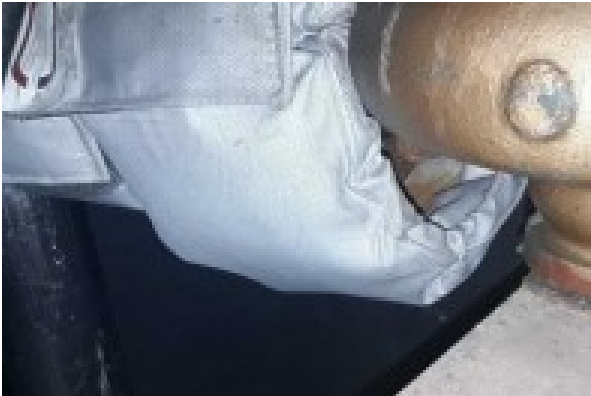
Item 64 Ref: 24-76425-8

The acoustic pads beneath 2 x pumps (Boiler Room/Area 001) do not contain asbestos.

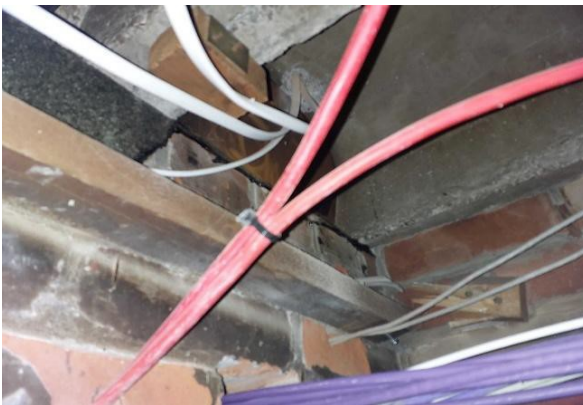
Item 68 Ref: 25-88025-3

The ceiling - felt to brickwork near pipework (Bitumen) (Electric Cupboard/Area: 019) does not contain asbestos.

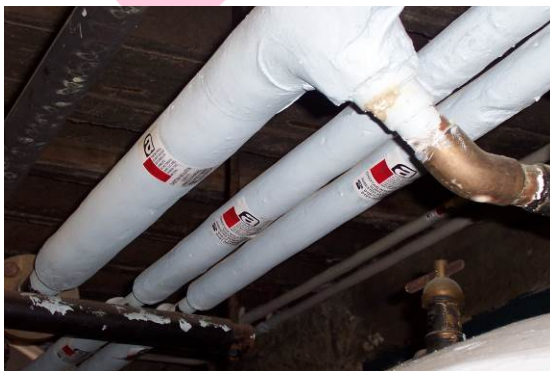
Ref:037SW3

The pipe insulation in the plant room (Room 23) contained asbestos.

This was removed in February 2014.

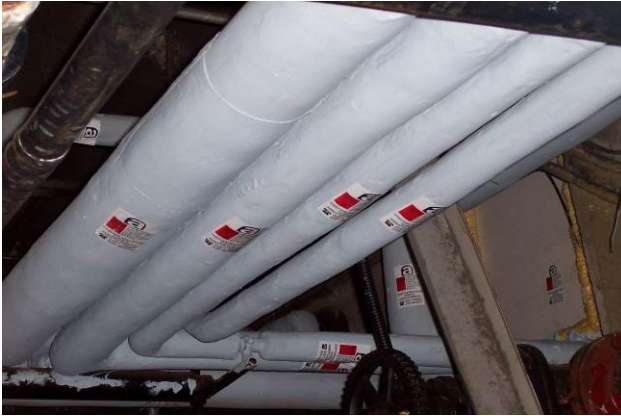
Ref:037SW3 and 037SW6

The pipe insulation in the plant room (Room 23) contained asbestos.

This was removed in February 2014.

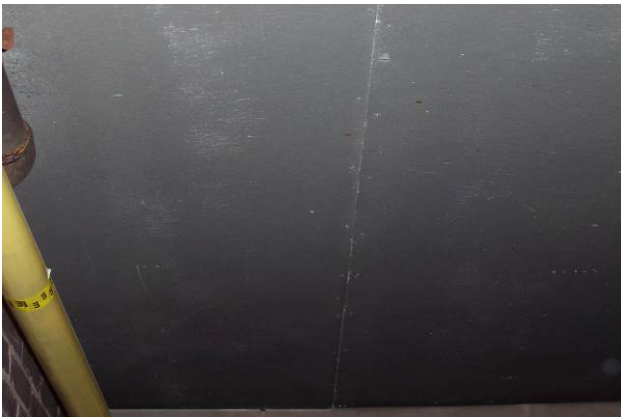
Ref: 037SW8

The ceiling boards to the plant room (Room 23) contained asbestos.

These have since been removed.

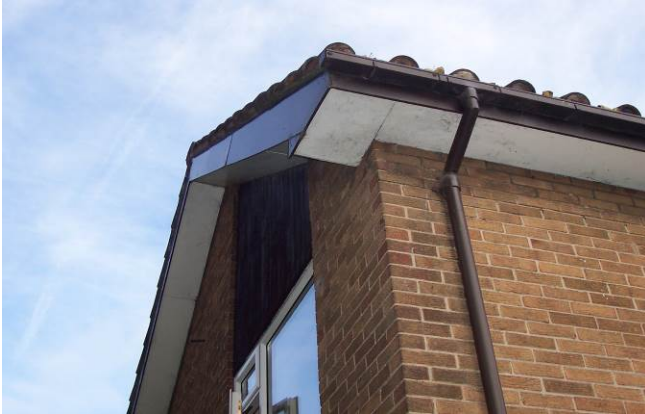
Item 39 - Ref: 037SW13

The soffitt boards to the Caretakers House contain asbestos.

Any change in its appearance should be recorded, and passed to Property Services.

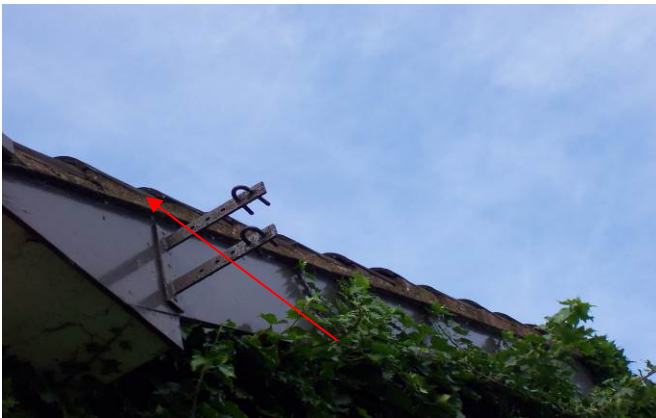
Item 40 - Ref: Presumed

The fillet board to the apex on the Caretakers House is presumed to contain asbestos.
