ASBESTOS SURVEY REPORT FOR WESSINGTON PRIMARY SCHOOL  
LANERCOST, WASHINGTON, TYNE AND WEAR, NE38 7QA.

## Asbestos Register for

**Wessington Primary School, Washington,  
NE38 7QA**

**Date: 22 August 2024**

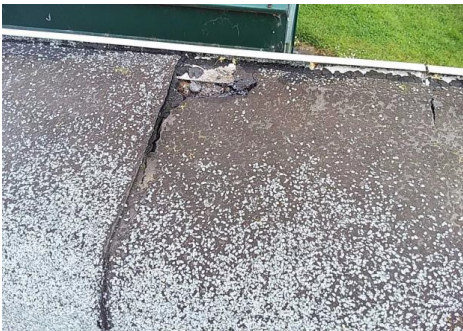
**Item 65 Ref: 22-47238-6**

The bitumen roof felt (Area 1/External) does not contain asbestos.

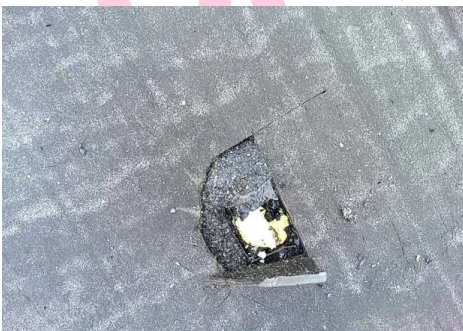
**Item 66 Ref: 22-47238-7**

The bitumen roof felt (Area 1/External) does not contain asbestos.

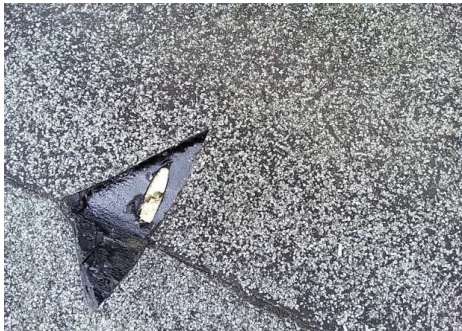
**Item 67 Ref: 22-47238-8**

The bitumen roof felt (Area 1/External) does not contain asbestos.
