### **ASBESTOS SURVEY REPORT FOR WESSINGTON PRIMARY SCHOOL LANERCOST, WASHINGTON, TYNE AND WEAR, NE38 7QA.**

## **Asbestos Register for**

**Wessington Primary School, Washington,  
NE38 7QA**

**Date: 01 August 2025**

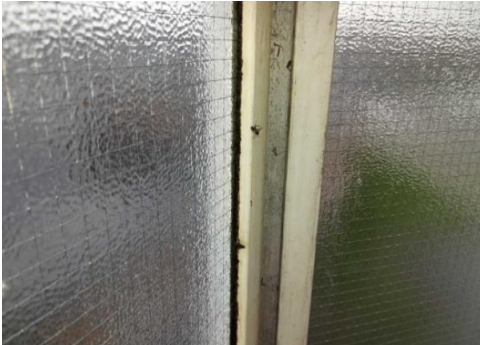
#### **Item 43 Ref: 20-28462-19**

The sealant to glass panes (Area 107/Tank Room) contains asbestos.

Any change in its appearance should be recorded and passed to Property Services.

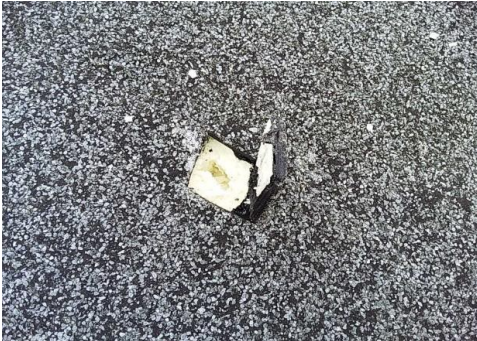
#### **Item 61 Ref: 22-47238-2**

The bitumen roof felt (Area 1/External) does not contain asbestos.

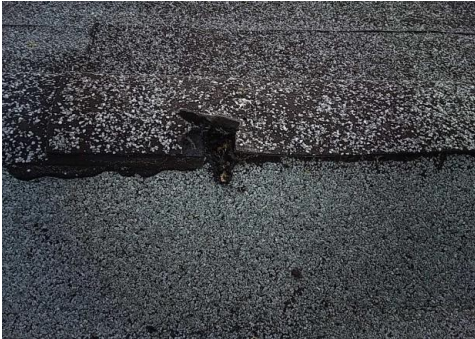
#### **Item 64 Ref: 22-47238-5**

The bitumen roof felt (Area 1/External) does not contain asbestos.

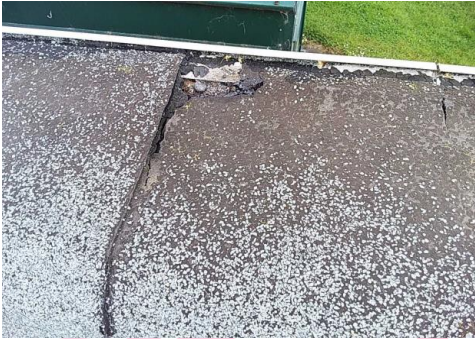
#### **Item 65 Ref: 22-47238-6**

The bitumen roof felt (Area 1/External) does not contain asbestos.

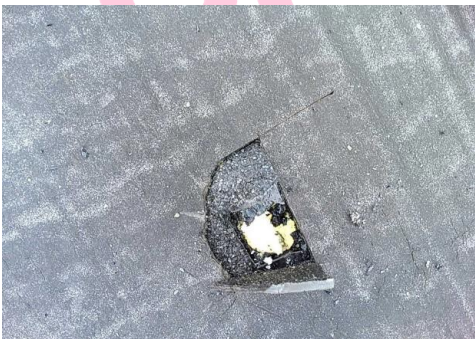
#### **Item 66 Ref: 22-47238-7**

The bitumen roof felt (Area 1/External) does not contain asbestos.

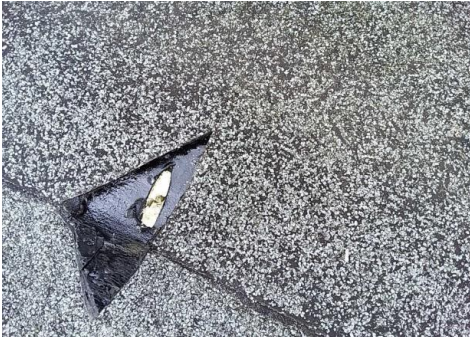
#### **Item 67 Ref: 22-47238-8**

The bitumen roof felt (Area 1/External) does not contain asbestos.

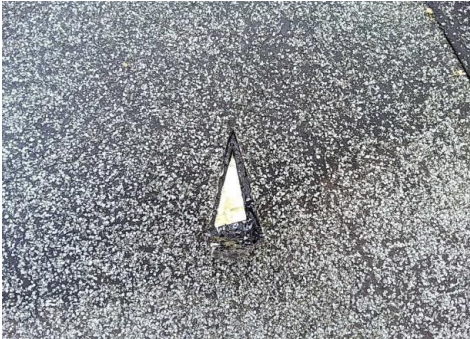
#### **Item 68 Ref: 22-47238-9**

The bitumen roof felt (Area 1/External) does not contain asbestos.
