ASBESTOS SURVEY REPORT FOR SOUTH HYLTON PRIMARY SCHOOL, SUNDERLAND

Asbestos Register for SOUTH HYLTON PRIMARY SCHOOL, SUNDERLAND

Date: 20 March 2025

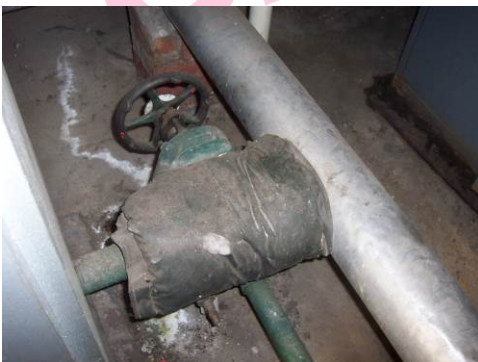
Item 21 – Ref: sample NO06/551

The pipe insulation in the boiler room does not contain asbestos.

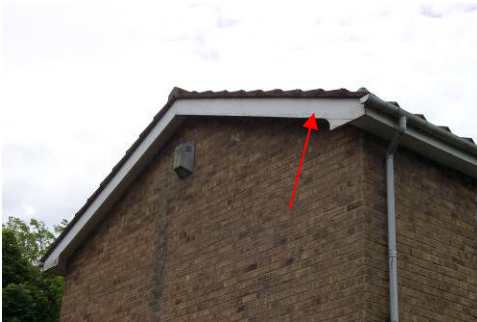
Caretakers House - Demolished

Presumed

The cement fillet to the apex on the Caretakers house was presumed to contain asbestos.

This has now been demolished.

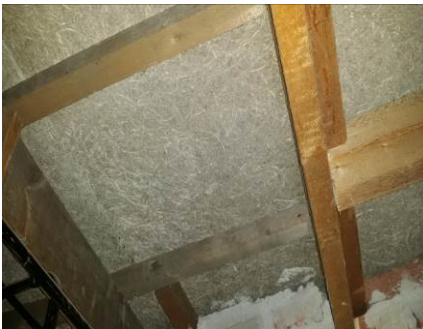
Item 29 – As 107247-1

The underside of the roof in the void above the hall corridor does not contain asbestos.

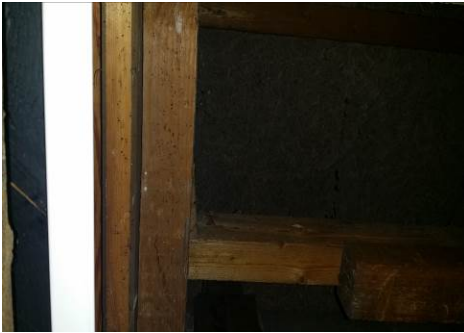
Item 30 – As 107247-1

The underside of the roof in the void above the corridor does not contain asbestos.

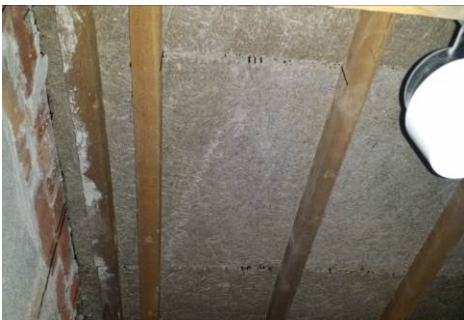
Item 31 – Ref: 107247-4

The underside of the roof in the void above the cleaners store does not contain asbestos.

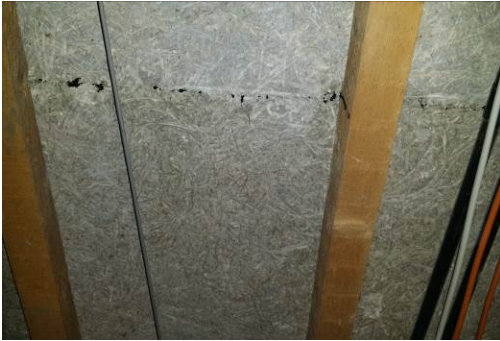
Item 33 – As 107247-4

The underside of the roof in the void above the kitchen does not contain asbestos.

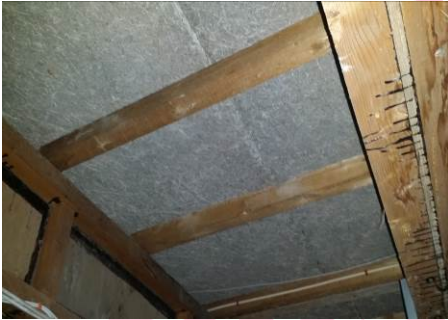
Item 37 – As 107247-4

The underside of the roof in the void above the quiet area does not contain asbestos.

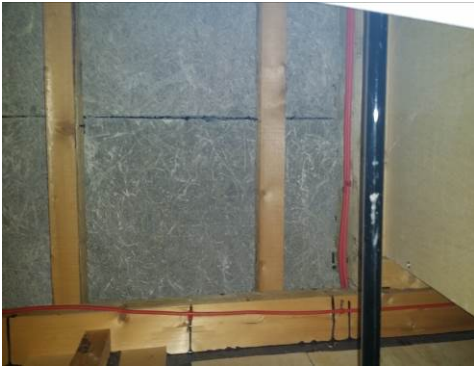
Item 42 – Ref:107247-8

The underside of the roof in the void above the deputy heads office does not contain asbestos.

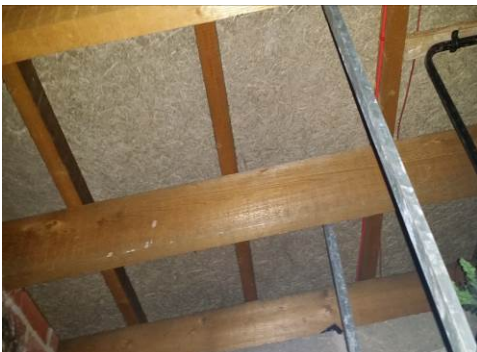
Item 44 – As 107247-8

The underside of the roof in the void above the store does not contain asbestos.

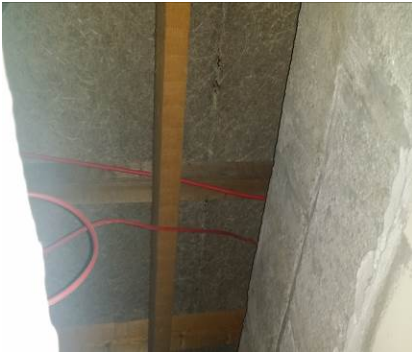
Item 45 – Ref:107247-8

The underside of the roof in the void above the store does not contain asbestos.

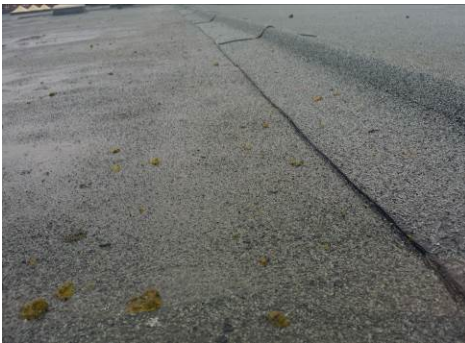
Item 46 – Ref: 107247-9

The roof felt to the external does not contain asbestos.

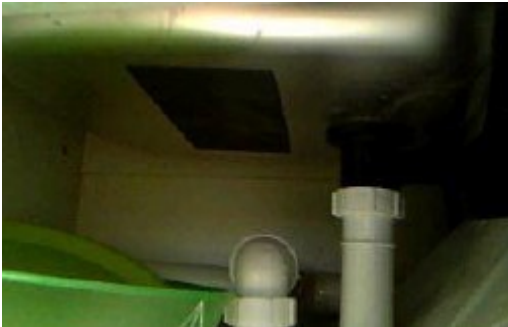
Item 58 – Ref BB000981

The Sink Pad in Room 13 (Infants current sink area) does not contain asbestos.

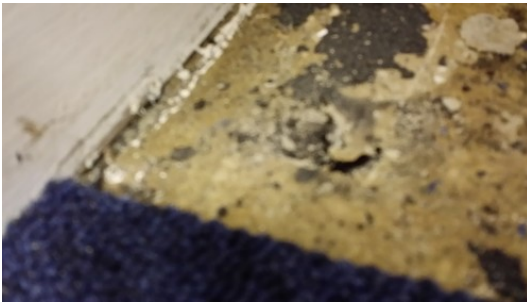
Item 61 – Ref 76223-1

The Floor black composite (001/classroom) does not contain asbestos.

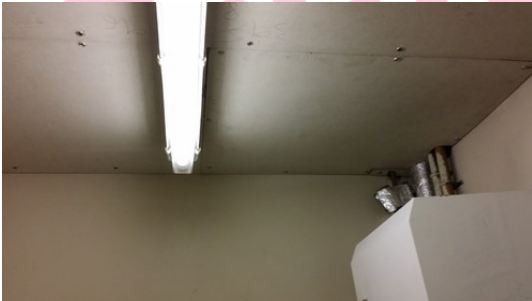
Item 62 – Ref 76223-2

The Ceiling (002/boiler cupboard) does not contain asbestos.

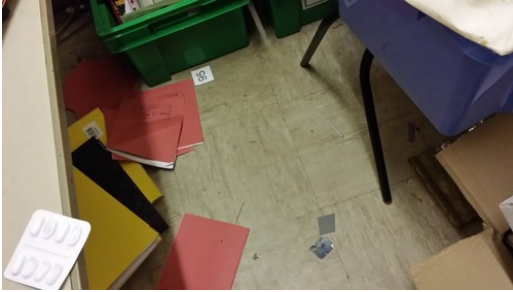
Item 63 – Ref 76223-3

The Vinyl tile floor covering (002/boiler cupboard) does not contain asbestos.

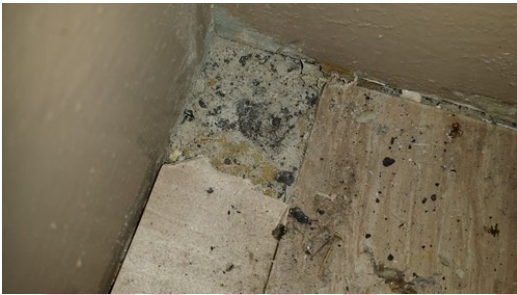
Item 64 – Ref As 76223-1

The Floor black composite (002/boiler cupboard) does not contain asbestos.

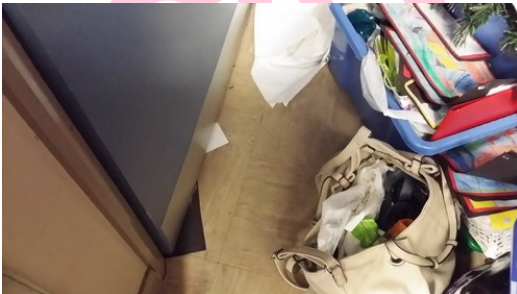
Item 65 – Ref As 76223-3

The Vinyl tile floor covering (003/store cupboard) does not contain asbestos.

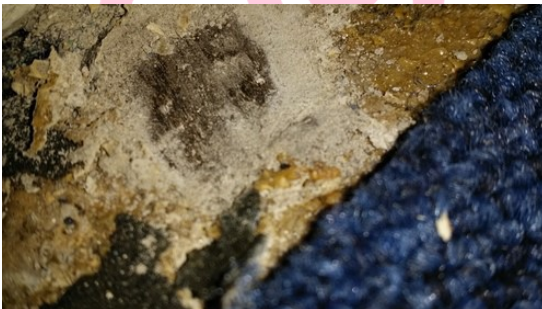
Item 68 – Ref As 76223-1

The Floor black composite (004/store cupboard) does not contain asbestos.

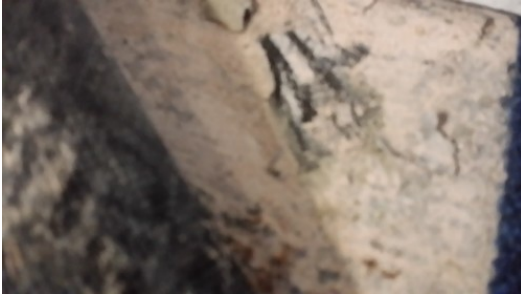
Item 69 – Ref As 76223-1

The Floor black composite (005/classroom) does not contain asbestos.

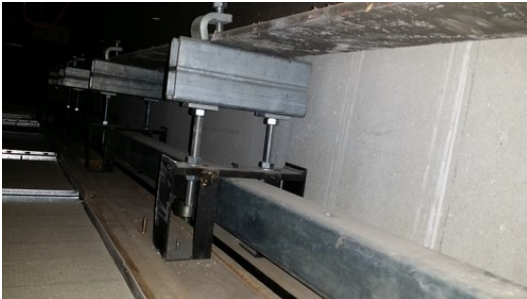
Item 70 – Ref 76223-4

The Firebreak (insulating board) (005/classroom-void above) does not contain asbestos.

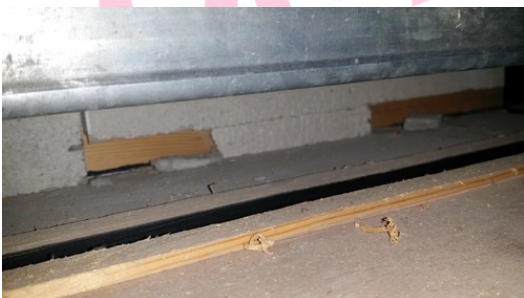
Item 71 – Ref As 76223-4

The Debris adjacent firebreak (insulating board) (005/classroom-void above) does not contain asbestos.

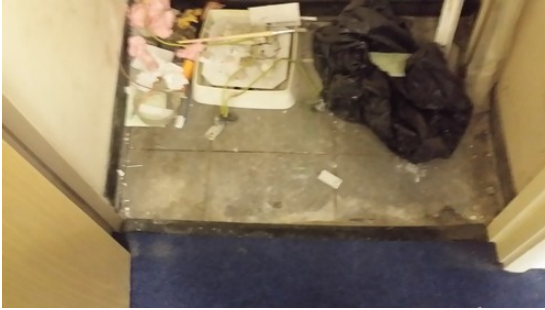
Item 72 – Ref 76223-5

The Vinyl floor tile incl. bitumen adhesive (008/DB1 cupboard) does not contain asbestos.

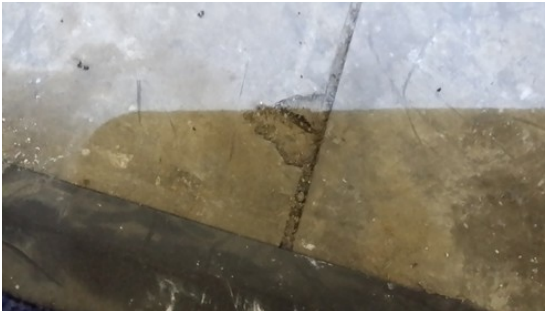
Item 73 – Ref As 76223-1

The Floor (008/DB1 cupboard) does not contain asbestos.

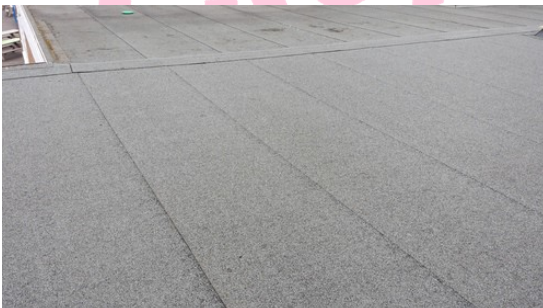
Item 74 – Ref 76223-7

The Flat roof (externals localised to proposed classroom extension) does not contain asbestos.

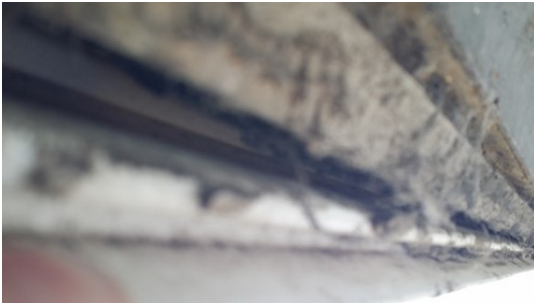
Item 75 – Ref 76223-6

The Felt layer behind plastic fascia (externals localised to proposed classroom extension) does not contain asbestos.
