ASBESTOS SURVEY REPORT FOR DERWENT HILL OUTDOOR EDUCATION AND TRAINING CENTRE, PORTINSCALE, KESWICK, CUMBRIA, CA12 5RD.

Asbestos Register for Derwent Hill Outdoor Education and Training Centre

Date: 25 June 2025

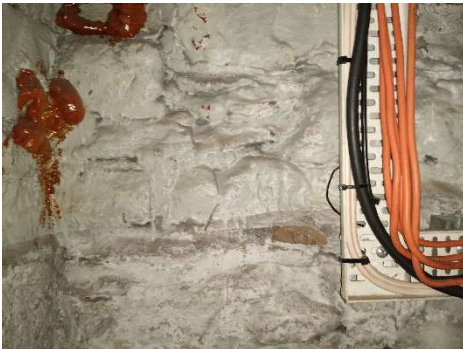
Item 9 Ref: 418920-20

The debris to walls in Boiler Room/-1/002 contains asbestos.

Removed and Encapsulated November 2020

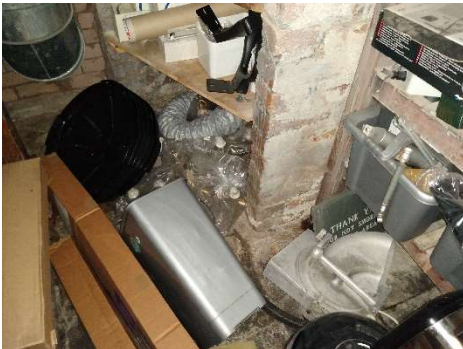
Item 15 Ref: 418920-25

The general debris to floor in Store/-1/003 contains asbestos.

Removed November 2020

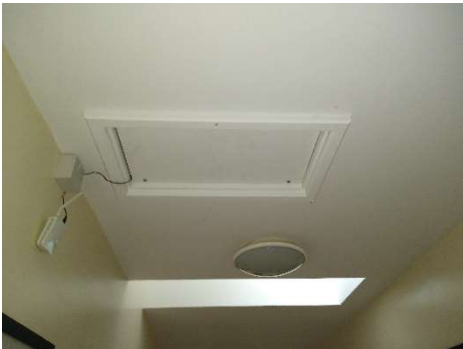
Item 18 Ref: As 418920-30

The panels to loft hatches in Corridor/0/012 do not contain asbestos.

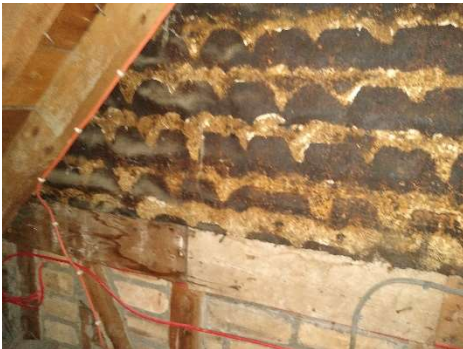
Item 24 Ref: 418920-29

The sarking to wall in Ennerdale loft above room and extension/0/018 does not contain asbestos.

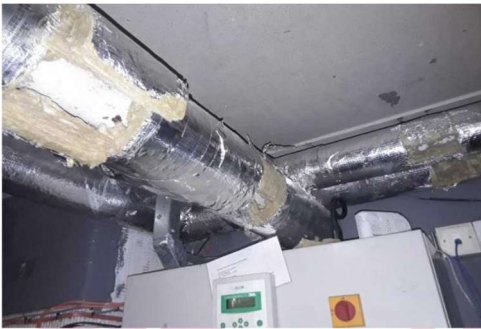
Item 61 Ref: 22-43184-1

- (Item 61) *Ref: 22-43184-1 – Pipes - residual insulation beneath Mmmf to old pipework (thermal insulation) (Area 3/Plant Room) – Low Risk*
- (Item 62) *Ref: 22-43184-4 – Pipes – residual insulation to pipe bracket (thermal insulation) (Area 5/Cleaners Store) – Medium Risk*

The pipes - residual insulation beneath Mmmf to old pipework (thermal insulation) (Area 3/Plant Room) contain asbestos.

Any change in its appearance should be recorded and passed to Property Services.

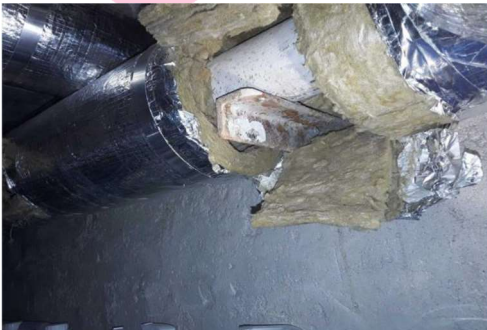
Item 62 Ref: 22-43184-4

The pipes – residual insulation to pipe bracket (thermal insulation) (Area 5/Cleaners Store) contain asbestos.

Any change in its appearance should be recorded and passed to Property Services.

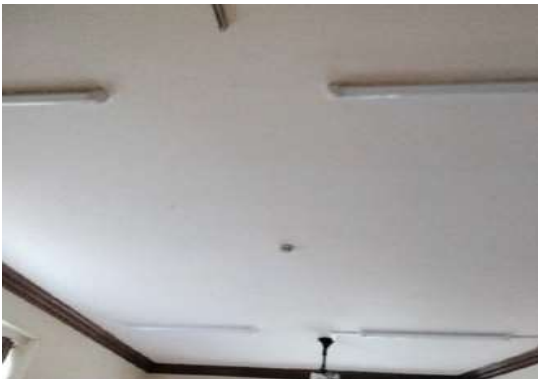
Item 67 Ref: KX001962

The ceiling papered with woodchip paper in the Living Room/Lounge (G/002) does not contain asbestos.

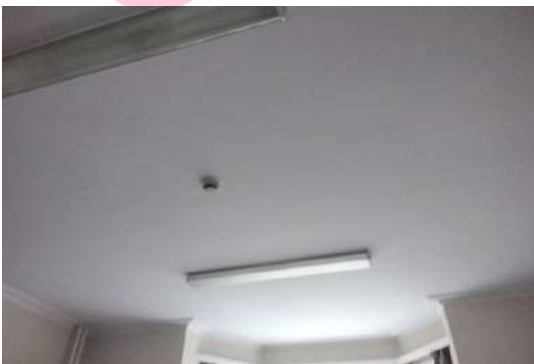
Item 68 Ref: KX001963

The ceiling in the Dales Dining Room (Room G/003) does not contain asbestos.

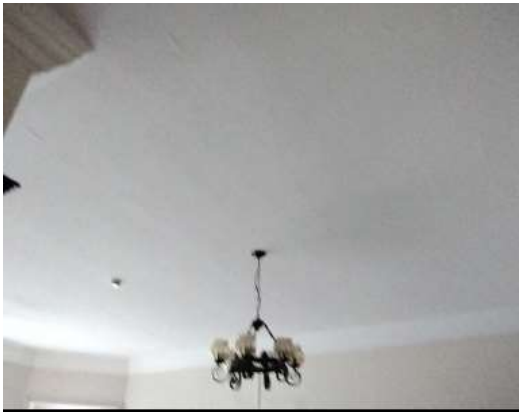
Item 69 Ref: KX001961

The papered ceiling in the Fells Dining Room (Room G/004) does not contain asbestos.

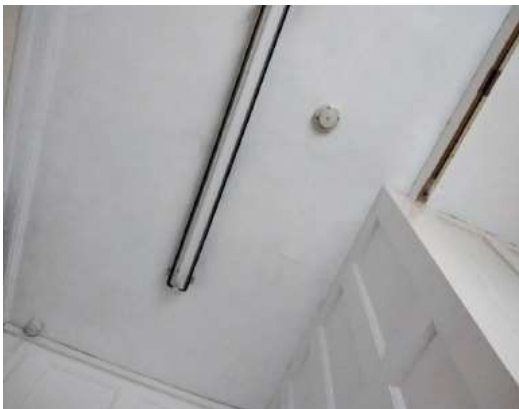
Item 70 Ref: KX001965

The ceiling in the Store Room Shop (G/005) does not contain asbestos.

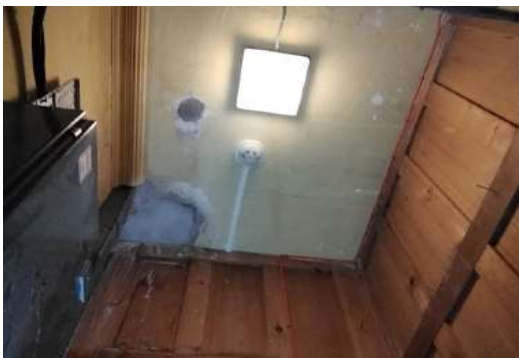
Item 71 Ref: KX001966

The ceiling in the Electrical cupboard in the shop (Room G/00) does not contain asbestos.

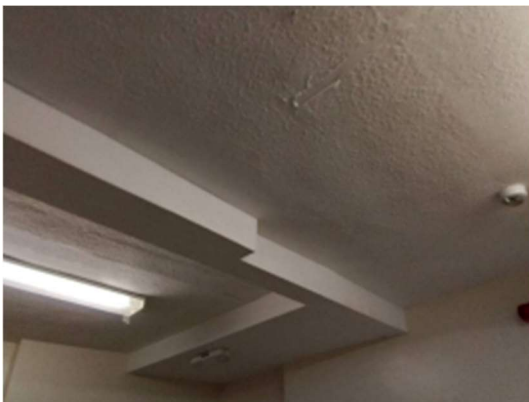
Item 74 Ref: QK000869

The ceiling wallpapered (Bedroom Scarfell Dormitory Rm 1/002) does not contain asbestos.

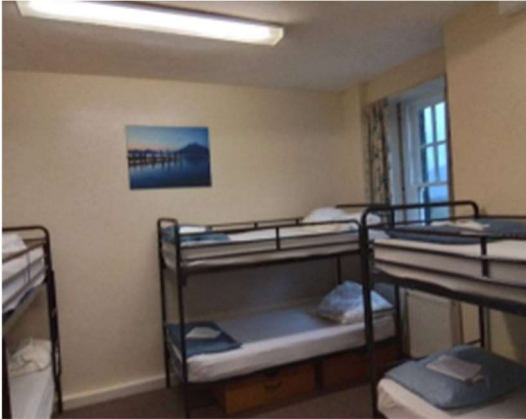
Item 75 Ref: QK000870

The wall (Bedroom Scarfell Dormitory Rm 1/002) does not contain asbestos.

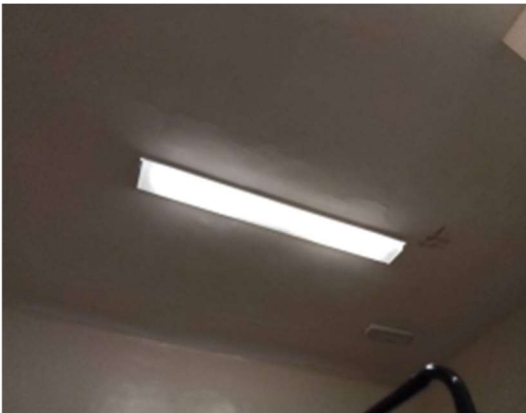
Item 76 Ref: QK000871

The ceiling (Bedroom Latrigg Dormitory Rm 1/003) does not contain asbestos.

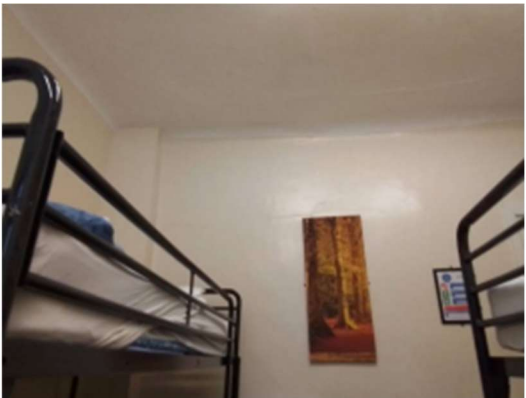
Item 77 Ref: QK000872

The wall (Bedroom Latrigg Dormitory Rm 1/003) does not contain asbestos.

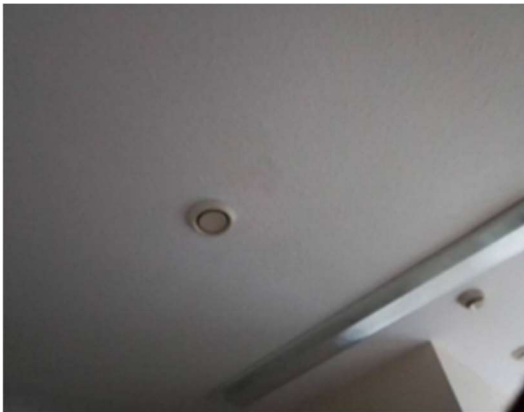
Item 78 Ref: QK000873

The ceiling (Bedroom Littleman Dormitory Rm 1/004) does not contain asbestos.

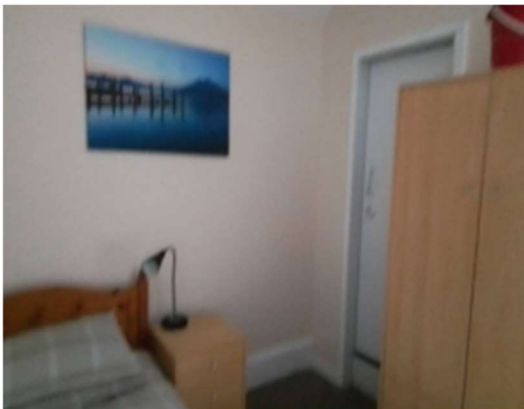
Item 79 Ref: QK000874

The wall (Bedroom Littleman Dormitory Rm 1/004) does not contain asbestos.

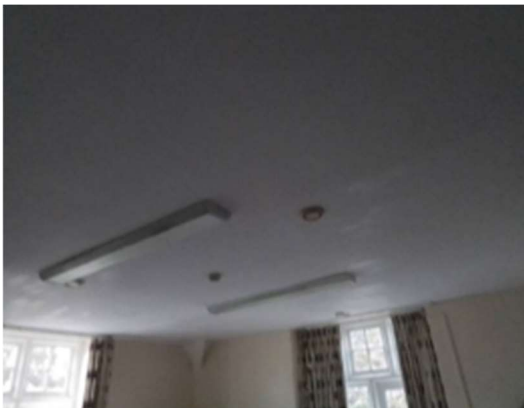
Item 80 Ref: QK000875

The ceiling (Bedroom Skiddaw Dormitory Rm 1/005) does not contain asbestos.

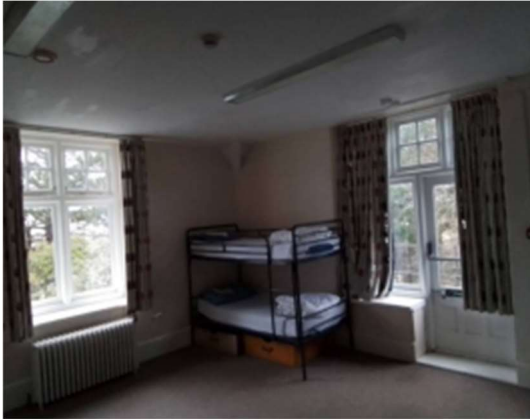
Item 81 Ref: QK000876

The wall (Bedroom Skiddaw Dormitory Rm 1/005) does not contain asbestos.

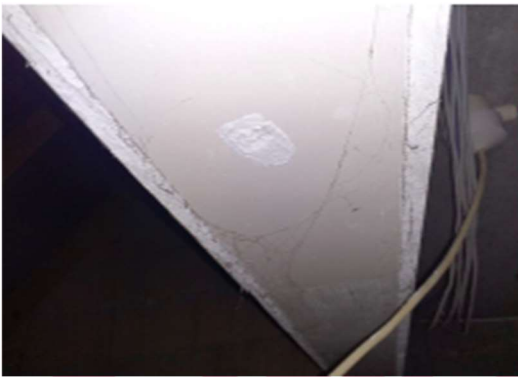
Item 88 Ref: EV006952

The insulating board – steel beams within ceiling voids in the Reception Area (G/02) does not contain asbestos.

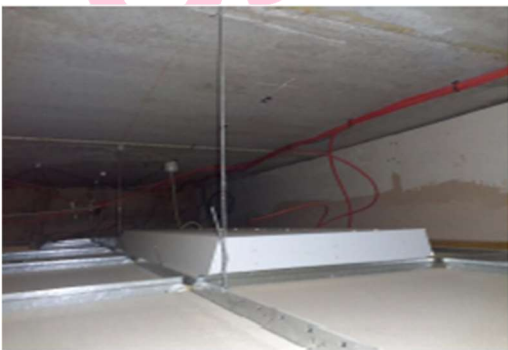
Item 89 Ref: As EV006952

The insulating board – steel beams within ceiling voids in the Office (G/03) does not contain asbestos.

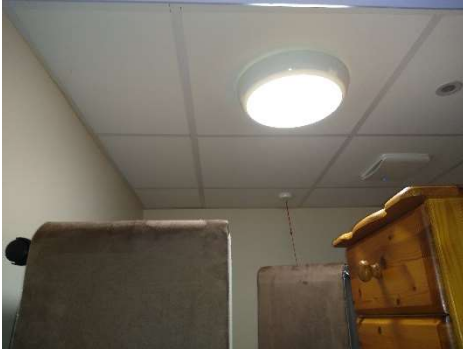
Item 29 Ref: As 418920-12

The suspended ceiling in Bedroom 15 ensuite bathroom/0/001 does not contain asbestos.

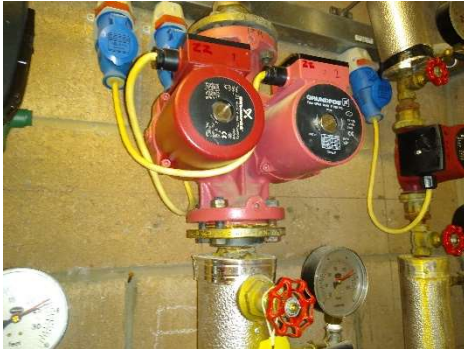
Item 32 Ref: 418920-28

The pipework flange gasket in Boiler Room 0/027 does not contain asbestos.

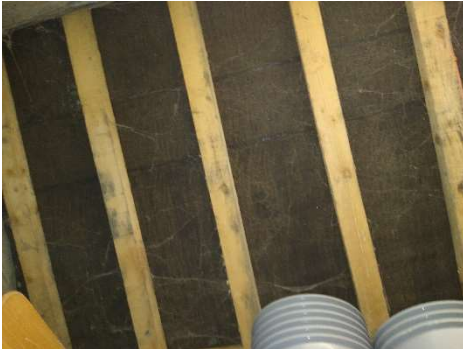
Item 36 Ref: As 418920-8

The sarking in Utility Room/0/004 does not contain asbestos.

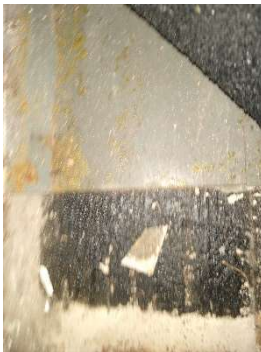
Item 40 Ref: 418920-2

The sub floor covering in Bedroom/0/001 contains asbestos.

Any change in its appearance should be recorded and passed to Property Services.

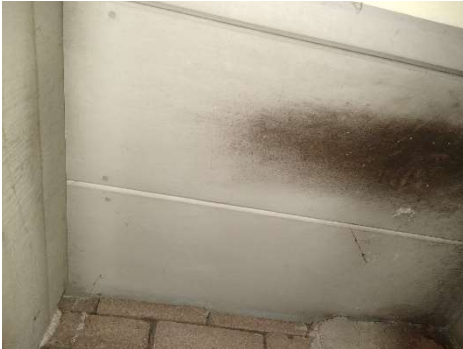
Item 42 Ref: As 418920-1

The ceiling in Kitchen cupboard/0/002 contains asbestos.

Any change in its appearance should be recorded and passed to Property Services.

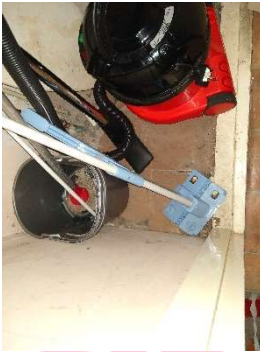
Item 43 Ref: 418920-3

The floor covering in Kitchen cupboard/0/002 contains asbestos.

Any change in its appearance should be recorded and passed to Property Services.

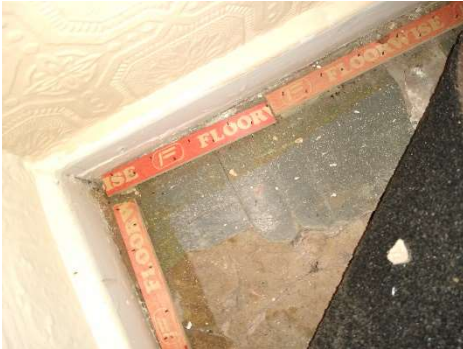
Item 45 Ref: As 418920-2

The sub floor covering in Living Room 0/003 contains asbestos.

Any change in its appearance should be recorded and passed to Property Services.

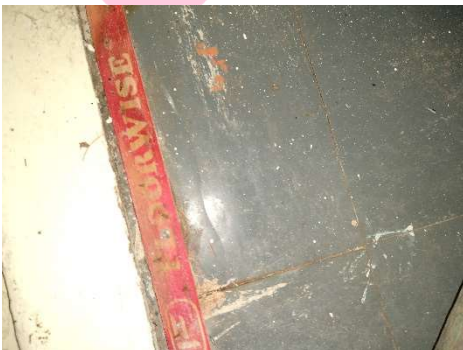
Item 47 Ref: As 418920-2

The sub floor covering in Hallway 0/004 contains asbestos.

Any change in its appearance should be recorded and passed to Property Services.

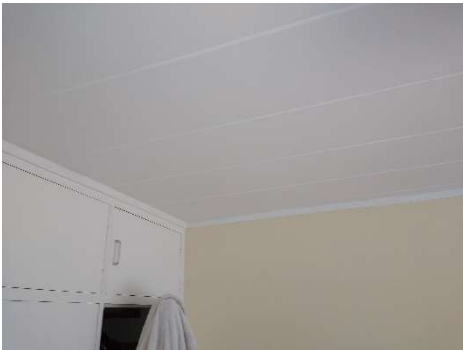
Item 48 Ref: As 418920-1

The ceiling in Bedroom 0/005 contains asbestos.

Any change in its appearance should be recorded and passed to Property Services.

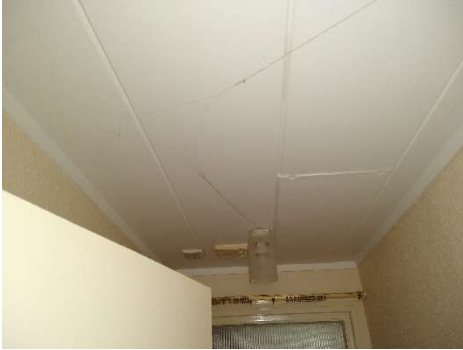
Item 54 Ref: As 418920-1

The ceiling in Toilet Room 0/008 contains asbestos.

Any change in its appearance should be recorded and passed to Property Services.
