ASBESTOS SURVEY REPORT FOR MARKET PLACE DEPOT, HOUGHTON LE SPRING,

Asbestos Register for Market Place Depot, Houghton le Spring

Premises Manager / Samo: - Tenant Date: 10 June 2025

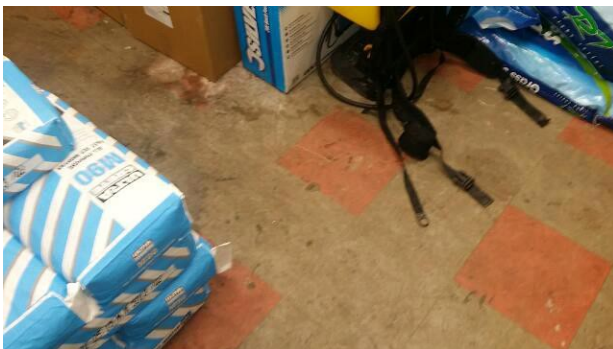
Item 3 Ref: 02

The floor tiles in the Store Room (Rm 0/10) do not contain asbestos.

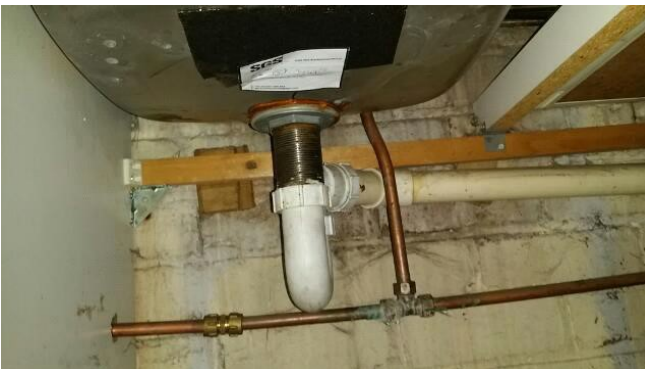
Item 12 Ref: 05

The sink pad in Kitchen (Rm 0/23) does not contain asbestos.

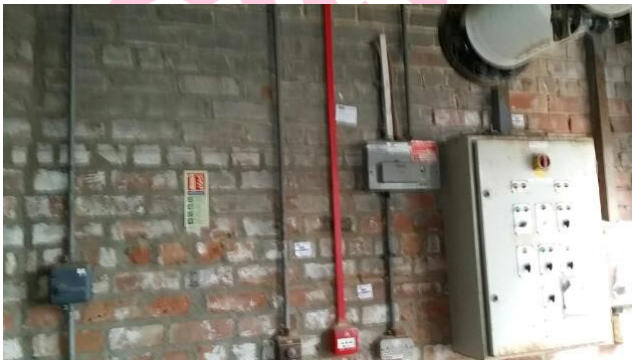
Item 27 Ref: 13

The debris to wall left hand side of electrical equipment in the Boiler Room (Rm 0/40) does not contain asbestos.

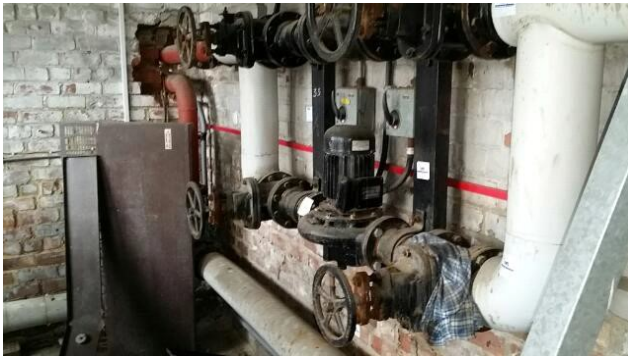
Item 32 Ref: 09

The gaskets in the Boiler Room (Rm 0/40) do not contain asbestos.

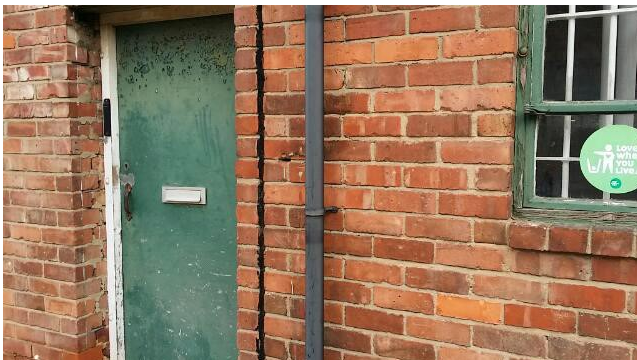
Item 60 Ref: 29

The jointing compound to the wall (External) does not contain asbestos.

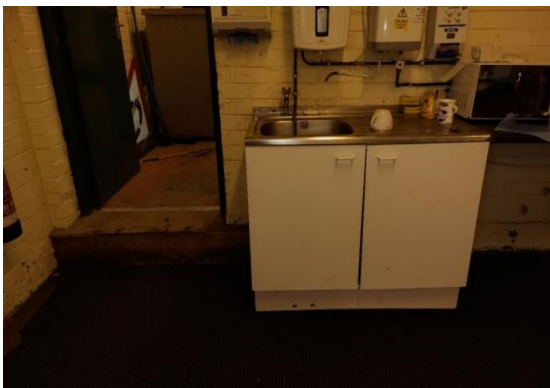
Item 69 Ref: 21-30764-4

The sink pad in Area 6/Ground Office does not contain asbestos.

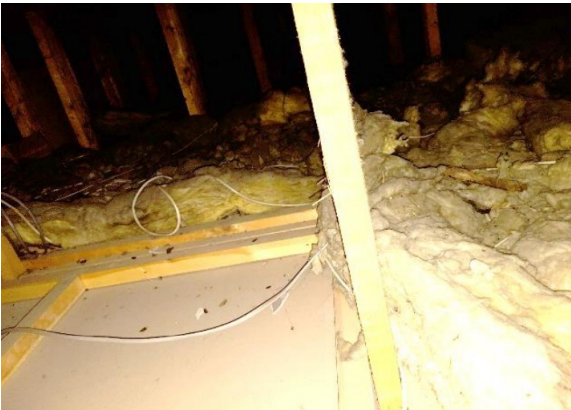
Item 74 Ref: 21-30764-9

The debris in Area 198/Loft space above areas 8,9,10 and 11 contains asbestos.

Any change in its appearance should be recorded and passed to Property Services.

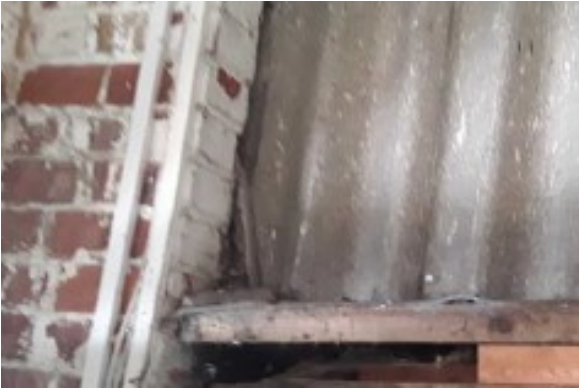
Item 85 Ref: 22-46862-3

The flashing to cement walls above doorway in Warehouse 2 does not contain asbestos.

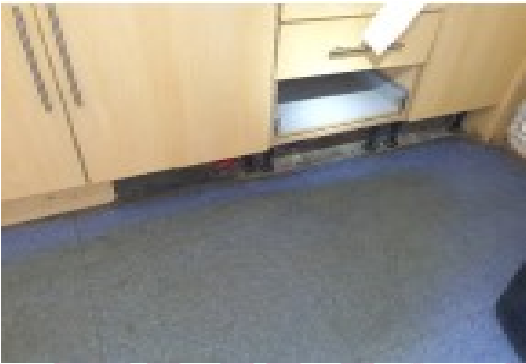
Item 107 Ref: As KG000707

The tile debris under cupboards in the Mess Room (G/01) does not contain asbestos.
