ASBESTOS SURVEY REPORT FOR RYHOPE RECREATION PARK, SUNDERLAND

Asbestos Register for Ryhope Park

Ryhope Recreation Park Last updated 15/05/2024 V.2.0

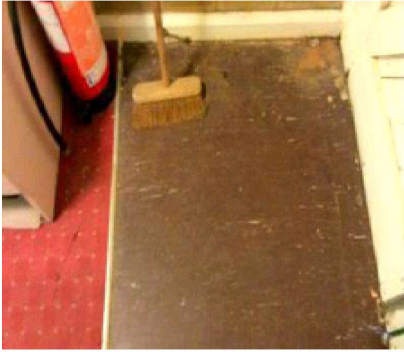
Item 1: Ref: EA003364

The brown vinyl floor covering to the locker area (Room 1) does not contain asbestos.

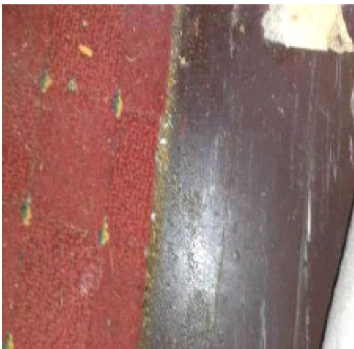
Item 3: As EA003364

The brown vinyl floor covering to the female changing area (Room 3) does not contain asbestos.

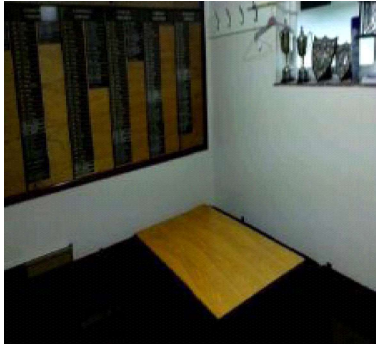
Room 5 (Male changing area) was accessed, and no suspect materials were found.

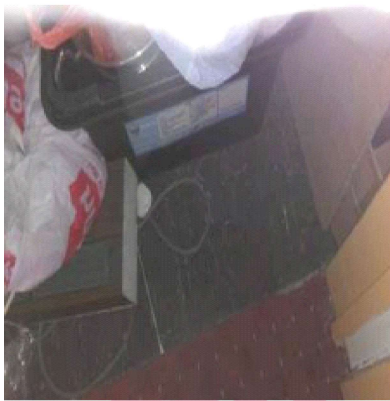
Item 7: As EA003364

The brown vinyl flooring to the cupboard (Room 6) does not contain asbestos.

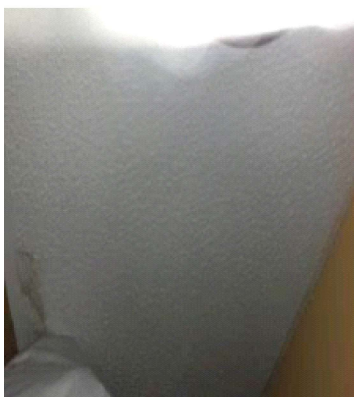
Item 8:Ref: EA003367

The textured coating to the ceiling in the cupboard (Room 6) does not contain asbestos.

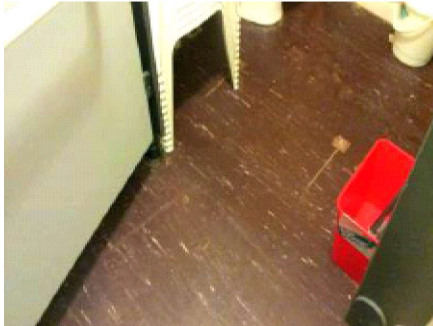
Item 9: As EA003364

The brown vinyl floor covering to the male toilets (Room 7) does not contain asbestos.

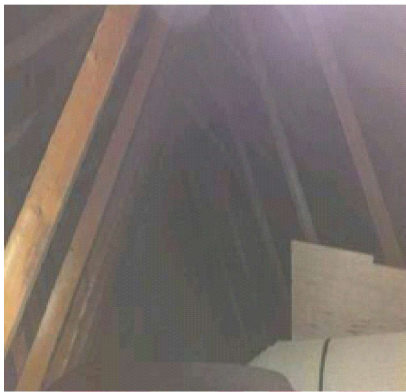
The loft (room 1) was accessed, and no suspect materials were found.

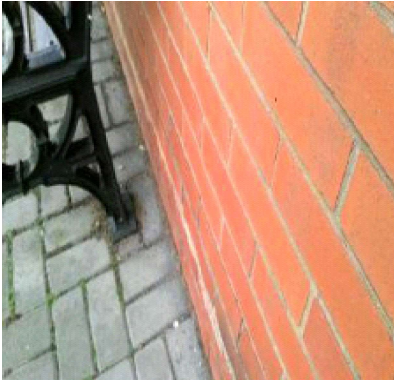
Item 11: Ref: EA003369

The damp proof course to the external does not contain asbestos.

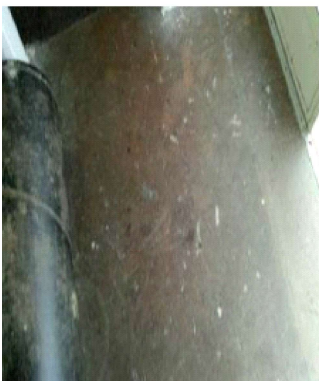
Item 13: Ref: EA003352

The brown vinyl flooring to the lobby (Room 1) does not contain asbestos.

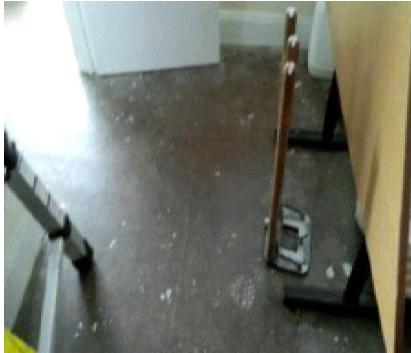
Item 14: As EA003352

The brown vinyl flooring to the store (Room 2) does not contain asbestos.

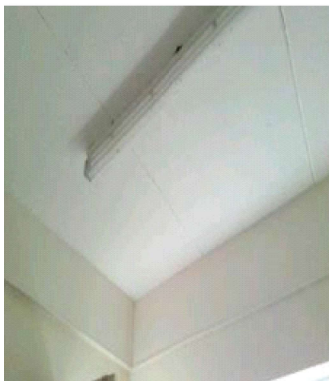
Item 16: Ref: EA003353

The fibreboard ceiling panels to the LHS changing Room (Room 4) do not contain asbestos.

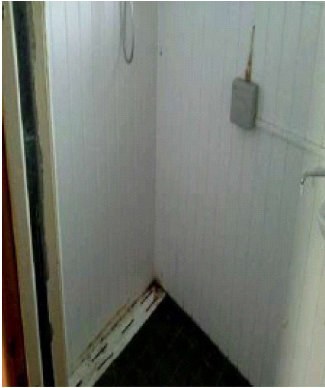
Room 5 (Showers on LHS) were accessed, and no suspect materials were found.

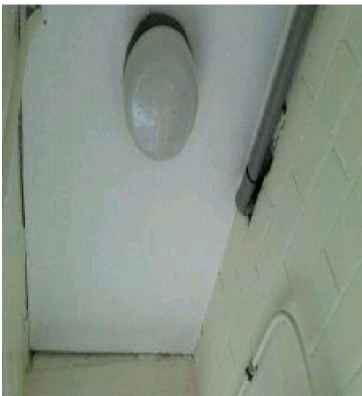
Item 17: As: EA003353

The fibreboard ceiling panels to the toilet on the left-hand side (Room 6) do not contain asbestos.

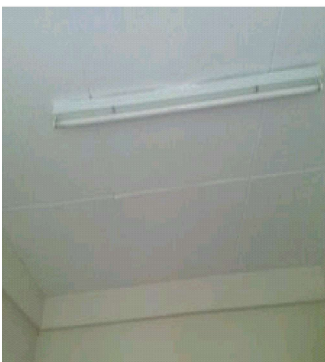
Item 18: As: EA003353

The fibre board ceiling panels to the changing room (RHS) (Room 7) do not contain asbestos.

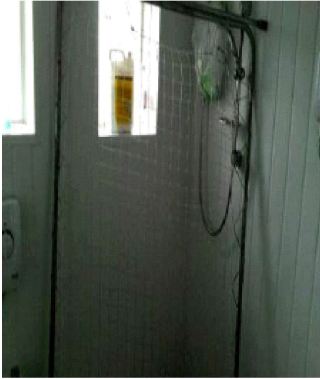
Room 8 (Shower - RHS) was accessed and no suspect materials were found.

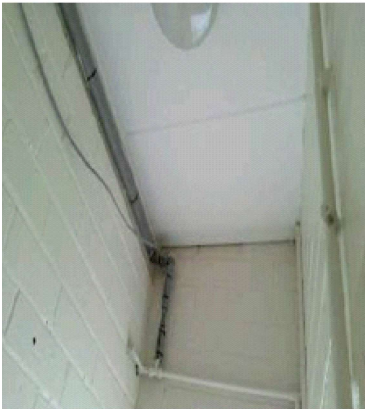
Item 19: As: EA003353

The fibreboard ceiling panels to the toilet (RHS) Room 9 do not contain asbestos.

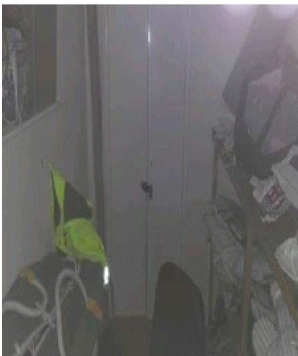
Room 10 (Cupboard) was inaccessible as it was locked. Further investigation required.

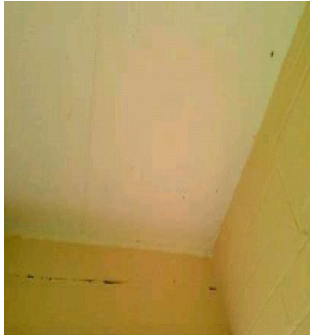
Item 20: As: EA003353

The fibreglass ceiling panels to the lady's toilet (Room 11) do not contain asbestos.

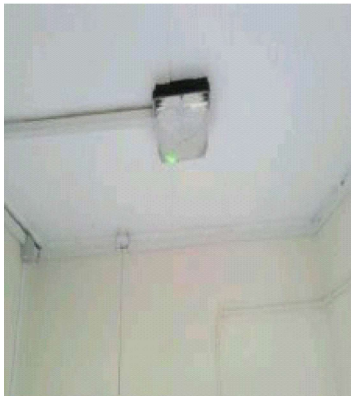
Item 21: As: EA003353

The fibreglass ceiling panels to the disabled toilet (Room 12) do not contain asbestos.

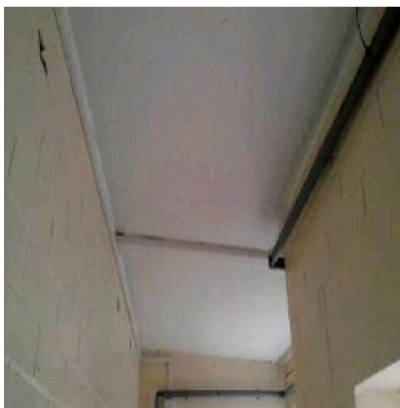
Item 22: As: EA003353

The fibreglass ceiling panels to the gent's toilet (Room 13) do not contain asbestos.

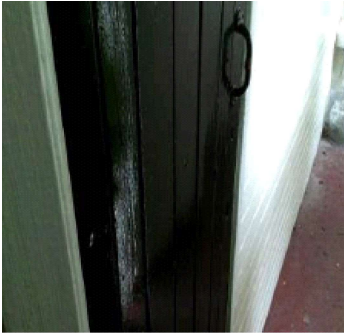
Room 14 (Cupboard) was inaccessible as there was no key. Further investigation will be required.

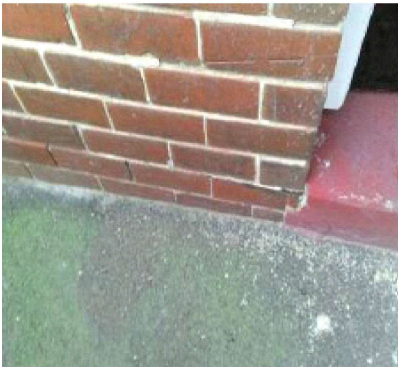
Item 23: Ref: EA003354

The damp proof course to the external does not contain asbestos.

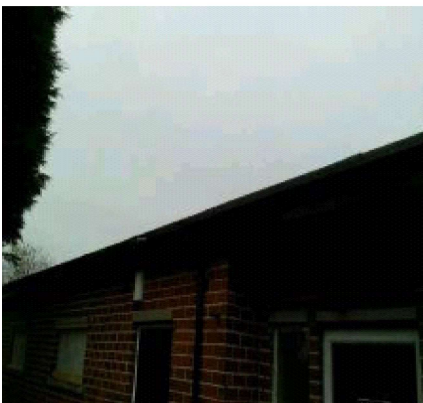
Item 24: Ref: EA003355

The bitumen to the flat roof does not contain asbestos.

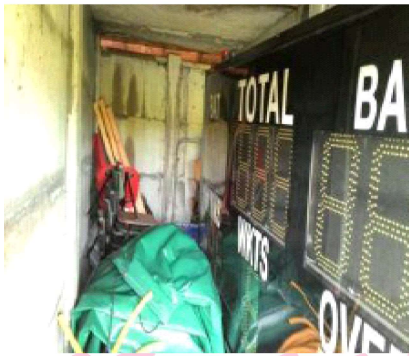
The cricket store (Room 1) was accessed, and no suspect materials were found.

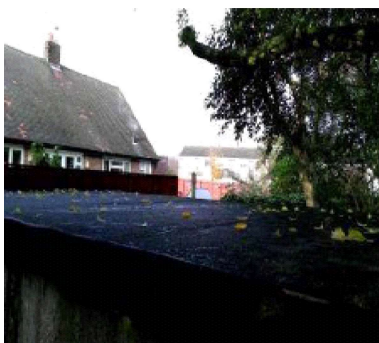
Item 26: Ref: EA003376

The bitumen to the flat roof (external) of the cricket store does not contain asbestos.

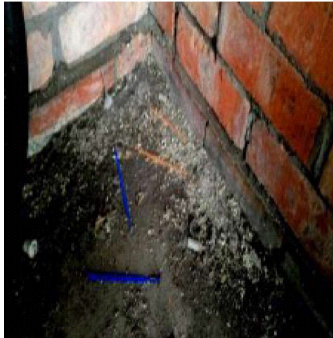
Item 27: Ref: EA003378

The damp proof course to the external of the electrical intake does not contain asbestos.

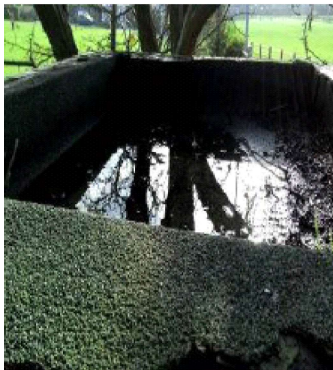
Item 28: Ref: EA003379

The bitumen to the roof of the electrical intake does not contain asbestos.

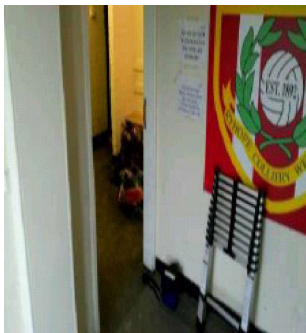
Room 1 (Lobby) was accessed, and no suspect materials were found.

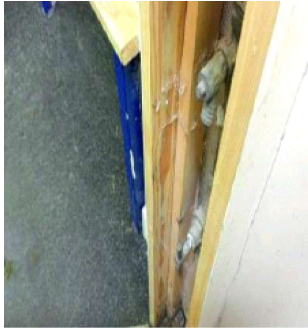
Room 2 (Home Changing Room) was accessed, and no suspect materials were found.

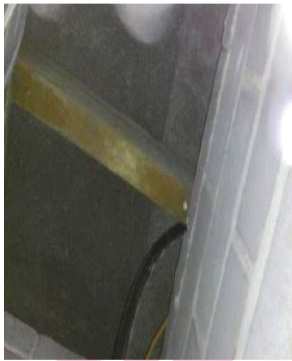
Item 29: Ref: EA003357

The residue to the batons in the electrical cupboard does not contain asbestos.

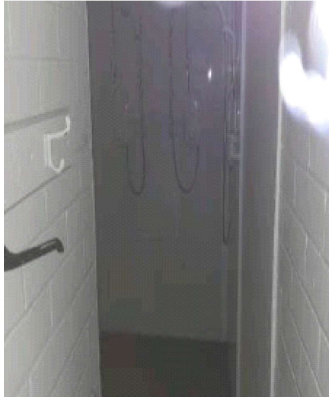
Room 4 (Home showers) was accessed, and no suspect materials were found.

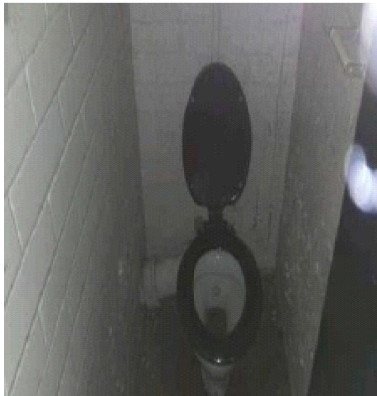
Item 31: Ref: EA003358

The wc seat to the Toilets (Room 5) does not contain asbestos.

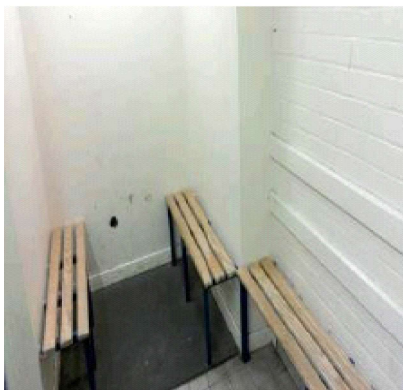
Room 6 (Away changing room) was accessed, and no suspect materials were found.

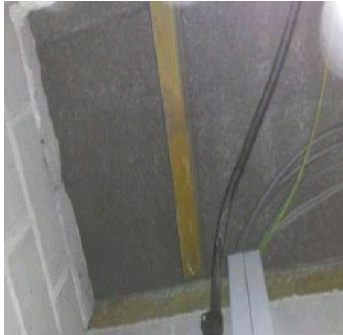
Item 32: Ref: EA003359

The residue to the timber batons to the ceiling in the electric cupboard (Room 7) does not contain asbestos.

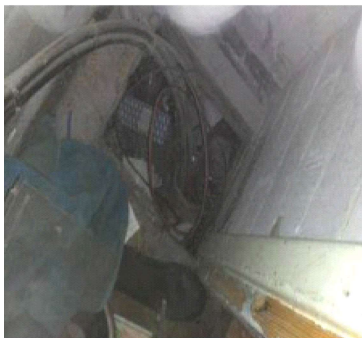
Item 33: Ref: EA003360

The debris to the floor void in the electrical cupboard (Room 7) does not contain asbestos.

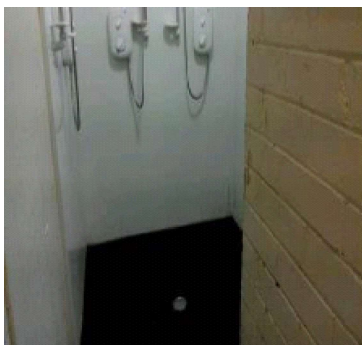
Room 8 (Away showers) was accessed, and no suspect materials were found.

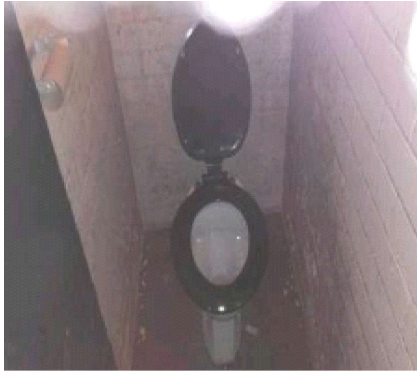
Item 34: As: EA003358

The WC seat to the toilet (Room 9) does not contain asbestos.

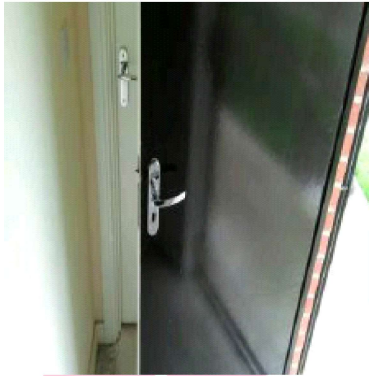
Room 10 (Vestibule) was accessed, and no suspect materials were found.

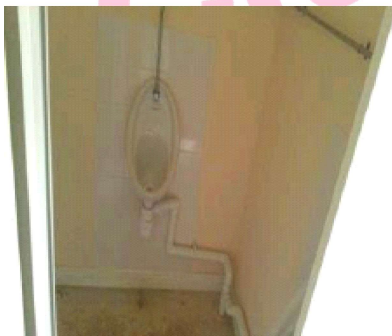
Room 11 (Male toilets) was accessed, and no suspect materials were found.

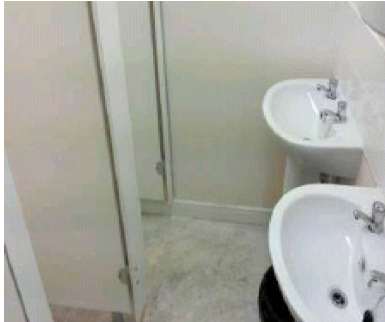
Room 12 (Female toilets) was accessed and no suspect materials were found.

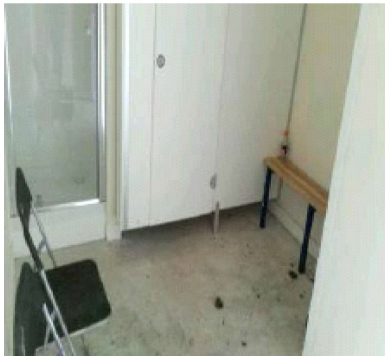
Room 13 (Officials area) was accessed and no suspect materials were found.

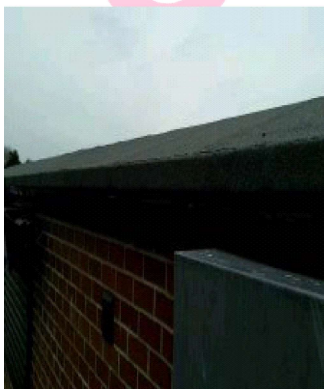
The roof felt to the external does not contain asbestos.

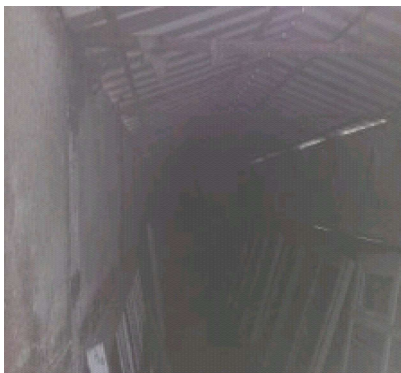
The internal area to the garage behind the staff cabin was accessed and no suspect materials were found.

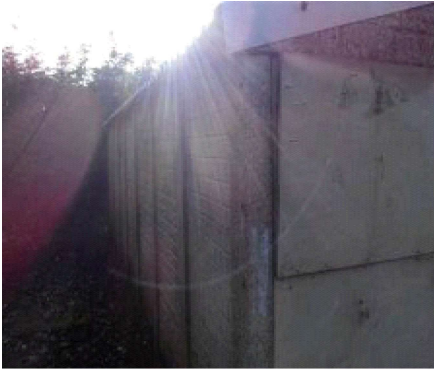
The external area to the garage behind the staff cabin was accessed and no suspect materials were found.

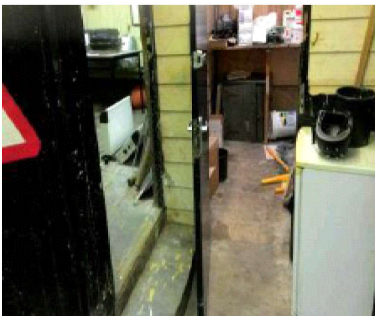
Room 1 (lobby) was accessed, and no suspect materials were found.

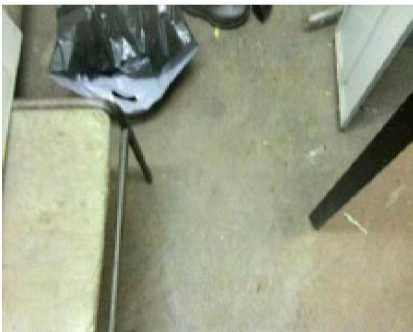
Item 37 Ref:EA003348

The red vinyl flooring to the office (Room 2) does not contain asbestos.

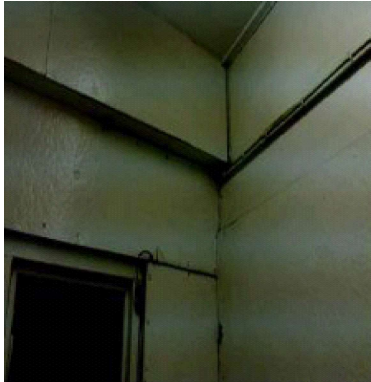
Item 38 Ref:EA003349

The fibreglass cladding to the walls in the office (Room 2) do not contain asbestos.

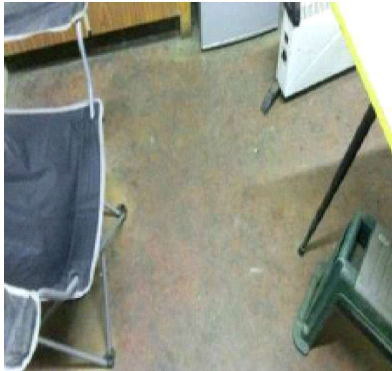
Item 39 As EA003348

The red vinyl floor covering to the staff room (Room 3) does not contain asbestos.

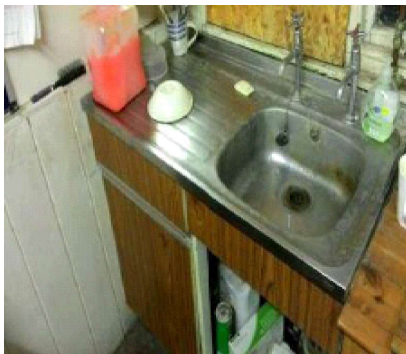
Item 40 Ref: EA003350

The sink pads to the sink and drainer in the staff room (Room 3) do not contain asbestos.

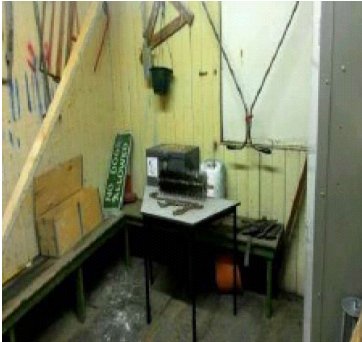
Room 4 (store) was accessed and no suspect materials were found.

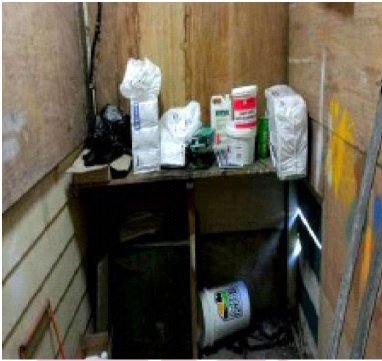
The store room (room 5) was accessed and no suspect materials were found.

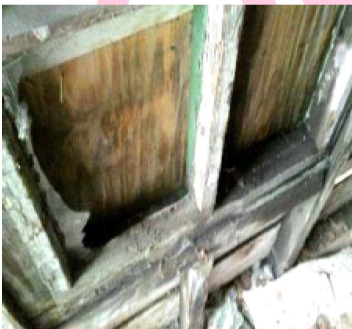
Item 41 Ref: EA003351

The window putty to the external of the mess / storage area does not contain asbestos.

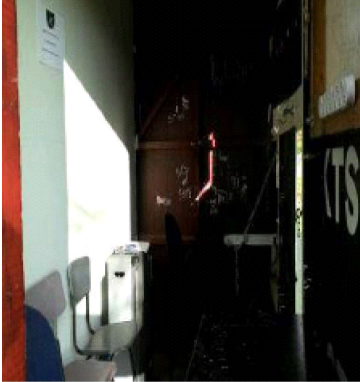
The scoreboard was accessed and no suspect materials were found.

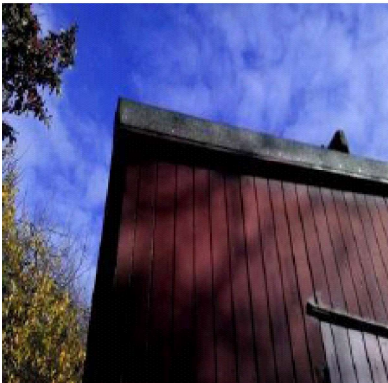
Item 42 Ref: EA003377

The bitumen felt to the flat roof of the scoreboard does not contain asbestos.

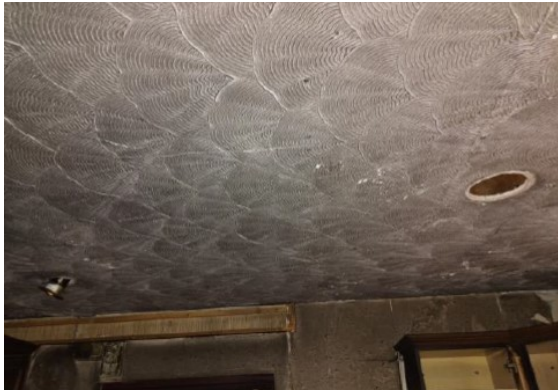
Item 43 Ref: 21-38916-1

The textured coated ceiling (Kitchen) does not contain asbestos.

Demolished 2022.

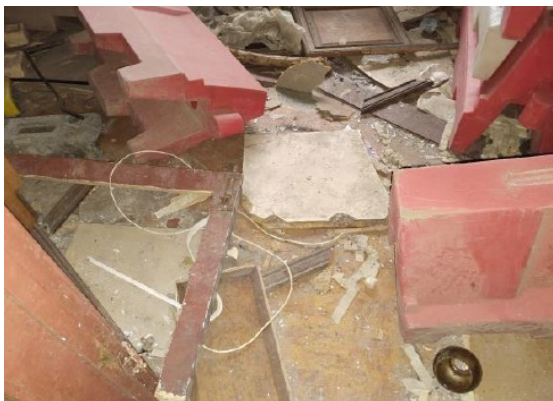
Item 44 Ref: 21-38916-1

The debris from ceiling to floor (Kitchen) does not contain asbestos.

Demolished 2022.

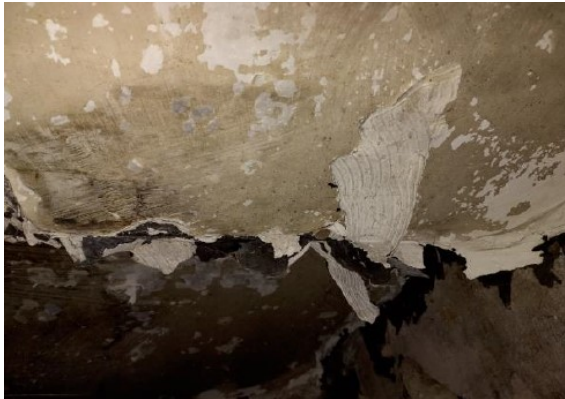
Item 46 Ref: 21-38916-1

The textured coated ceiling (Hall) does not contain asbestos.

Demolished 2022.

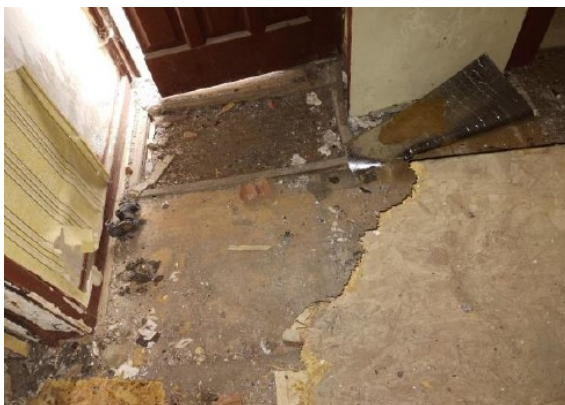
Item 47 Ref: 21-38916-1

The debris from ceiling to floor (Hall) does not contain asbestos.

Demolished 2022.

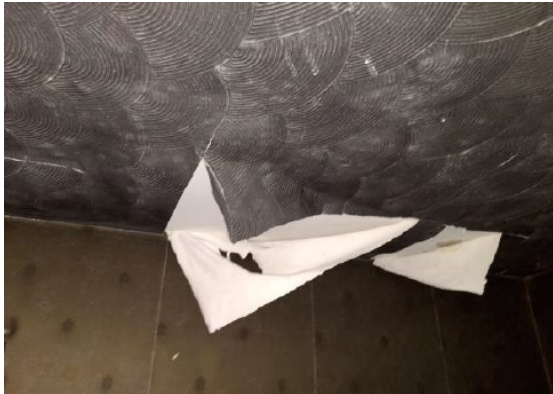
Item 52 Ref: 21-38916-1

The textured coated ceiling (Stairs and Landing) does not contain asbestos.

Demolished 2022.

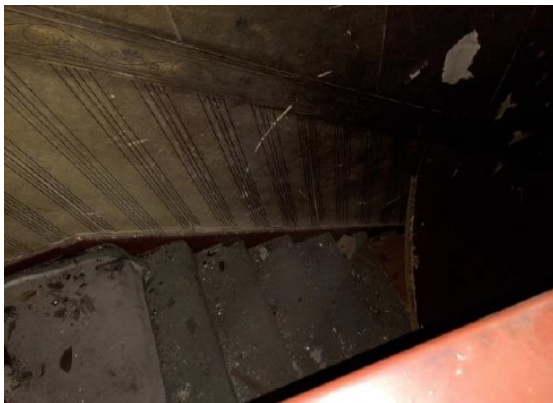
Item 53 Ref: 21-38916-1

The textured coated ceiling (Stairs and Landing) does not contain asbestos.

Demolished 2022.

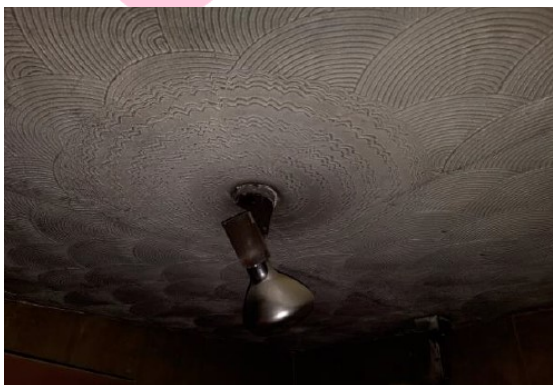
Item 54 Ref: 21-38916-1

The textured coated ceiling (Bathroom) does not contain asbestos.

Demolished 2022.

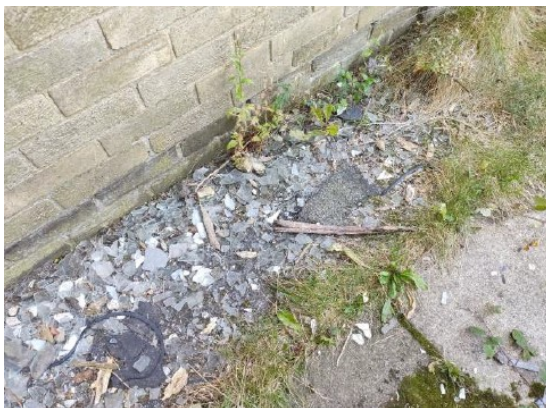
Item 56 Ref: 21-38916-11

The bitumen felt to floor (External) does not contain asbestos.

Demolished 2022.

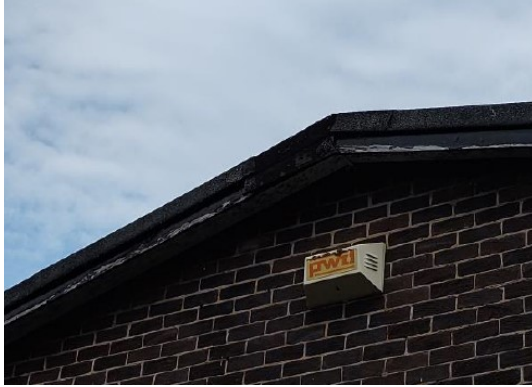
Item 58 Ref: 21-38916-6

The felt bitumen to roof (External) does not contain asbestos.

Demolished 2022.

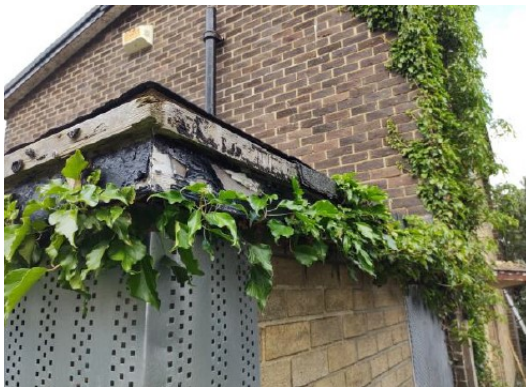
Item 59 Ref: 21-38916-6

The felt bitumen to outhouse roof (External) does not contain asbestos.

Demolished 2022.

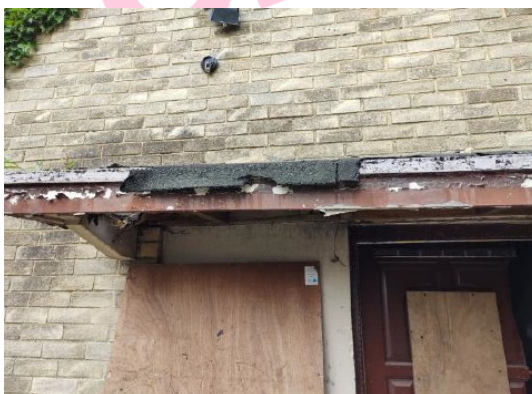
Item 60 Ref: 21-38916-6

The felt bitumen to canopy roof (External) does not contain asbestos.

Demolished 2022.

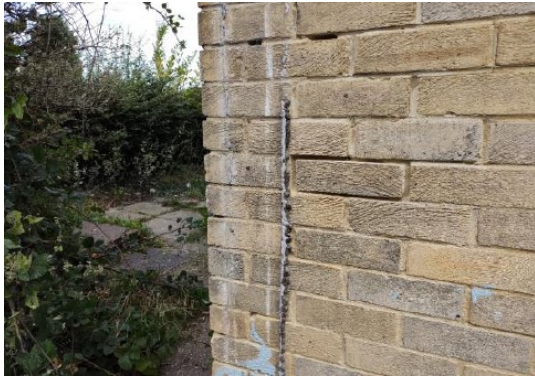
Item 61 Ref: 21-38916-7

The frame sealant to outhouse walls (External) does not contain asbestos.

Demolished 2022.

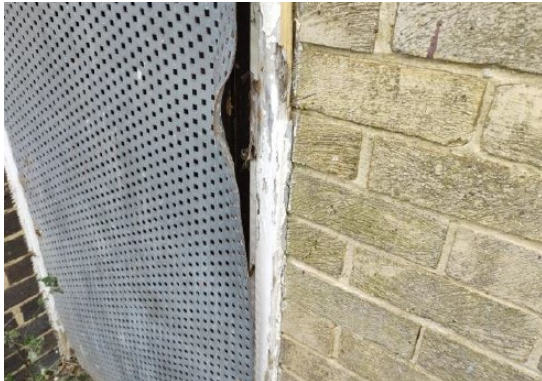
Item 62 Ref: 21-38916-8

The frame sealant to outhouse door (External) does not contain asbestos.

Demolished 2022.
