ASBESTOS SURVEY REPORT FOR RYHOPE RECREATION PARK, SUNDERLAND

Asbestos Register for Ryhope Park

Date: 03 April 2025

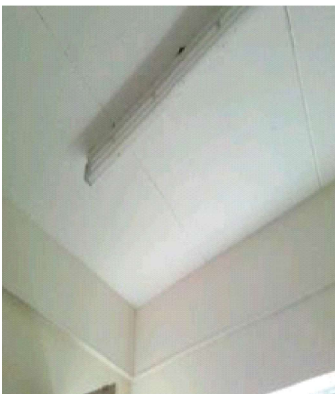
Item 16: Ref: EA003353

The fibreboard ceiling panels to the LHS changing Room (Room 4) do not contain asbestos.

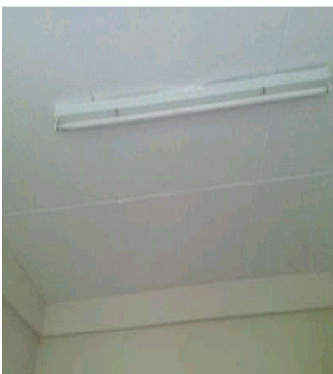
Item 18: As: EA003353

The fibre board ceiling panels to the changing room (RHS) (Room 7) do not contain asbestos.
