ASBESTOS SURVEY REPORT FOR ENDURANCE WAREHOUSE, NORTH MOOR STREET, SUNDERLAND, SR1 2BQ

Asbestos Register for

**ENDURANCE HOUSE AND WAREHOUSE, NORTH
MOOR STREET,
SUNDERLAND, SR1 2BQ**

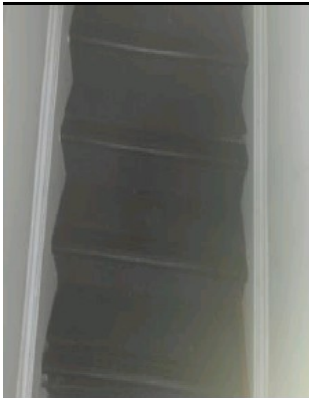
Item 1 Ref: EA001484

The stair nosing to the entrance lobby (Room 1) does not contain asbestos.

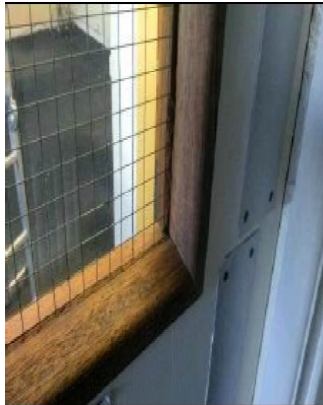
Item 2 - Ref: EA001485

The window putty to door glass in the entrance lobby (Room 1) does not contain asbestos.

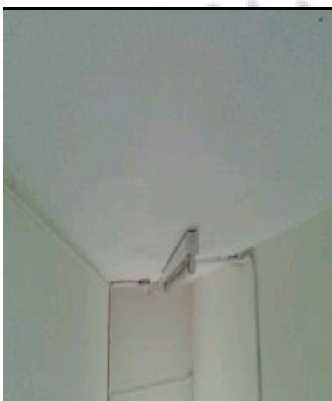
Item 3 - Ref: EA001486

The textured coating to ceiling (Entrance Lobby) (Room 1) does not contain asbestos.

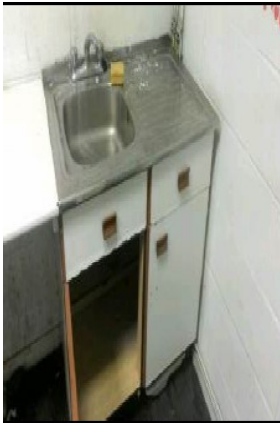
Item 31 - Ref: EA001499

The Bitumen pads to the underside of the sink and drainer to the kitchen (Room 11) do not contain asbestos.

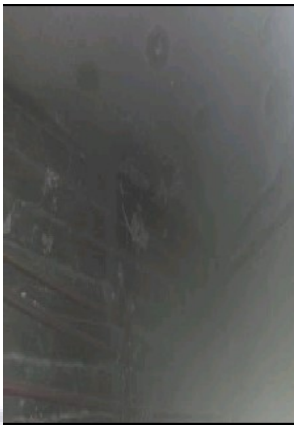
Item 32 - Ref: As EA001495

The paper lined fibreboard ceiling panels to the kitchen (Room 11) contain asbestos.

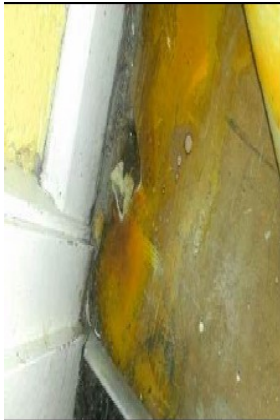
Item 34 - Ref: EA001501

The old lino beneath modern flooring in cubicles to the toilets (Room 12) does not contain asbestos.

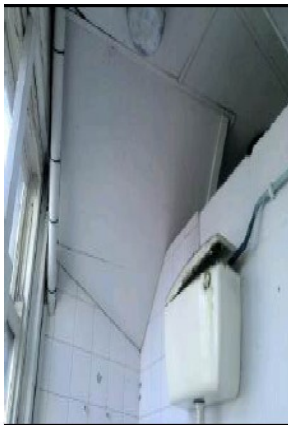
Item 35 - Ref: As EA001488

The cladding to the underside of the stairs in the toilets (Room 12) does not contain asbestos.

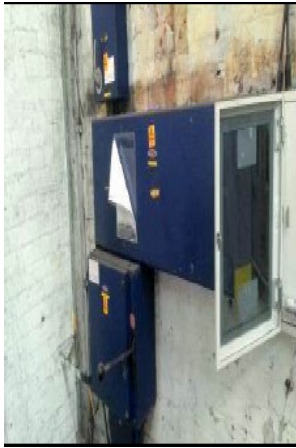
Item 37 - Presumed

It was presumed asbestos was present in the flash guards within fuse box in warehouse 1 (Ground Floor) (Room 14).

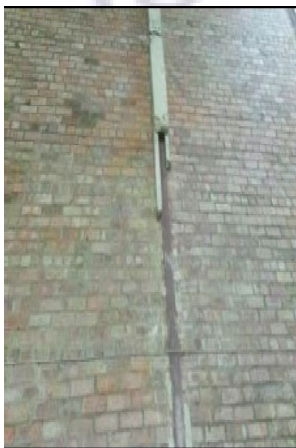
Item 39 - Ref: EA001510

The vermiculite cladding to steel columns top warehouse 4 (Room 16) does not contain asbestos.

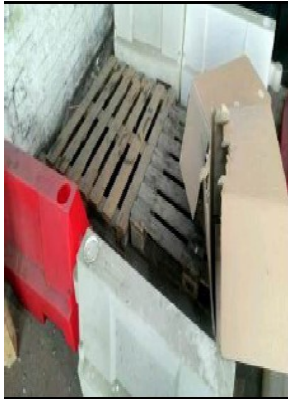
No access within underground pit to warehouse 1. (Room 14). Further investigation required.

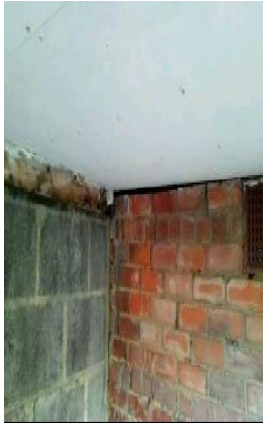
Item 50 - Ref: EA001529

The ceiling boards to the Gas intake room (Room 20) contain asbestos.

Any change in its appearance should be recorded, and passed to Property Services.

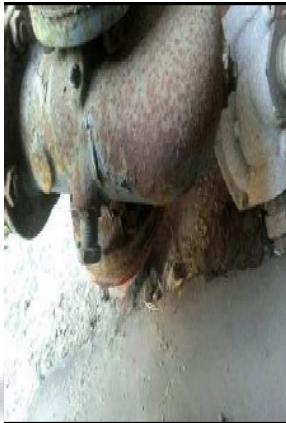
Item 51 - Ref: EA001523

The gasket to pipework flanges to the Gas intake room (Room 20) does not contain asbestos.

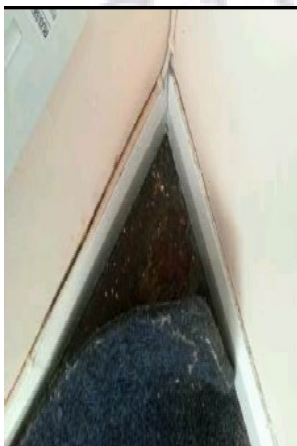
Item 61 - Ref: As EA001502

The red screed to floor to office 6 (First floor - room 5) does not contain asbestos.

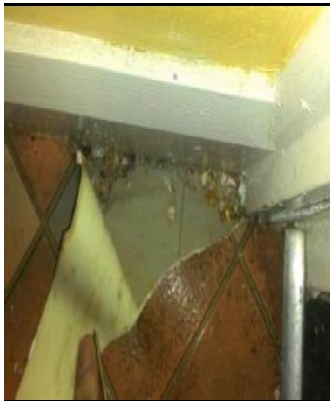
Item 63 - Ref: As EA001502

The red screed to the WC lobby (First floor - Room 7) does not contain asbestos.

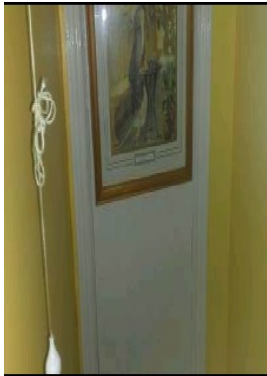
Item 65 - Ref: EA001506

The panel to the window in the female wc (First Floor Room 8) does not contain asbestos.

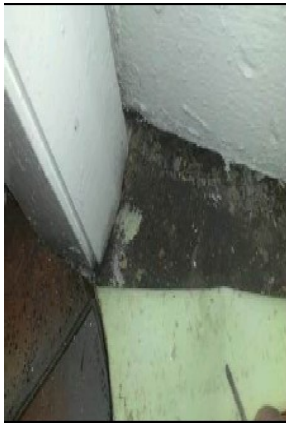
Item 66 - Ref: As EA001502

The red floor screed to floor of the male wc (First floor Room 9) does not contain asbestos.

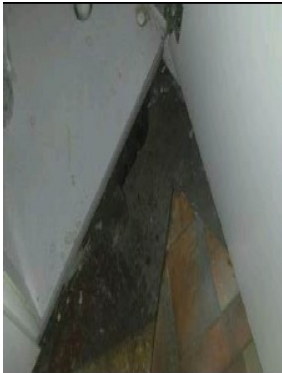
Item 68 - Ref: As EA001502

The red screed to floor of the male wc (First floor Room 9) does not contain asbestos.

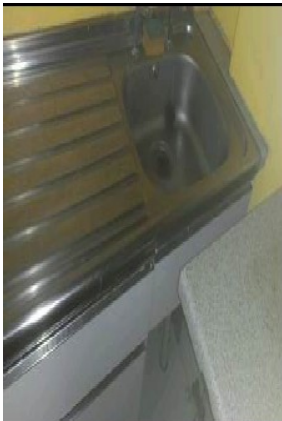
Item 69 - Ref: EA001507

The bitumen pads to the underside of sink drainers in the kitchen (First Floor Room 10) do not contain asbestos.

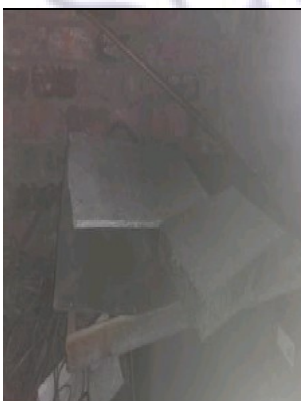
Item 70 - Ref: EA001527

The panel on top of the water tank (Roof Void) (Room 1) does not contain asbestos.

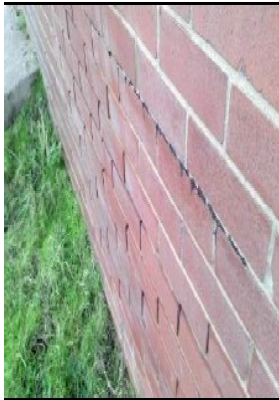
Item 76 - Ref: EA001521

The damp proof course to Warehouse 4 (External) contains asbestos.

Any change in its appearance should be recorded and passed to Property Services.

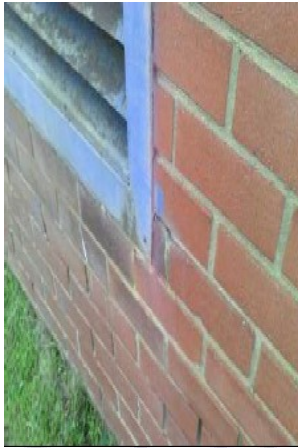
Item 77 - Ref: EA001522

The mastic to vent frills on boiler room walls (External) does not contain asbestos.

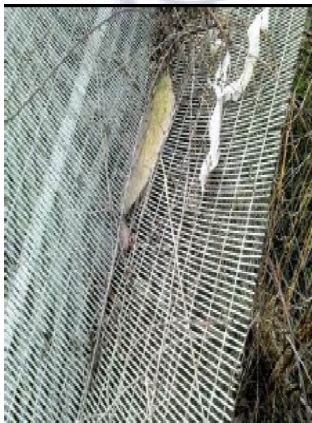
Item 78 - Ref: EA001525

The cement debris to the ground (External) contains asbestos.

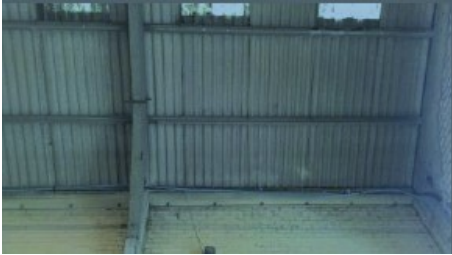
Item 79 - Ref: EC001129

The cement ceiling panels to Room 1 Warehouse 2 contain asbestos.

Any change in its appearance should be recorded and passed to Property Services.

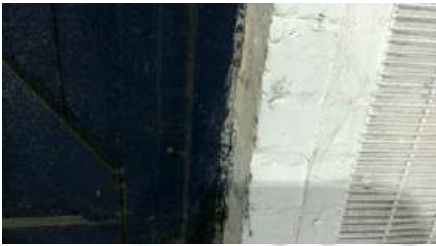
Item 80 - Ref: EC001130

The mastic to the door in room 1 to warehouse 2 does not contain asbestos.

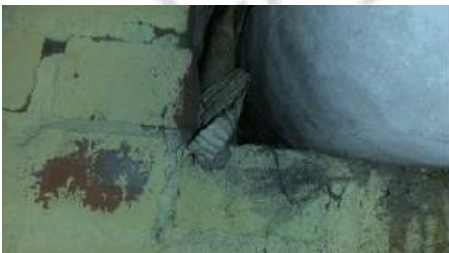
Item 81 - Ref: EC001131

The flue penetration to room 1 in warehouse 2 does not contain asbestos.

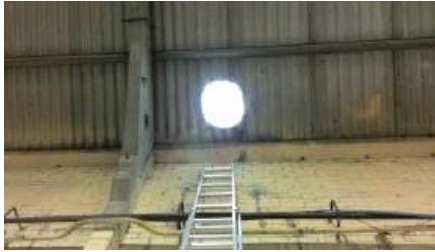
Item 82 - Ref: EC001132

The cement ceiling panels to Room 1 Warehouse 2 contain asbestos.

Any change in its appearance should be recorded and passed to Property Services.

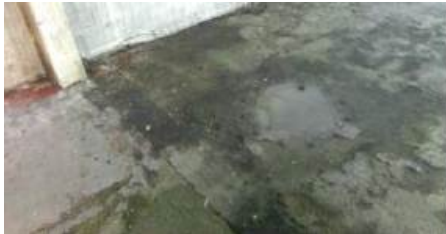
Item 83 - Ref: EC001133

The random debris to the floor in room 1, Warehouse 2 does not contain asbestos.

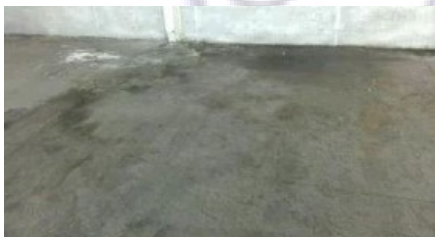
Item 84 - Ref: EC001134

The random debris to the floor in room 1, Warehouse 2 does not contain asbestos.

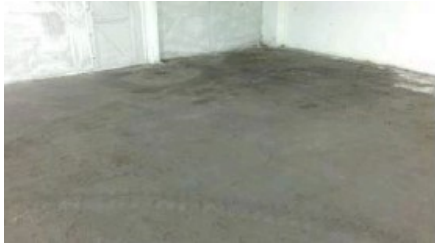
Item 85 - Ref: EC001135

The random debris to the floor in room 1, Warehouse 2 does not contain asbestos.

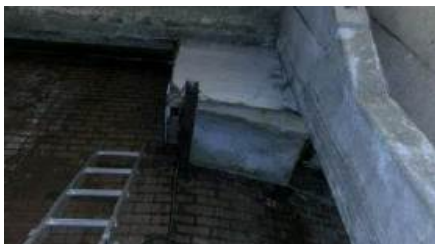
Item 89 - Ref: EC001138

The boxing to room 1 in Warehouse 3 contains asbestos.

Any change in its appearance should be recorded and passed to Property Services.

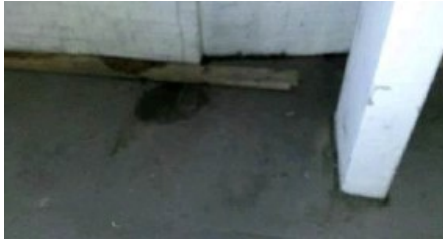
Item 91 - Ref: EC001140

The floor debris to room 1 of warehouse 3 does not contain asbestos.

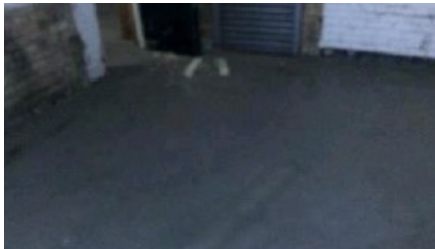
Item 92 - Ref: EC001141

The debris to the floor in room 1 in Warehouse 3 does not contain asbestos.

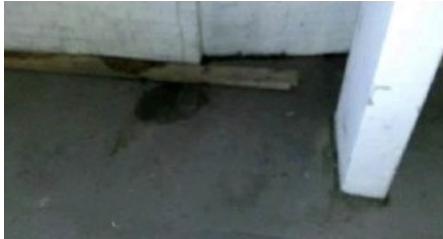
Item 94 - Ref: EC001146

The floor debris to room 1 of warehouse 3 does not contain asbestos.

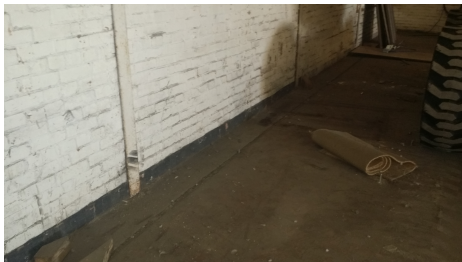
Item 98 - Ref: 279740-1

The expansion joint filler to floor in Warehouse 3 (Room 001) does not contain asbestos.

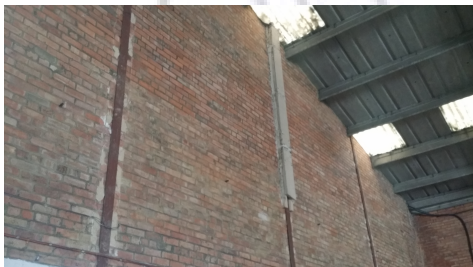
Item 99 - Ref: 279740-2

The remnant boxing to columns north in Warehouse 3 (Room 001) does not contain asbestos.

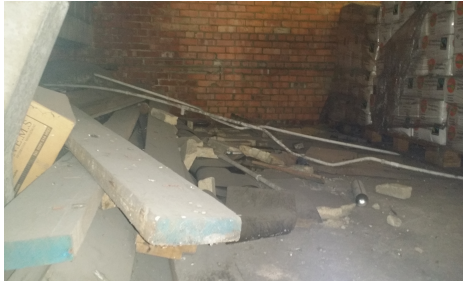
Item 100 - Ref: As 279740-2

The debris to flat roof of air lock in Warehouse 3 (Room 001) does not contain asbestos.
