ASBESTOS SURVEY REPORT FOR JOPLING HOUSE, JOHN STREET,
SUNDERLAND, SR1 1DP.

Asbestos Register for Jopling House, John Street, Sunderland

UPRN: - J171340

Date: 13 February 2025

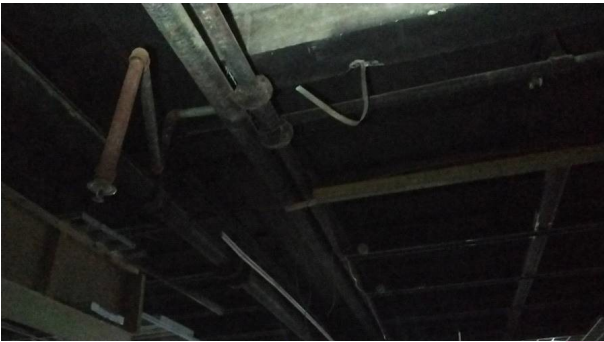
3.	NO000253	Pipework Gaskets	Z-Sub level 1 Shop Floor (Room Z1/001)	No Risk
4.	Presumed	Pipework Gaskets to deeply recessed to sample	Z-Sub level 1 Shop Floor (Room Z1/001)	This item is classed as very low risk and should be inspected every 12 months

4.	Presumed	Pipework Gaskets to deeply recessed to sample	Z-Sub level 1 Shop Floor (Room Z1/001)	Presumed to contain asbestos - Any change in its appearance should be recorded and passed to Property Services.

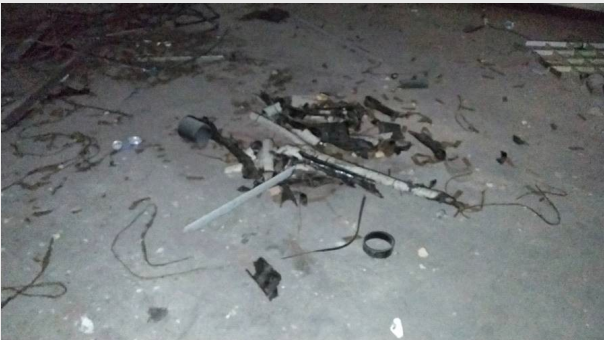
5.	NO000254	Cable braiding insulation	Z-Sub level 1 Shop Floor (Room Z1/001)	Does not contain asbestos.

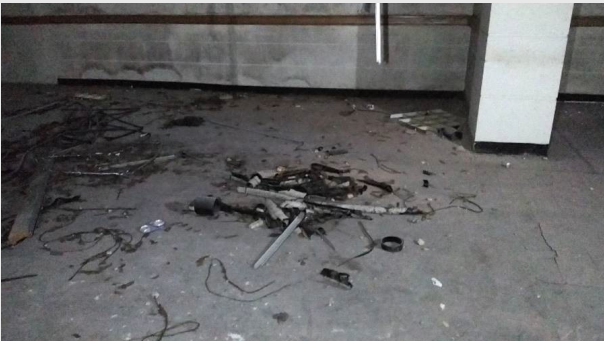
6.	NO000255	Cable braiding insulation	Z-Sub level 1 Shop Floor (Room Z1/001)	Does not contain asbestos.

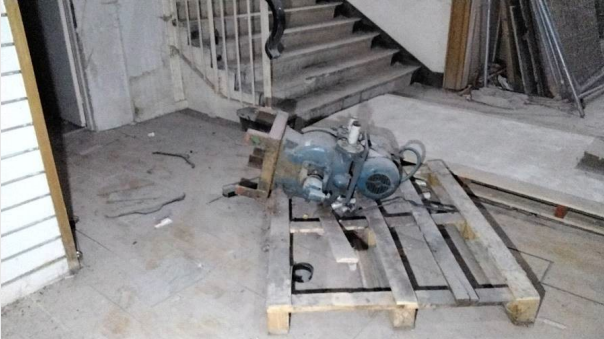
10.	NO000259	Debris/Residue to redundant pump	Z-Sub level 1 Shop Floor (Room Z1/001)	Does not contain asbestos.

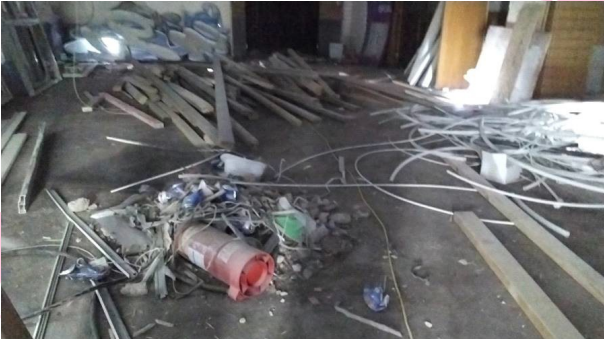
11.	NO000264	Debris/Residue to floor adjacent stairwell	Z-Sub level 1 Shop Floor (Room Z1/001)	Removed Sept 2023

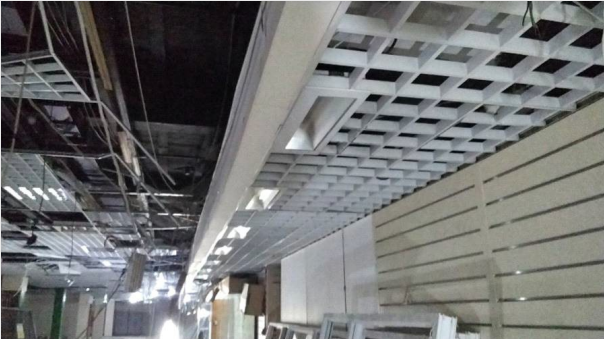
12.	NO000266	Ceiling tile behind metal grid tiles	Z-Sub level 1 Shop Floor (Room Z1/001)	Does not contain asbestos.

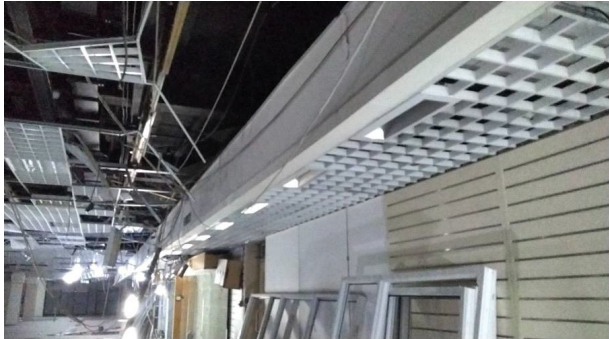
13.	NO000267	Ductwork joints	Z-Sub level 1 Shop Floor (Room Z1/001)	This item is classed as low risk and should be inspected every 6 months
14.	NO000260	Floor tile on shelving	Z-Sub level 1 Store Room (Room Z1/006)	No Risk

13.	NO000267	Ductwork joints	Z-Sub level 1 Shop Floor (Room Z1/001)	Contains asbestos - Any change in its appearance should be recorded and passed to Property Services.

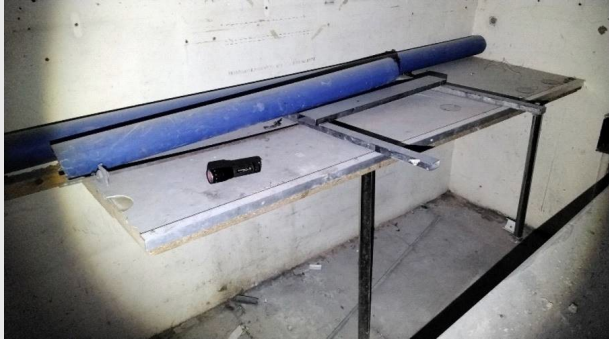
14.	NO000260	Floor tile on shelving	Z-Sub level 1 Store Room (Room Z1/006)	Does not contain asbestos.

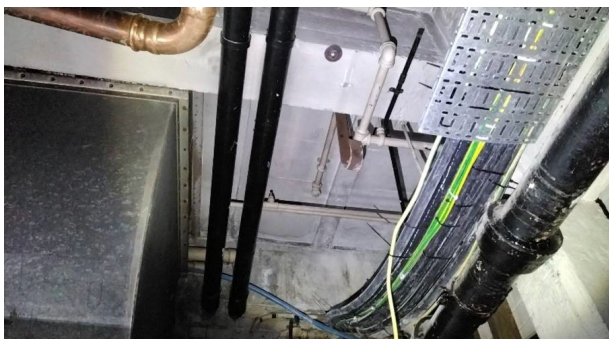
15.	NO000261	Debris/Residue to redundant pipe hanger	Z-Sub level 1 Switch Room (Room Z1/007)	Removed Sept 2023

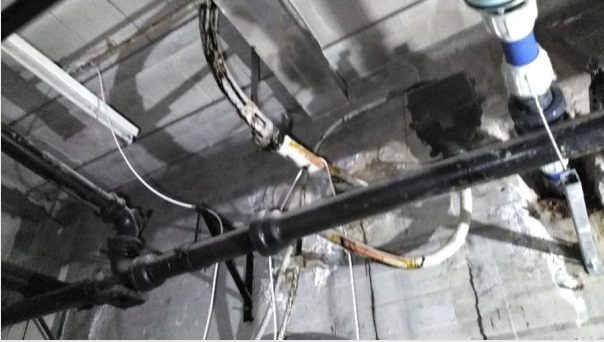
16.	As NO000254	Cable braiding insulation	Z-Sub level 1 Switch Room (Room Z1/007)	Does not contain asbestos.

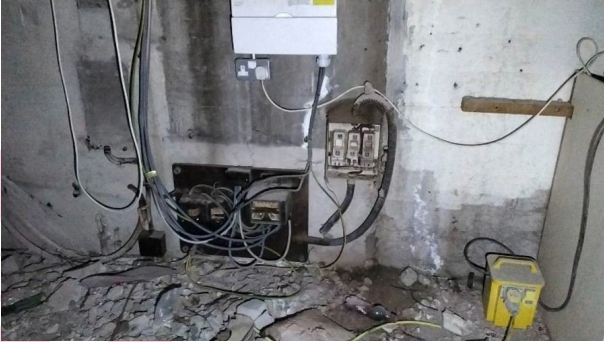
17.	NO000256	Fuses flashguards	Z-Sub level 1 Switch Room (Room Z1/007)	This item is classed as very low risk and should be inspected every 12 months
18.	NO000302	Door seal/gasket discarded on floor	Z-Sub level 1 Switch Room (Room Z1/007)	No Risk

17.	NO000256	Fuses flashguards	Z-Sub level 1 Switch Room (Room Z1/007)	Contains asbestos - Any change in its appearance should be recorded and passed to Property Services.

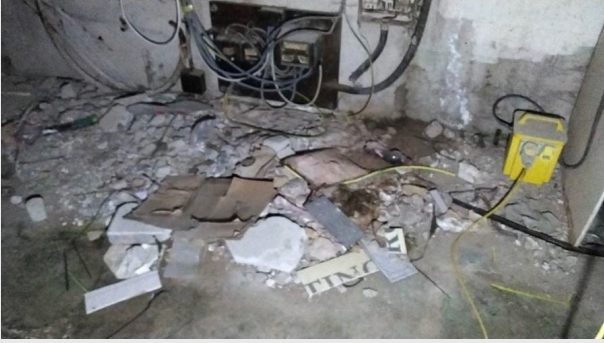
18.	NO000302	Door seal/gasket discarded on floor	Z-Sub level 1 Switch Room (Room Z1/007)	Does not contain asbestos.

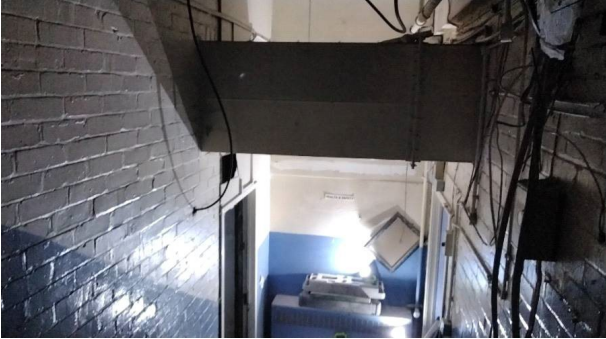
22.	NO000265	Wall	Z-Sub level 1 Staircase/Stairwell (Room Z1/009)	Contains asbestos - Any change in its appearance should be recorded and passed to Property Services.

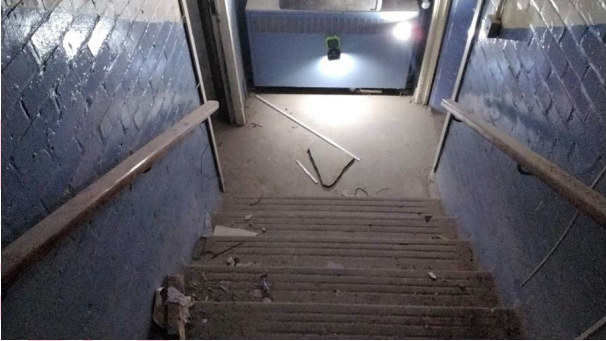
23.	As NO000265	Debris/Residue foot of stairwell and adjacent areas	Z-Sub level 1 Staircase/Stairwell (Room Z1/009)	Removed Sept 2023

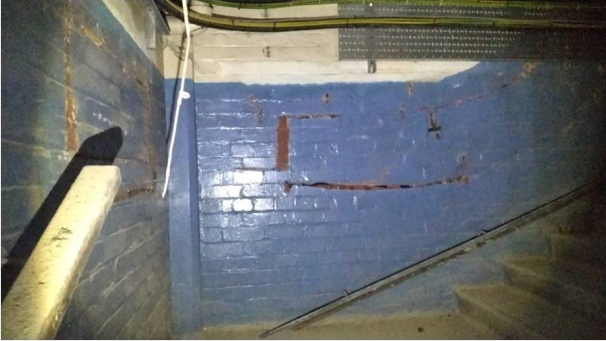
24.	NO000301	Cable braiding insulation remnants to wall	Z-Sub level 1 Staircase/Stairwell (Room Z1/009)	Does not contain asbestos.

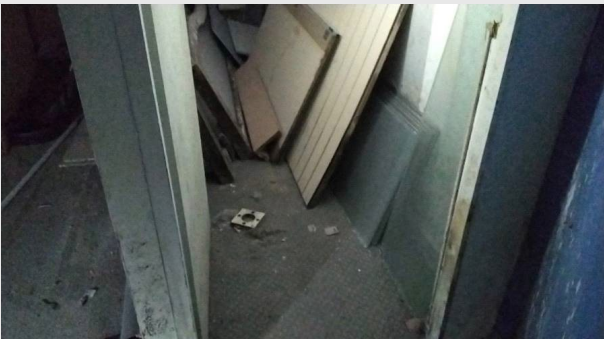
39.	As NO000272	Floor tile cream	Z-Sub level 1 Shop Floor (Room Z1/019)	Does not contain asbestos.

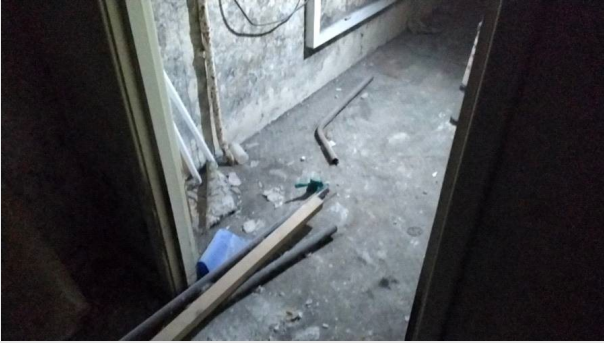
46.	As NO000268	Floor tile	Z-Sub level 1 Store Room (Room Z1/023)	Does not contain asbestos.

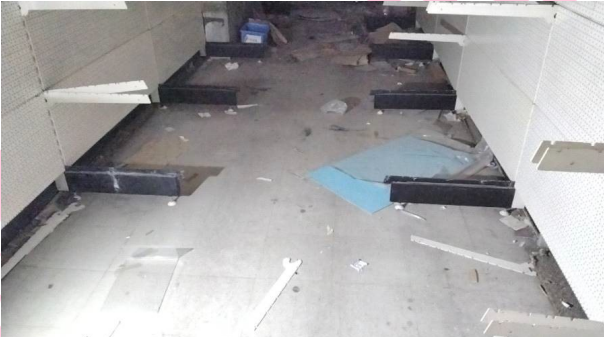
47.	NO000275	Floor tile grey	Z-Sub level 1 Store Room (Room Z1/026)	Contains asbestos - Any change in its appearance should be recorded and passed to Property Services.

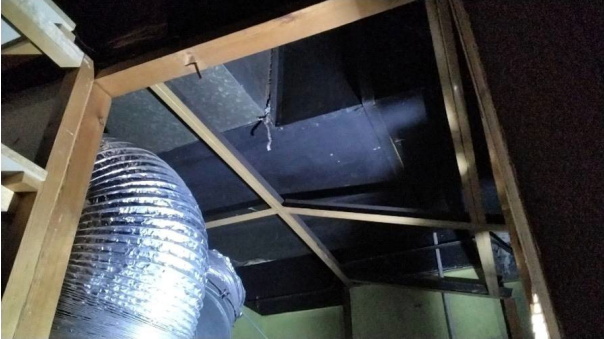
55.	NO000280	Ductwork joints	Z-Sub level 1 Store Room (Room Z1/029)	Contains asbestos - Any change in its appearance should be recorded and passed to Property Services.

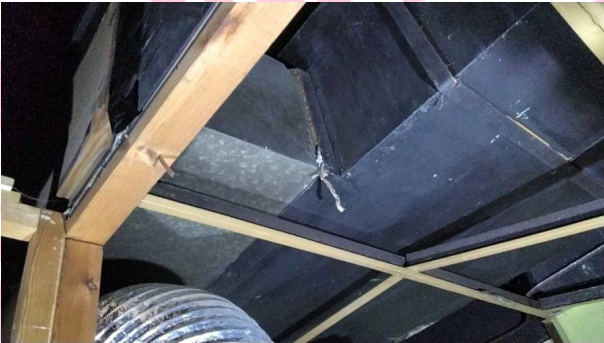
56.	NO000281	Ductwork joints red/brown mastic	Z-Sub level 1 Store Room (Room Z1/029)	Contains asbestos - Any change in its appearance should be recorded and passed to Property Services.

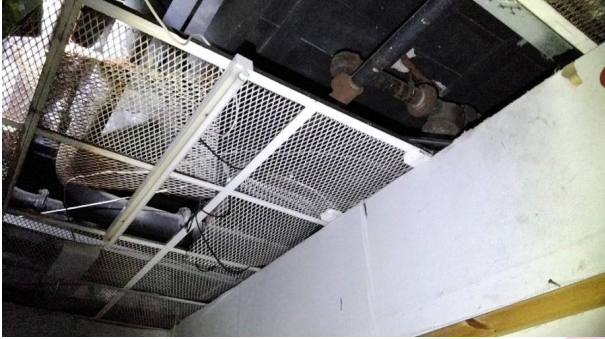
67.	As NO000271	Pipework gasket	Z-Sub level 1 Store Room (Room Z1/032)	Presumed to contain asbestos - Any change in its appearance should be recorded and passed to Property Services.

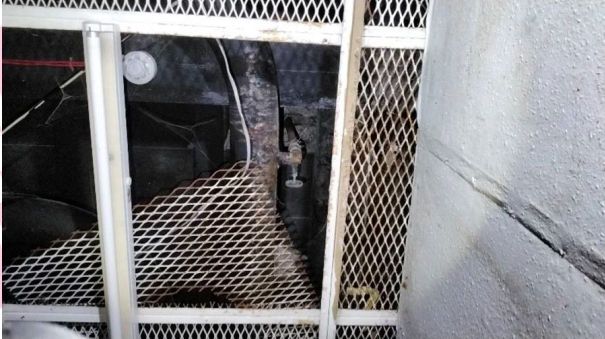
68.	NO000290	Pipework wrap to pipe penetrations in ceiling	Z-Sub level 1 Store Room (Room Z1/032)	Contains asbestos - Any change in its appearance should be recorded and passed to Property Services.

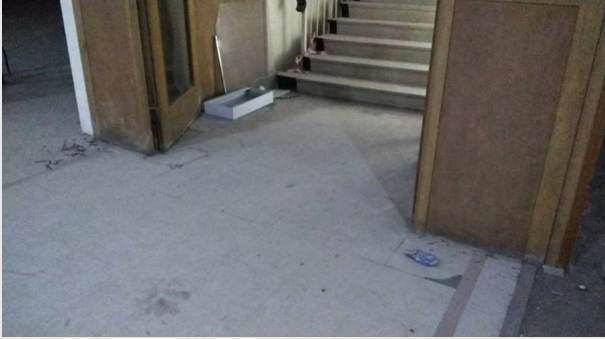
69.	As NO000251	Floor tile pink/grey including debris up the stairs	Z-Sub level 1 Stairwell Staircase (Room Z1/034)	Does not contain asbestos.

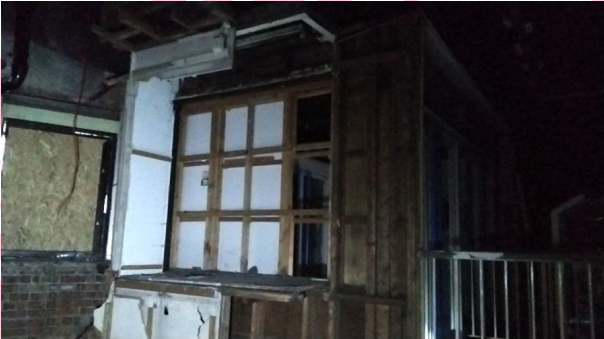
74.	NO000295	Debris/Residue to entrance porch, on top and to sides, including beneath shelf and framework	Ground Floor Shop Floor Unit 1 (Room G/001)	Contains asbestos - Any change in its appearance should be recorded and passed to Property Services.

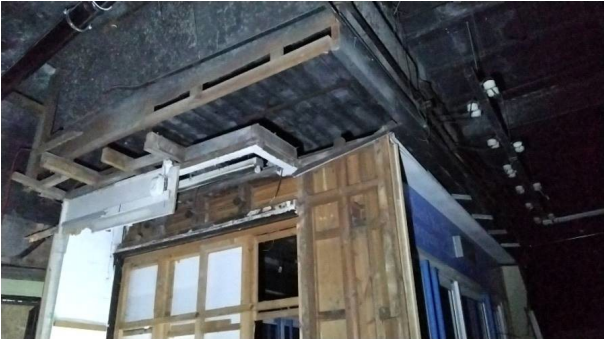
75.	NO000296	Debris/Residue to top of ceiling at entrance porch	Ground Floor Shop Floor Unit 1 (Room G/001)	Removed Sept 2023

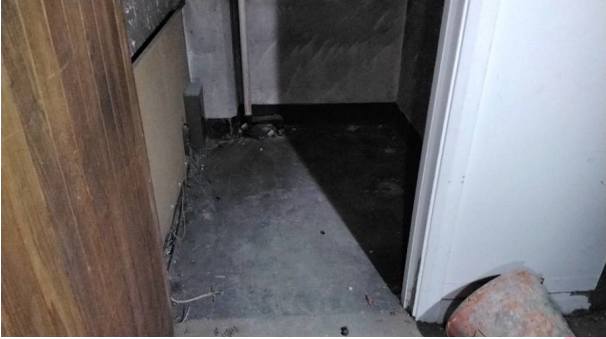
85.	As NO000293	Floor adhesive remnants	Ground Floor Store Room Unit 1 (Room G/004)	Presumed to contain asbestos - Any change in its appearance should be recorded and passed to Property Services.

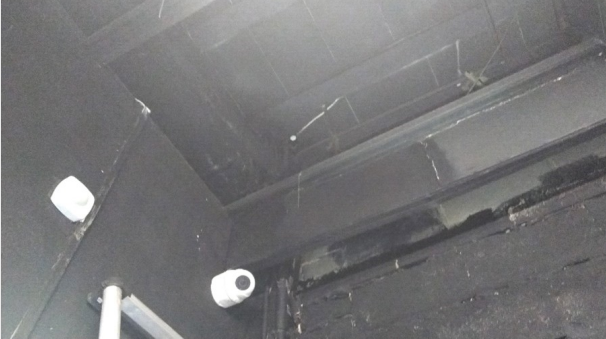
87.	NO000304	Ceiling shuttering	Ground Floor Store Room Bike Store (Room G/005)	Does not contain asbestos.

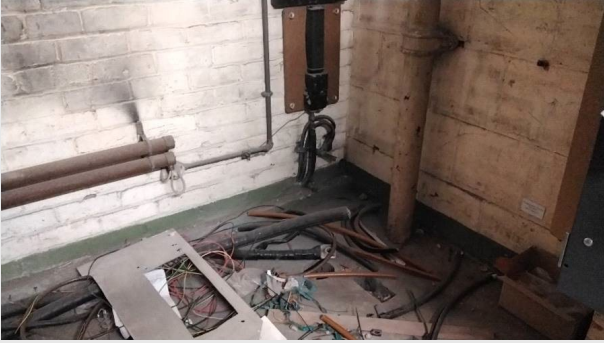
91.	As NO000254	Cable braiding insulation	Ground Floor Switch Room behind lifts (Room G/009)	Does not contain asbestos.

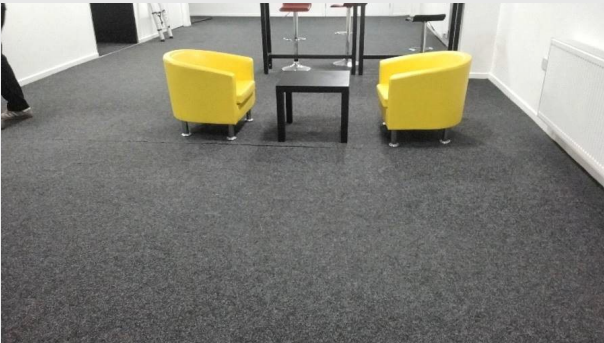
93.	NO000307	Floor adhesive remnants beneath carpet	Ground Floor Hallway/passageway lift lobby (Room G/010)	Does not contain asbestos.

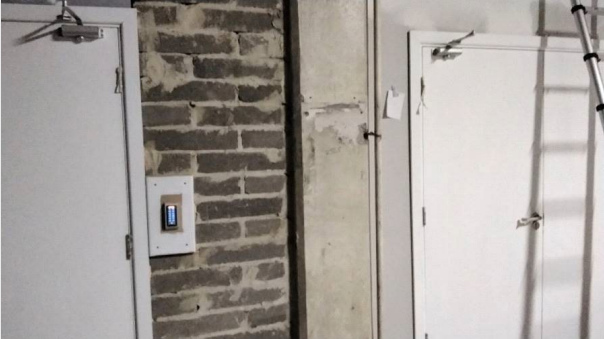
103.	NO000311	Wall to nail/screw heads, various points on column	Ground Floor Store Room (Room G/017)	Does not contain asbestos.

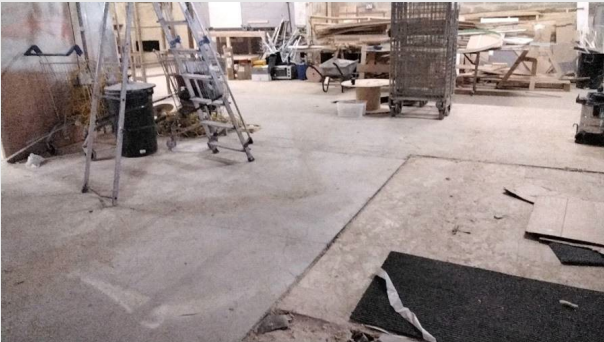
104.	As NO000306	Floor jointing compound	Ground Floor Store Room unit 4 (Room G/018)	Does not contain asbestos.

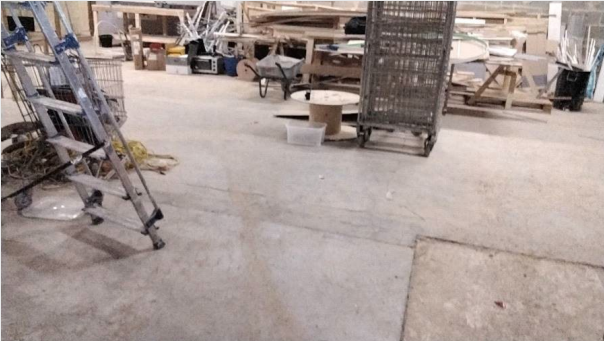
105.	As NO000307	Floor adhesive remnants	Ground Floor Store Room unit 4 (Room G/018)	Does not contain asbestos.

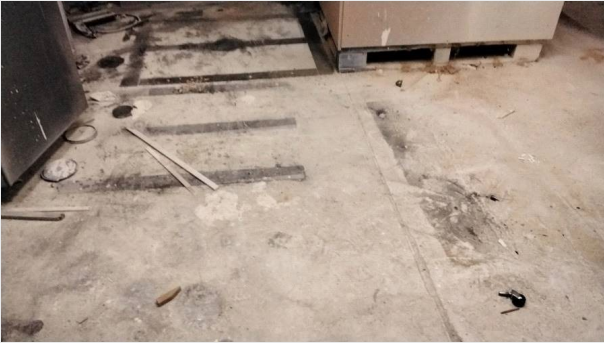
109.	As NO000307	Floor adhesive remnants	Ground Floor Store Room (Room G/020)	Does not contain asbestos.

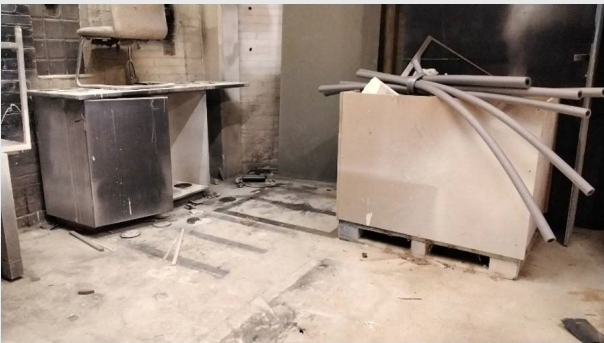
110.	As NO000301	Cabling braiding insulation	Ground Floor Store Room (Room G/020)	Does not contain asbestos.

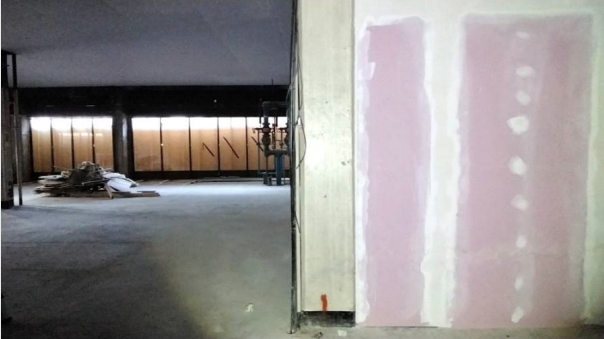
112.	As NO000311	Wall to nail/screw heads various points on column	Ground Floor Unit 3 (café) limited inspection to ceiling (Room G/022)	Does not contain asbestos.

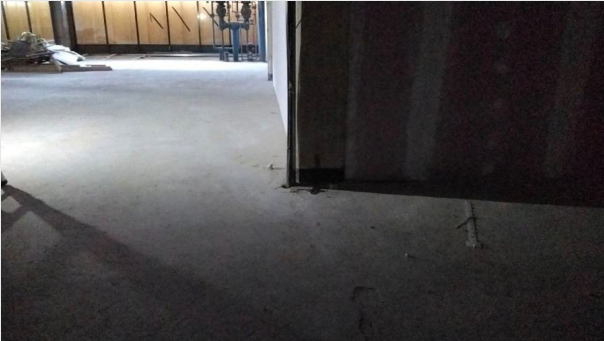
113.	As NO000307	Floor adhesive remnants	Ground Floor Unit 3 (café) limited inspection to ceiling (Room G/022)	Does not contain asbestos.

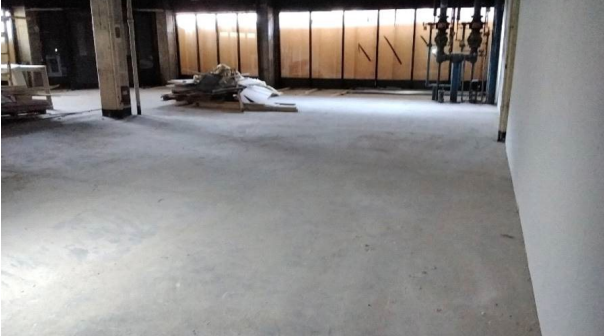
114.	As NO000303	Floor tile remnants	Ground Floor Unit 3 (café) limited inspection to ceiling (Room G/022)	Presumed to contain asbestos - Any change in its appearance should be recorded and passed to Property Services.

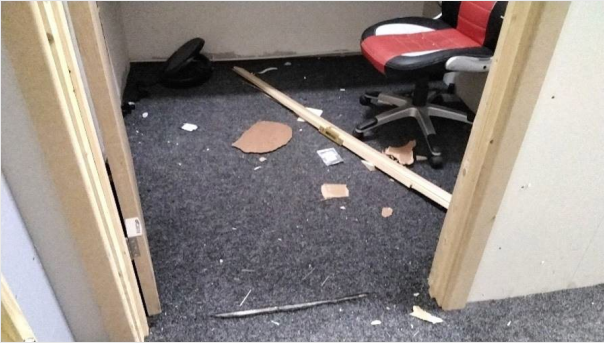
118.	As NO000307	Floor adhesive remnants	Ground Floor Office (Room G/026)	Does not contain asbestos.

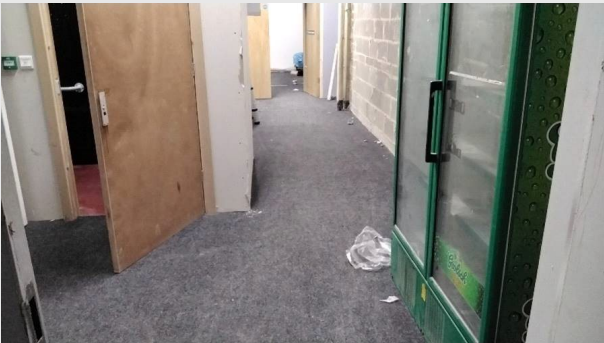
120.	As NO000307	Floor adhesive remnants	Ground Floor Hallway/passageway (Room G/028)	Does not contain asbestos.

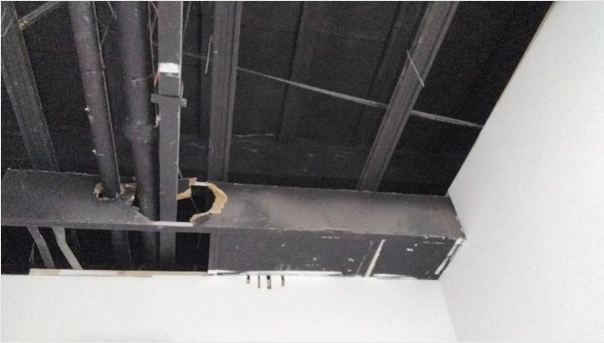
121.	NO000315	Ceiling tiles	Ground Floor Bin store (Room G/031)	Does not contain asbestos.

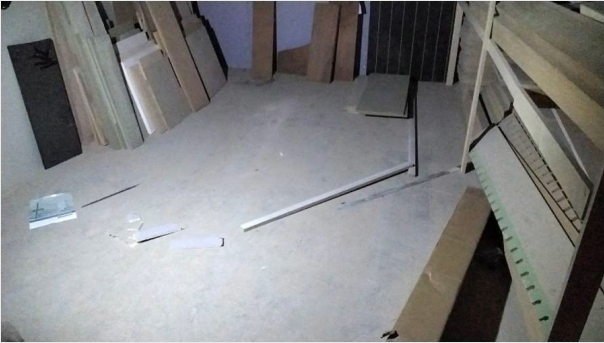
124.	As NO000307	Floor adhesive remnants	Ground Floor Store Room (Room G/032)	Does not contain asbestos.

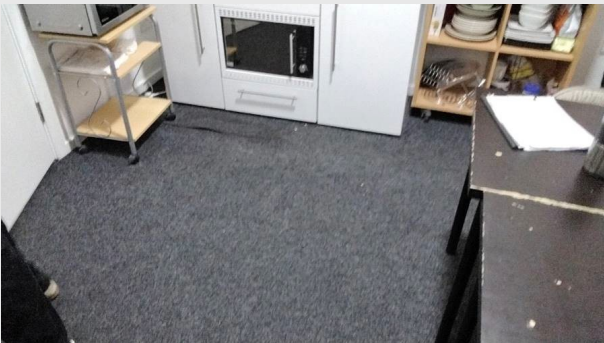
125.	As NO000307	Floor adhesive remnants	Ground Floor Staff Room (Room G/035)	Does not contain asbestos.

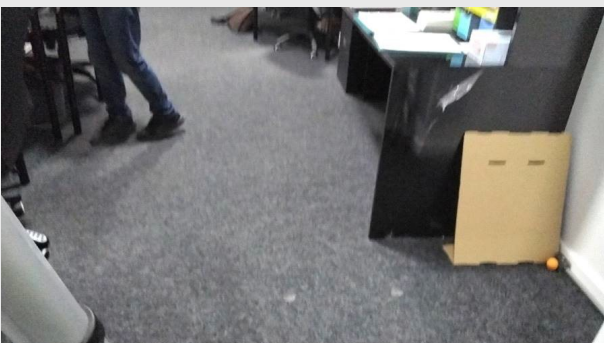
126.	As NO000307	Floor adhesive remnants	Ground Floor Office (Room G/036)	Does not contain asbestos.

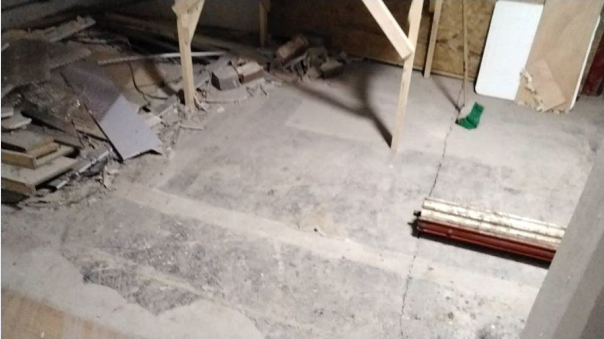
130.	As NO000307	Floor adhesive remnants	Ground Floor Staircase/Stairwell (Room G/039)	Does not contain asbestos.

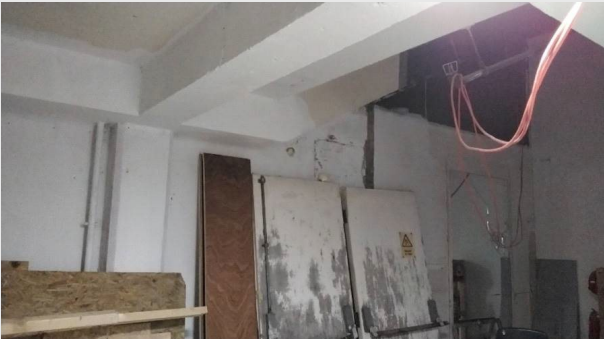
131.	NO000318	Wall – within hole in wall under stairs	Ground Floor Staircase/Stairwell (Room G/039)	Does not contain asbestos.

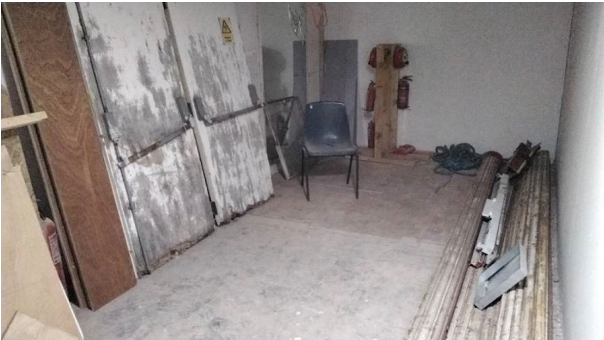
132.	NO000319	Window putty/seal to discarded window	Ground Floor Staircase/Stairwell (Room G/039)	Contains asbestos - Any change in its appearance should be recorded and passed to Property Services.

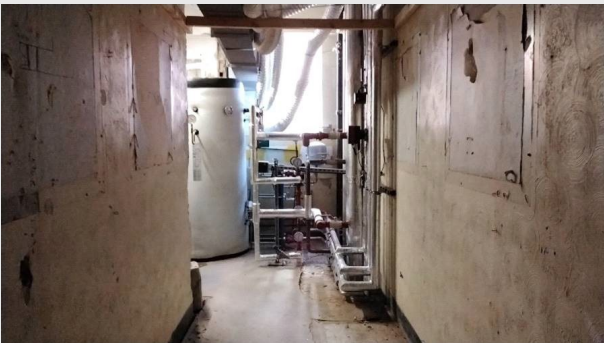
137.	NO000322	Wall Coating	Second Floor Plant Room (Room 2/004)	Does not contain asbestos.

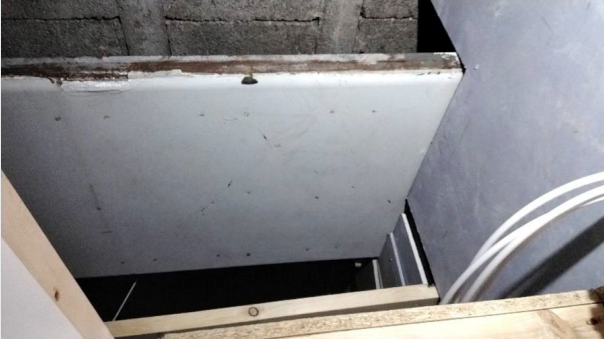
139.	NO000324	Ceiling void insulation top Of ceiling heater	Second Floor Hallway/passageway (Room 2/010)	Does not contain asbestos.

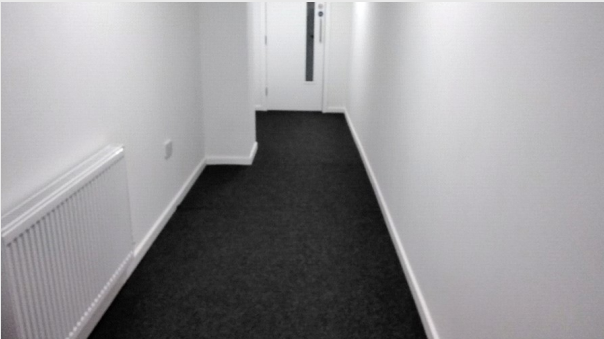
140.	As NO000321	Floor tile beneath carpet	Second Floor Hallway/passageway (Room 2/013)	Does not contain asbestos.

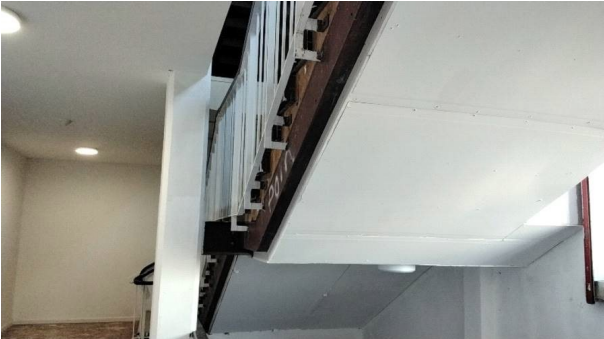
141.	NO000325	Debris/Residue to stairs	Second Floor Fire escape (Room 2/015)	Removed Sept 2023

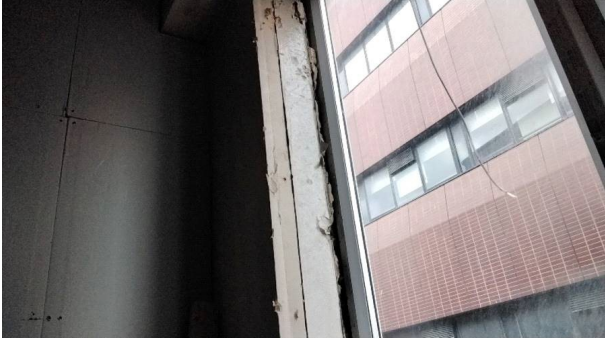
148.	NO000330	Window/putty seal from removed window	Second Floor Store Room (Room 2/018)	Contains asbestos - Any change in its appearance should be recorded and passed to Property Services.

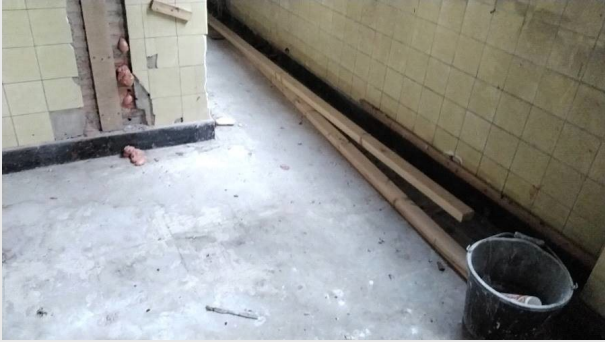
149.	As NO000321	Floor tile beneath carpet	Second Floor Store Room Former toilets (Room 2/019)	Does not contain asbestos.

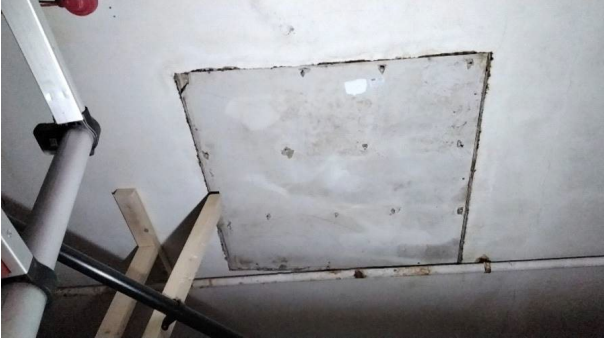
151.	NO000331	Ceiling void ceiling above panel	Third Floor Landing (Room 3/001)	Contains asbestos - Any change in its appearance should be recorded and passed to Property Services.

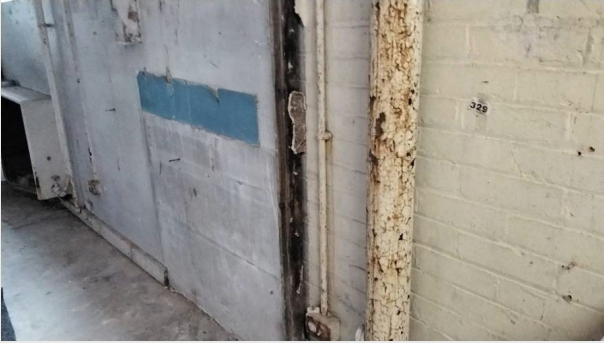
152.	NO000332	Wall tile	Third Floor Plant Room (Room 3/004)	Does not contain asbestos.

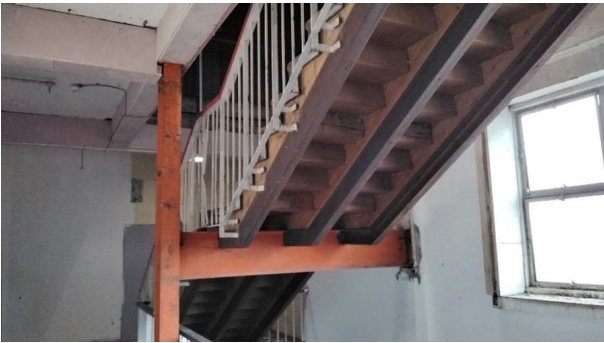
153.	NO000333	Debris/Residue to stairs	Third Floor Fire Escape (Room 3/016)	Contains asbestos - Any change in its appearance should be recorded and passed to Property Services.

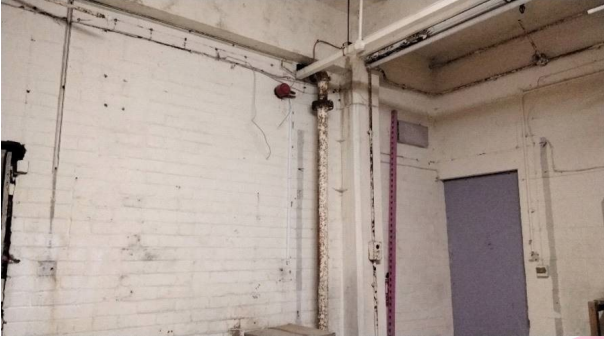
157.	Presumed	Pipework gaskets too deeply recessed to sample	Third Floor Store Room (Room 3/023)	Presumed to contain asbestos - Any change in its appearance should be recorded and passed to Property Services.

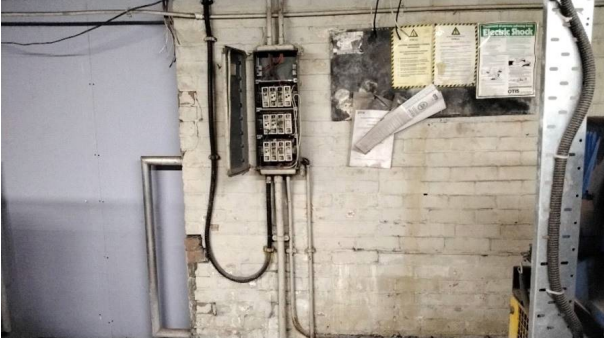
169.	NO000342	Fuses/flashguards isolation strips	Fourth Floor Lift Machinery Room (Room 4/008)	Contains asbestos - Any change in its appearance should be recorded and passed to Property Services.

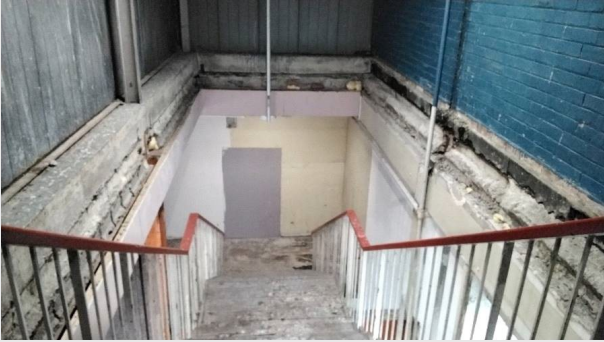
170.	NO000373	Roof felt remnants to concrete	Fourth Floor Fire escape (Room 4/058)	Does not contain asbestos.

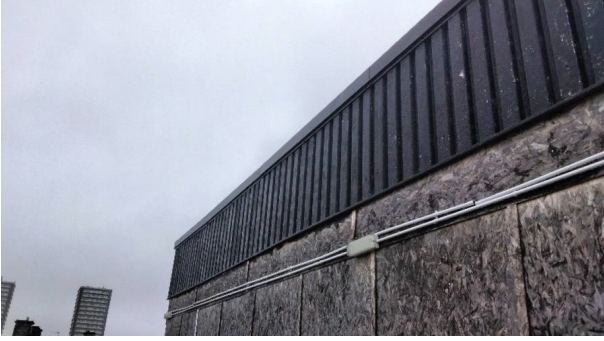
171.	NO000374	Wall coating to upper metal cladding	Fourth Floor External roof area (Room 4/059)	Contains asbestos - Any change in its appearance should be recorded and passed to Property Services.

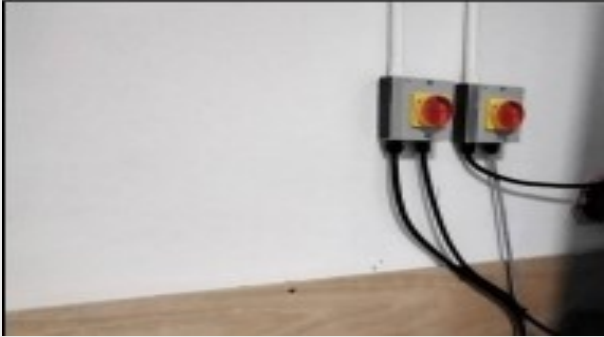
173.	NG001611	Wall panel	Ground Floor, Laundry (Room G/001)	Does not contain asbestos.

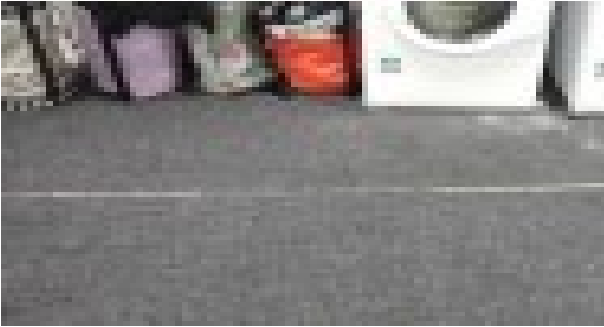
174.	NG001612	Floor tile (with adhesive) grey beneath carpet	Ground Floor, Laundry (Room G/001)	Contains asbestos - Any change in its appearance should be recorded and passed to Property Services.

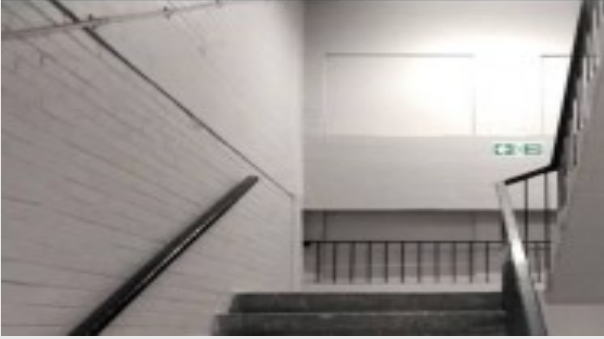
199.	NG001608	Wall coating	Staircase/Stairwell Emergency fire exit (Room 2/009)	Does not contain asbestos.

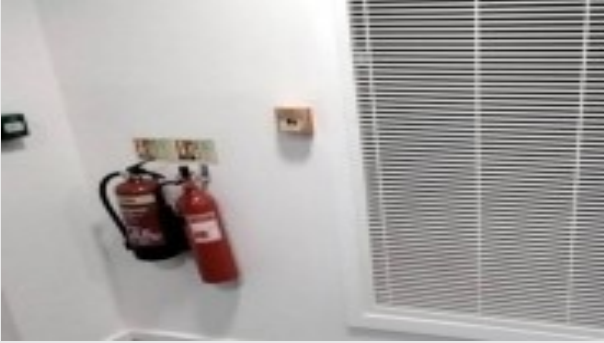
208.	NG001598	Wall panel	Entrance Hall/Foyer/Lobby (Room 3/005)	Does not contain asbestos.

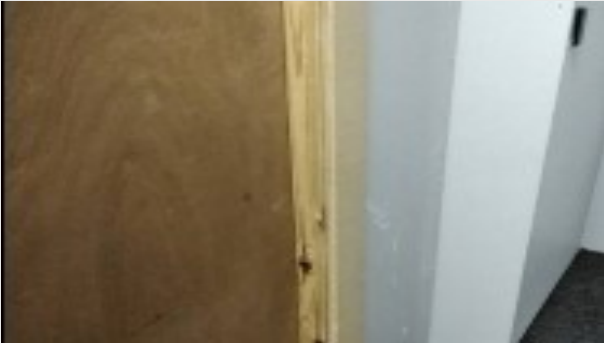
209.	NG001599	Wall panel	Staircase/Stairwell (Room 3/006)	Does not contain asbestos.

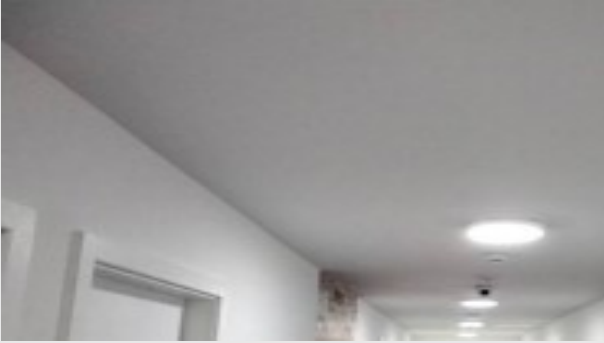
214.	As NG001614	Ceiling coating	Corridor West Corridor (Room 3/010)	Does not contain asbestos.

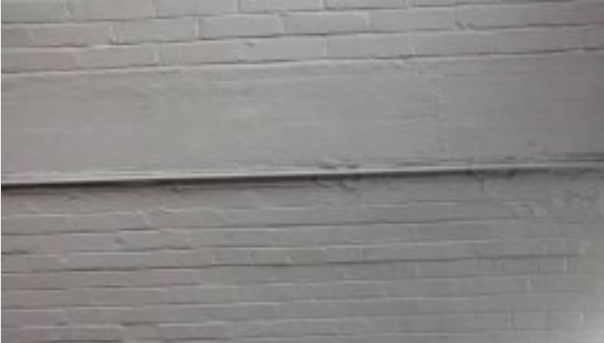
215.	NG001588	Wall coating to brickwork	Entrance Hall/Foyer/Lobby (Room 4/001)	Does not contain asbestos.

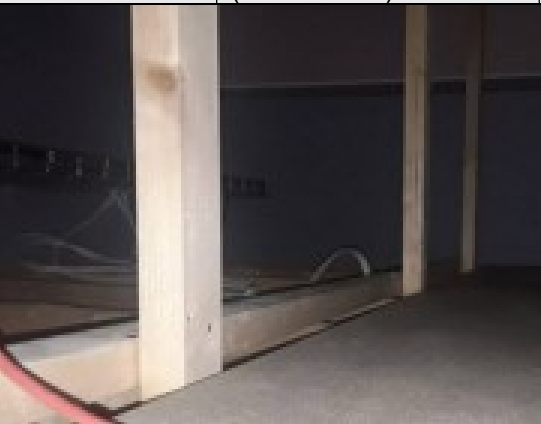
260.	NZ001402	Debris/Residue to ceiling floor below	Loft space within corridor to flats 415-416 (Room 4/003)	Does not contain asbestos.
