ASBESTOS SURVEY REPORT FOR ELDON GROVE ACADEMY, ELDON GROVE, HARTLEPOOL, TS26 9LY

Asbestos Register for Eldon Grove Academy

Date: 27 June 2025

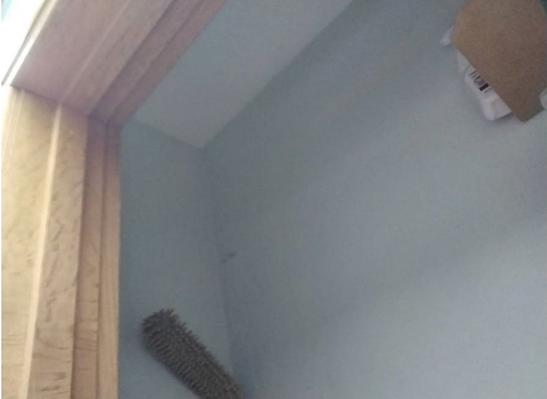
18	As SC004860	Ceiling Coating	Main building Ground Floor, Cleaners Cupboard (Room G/024)	Does not contain asbestos.

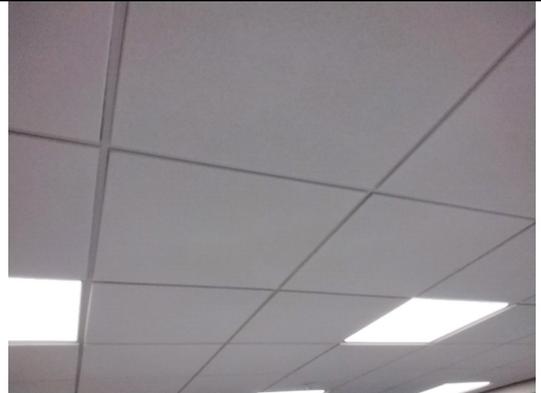
21	SC004861	Ceiling Coating	Main building Ground Floor, Classroom 7 (Room G/038)	Does not contain asbestos.

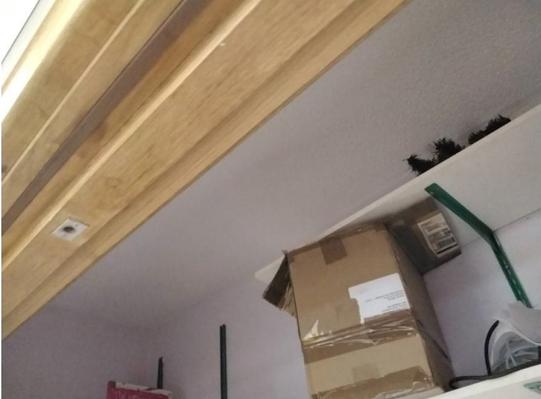
22	As SC004861	Ceiling Coating	Main building Ground Floor, Cupboard (Room G/039)	Does not contain asbestos.

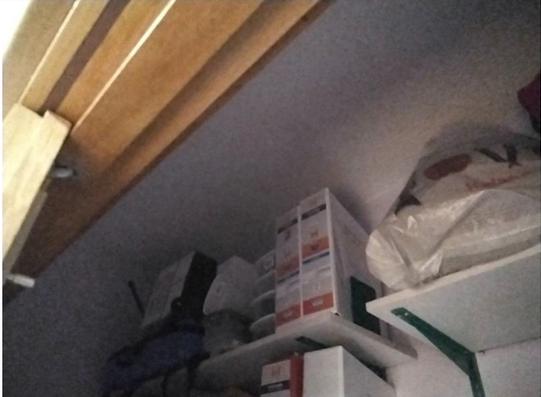
24	As SC004861	Ceiling Coating	Main building Ground Floor, Cupboard (Room G/042)	Does not contain asbestos.

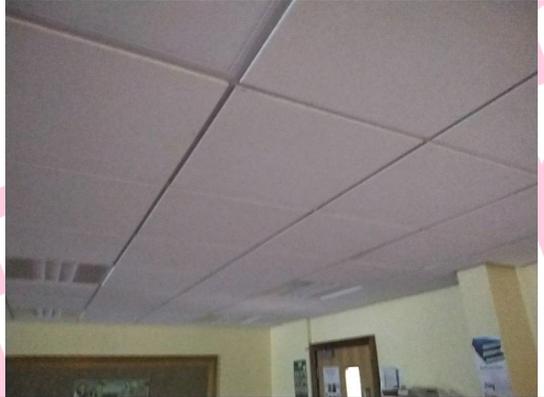
26	As SC004862	Ceiling Coating	Main building Ground Floor, Classroom 9 (Room G/044)	Does not contain asbestos.

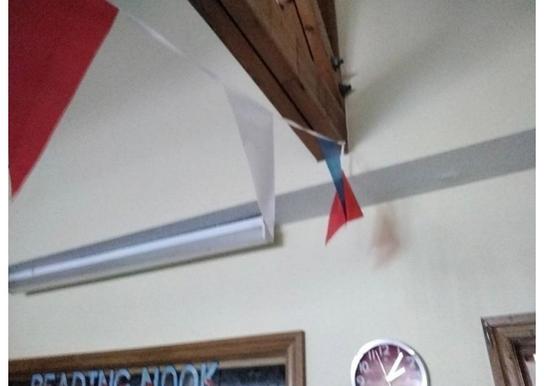
27	As SC004862	Ceiling Coating	Main building Ground Floor, Classroom 10 (Room G/045)	Does not contain asbestos.

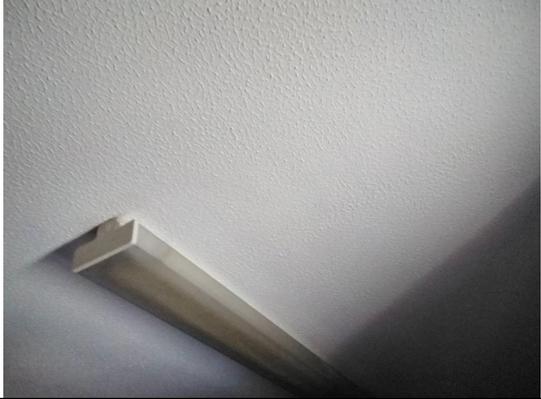
34	As SC004863	Ceiling Coating	Main building Ground Floor, Female Toilets (Room G/050)	Does not contain asbestos.

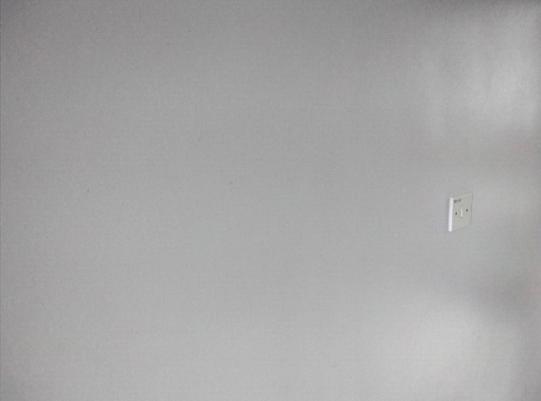
35	As SC004864	Wall Coating	Main building Ground Floor, Female Toilets (Room G/050)	Does not contain asbestos.

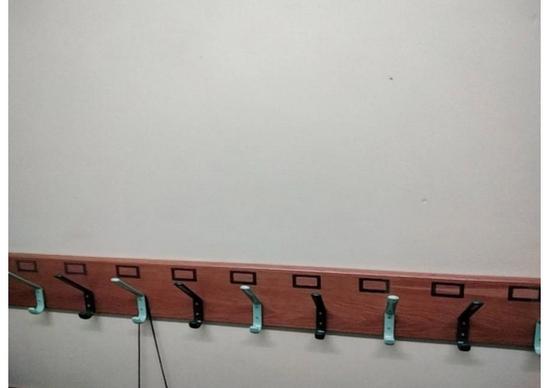
39	As SC004864	Wall Coating	Main building Ground Floor, Changing Room (Room G/052)	Does not contain asbestos.

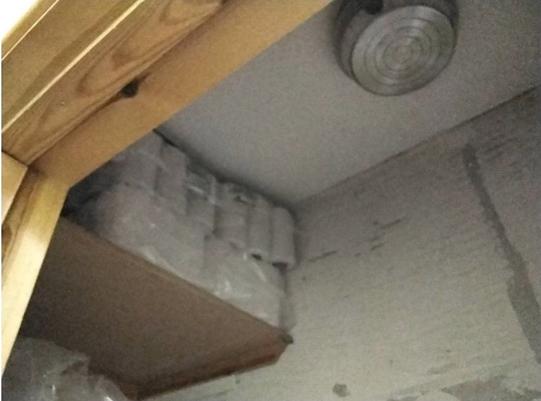
40	As SC004863	Ceiling Coating	Main building Ground Floor, Cleaners Cupboard (Room G/053)	Does not contain asbestos.

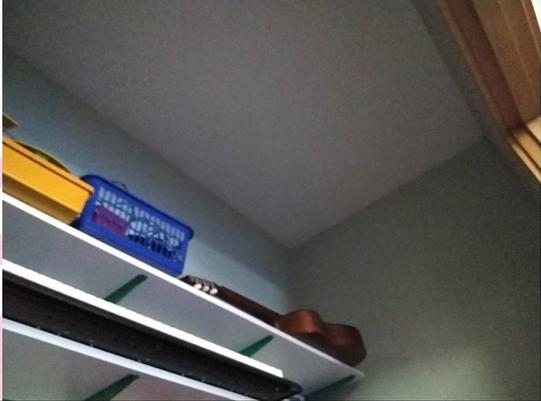
41	As SC004863	Ceiling Coating	Main building Ground Floor, Cupboard (Room G/055)	Does not contain asbestos.

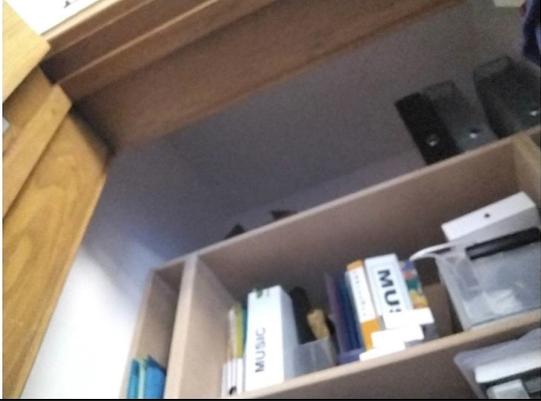
42	As SC004863	Ceiling Coating	Main building Ground Floor, Cupboard (Room G/056)	Does not contain asbestos.

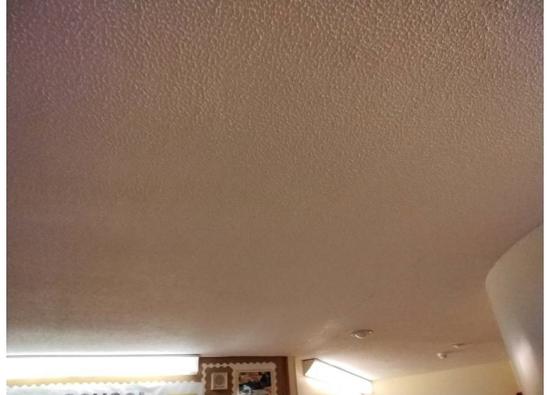
54	SC004867	Ceiling Coating	Main building Ground Floor, Key Stage 1 (Room G/072)	Does not contain asbestos.

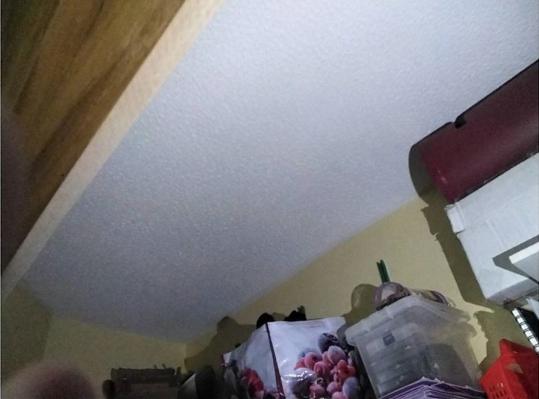
58	As SC004868	Ceiling Coating	Main building Ground Floor, Cupboard (Room G/077)	Does not contain asbestos.

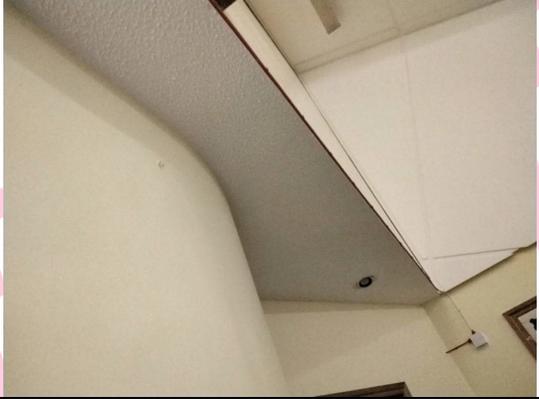
59	As SC004868	Ceiling Coating	Main building Ground Floor, Classroom 16 (Room G/078)	Does not contain asbestos.

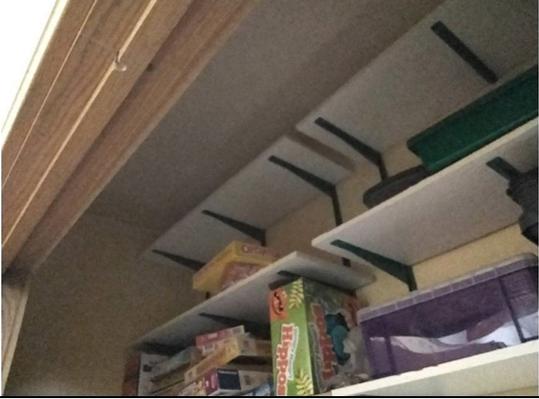
60	As SC004868	Ceiling Coating	Main building Ground Floor, Cupboard (Room G/079)	Does not contain asbestos.

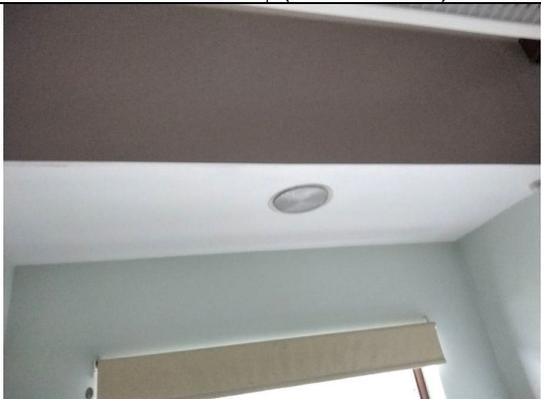
61	As SC004868	Ceiling Coating	Main building Ground Floor, Classroom 17 (Room G/081)	Does not contain asbestos.

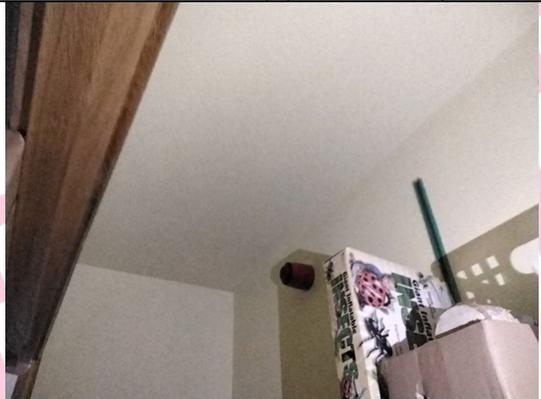
62	As SC004868	Ceiling Coating	Main building Ground Floor, Cupboard (Room G/082)	Does not contain asbestos.

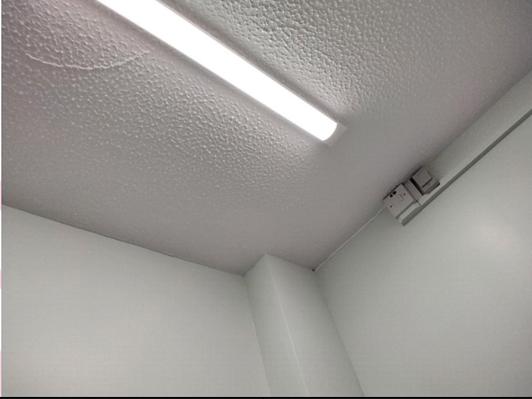
65	As SC004869	Ceiling Coating	Main building Ground Floor, Entrance Lobby (Room G/086)	Does not contain asbestos.

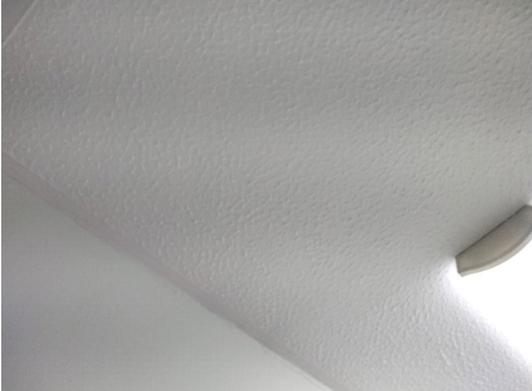
66	SC004870	Ceiling Coating	Main building Ground Floor, Staff WC (Room G/087)	Does not contain asbestos.

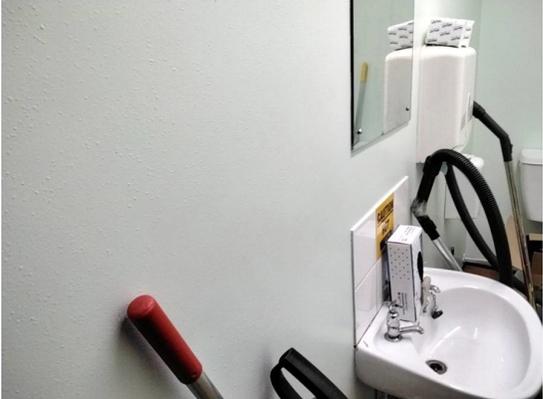
67	SC004871	Wall Coating	Main building Ground Floor, Staff WC (Room G/087)	Does not contain asbestos.

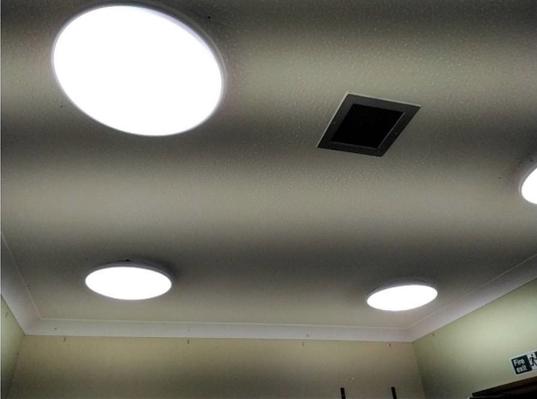
70	SC004872	Ceiling Coating	Main building Ground Floor, Staff Room Lobby (Room G/089)	Does not contain asbestos.

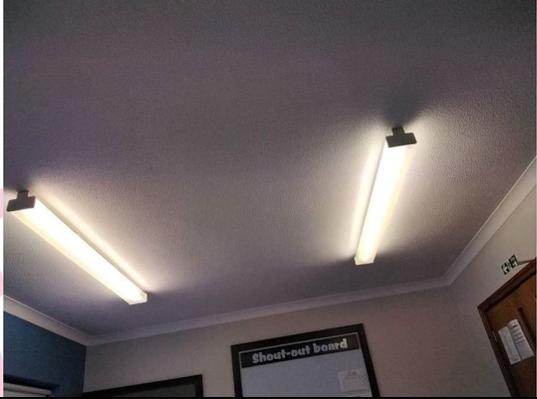
71	As SC004872	Ceiling Coating	Main building Ground Floor, Staff Room (Room G/090)	Does not contain asbestos.

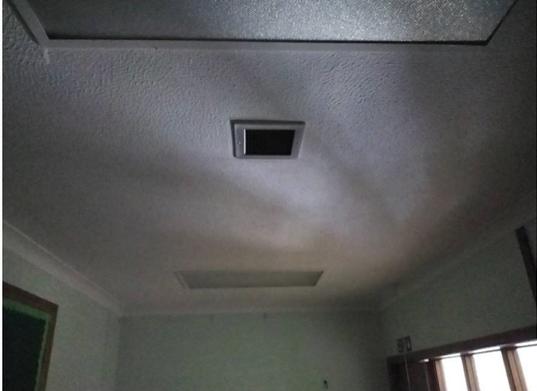
72	As SC004872	Ceiling Coating	Main building Ground Floor, Computer Room (Room G/093)	Does not contain asbestos.

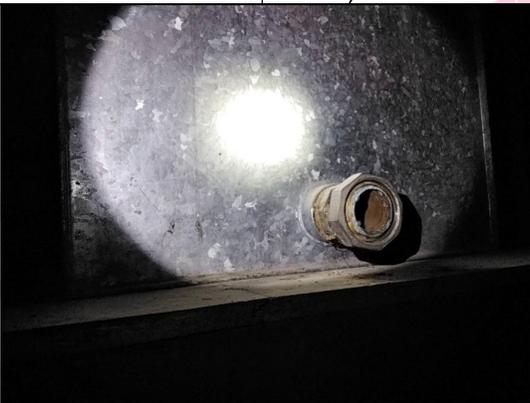
74	SC004887	Tank Pipework Gasket	Main building Roof void Loft space (Room R/001)	Does not contain asbestos.

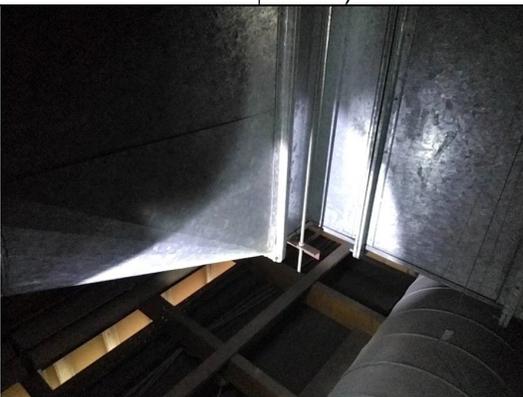
75	SC004888	Ductwork joints	Main building Roof void Loft space (Room R/001)	Does not contain asbestos.

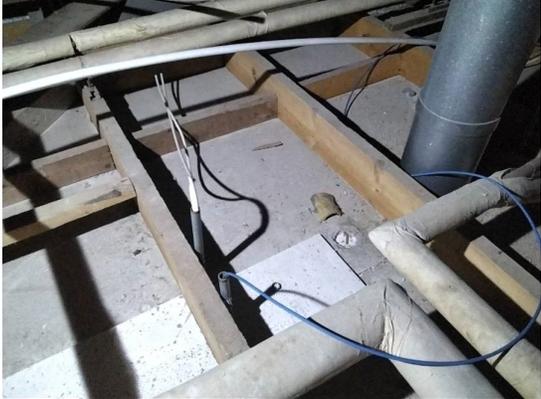
76	As SC004882	Ceiling	Main building Roof void Loft space (Room R/001)	Does not contain asbestos.

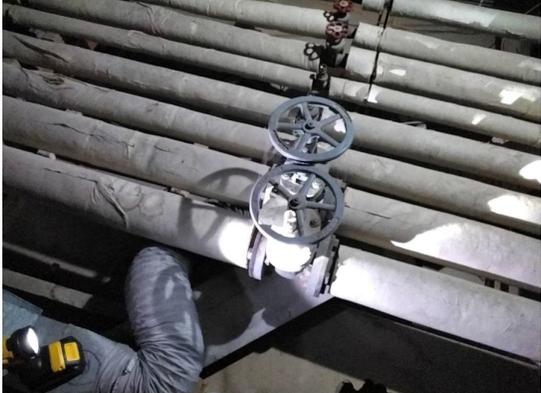
78	SC004889	Pipework Gasket	Main building Roof void Loft space (Room R/002)	Contains asbestos - Any change in appearance should be recorded and passed to Property Services.

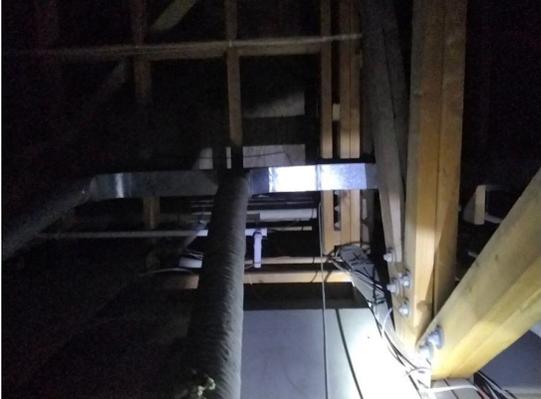
79	As SC004888	Ductwork joints	Main building Roof void Loft space (Room R/005)	Does not contain asbestos.

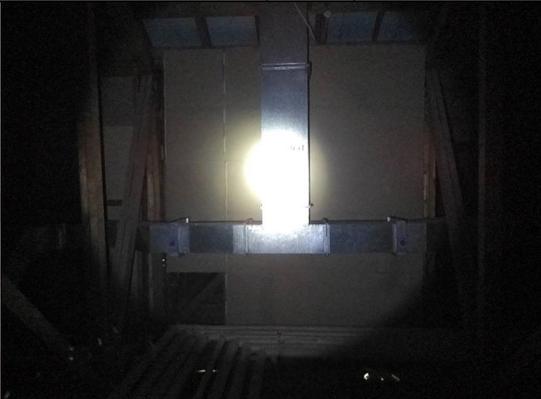
80	As SC004888	Ductwork joints	Main building Roof void Loft space (Room R/006)	Does not contain asbestos.

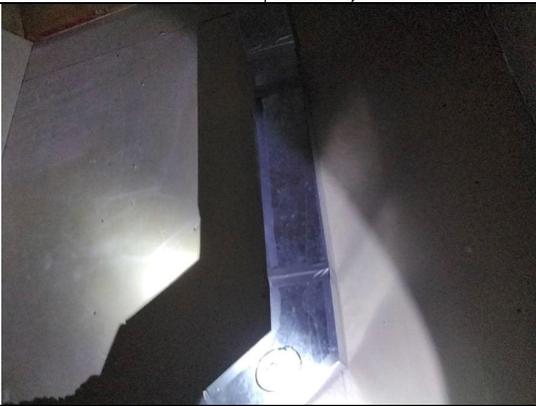
82	As SC004888	Ductwork joints	Main building Roof void Loft space (Room R/011)	Does not contain asbestos.

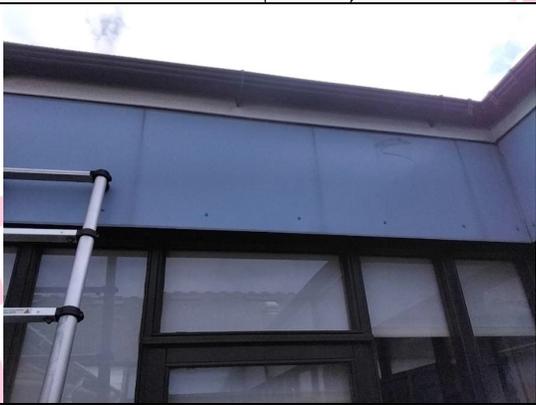
83	SC004874	Wall sheet cladding	Main building External Courtyard 1 (Room E/001)	Does not contain asbestos.

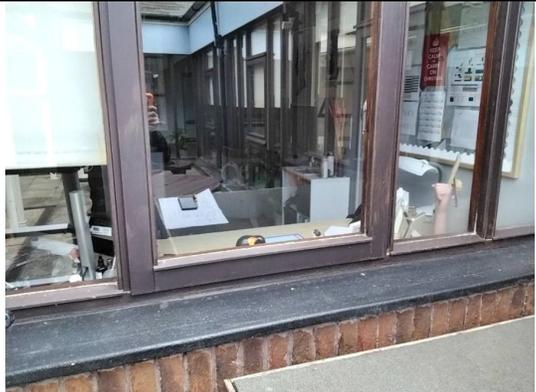
84	SC004875	Window beading putty/seal	Main building External Courtyard 1 (Room E/001)	Does not contain asbestos.

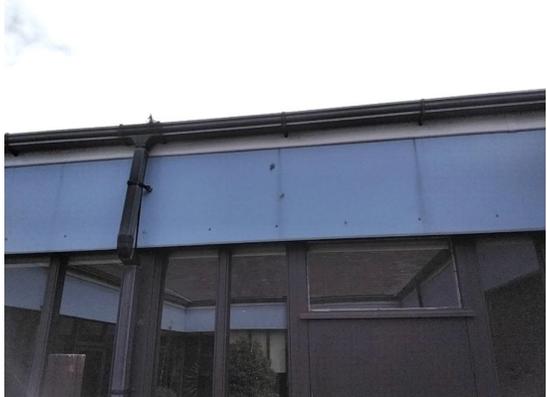
87	As SC004874	Wall sheet cladding	Main building External Courtyard 2 (Room E/002)	Does not contain asbestos.

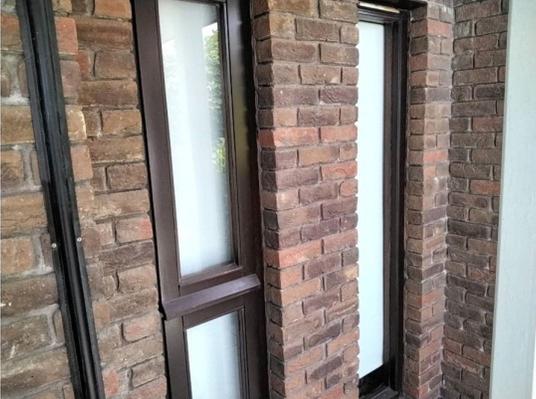
94	As SC004877	Window putty/seal	Main building External (Room E/003)	Does not contain asbestos.

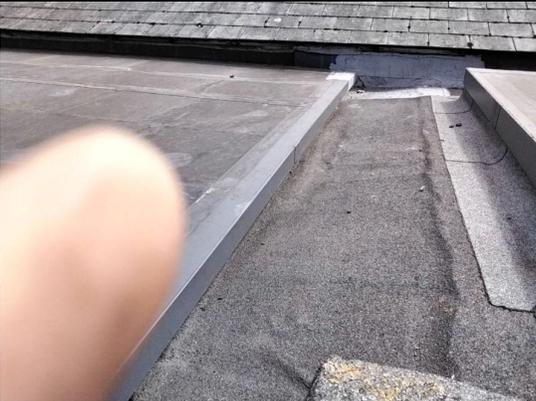
95	SC004878	Roof felt below all rubber coverings	Main building External (Room E/003)	Does not contain asbestos.

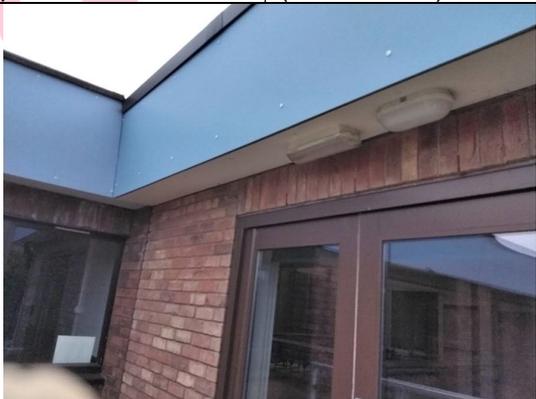
96	SC004879	Soffits to building perimeter	Main building External (Room E/003)	Does not contain asbestos.

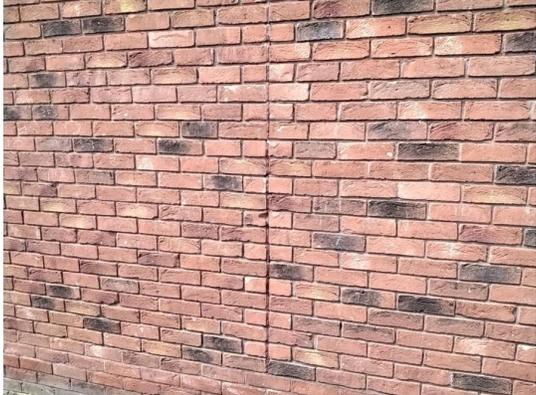
97	SC004880	Wall expansion joints	Main building External (Room E/003)	Does not contain asbestos.

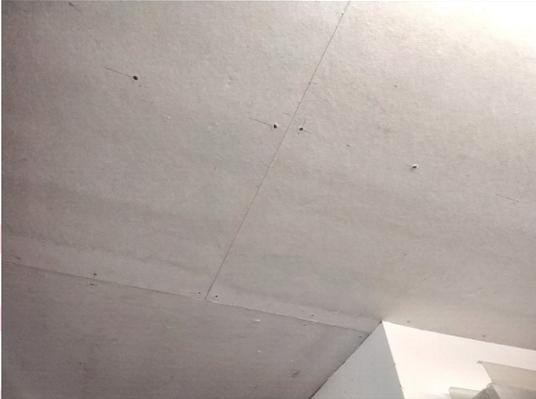
98	SC004881	Ceiling	Main building External Caretakers Store (Room E/004)	Does not contain asbestos.

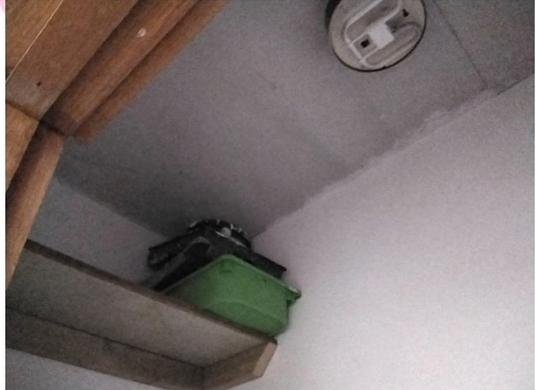
99	As SC004881	Ceiling	Main building External Toilets (Room E/005)	Does not contain asbestos.

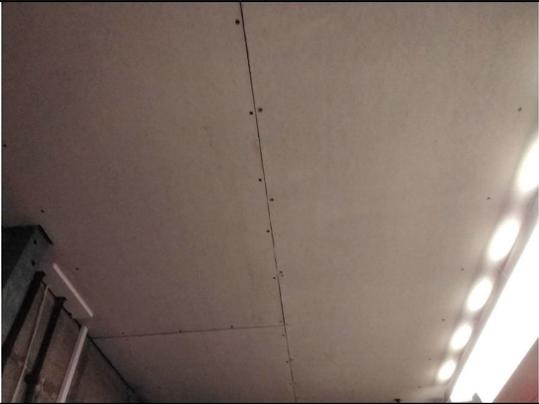
100	SC004882	Ceiling	Main building External Plant Room (Room E/006)	Does not contain asbestos.

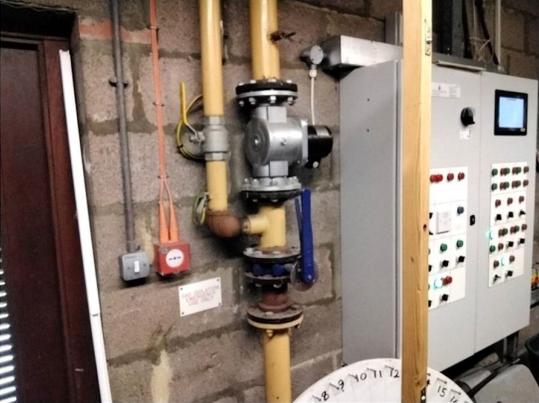
102	SC004884	Pipework Gaskets	Main building External Plant Room (Room E/006)	Does not contain asbestos.

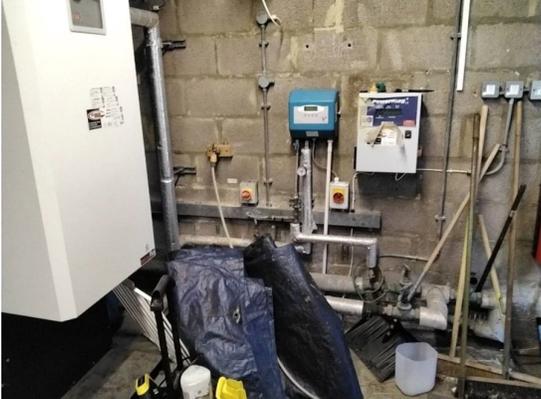
103	SC004885	Debris to ledges	Main building External Plant Room (Room E/006)	Does not contain asbestos.

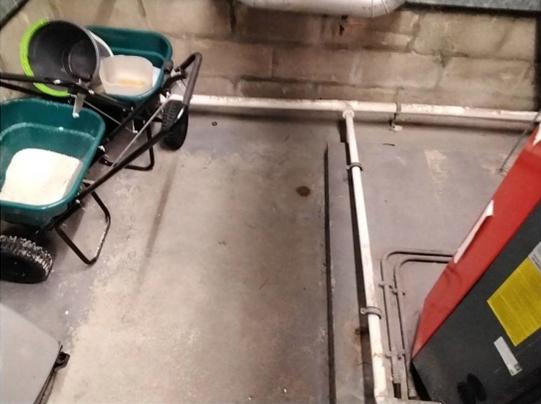
104	SC004886	Debris to floor	Main building External Plant Room (Room E/006)	Does not contain asbestos.

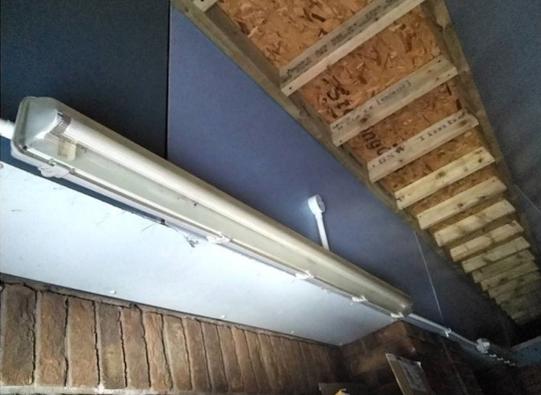
105	As SC004874	Wall sheet cladding	Main building External PE Cupboard (Room E/007)	Does not contain asbestos.

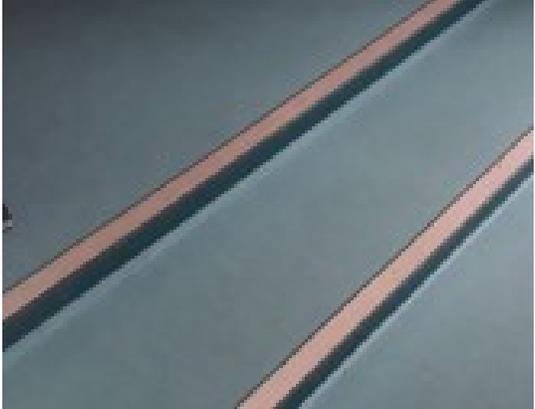
112	As NZ001423	Floor nosing to stairs	Main building Ground Floor Classroom D (Room G/004)	Does not contain asbestos.
